DART+ West Project
Section C: Barberstown to
Maynooth Depot

Stage 1 Road Safety Audit

Document Ref:	P22-021-PSW3-RP-001
----------------------	----------------------------

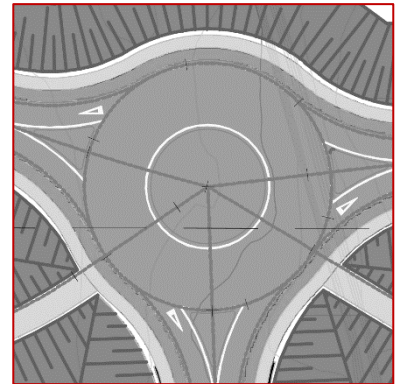
Summary: Large vehicles travelling through the roundabout junction may overhang pedestrian footpaths.

Information regarding the swept path of vehicles has not been provided to the Audit Team. Large vehicles (e.g. buses) may overhang the footpath as they manoeuvre through the roundabout, which may increase the risk of a collision with a pedestrian or cyclist.

A swept analysis should be undertaken to ensure large vehicles do not overhang pedestrian and/or cyclist facilities as they manoeuvre through the roundabout junction.

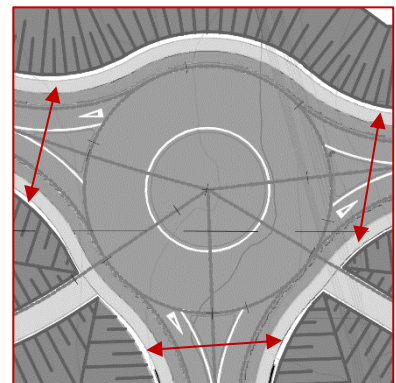
Summary: No pedestrian crossing indicated at the approaches to the R148 roundabout.

No pedestrian crossings are indicated at the proposed R148 roundabout layout. The proposed scheme can be expected to attract pedestrians to the area, many of which may wish to travel towards the surrounding amenities. A failure to provide crossing facilities along expected pedestrian desire lines could result in pedestrians, particularly mobility and visually impaired pedestrians, being unable to safely and independently navigate the proposed road layout.

Provide safe crossing locations on pedestrian design lines.

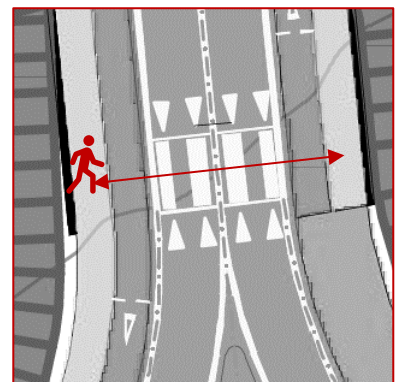
Summary: No safe access route between footpaths at the proposed raised table location.

A raised table is indicated at the southbound approach of the L5041 roundabout. However, to access the opposite footpath, pedestrians would be required to cross the cycle track where no crossing has been indicated. A lack of a formal crossing facilities may lead to an increased risk of pedestrians being struck by cyclists when attempting to cross the carriageway.

The segregated pedestrian /cycle track should transition into a shared use footway either side of the crossing. Additionally, tactile paving will be required at the pedestrian crossing.

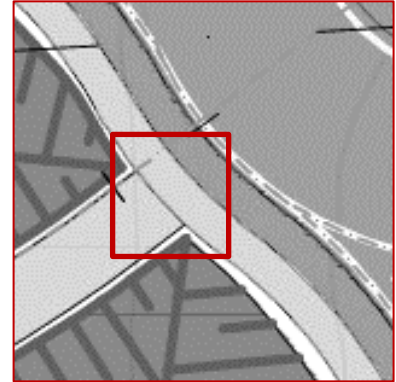
Summary: Visually impaired pedestrians may find it difficult to navigate the shared surfaces safely and independently.

A number of intersections between shared surfaces and segregated footpaths are shown. However, no tactile paving has been indicated at these intersections, resulting in visually impaired pedestrians not being advised/warned that they are entering a section of path which includes segregated pedestrian/cyclist facilities. This may increase the risk of visually impaired pedestrians inadvertently entering the cycle track, where they are at increased risk of being struck by a cyclist.

Tactile paving (e.g. “Ladder & Tramline”) should be provided at the interface between shared and segregated facilities.

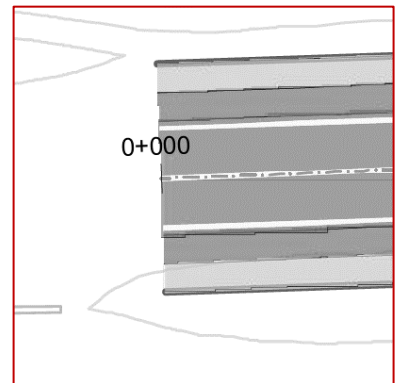
Summary: It is unclear if the proposed upgrade works sufficiently tie-into the existing road network.

As part of the L5041/R148 realignment works, amendments to the existing road layout have been indicated. It is unclear how the segregated pedestrian footways and cycleway will be tied into the existing R148 and L5041.

If the proposed upgrades do not sufficiently tie-into the existing road layout there is a risk that drivers will be directed into adjacent, or opposing, traffic lanes where there is an increased risk of side swipe or head-on collisions respectively.

Additionally, if safe transitions between the new cross section and the existing cross section are not fully considered at this early stage, there is a risk that locked-in land and road constraints lead to unsafe road layouts being developed at the next design stage.

Ensure the amended sections of carriageway and NMU (Non-motorised User) facilities sufficiently align with the existing road layout at the scheme tie-ins ensuring a smooth transition between the upgraded sections of carriageway to the old sections of carriageway.

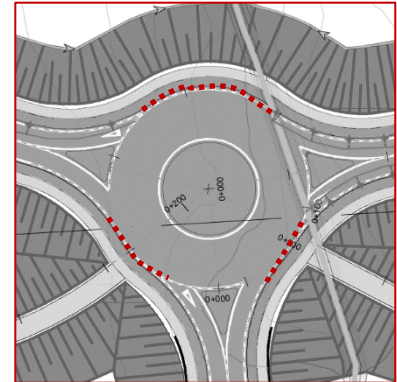
Summary: Unclear if the circulating carriageway will sufficiently drain surface water.

Information regarding the proposed drainage measures within the circulating carriageway have not been indicated. It is therefore unclear if the carriageway will sufficiently shed surface water. A failure to provide sufficient drainage measures could lead to ponding on the carriageway resulting in loss of control type collisions during wet or icy weather.

Ensure the circulating carriageway will be adequately drained.

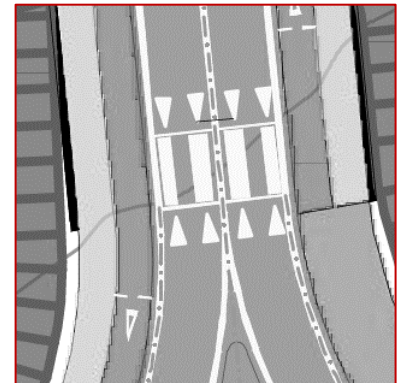
Summary: Unclear if there is sufficient drainage provision at raised table locations.

Drainage provision has not been indicated at the raised table. Should inadequate drainage measures be provided, this could lead to ponding on the footpath or carriageway resulting in slips, trips and falls during wet or icy weather.

Ensure that the footpath and carriageway is adequately drained, particularly at locations where raised tables are provided and where any low spots may exist.

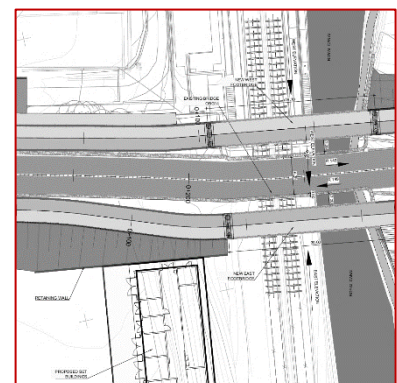
Summary: The vertical and horizontal alignment may lead to possible side-swipe collisions.

The combination of the steep vertical gradients, horizontal alignments and the narrow lanes may lead to poor lane discipline, and possible side-swipe and material damage collisions as opposing drivers cross the bridge.

Swept path analysis should be undertaken to confirm that opposing HGVs can safely pass each other on the structure. Additionally, traffic calming measures should be provided to passively control vehicle speeds on approach to the Leixlip Confey Bridge, along with warning signs to be provided advising of steep gradients and road narrowing.

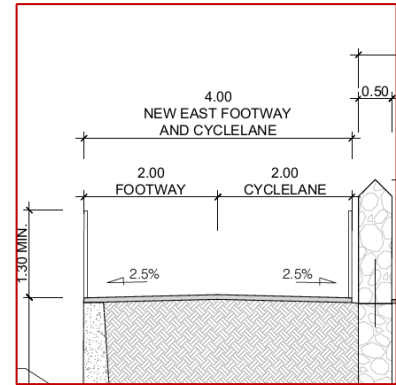
Summary: No difference in level is shown between the cycleway and footpath.

There is no difference in level between the cycleway and the footpath in the cross sections provided. This may result in visually impaired pedestrians inadvertently entering the cycleway resulting in conflicts with cyclists.

A level difference and kerbed upstand should be provided between the footpath and the cycleway.

Alternatively, contrasting materials should be used in the footway and cycleway to provide colour contrast, including a solid white line separating the two uses.

Ladder and tramline tactile paving should be provided at the start and end of the segregated facilities.

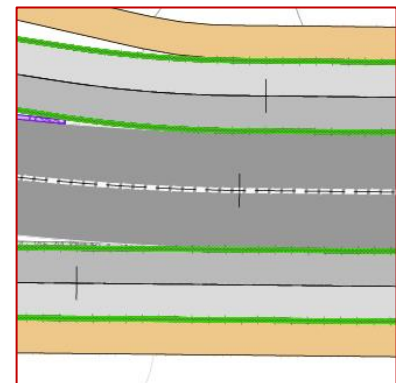
Summary: It is unclear how the proposed upgrade works will tie-into the existing road network.

It is unclear how the segregated ped/cycle facilities will tie into the existing road network up and downstream of the bridge construction.

If safe transitions between the new cross section and the existing cross section are not fully considered at this early stage, there is a risk that locked-in land and road constraints lead to unsafe road layouts being developed at the next design stage.

Ensure the amended sections of carriageway and NMU facilities sufficiently align with the existing road layout at the scheme tie-ins, ensuring a smooth transition between the upgraded sections of carriageway to the old sections of carriageway.

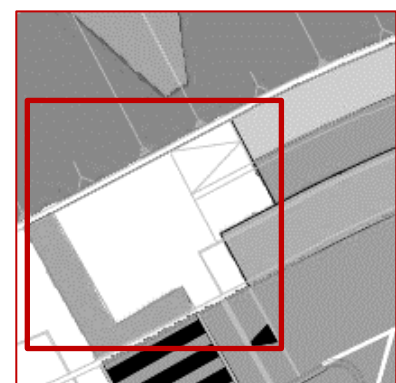
Summary: Tactile paving has not been indicated at the transitions between shared surfaces and segregated footways.

Tactile paving (e.g. ladder and tram) has not been indicated at the start and end of shared and segregated surfaces. This could lead to visually impaired pedestrians inadvertently entering the cycle track, or approaching shared surfaces and being unaware of the presence of cyclists, which may increase the risk of pedestrian-cyclist collisions.

Tactile paving (e.g. ladder and tram) should be provided at the interfaces between shared and segregated surfaces.

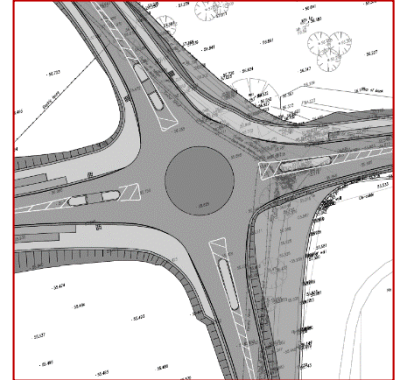
Summary: Unclear if the proposed roundabout can safely accommodate the swept path of large vehicles.

Information regarding the swept path of vehicles turning at this roundabout has not been provided to the Audit Team and it is therefore unclear if these vehicles can safely undertake U-turn manoeuvres at these locations. If this roundabout cannot accommodate the swept path of large vehicles there is a risk that they may overhang the footpath as they manoeuvre through the roundabout which may lead to a collision with a pedestrian or cyclist or collisions with items of roadside furniture.

A swept analysis should be undertaken to ensure all vehicles can be safely accommodated at the roundabout junction.

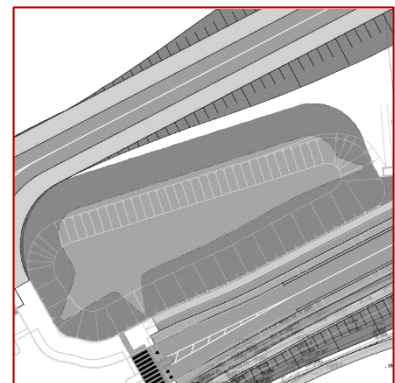
Summary: Maintenance access to attenuation ponds may lead to operatives parking their vehicles at unsafe locations where they may present hazards to other road users.

An attenuation or stormwater pond has been indicated. It is unclear how maintenance operatives will access the pond, or where they will park when servicing the pond. Insufficient or inappropriate access may lead to maintenance operatives parking their vehicle at unsafe locations such as within the carriageway, at accesses or on the footpath or cycle track where it will present obstacles to other road users.

Safe access and parking for maintenance operatives should be provided at proposed pond.

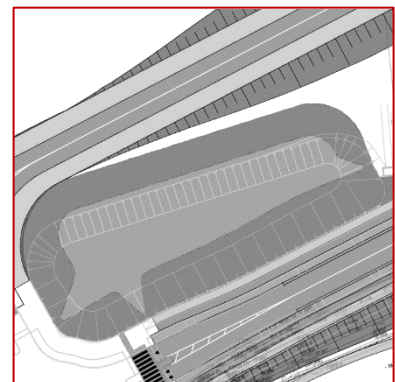
Summary: Edge protection has not been indicated at the proposed attenuation pond.

An attenuation or stormwater pond has been indicated within the proposed scheme. Edge protection has not been indicated at the pond. In some instances, this pond is located close to footpaths, which could increase the risk of pedestrians, especially small children, gaining access to the pond, where there is a risk of falling from height and possible drowning.

Additionally, a vehicle restraint system has not been indicated. The absence of a vehicle restraint system could result in an errant vehicle entering the pond, leading to increased injury severity for vehicle occupants.

Edge protection and vehicle restrain systems should be provided at the pond.

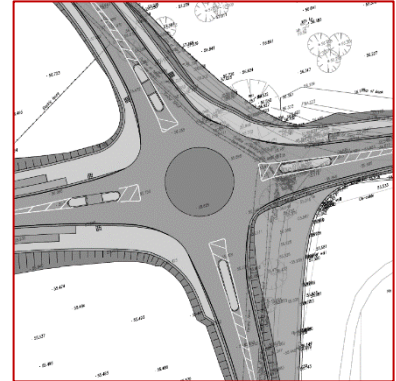
Summary: The splitter island locations may lead to poor lane discipline and possible material damage collisions.

The splitter islands on the approach to the roundabout stop short of the circulating carriageway. As road markings may fade over time, the junction layout may become less defined, resulting in poor lane discipline, and turning traffic on the circulating carriageway possibly over-running the yield line, which may increase the risk of side-on collisions.

The physical splitter islands should be extended to the yield line on all four approaches.

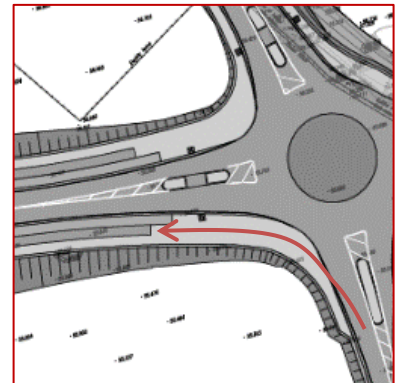
Summary: Cyclists may attempt to mount/dismount a full height kerb when accessing the off-road cycle track.

An off-road cycle track is provided at the western arm of the Milestown Roundabout. However, it is unclear how northbound cyclists travelling within the carriageway at the southern arm of the roundabout will gain access to the off-road cycle track at the western arm. The absence of cycle facilities connecting the off-road cycle track with the carriageway may lead to personal injury collisions where cyclists attempt to mount/dismount a full height kerb.

Cyclist facilities (e.g. ramp access) should be provided upstream of the roundabout, allowing cyclists to safely access the off-road cycle track in advance of the roundabout.

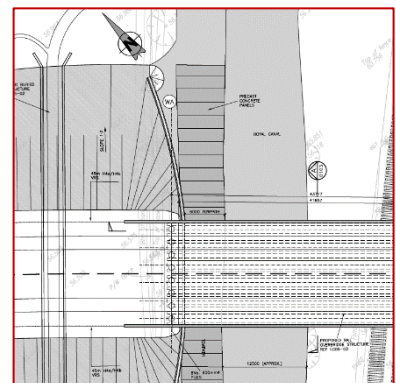
Summary: Risk of pedestrians and cyclists falling from height.

The shared pedestrian/cyclist track runs parallel to the canal edge. The RSA Team is concerned that a visually impaired pedestrian may be unaware of the canal towpath edge, and inadvertently fall into the canal, where there is a risk of drowning.

Ensure appropriate vegetation is placed along the edge of the canal to prevent pedestrians walking too near the edge, and that a safe minimum width is maintained at all points along the canal.

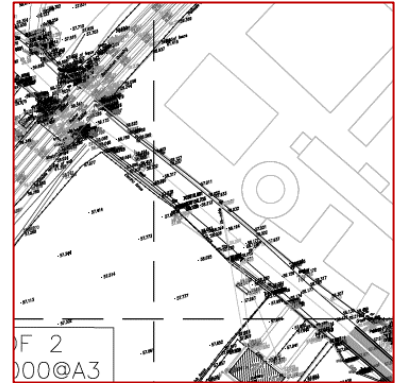
Summary: It is unclear how the carriageway will be terminated on the northern and southern side of the existing Barberstown level crossing after closure.

It is assumed that Milestown Road will be terminated on either side of the existing Barberstown level crossing. It is unclear if there is sufficient space to undertake U-turns at the end of each road. Insufficient space to safely turn a vehicle may increase the likelihood drivers reserving long distance to exit the cul de sac, leading to possible rear-end-shunt or material damage collisions.

A turning head should be provided at the end of each road, ensuring drivers have sufficient space to turn and exit the cul de sac.

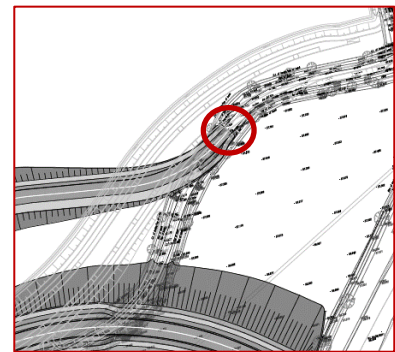
Summary: The proposed tie-in point between the new and old road cross sections is up-stream of a high demand bend.

The local road tie-in is at a high demand bend, where vehicles leave an improved cross section into an area with poor visibility and deficient cross section. Drivers leaving the new road may be unprepared to reduce their speed ahead of the narrow cross section/high demand bend, leading to possible loss of control and head-on collisions.

The new road tie-in should extent further east, to a point that is beyond the high demand bend, ensuring drivers have adequate visibility when transitioning between the new and old cross sections.

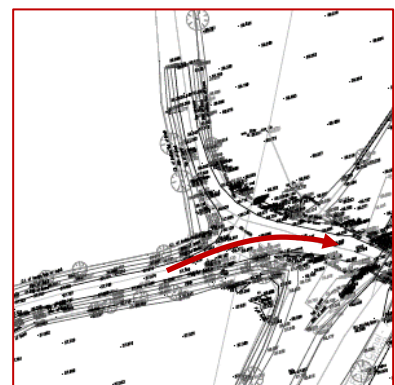
Summary: Poorly defined existing junction between Barberstown Lane North and Barberstown Lane South.

The existing junction between Barberstown Lane North and Barberstown Lane South is located northeast for the proposed Barberstown level crossing. The traffic at this junction is likely to increase due to the proposed works. However, the existing junction alignment and layout is substandard, and may increase the risk of eastbound drivers sighting into the primary road, which may contribute to overshoot collisions.

The existing junction should be revised to provide greater junction definition, and to passively slow vehicles turning into and out of the junction.

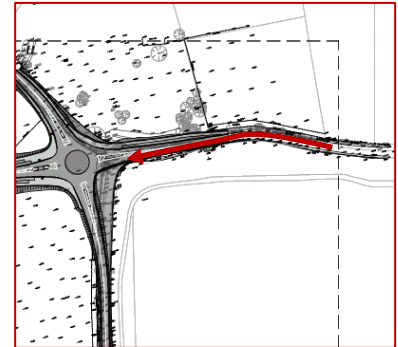
Summary: Westbound drivers may be unaware of the roundabout junction due to the horizontal alignment upstream of the junction.

Westbound drivers may be unaware of the roundabout junction, or possible queues forming at the roundabout, as forward visibility is limited by the horizontal alignment. Insufficient visibility to the roundabout junction may result in drivers failing to reduce their speed accordingly, leading to rear-end-shunt collisions.

The horizontal alignment on the approach to the roundabout should be amended to maximise forward visibility to the junction. Additionally, advance warning signs and road markings should be provided to warn drivers of the junction.

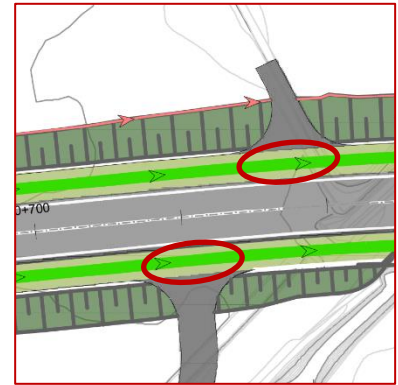
4.1 Grass verges are indicated between multiple side roads and the mainline carriageway at the L5041/R149 realignment works. It is assumed that this is a CAD error, however the drawing should be amended to correctly show the side road junctions connecting with the main road.

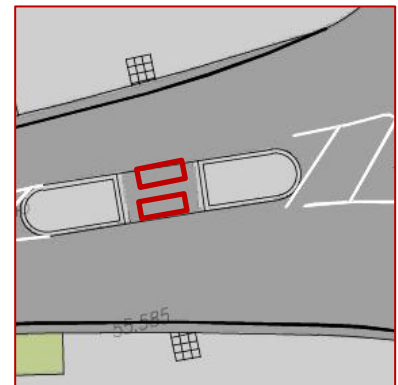
4.2 Tactile paving should be provided within the splitter island.

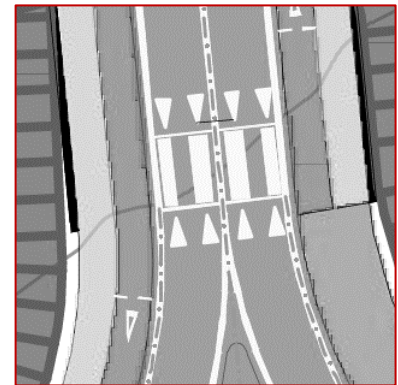
4.3 A raised table with a pedestrian crossing has been indicated across the L5041, however, the type of crossing proposed is unclear (appears to be a Zebra Crossing). An assessment should be undertaken to determine the most appropriate type of pedestrian crossing to use at this location.

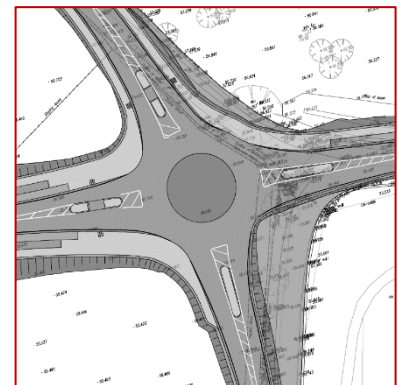
4.4 The junction control has not been indicated at the proposed roundabouts as part of Barberstown level crossing replacement works. Yield road markings and signs should be provided at the entrance to the roundabout circulating carriageway on all arms to clearly advise drivers of the priority at the roundabout.
