# APPENDIX A

# Building Inventories

Protected Structures Impact Statement

PARNELL SQUARE CULTURAL QUARTER  
 Architectural Heritage—Decorative Fabric Inventory  
 Nos. 20, 21, 23-28 Parnell Square, Dublin 1  
 November 2015—Shaffrey Associates Architects

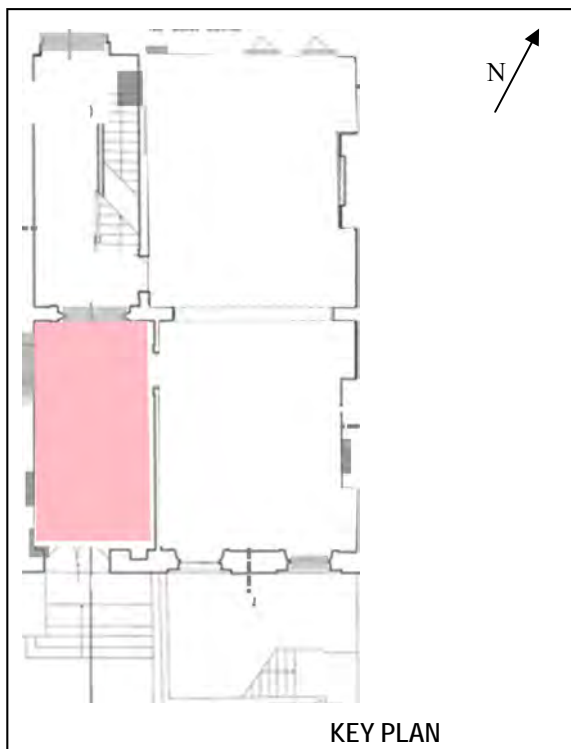
TYPE AND DESCRIPTION OF FABRIC Cornice: in medium-high relief; decorative frieze of foliate bunches forming trefoil arches.
BUILDING PHASE C18th
CONDITION Poor—fair

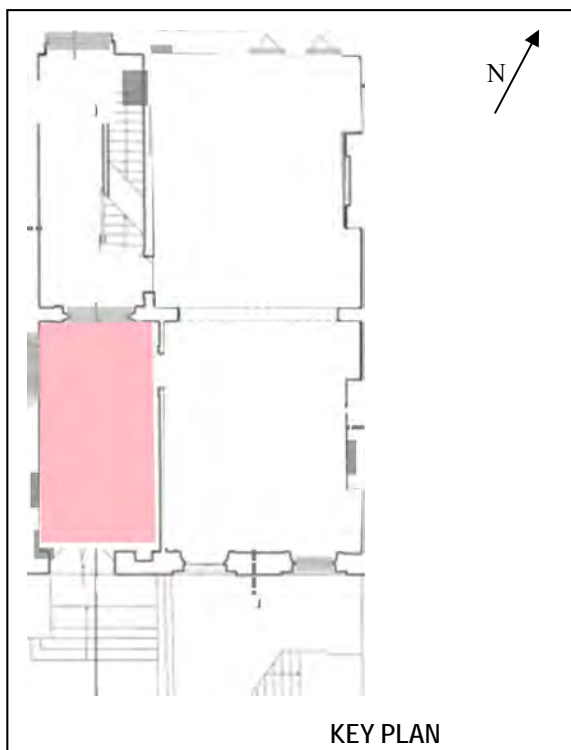
<b>TYPE AND DESCRIPTION OF FABRIC</b> Door to stair hall: arched opening; timber casing and surround with carved flanking pilasters having impost moulding to arch; carved surround to arch-way; 2-leaf timber doors with glazed panels.
<b>BUILDING PHASE</b> C18th surround, C20th doors
<b>CONDITION</b> Poor—fair

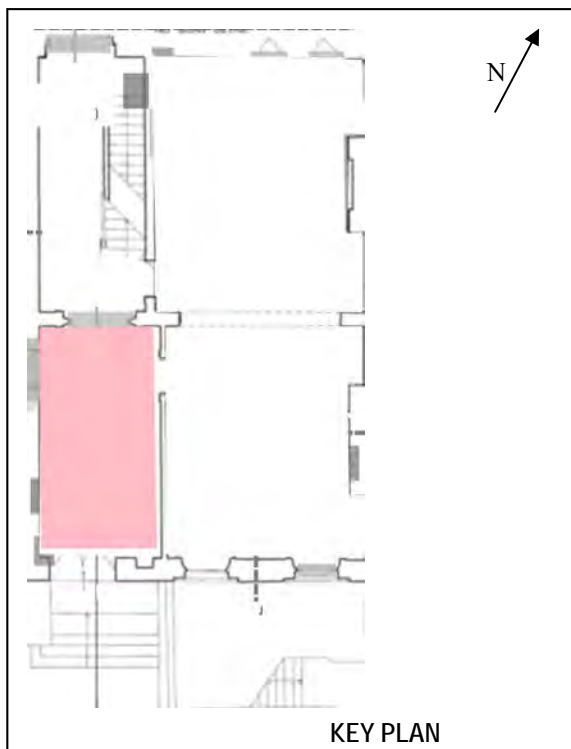
TYPE AND DESCRIPTION OF FABRIC Skirting: timber profile
BUILDING PHASE C18th
CONDITION Poor

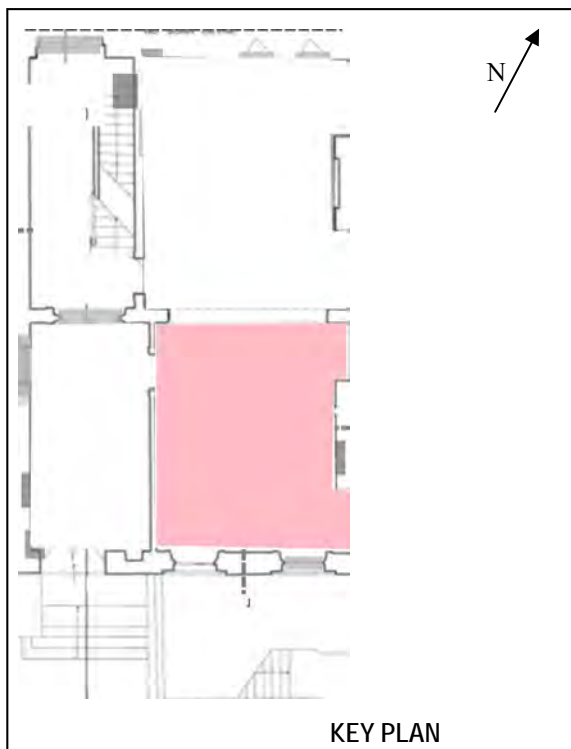
<b>TYPE AND DESCRIPTION OF FABRIC</b> Cornice: rinceau frieze in medium-high relief; heavily overpainted obscuring detail.
<b>BUILDING PHASE</b> C18th
<b>CONDITION</b> Poor

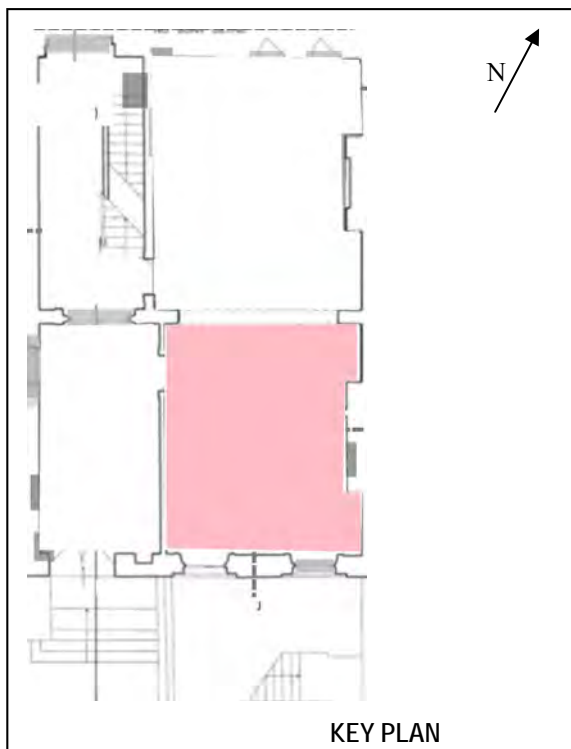
TYPE AND DESCRIPTION OF FABRIC Opening between front and rear rooms: elliptical archway; plasterwork detail to arch with keystone motif and impost mouldings to flanking walls.
BUILDING PHASE Early C20th
CONDITION Poor— fair

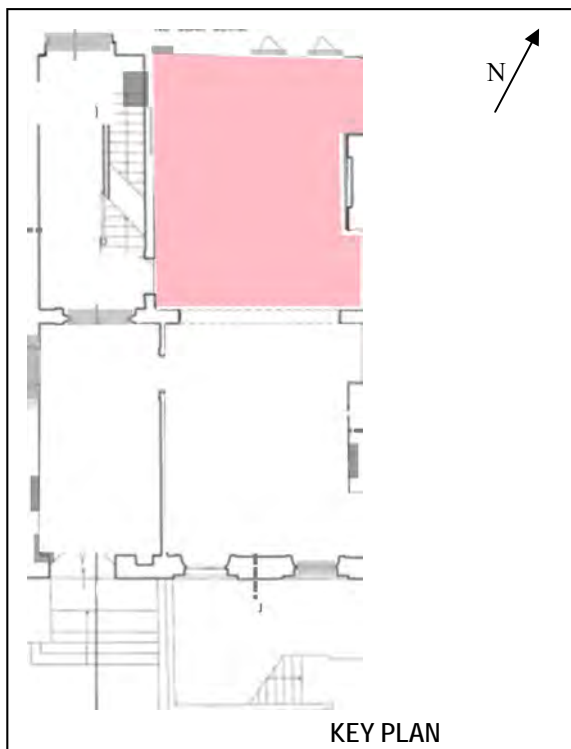
<b>TYPE AND DESCRIPTION OF FABRIC</b> Cornice: patterned frieze between moulded borders; heavily over-painted.
<b>BUILDING PHASE</b> C18th
<b>CONDITION</b> Poor

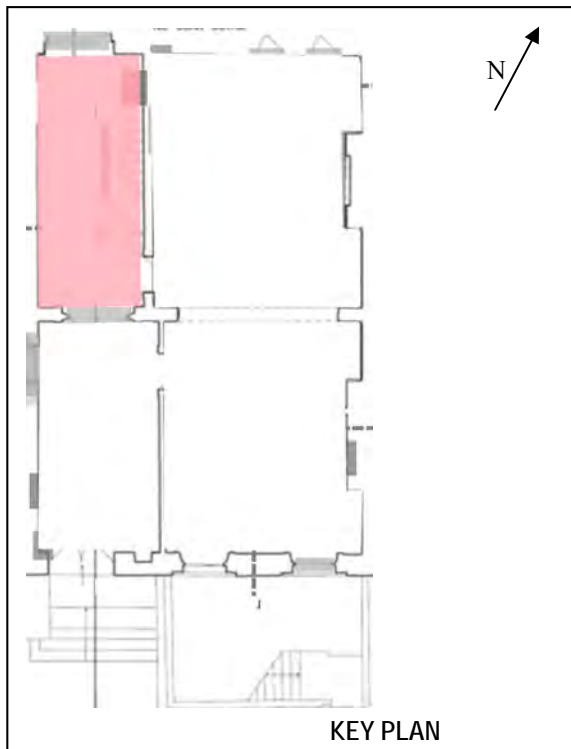
<b>TYPE AND DESCRIPTION OF FABRIC</b> Doors to rear/basement: timber casing; timber architrave; 2-leaf timber doors with glazed panels.
<b>BUILDING PHASE</b> C20th
<b>CONDITION</b> Poor

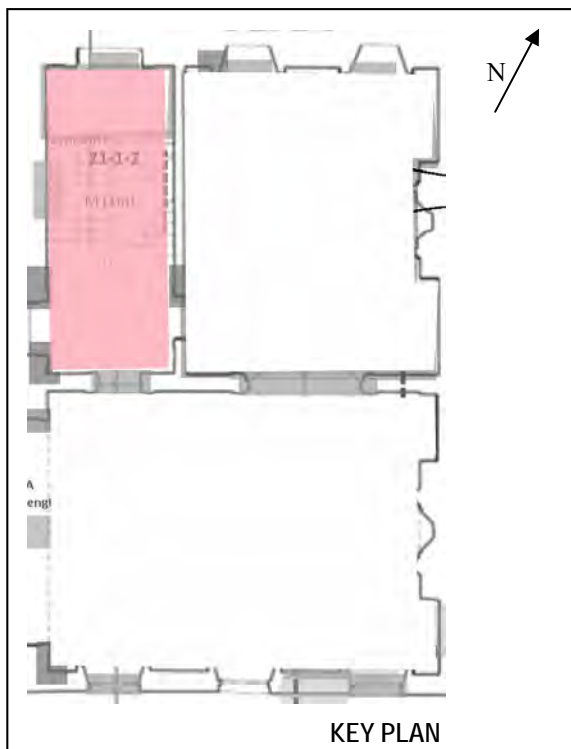
TYPE AND DESCRIPTION OF FABRIC Door to front reception room: timber casing; carved timber surround with modillion brackets, cornice and carved frieze; 6-panel timber door with brass door furniture.
BUILDING PHASE C18th
CONDITION Fair

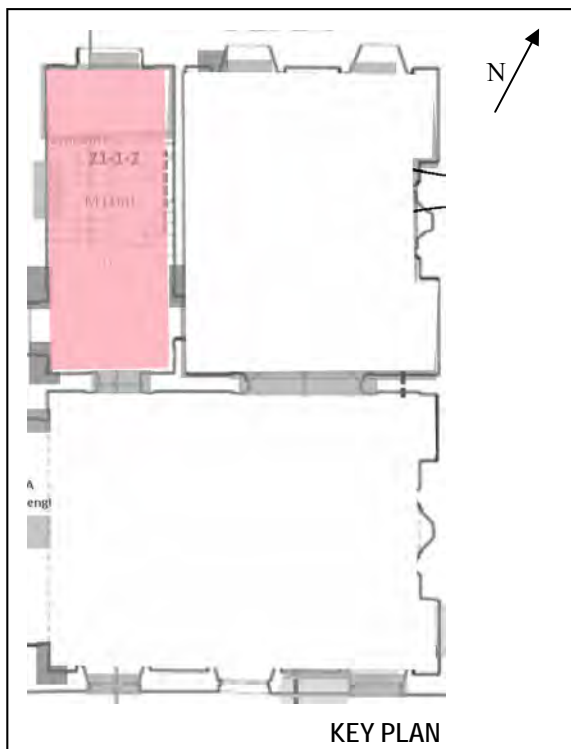
<b>TYPE AND DESCRIPTION OF FABRIC</b> Staircase: timber stairs with open string, having carved detail; turned paired balusters; mahogany handrail; elbow detail with swans neck and paired newel posts.
<b>BUILDING PHASE</b> C18th
<b>CONDITION</b> Poor—fair

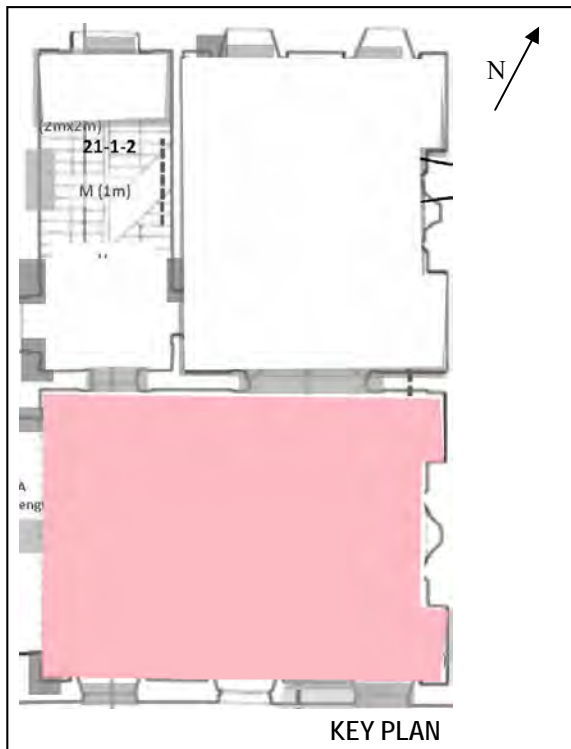
TYPE AND DESCRIPTION OF FABRIC Ceiling border decoration: low-medium relief; C-scrolls with rocaille; birds; cornucopias; baskets of flowers.
BUILDING PHASE C18th
CONDITION Fair

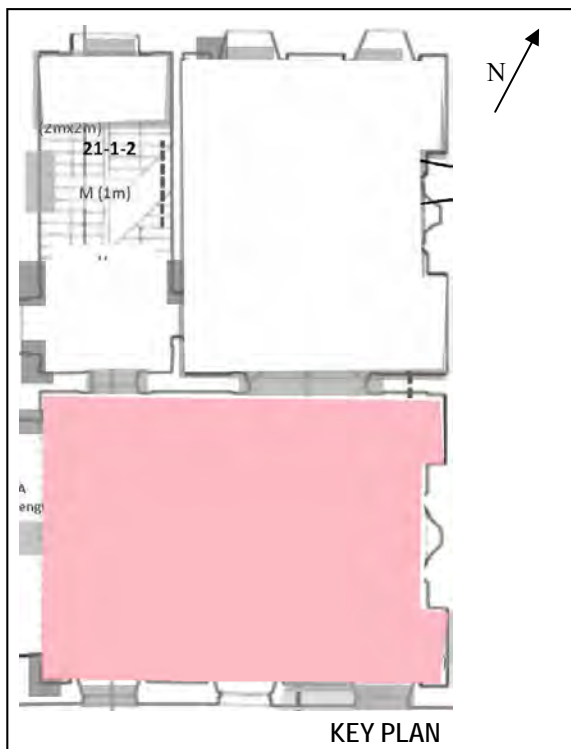
TYPE AND DESCRIPTION OF FABRIC Window, W (RHS internally): timber casing with panelled shutters; timber architrave extending to floor; single-pane sliding timber sashes.
BUILDING PHASE C19th
CONDITION Poor—fair

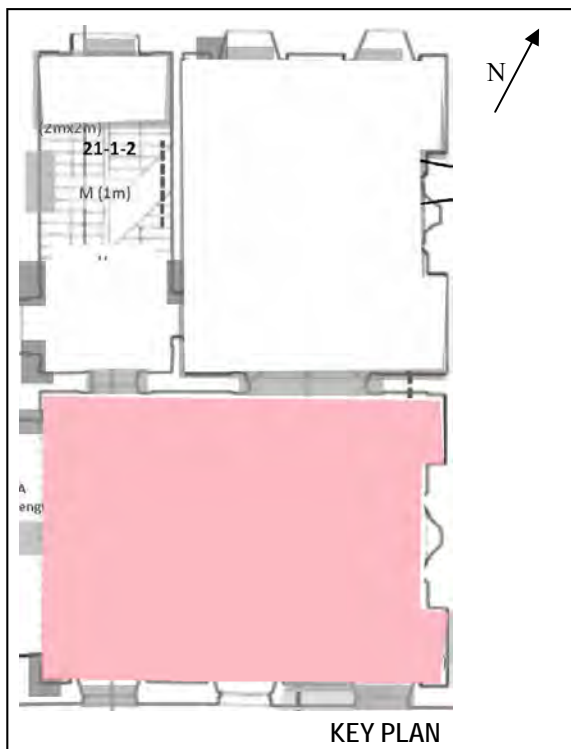
TYPE AND DESCRIPTION OF FABRIC Partition doors to No.21: opening extending across majority of party wall; timber casing; timber architrave; multi-leaf folding/sliding timber doors.
BUILDING PHASE C20th
CONDITION Poor—fair

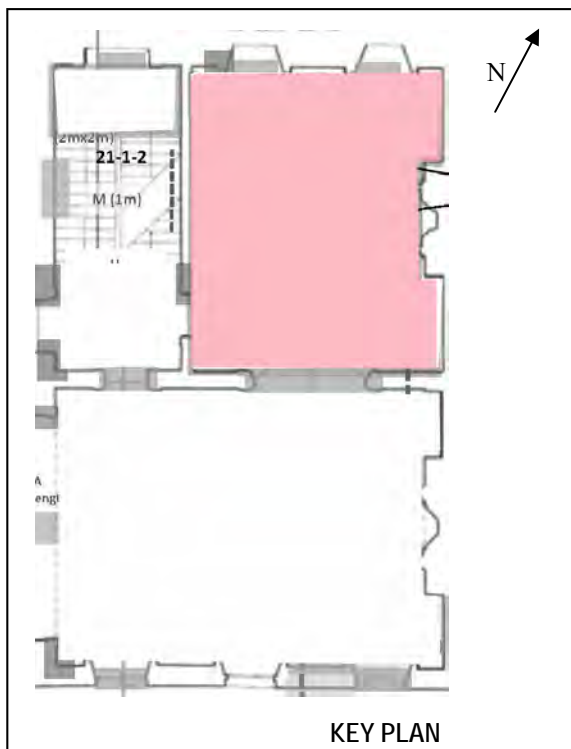
<b>TYPE AND DESCRIPTION OF FABRIC</b> Cornice: medium-high relief; rinceau mouldings and floral details between borders.
<b>BUILDING PHASE</b> C18th
<b>CONDITION</b> Poor—fair

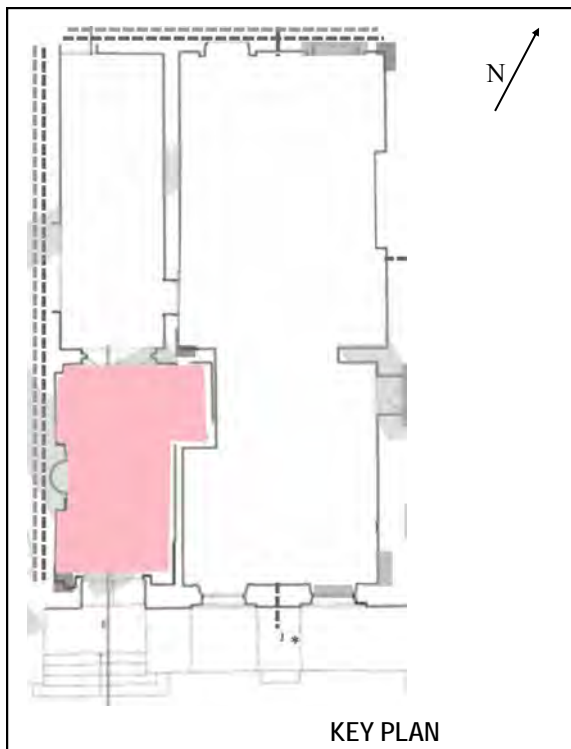
TYPE AND DESCRIPTION OF FABRIC Cornice: in medium-high relief; decorative frieze of foliate bunches forming trefoil arches.
BUILDING PHASE C18th
CONDITION Fair

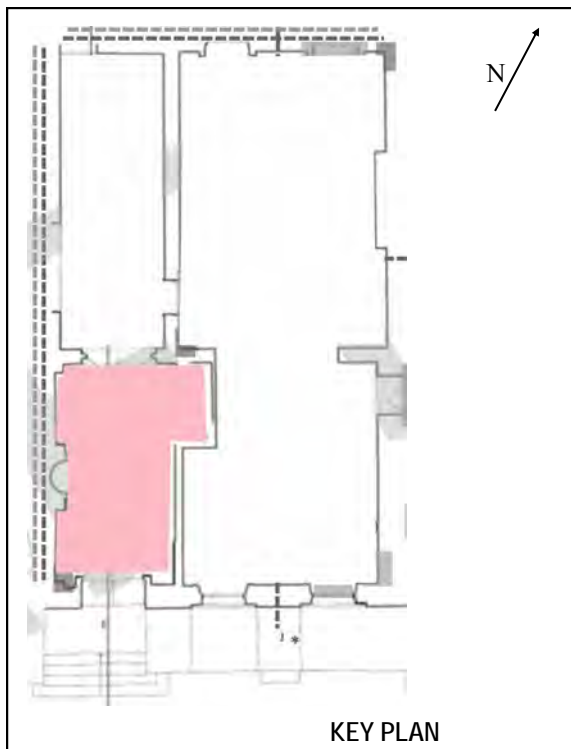
<b>TYPE AND DESCRIPTION OF FABRIC</b>
Wall niches: Central arched niche with flanking pilasters and moulded plasterwork arch; stone slab at plinth level; plain flanking arches either side of central niche.
<b>BUILDING PHASE</b>
C18th
<b>CONDITION</b>
Fair

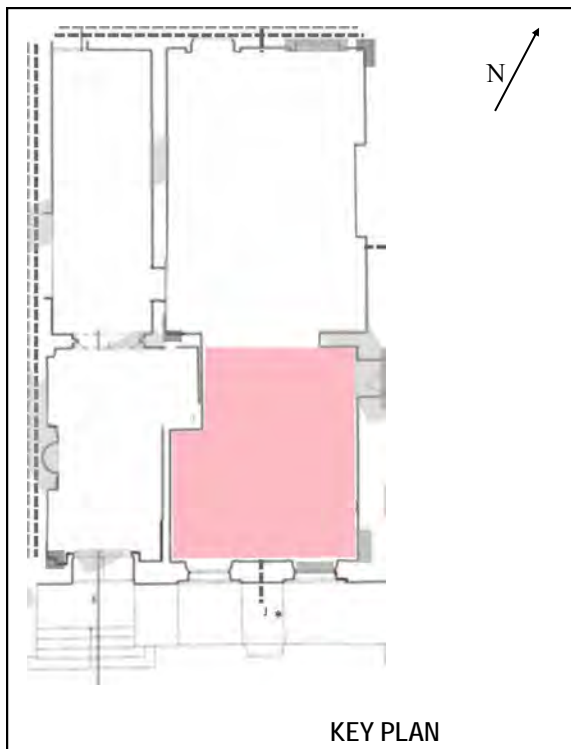
TYPE AND DESCRIPTION OF FABRIC Cornice: medium relief; heavily overpainted
BUILDING PHASE C18th
CONDITION Poor—fair

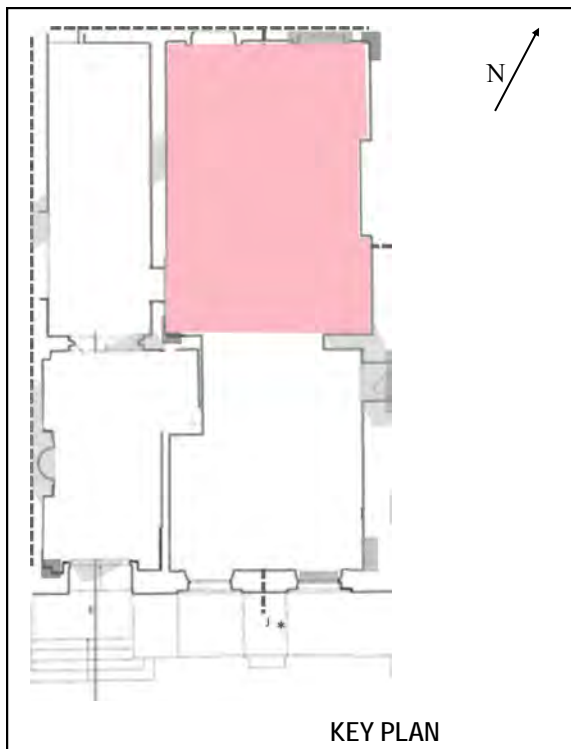
TYPE AND DESCRIPTION OF FABRIC Door to former stair hall: timber casing; lugged and shouldered timber architrave; 6-panel timber door leaf.
BUILDING PHASE C18th
CONDITION Fair
