ASBESTOS SURVEY REPORT

(Refurbishment / Demolition Survey)

**Location: Belgard House,
Belgard Road, Tallaght, Dublin 24**

Report No. PE 17-641

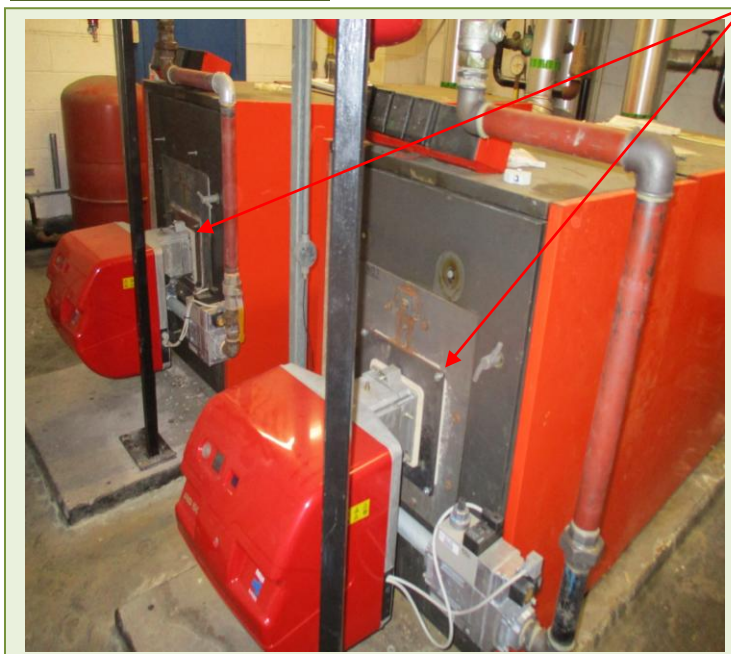
MATERIAL ASSESSMENT		PRIORITY ASSESSMENT
Product type	CAF gasket	Normal occupant activity	N/A
Extent of damage	Medium damage	Likelihood of disturbance	N/A
Surface treatment	None	Human exposure potential	N/A
Asbestos type	Chrysotile	Maintenance activity	N/A
	Material assessment score N/A	TOTAL SCORE: N/A	Priority assessment score N/A

The Compressed Asbestos Fibre (CAF) Gaskets identified behind the front plate of the boiler unit in the 1st floor boiler room contains Chrysotile (white) asbestos fibers. CAF gaskets contain almost 100% asbestos fibres, with a small amount of binder

The CAF gaskets should be removed by an asbestos removal contractor and disposed of as asbestos waste before the demolition works commence

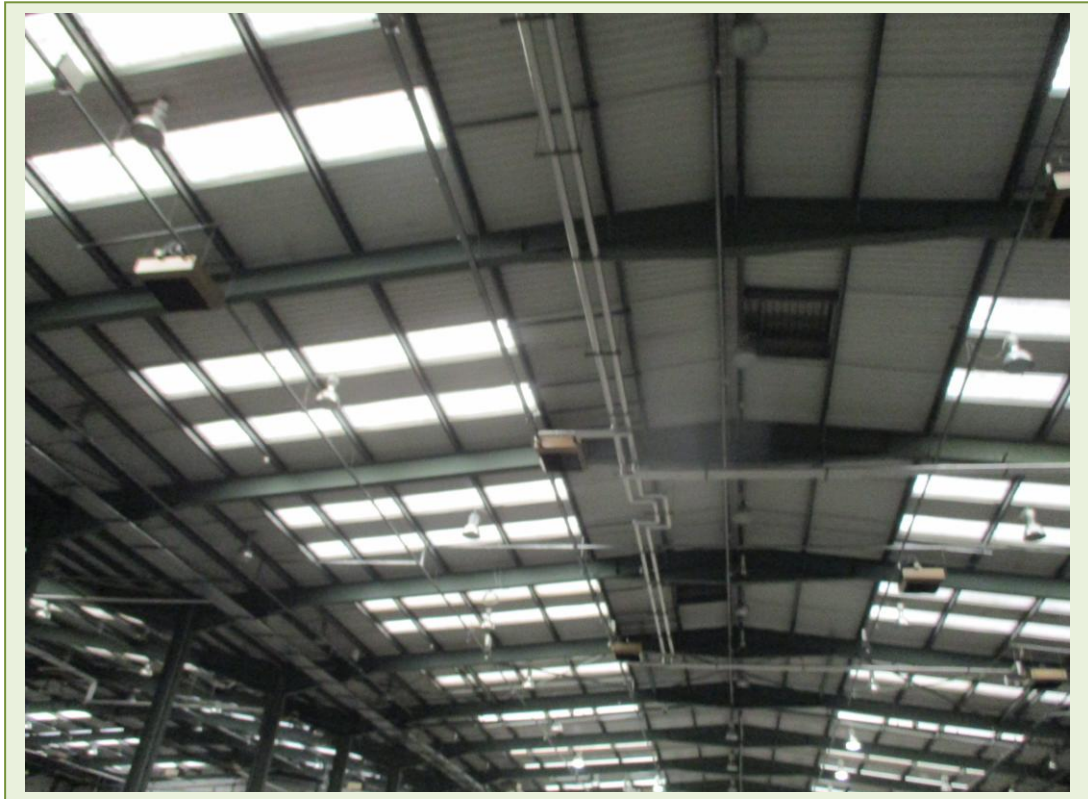
Roof cladding. No Asbestos Containing Materials (ACM's) detected

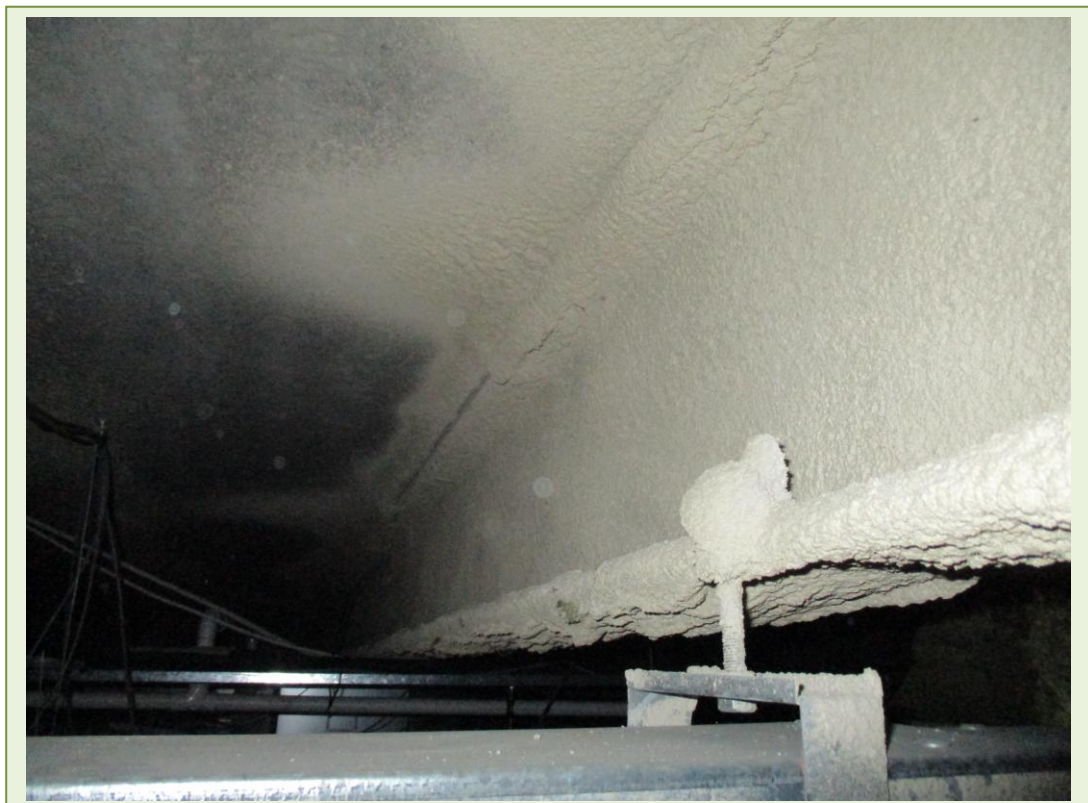
Sprayed coating on the beams in the office areas. No ACM's detected

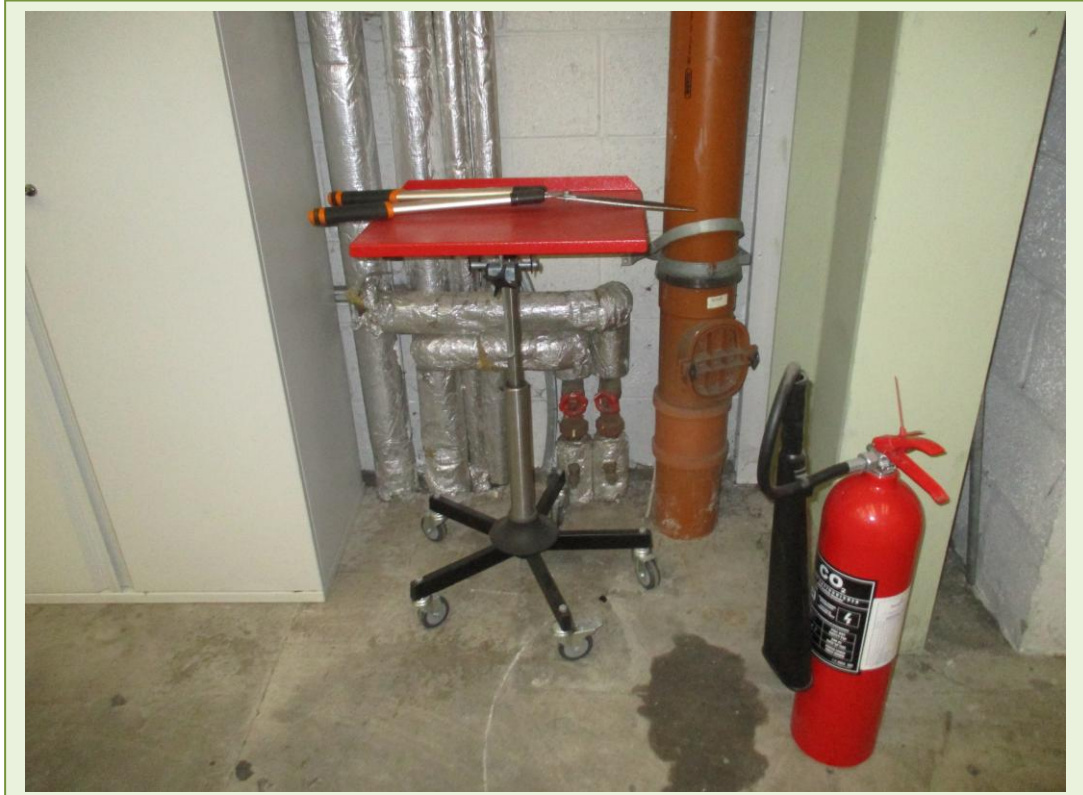
Pipework insulation. No ACM's detected

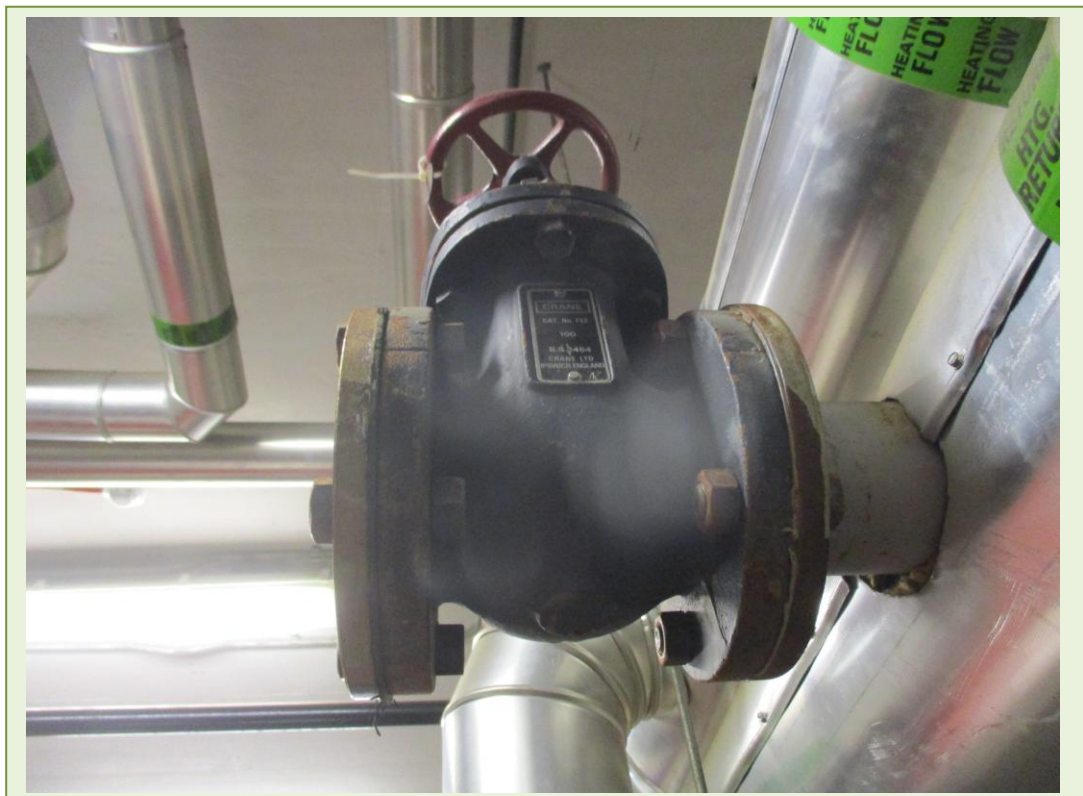
Gaskets found between the pipework flanges in the 1st floor plant room. No ACM's detected

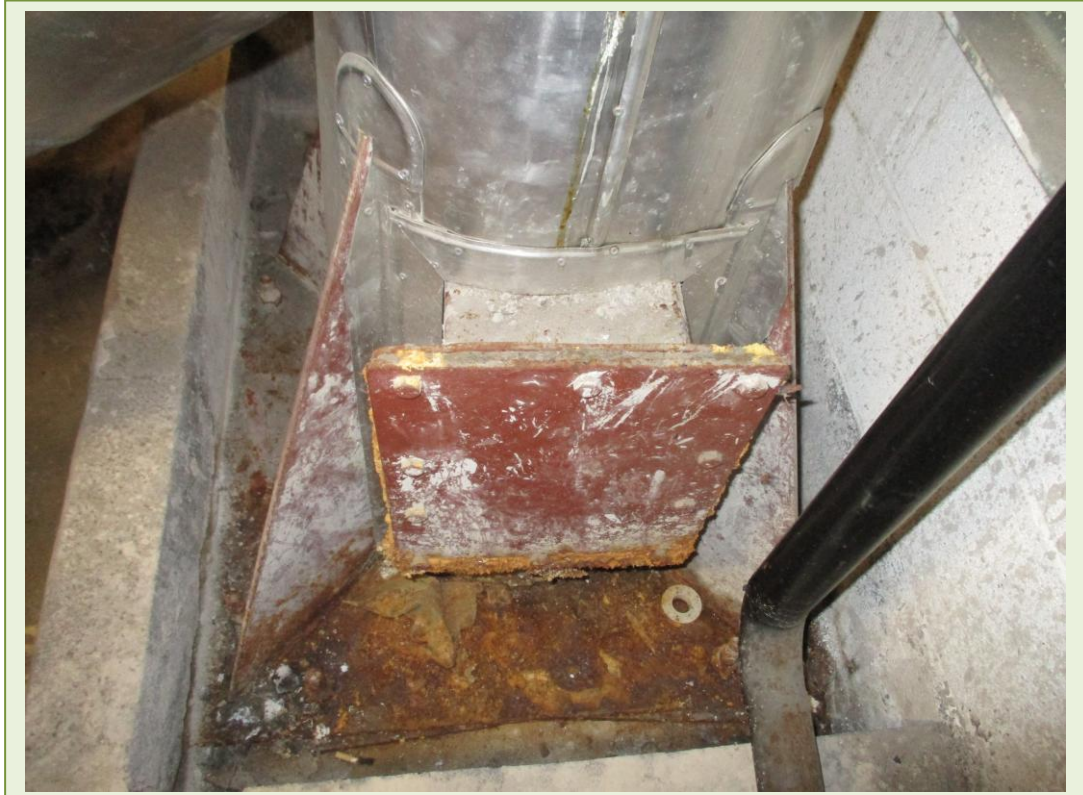
Rope between the ducting flanges in the 1st floor plant room. No ACM's detected

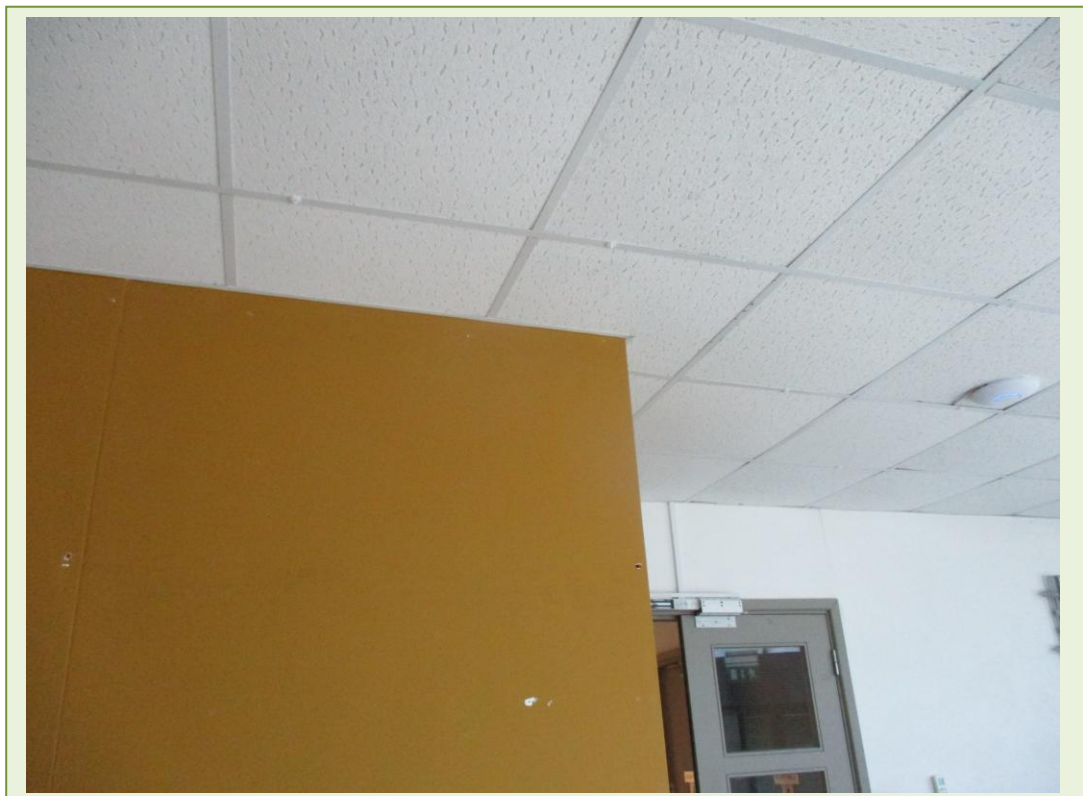
Ceiling tiles in the office areas. No ACM's detected

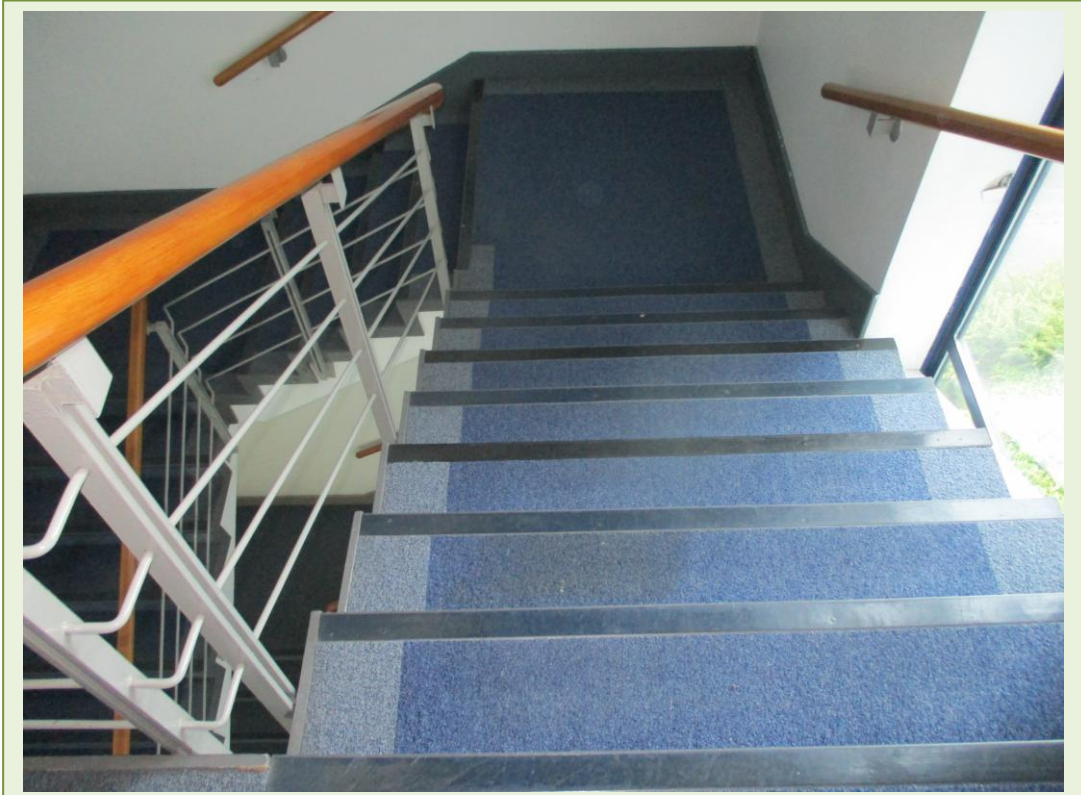
Stair nosing. No ACM's detected

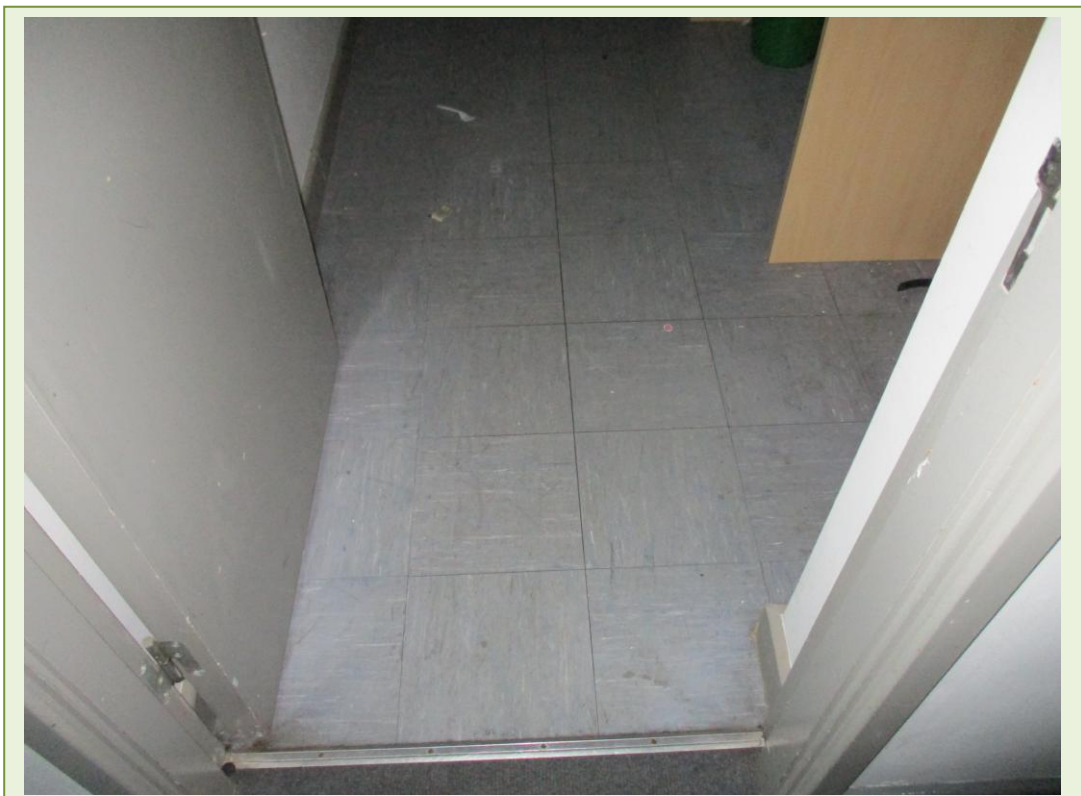
Floors tiles in kitchette areas in office block. No ACM's detected

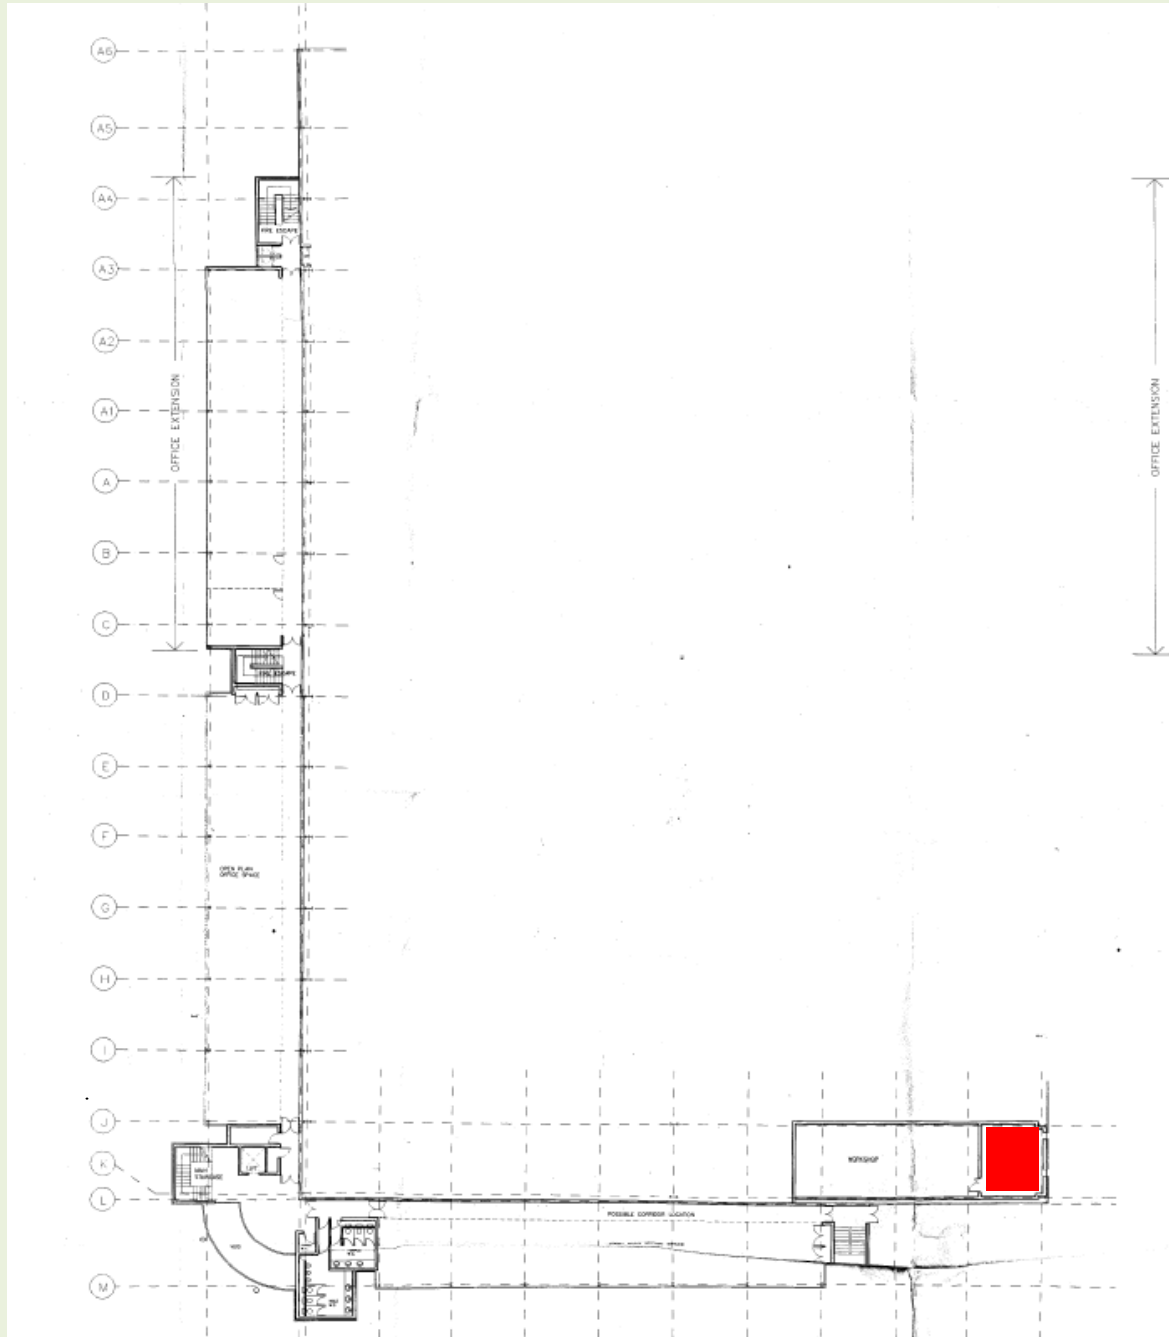
1ST FLOOR PLAN

Areas where the presence of asbestos containing gaskets were identified
