# **ASBESTOS SURVEY REPORT**

**(Refurbishment / Demolition Survey)**

**Location: Former Cuisine De France Site,  
Belgard Road, Tallaght, Dublin 24**

**Report No. PE 17-646**

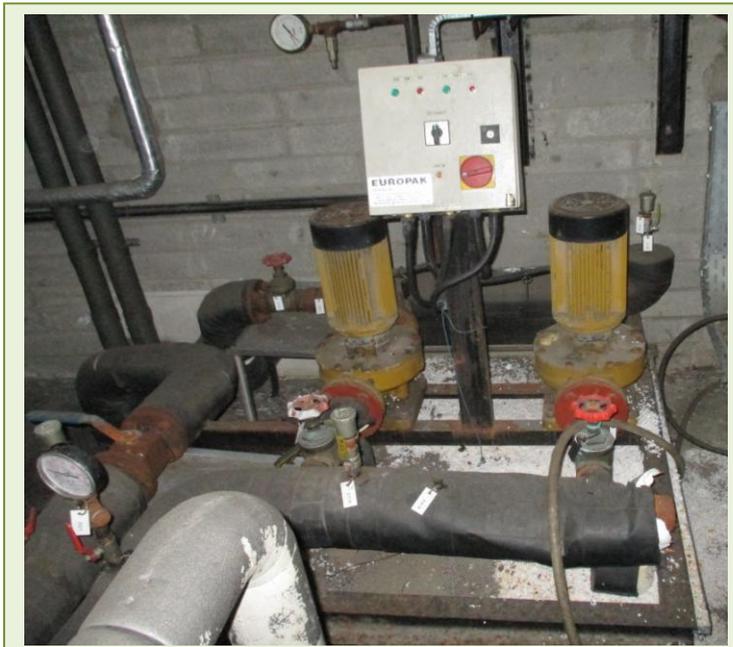
MATERIAL ASSESSMENT		PRIORITY ASSESSMENT
Product type	CAF Gasket	Normal occupant activity	N/A
Extent of damage	Low damage	Likelihood of disturbance	N/A
Surface treatment	Sealed	Human exposure potential	N/A
Asbestos type	Chrysotile	Maintenance activity	N/A
Material assessment score N/A		TOTAL SCORE: N/A	
		Priority assessment score N/A

The Compressed Asbestos Fibre (CAF) Gaskets found between the pipe work flanges throughout the warehouse buildings contain Chrysotile (white) asbestos fibers. CAF gaskets contain almost 100% asbestos fibres, with a small amount of binder

The CAF gaskets should be removed by an asbestos removal contractor and disposed of as asbestos waste before the demolition works begin

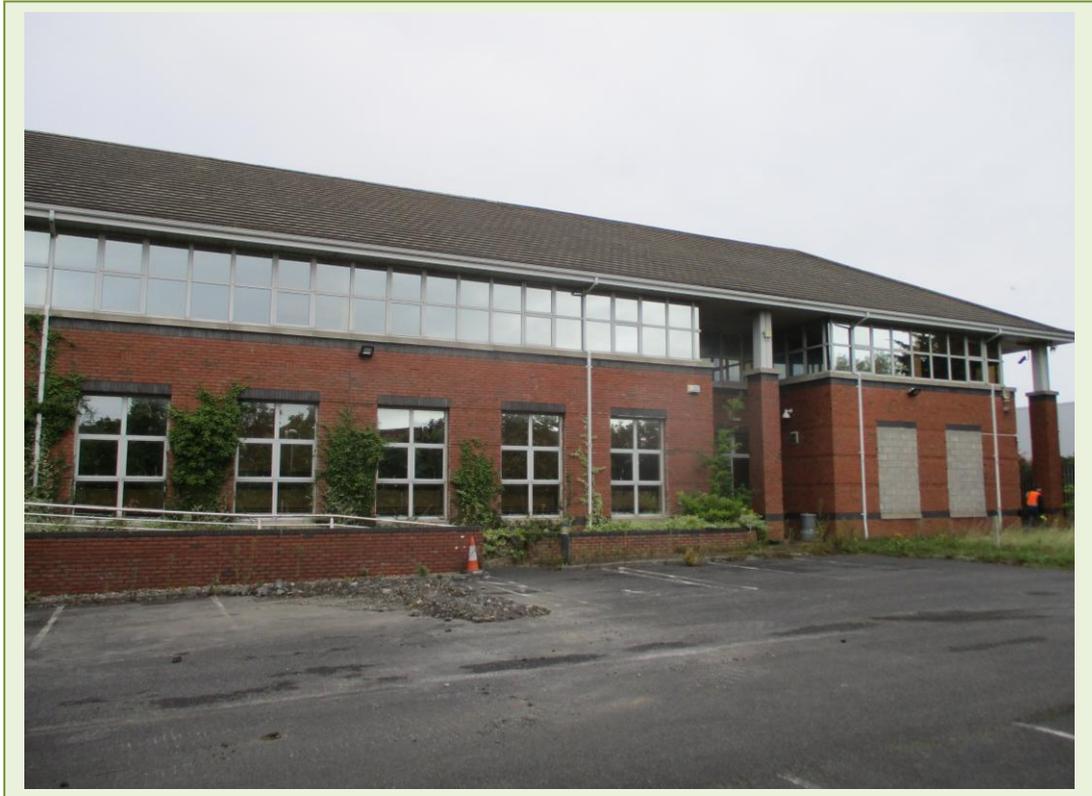
Tiles on roof of office block. No Asbestos Containing Materials (ACM's) detected

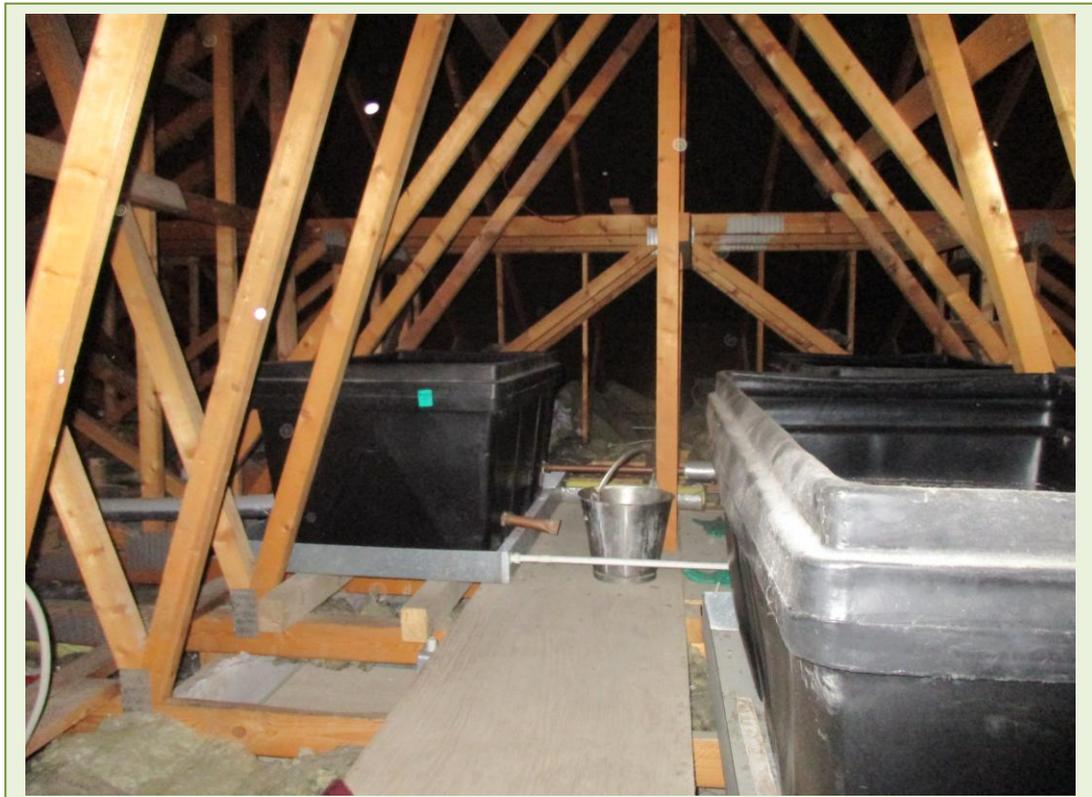
Attic insulation, roof felt and water tanks in office block. No ACM's detected

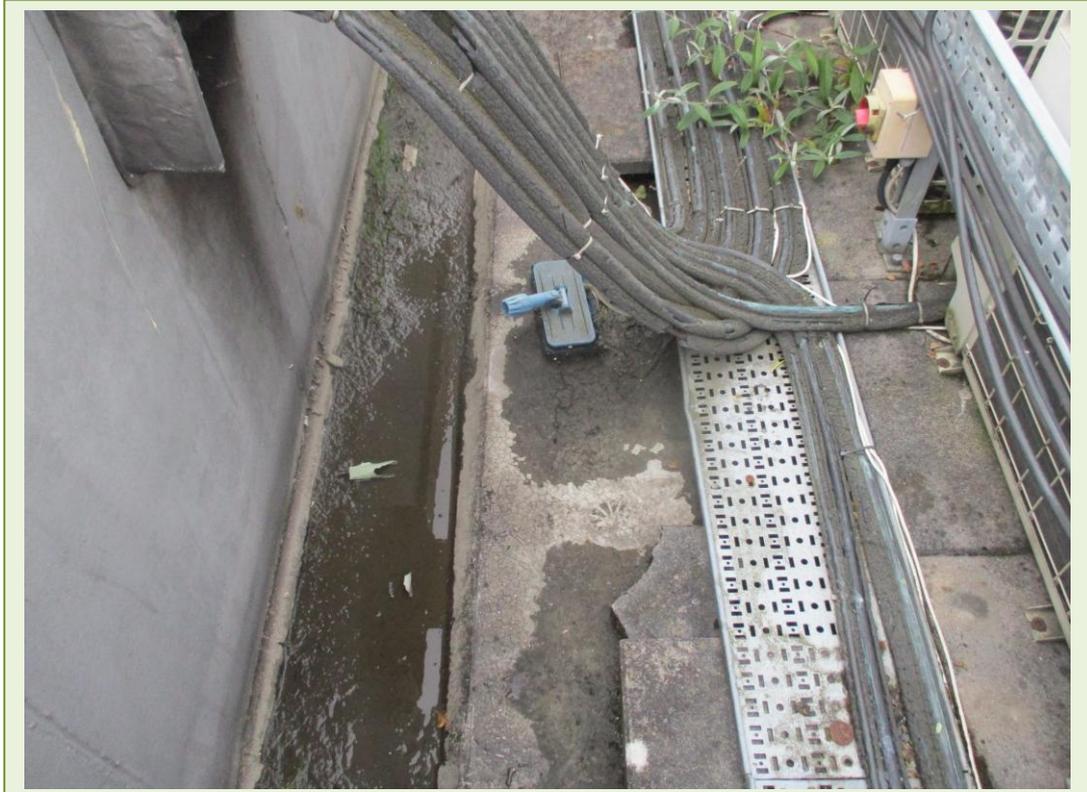
Felt on flat roof area of office block. No ACM's detected

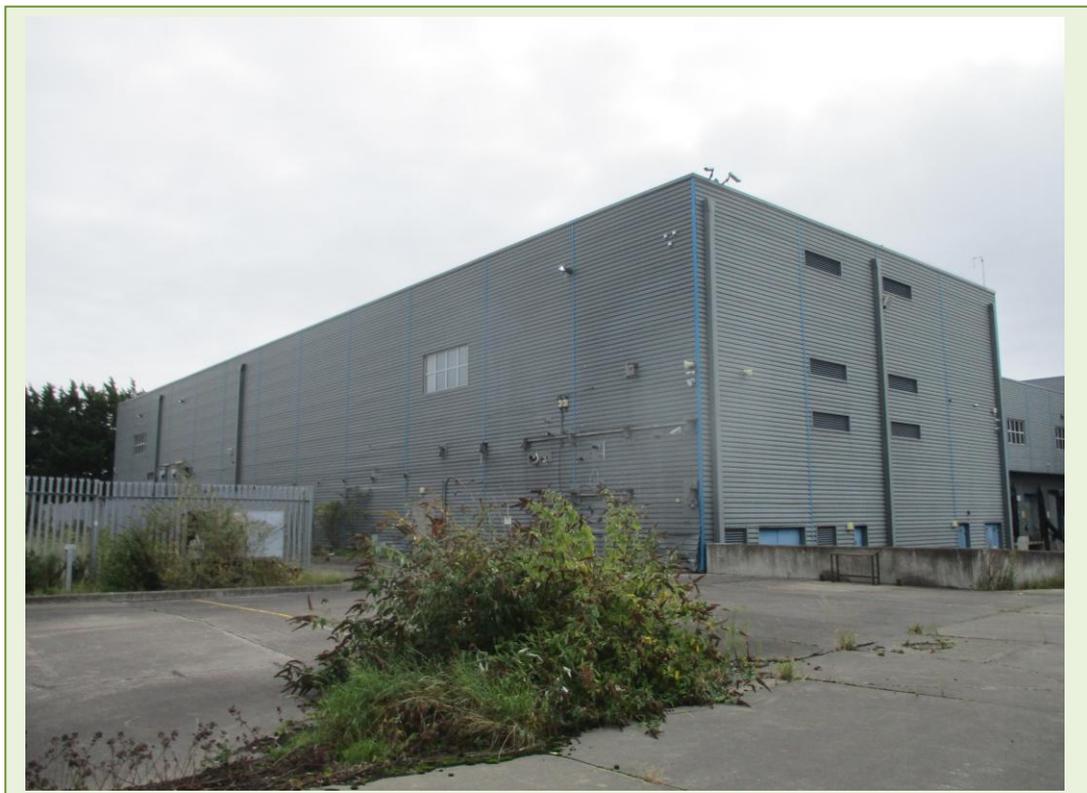
External cladding on warehouse building. No ACM's detected

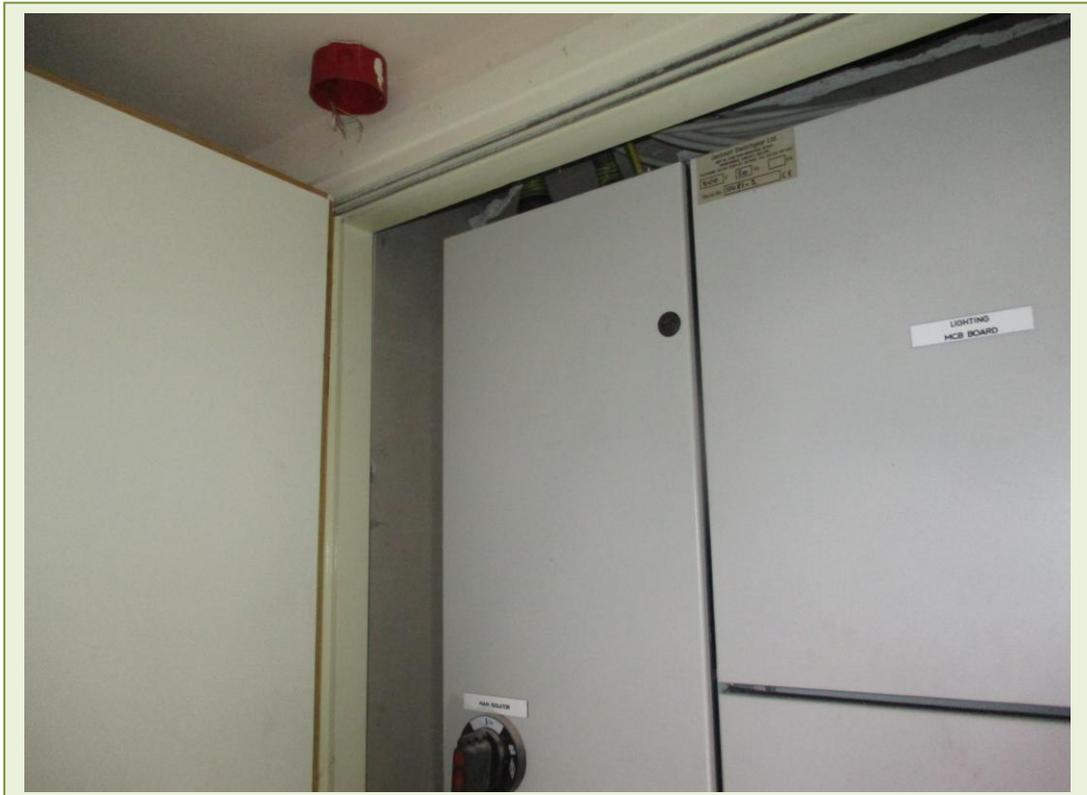
Board around electrical panel. No ACM's detected

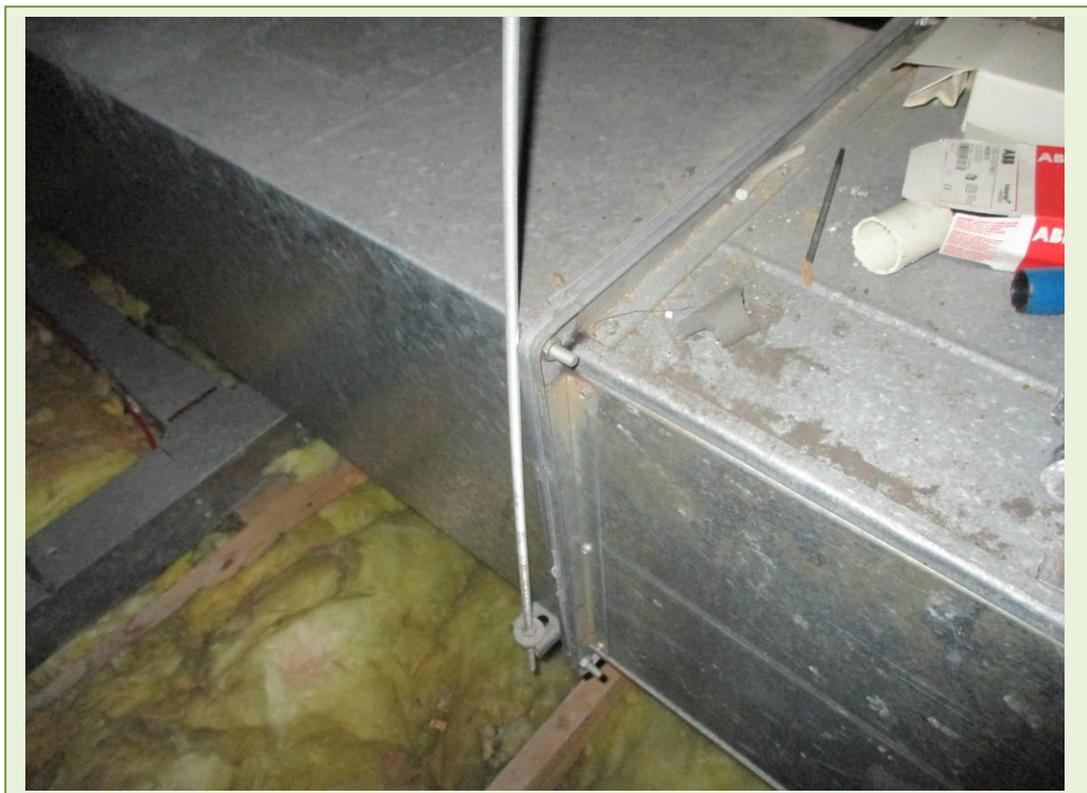
Seals between ducting. No ACM's detected

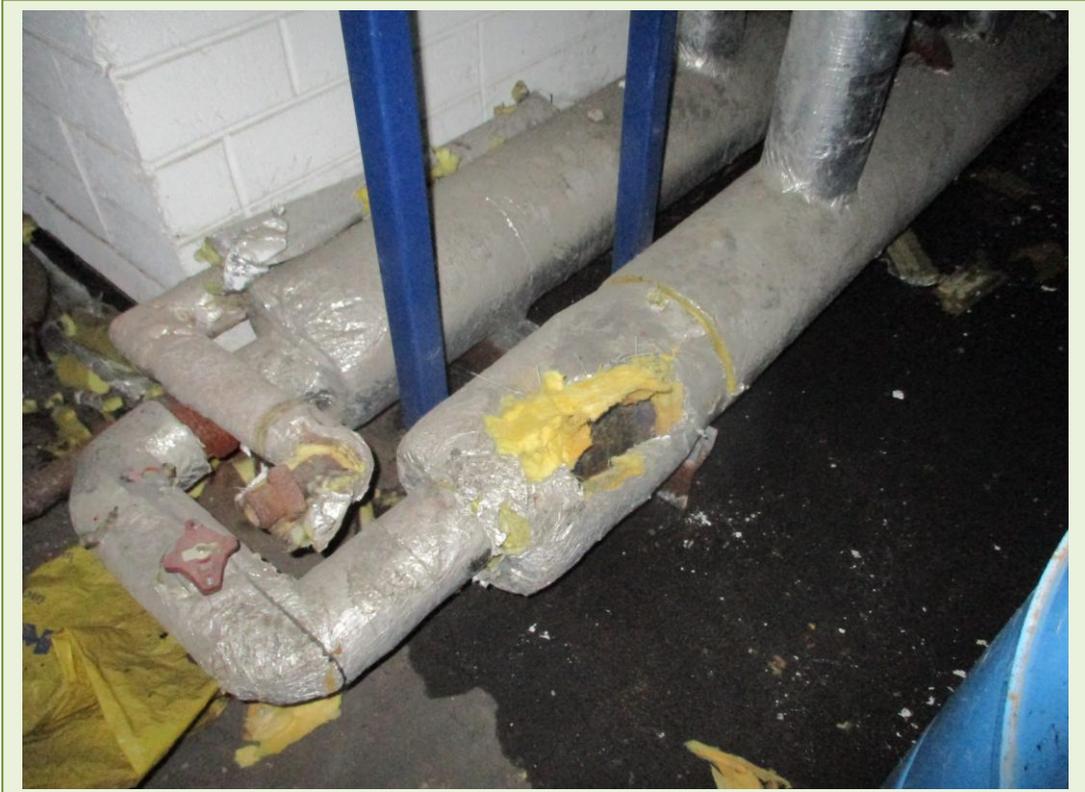
Fiberglass insulation in plant room. No ACM's detected

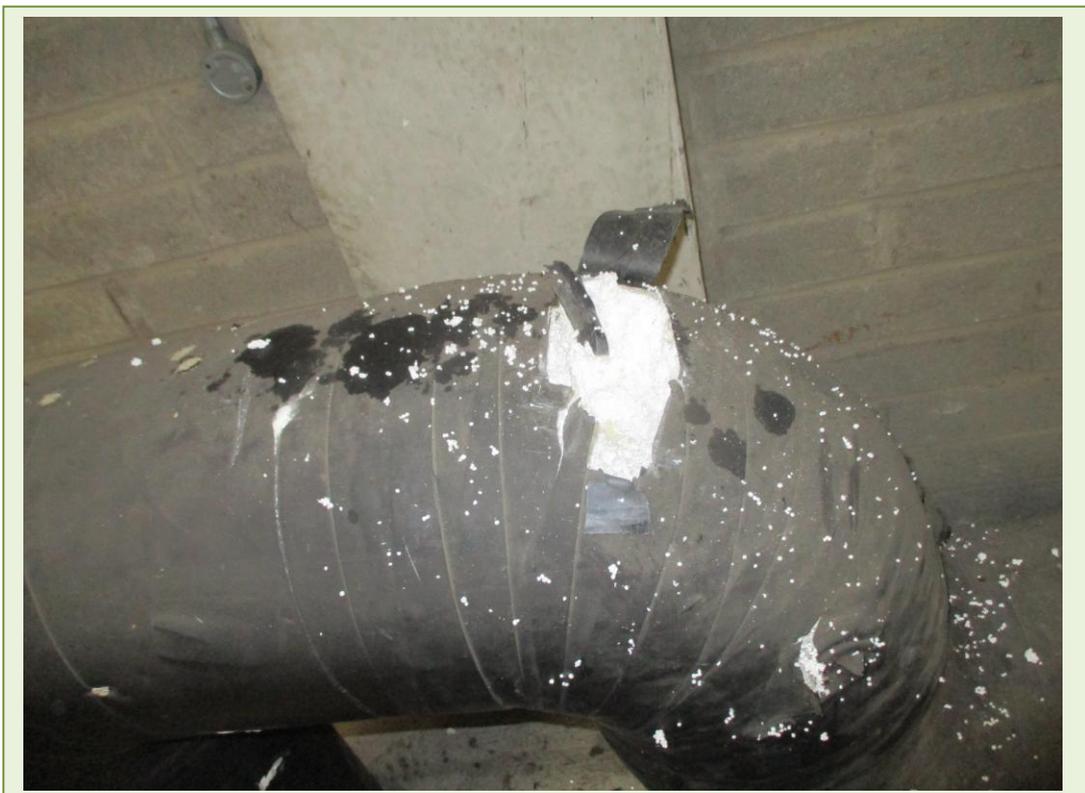
Polystyrene insulation on cold lines. No ACM's detected

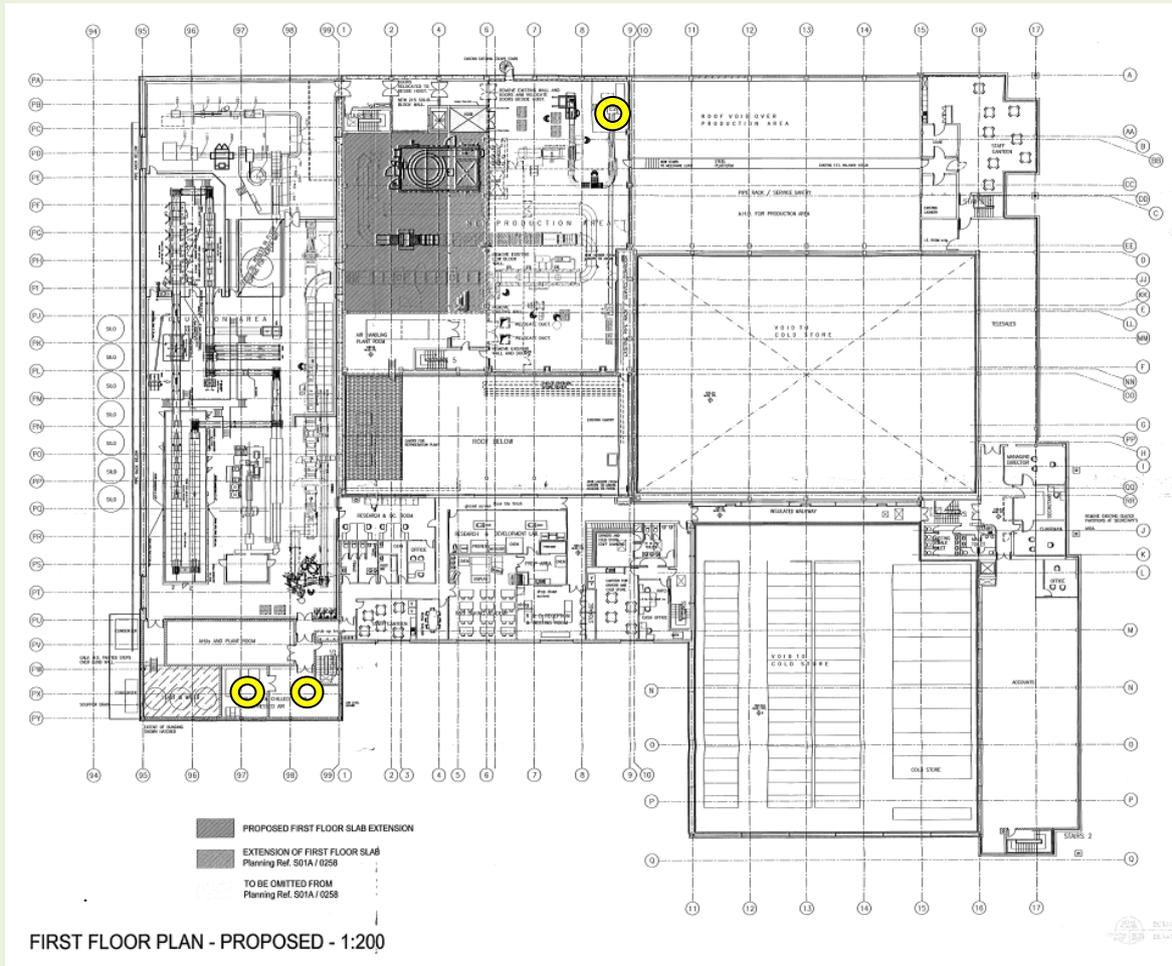
### 1<sup>st</sup> FLOOR PLAN

Areas where the presence of CAF Gaskets were identified
	Note: CAF gaskets were identified throughout the site
