ASBESTOS SURVEY REPORT

(Refurbishment / Demolition Survey)

**Location: Former Uniphar Site,
Belgard Road, Tallaght, Dublin 24**

Report No. PE 17-642

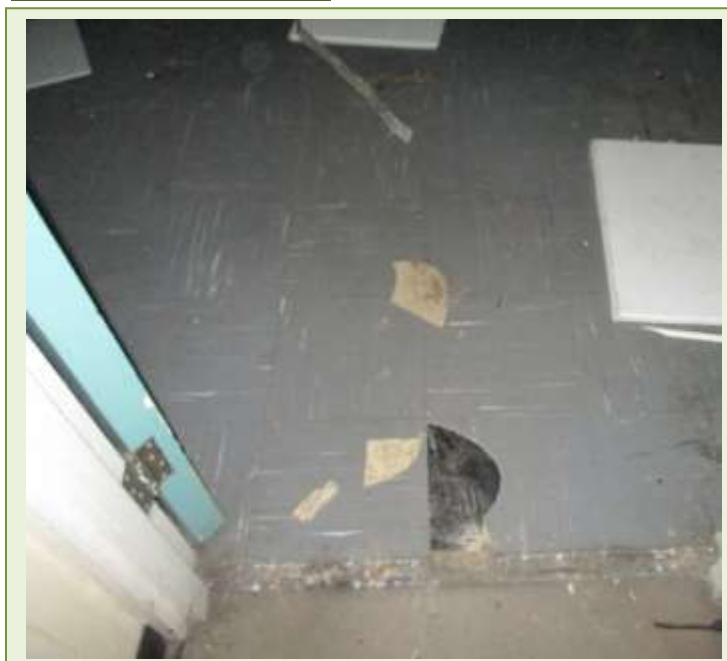
MATERIAL ASSESSMENT		PRIORITY ASSESSMENT
Product type	Floor tile & bitumen adhesive	Normal occupant activity	N/A
Extent of damage	Medium damage	Likelihood of disturbance	N/A
Surface treatment	Composite material	Human exposure potential	N/A
Asbestos type	Chrysotile	Maintenance activity	N/A
	Material assessment score N/A	TOTAL SCORE: N/A	Priority assessment score N/A

The floor tile and bitumen adhesive found on the ground, first and second floor in the office area of the Industrial Building contains Chrysotile (white) asbestos fibers. Thermoplastic floor tiles can contain up to 25% asbestos fibres, usually Chrysotile. Bitumen adhesives contain a small quantity of asbestos fibres

The asbestos floor tiles and bitumen adhesive should be removed by an asbestos removal contractor and disposed of as asbestos waste before the demolition works begin

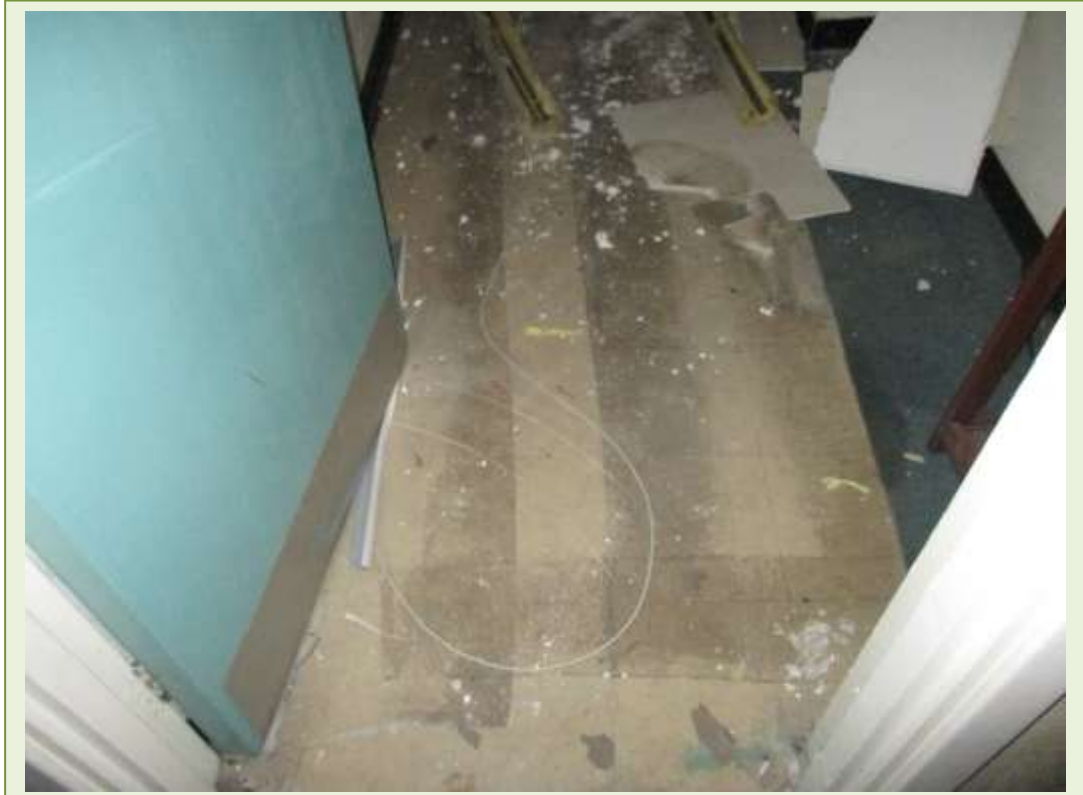
Floor tiles in the office areas of the industrial unit

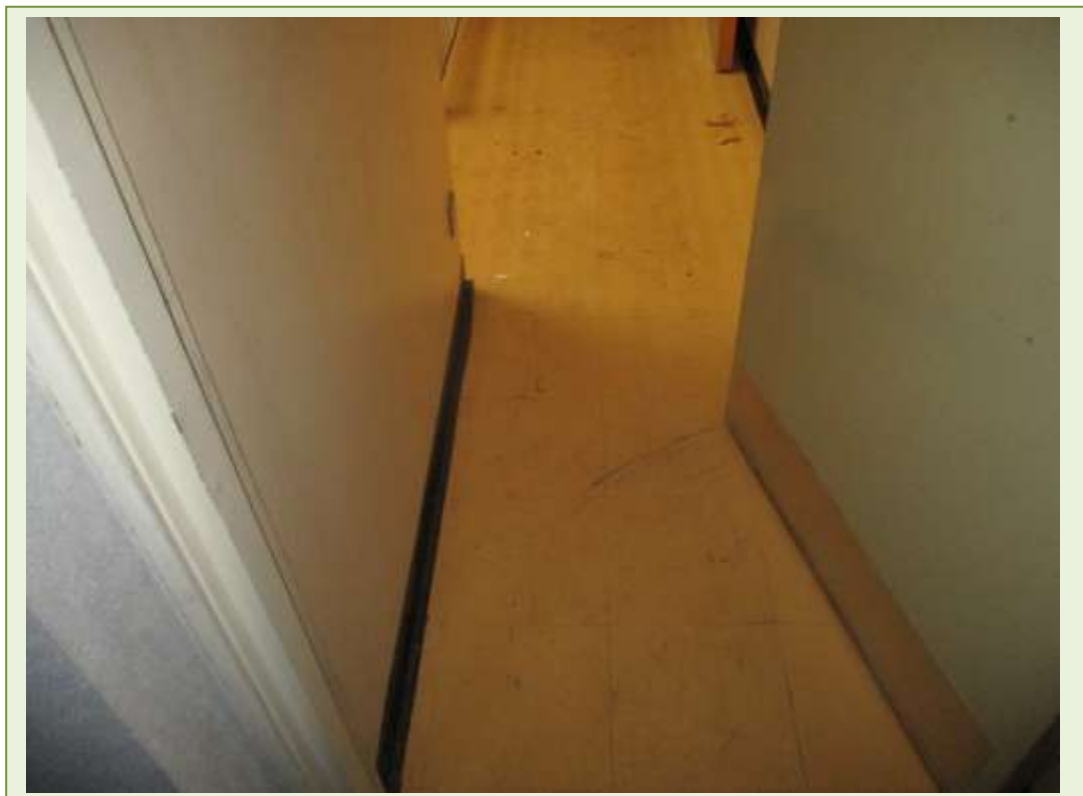
Floor tile identified in the office areas of the industrial unit

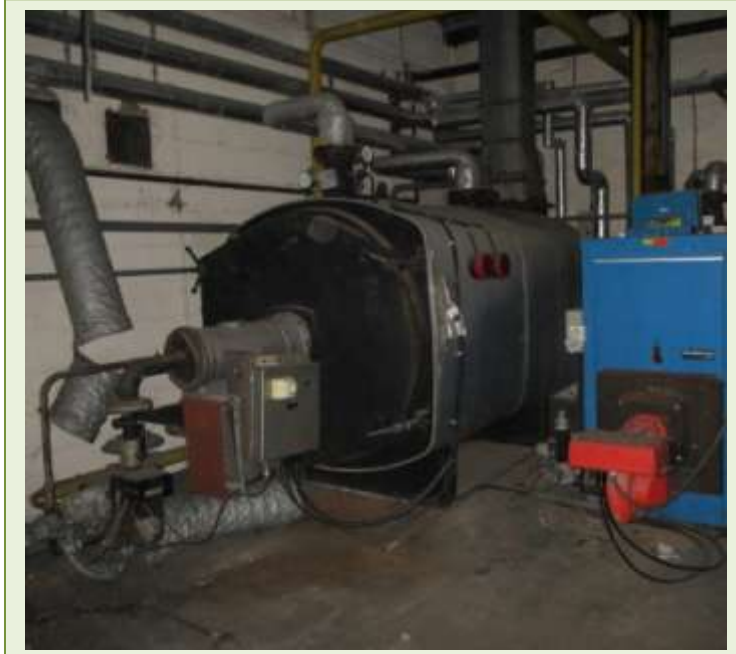
MATERIAL ASSESSMENT		PRIORITY ASSESSMENT
Product type	Rope	Normal occupant activity	N/A
Extent of damage	Medium	Likelihood of disturbance	N/A
Surface treatment	None	Human exposure potential	N/A
Asbestos type	Chrysotile	Maintenance activity	N/A
Material assessment score N/A		TOTAL SCORE: N/A	
		Priority assessment score N/A

The rope seals found in the boiler units in the 2nd floor plant room in the Industrial Unit contain Chrysotile (white) asbestos fibres. Asbestos rope seals contain up to 100% asbestos fibres

The asbestos rope seals should be removed by an removal contractor and disposed of as asbestos waste before the demolition works begin

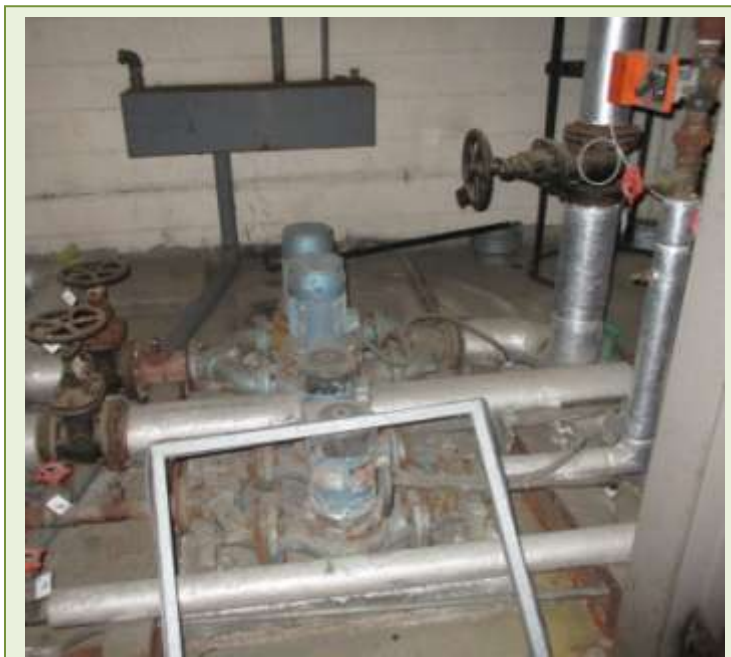
MATERIAL ASSESSMENT		PRIORITY ASSESSMENT
Product type	CAF Gasket	Normal occupant activity	N/A
Extent of damage	Medium	Likelihood of disturbance	N/A
Surface treatment	None	Human exposure potential	N/A
Asbestos type	Chrysotile	Maintenance activity	N/A
Material assessment score N/A		TOTAL SCORE: N/A	
		Priority assessment score N/A

The Compressed Asbestos Fibre (CAF) Gaskets found between the pipe work flanges throughout the industrial unit contain Chrysotile (white) asbestos fibers. CAF gaskets contain almost 100% asbestos fibres, with a small amount of binder

The CAF gaskets should be removed by an asbestos removal contractor and disposed of as asbestos waste before the demolition works begin

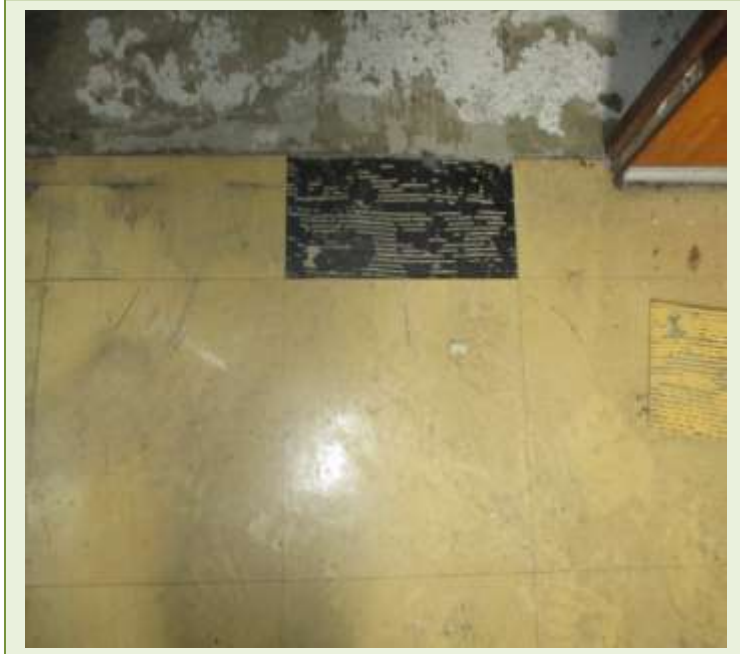
MATERIAL ASSESSMENT		PRIORITY ASSESSMENT
Product type	Floor tile & bitumen adhesive	Normal occupant activity	N/A
Extent of damage	Medium damage	Likelihood of disturbance	N/A
Surface treatment	Composite material	Human exposure potential	N/A
Asbestos type	Chrysotile	Maintenance activity	N/A
	Material assessment score N/A	TOTAL SCORE: N/A	Priority assessment score N/A

The floor tile and bitumen adhesive found in the stairwell and in the Stationary Room in the Office Building contains Chrysotile (white) asbestos fibers. Thermoplastic floor tiles can contain up to 25% asbestos fibres, usually Chrysotile. Bitumen adhesives contain a small quantity of asbestos fibres

The asbestos floor tiles and bitumen adhesive should be removed by an asbestos removal contractor and disposed of as asbestos waste before the demolition works begin

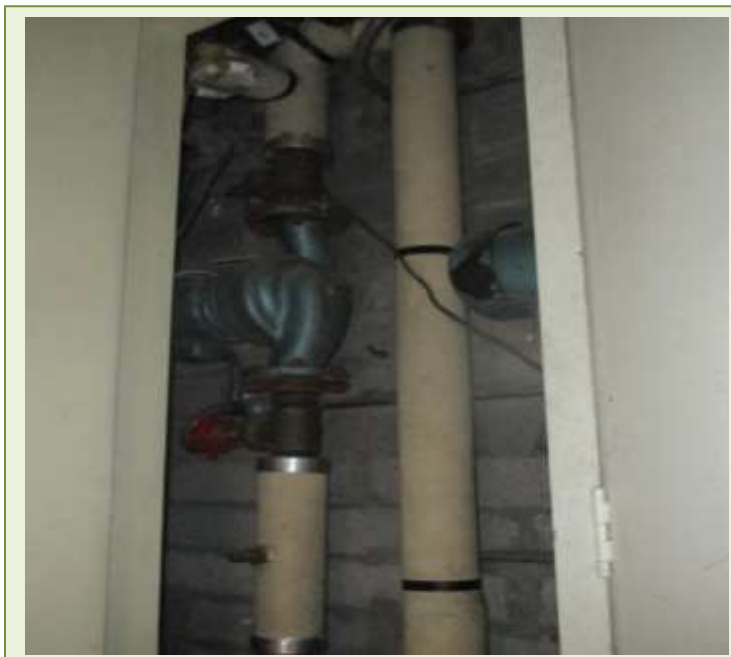
MATERIAL ASSESSMENT		PRIORITY ASSESSMENT
Product type	CAF Gasket	Normal occupant activity	N/A
Extent of damage	Medium	Likelihood of disturbance	N/A
Surface treatment	None	Human exposure potential	N/A
Asbestos type	Chrysotile	Maintenance activity	N/A
	Material assessment score N/A	TOTAL SCORE: N/A	Priority assessment score N/A

The Compressed Asbestos Fibre (CAF) Gaskets found between the pipe work flanges in the plant room in the Office Building contain Chrysotile (white) asbestos fibers. CAF gaskets contain almost 100% asbestos fibres, with a small amount of binder

The CAF gaskets should be removed by an asbestos removal contractor and disposed of as asbestos waste before the demolition works begin

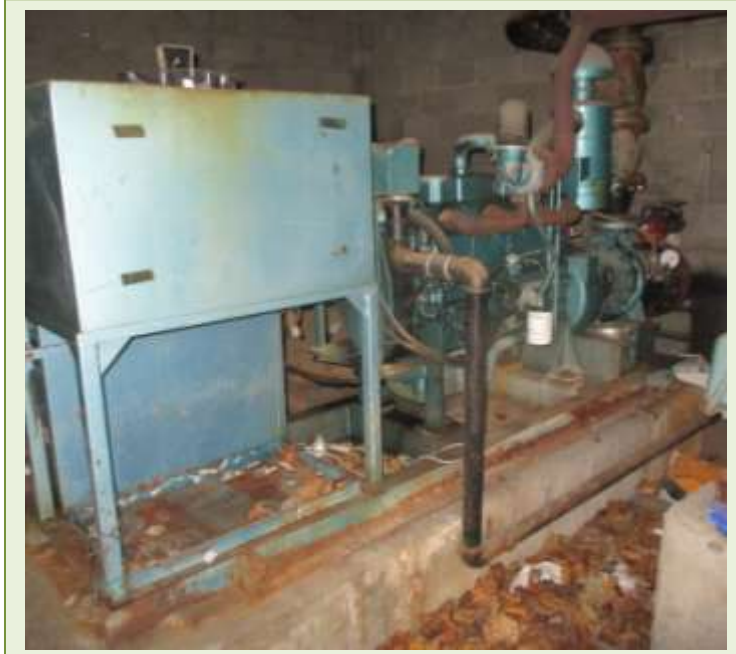
MATERIAL ASSESSMENT		PRIORITY ASSESSMENT
Product type	CAF Gasket	Normal occupant activity	N/A
Extent of damage	Medium	Likelihood of disturbance	N/A
Surface treatment	None	Human exposure potential	N/A
Asbestos type	Chrysotile	Maintenance activity	N/A
Material assessment score N/A		TOTAL SCORE: N/A	
		Priority assessment score N/A

The Compressed Asbestos Fibre (CAF) Gaskets found between the pipe work flanges and generator flanges in the Generator Building contain Chrysotile (white) asbestos fibers. CAF gaskets contain almost 100% asbestos fibres, with a small amount of binder

The CAF gaskets should be removed by an asbestos removal contractor and disposed of as asbestos waste before the demolition works begin

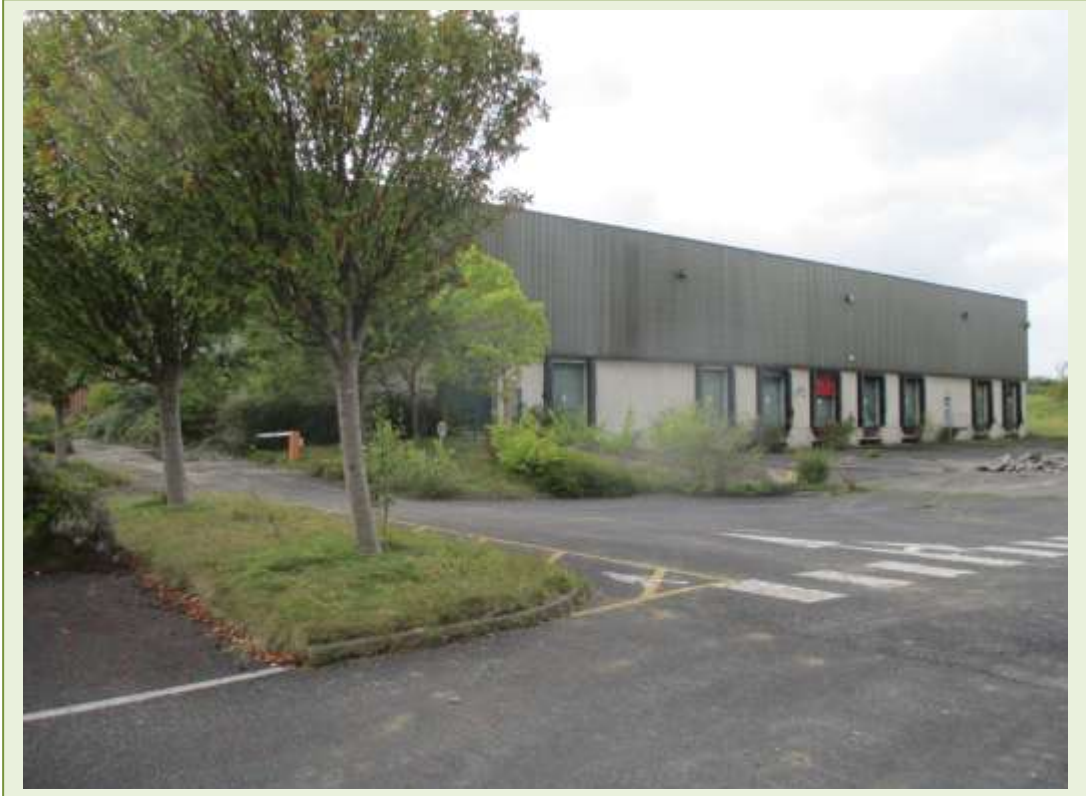
Metal cladding. No Asbestos Containing Materials (ACM's) detected

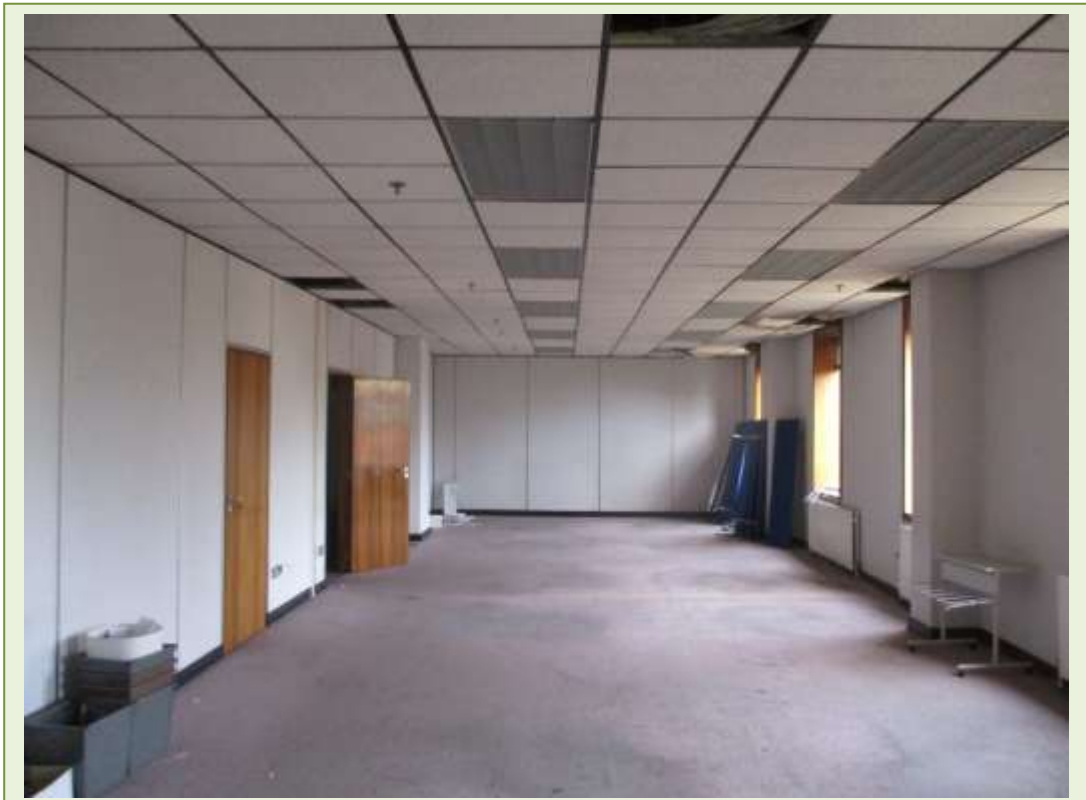
Ceiling tiles. No ACM's detected

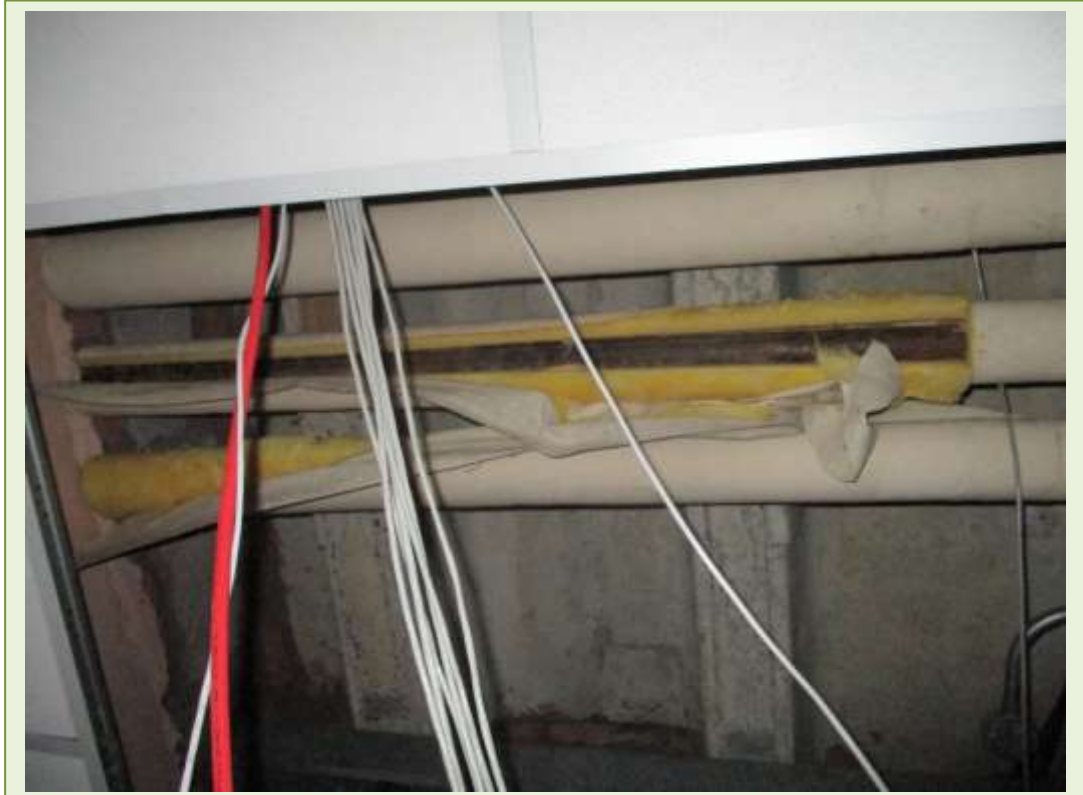
Fiberglass pipework insulation. No ACM's detected

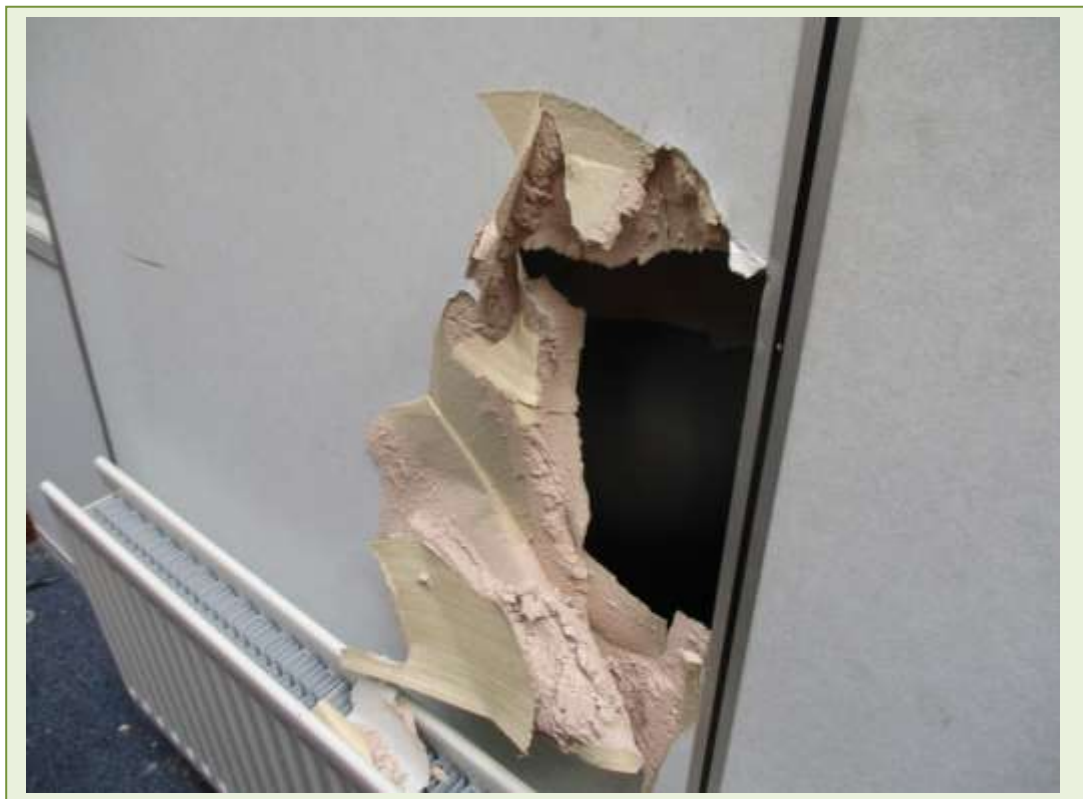
Wall panels. No ACM's detected

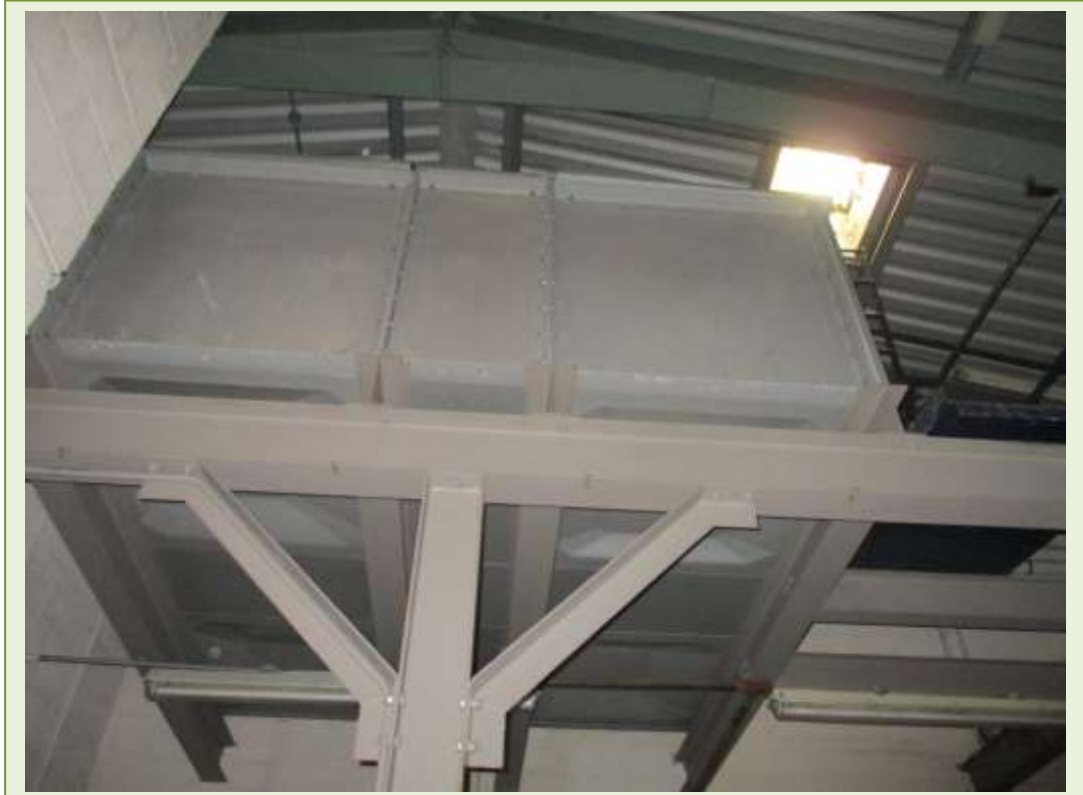
Water tank. No ACM's detected

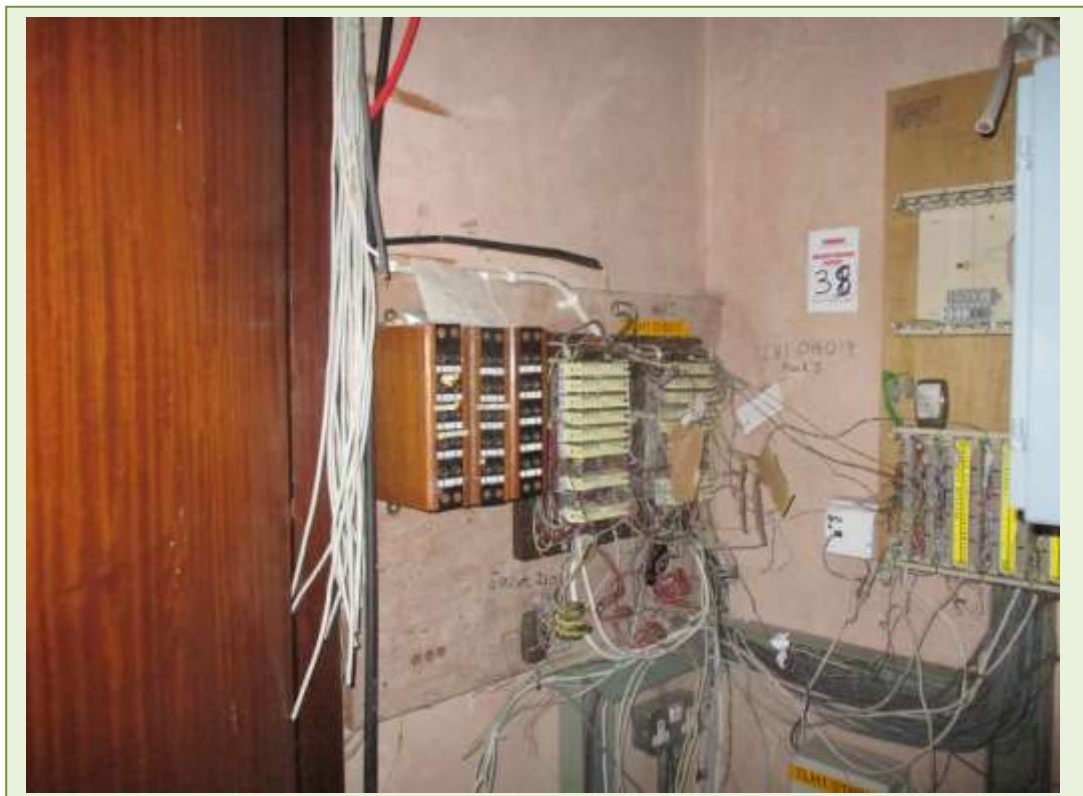
Telecoms fire stopping. No ACM's detected

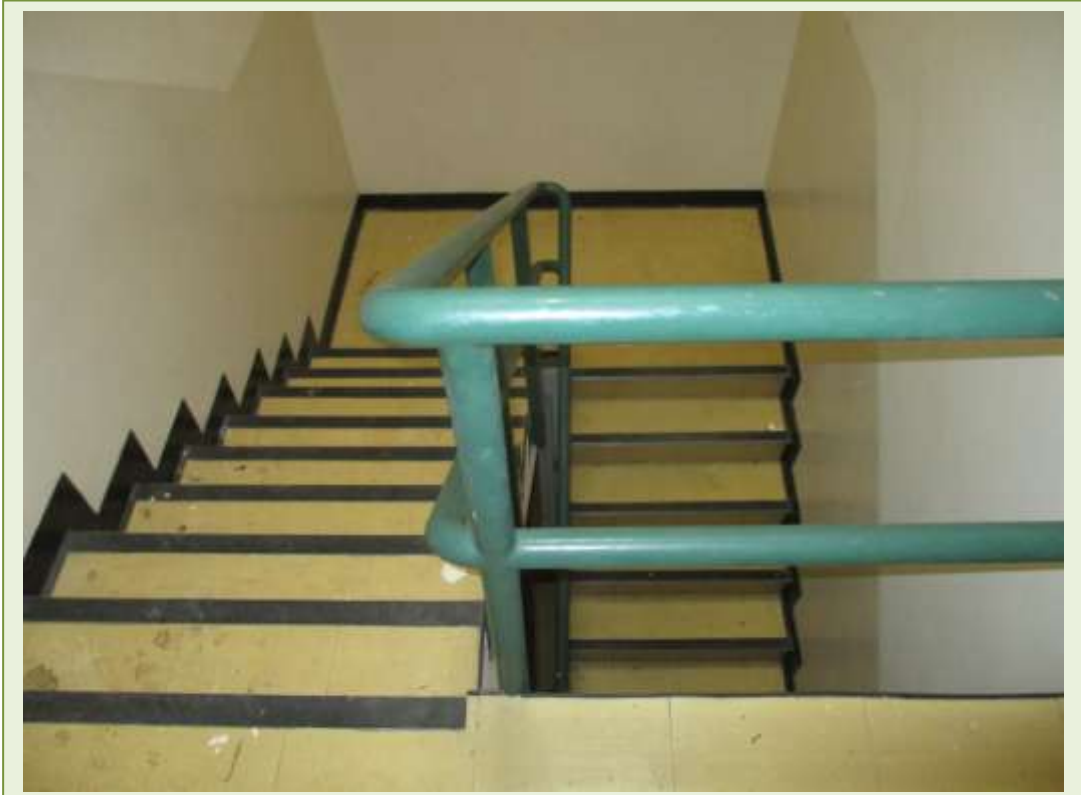
Step nosings. No ACM's detected

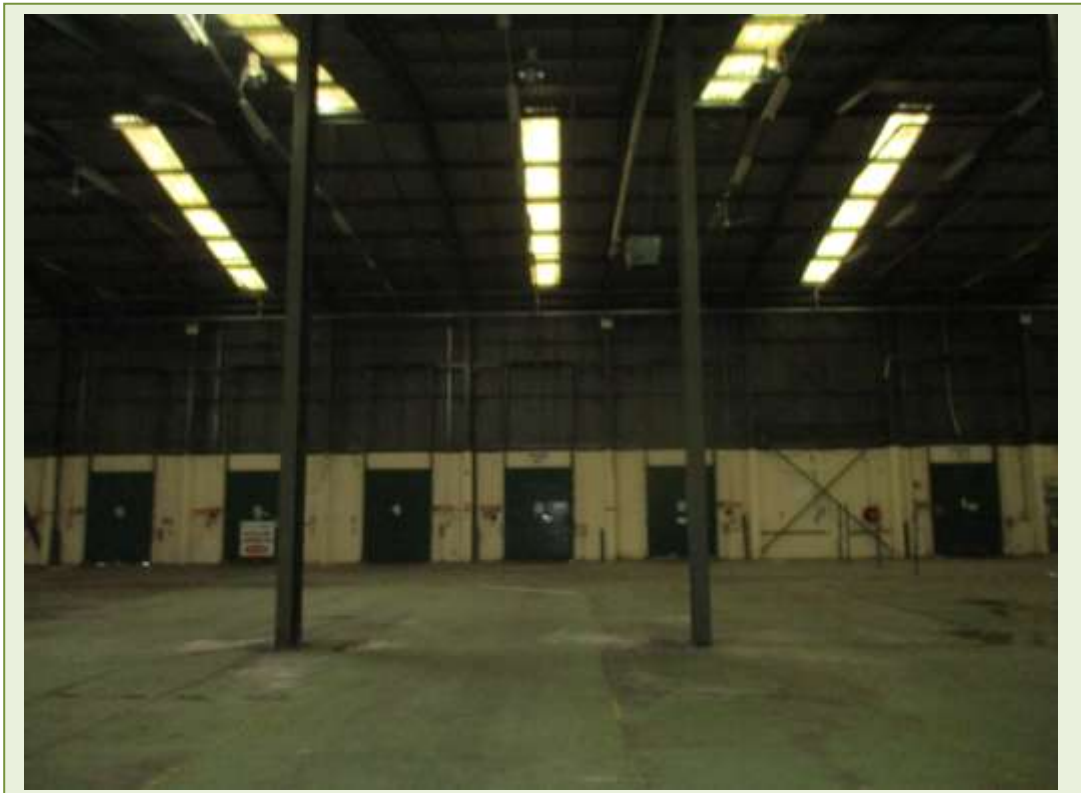
Warehouse floors. No ACM's detected

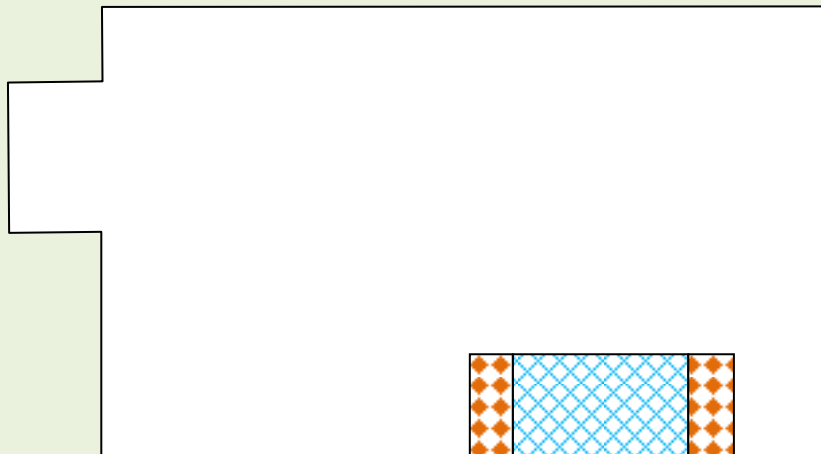
2ND FLOOR PLAN

Areas where asbestos containing floor tile & bitumen adhesive was identified (intermittently)

Areas where the presence of asbestos containing rope and CAF Gaskets were identified

Note: CAF gaskets were identified throughout the site

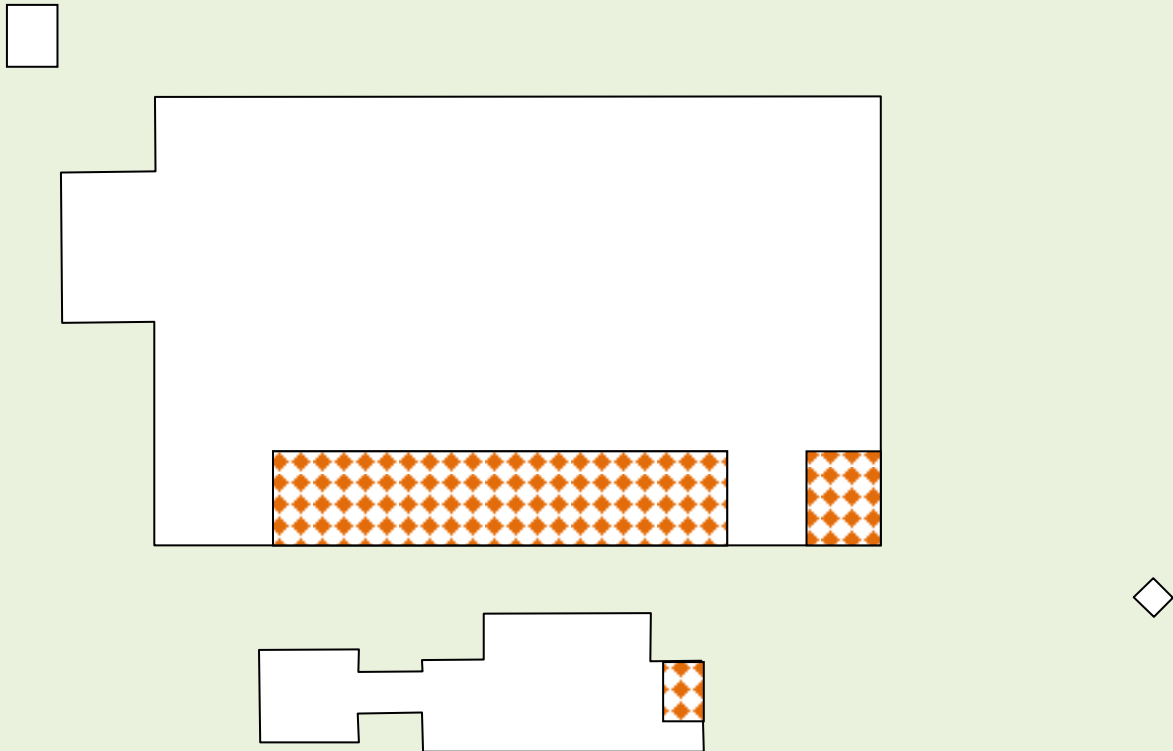
1ST FLOOR PLAN

Areas where asbestos containing floor tile & bitumen adhesive was identified (intermittently)

Note: CAF gaskets were identified throughout the site

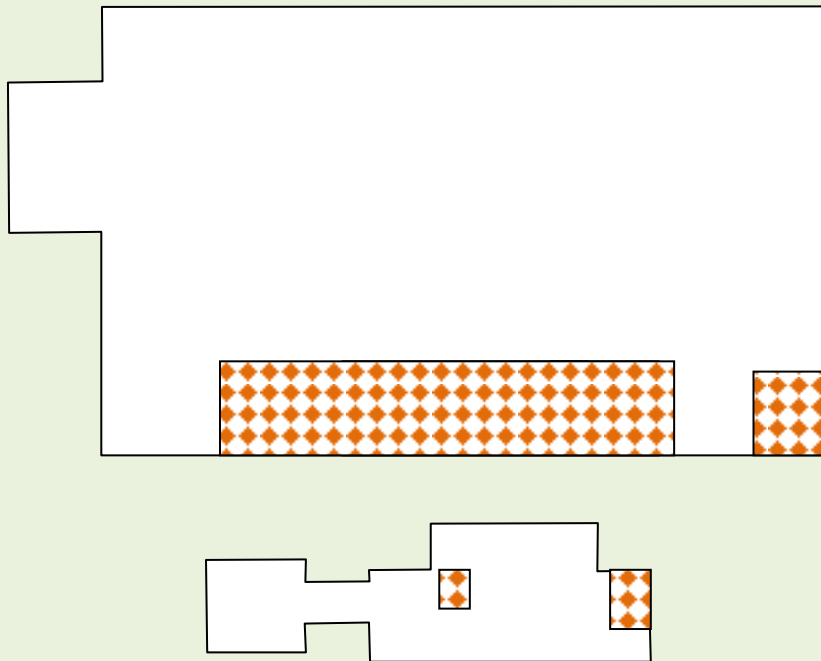
GROUND FLOOR PLAN

Areas where asbestos containing floor tile & bitumen adhesive was identified (intermittently)

Areas where the presence of CAF Gaskets were identified

Note: CAF gaskets were identified throughout the site
