Project Opera Limerick

Infrastructure Report

Project number: 60568520

8 March 2019

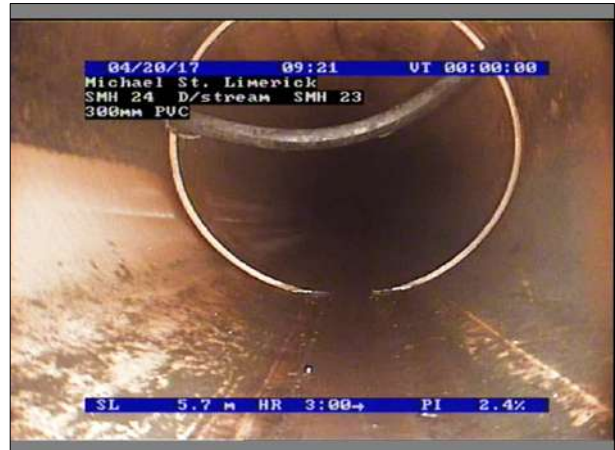
Photo: 3_3_21_A.jpg, 00:00:50
 5.7m, Sealing ring intruding, from 9 to 2 o'clock

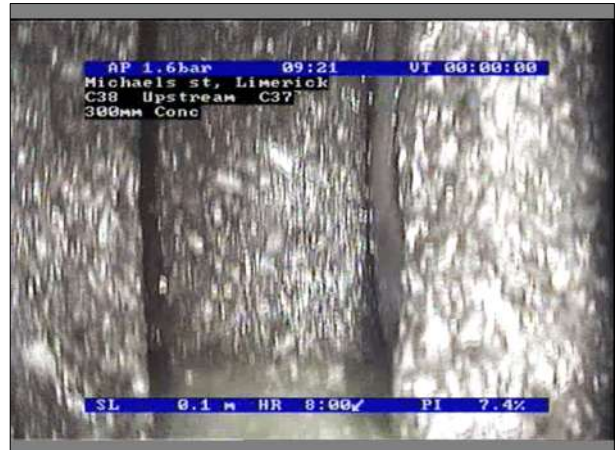
Photo: 8_8_34_A.jpg, 00:00:10
 0.1m, Open joint, medium

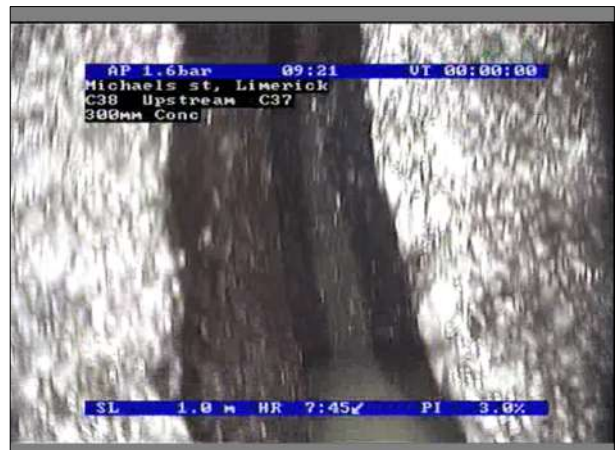
Photo: 8_8_36_A.jpg, 00:00:27
 1m, Open joint, medium

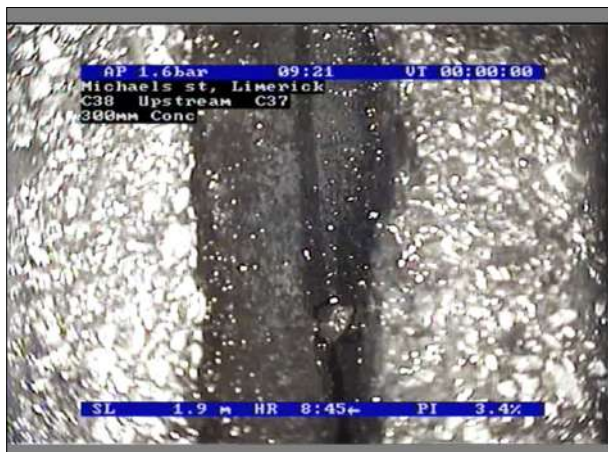
Photo: 8.8_37_A.jpg, 00:00:46
 1.9m, Open joint, medium

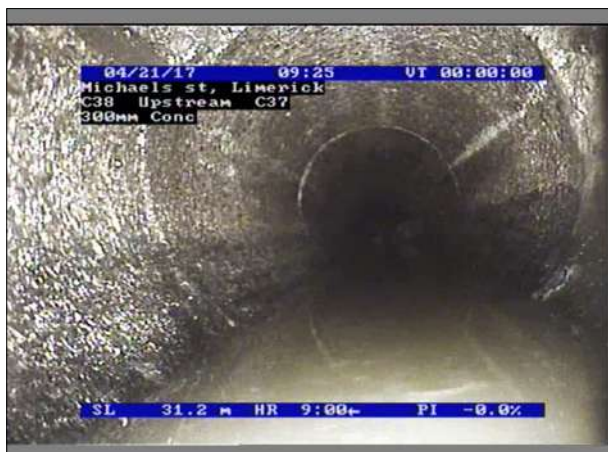
Photo: 8.8_39_A.jpg, 00:04:35
 31.2m, Water level, 10% of the vertical dimension

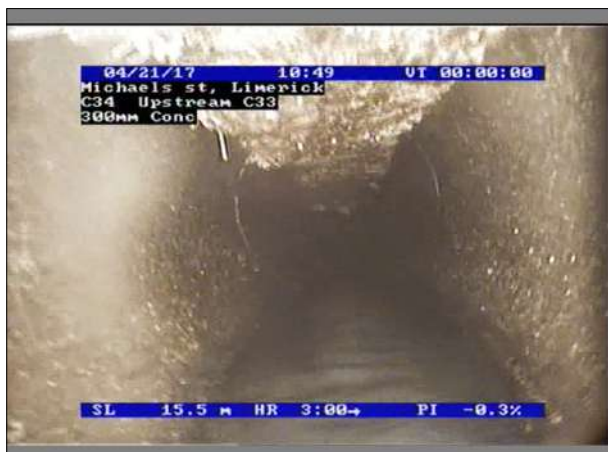
Photo: 11_11_46_A.jpg, 00:01:19
 15.5m, Attached deposits, fouling, at 12 o'clock, 5% cross-sectional area loss
 Remarks: continuous

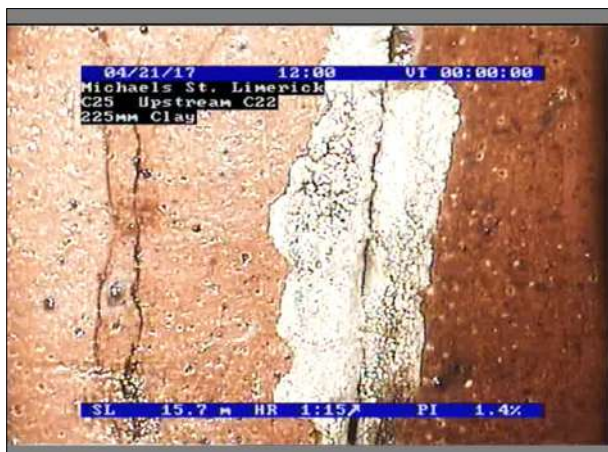
Photo: 12_12_51_A.jpg, 00:03:19
 15.7m, Crack, circumferential, from 11 to 2 o'clock

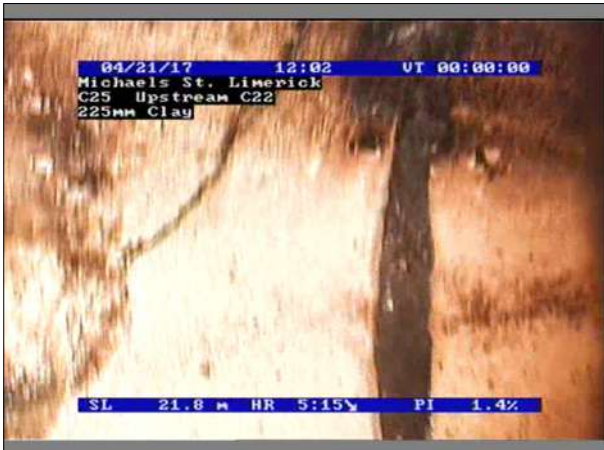
Photo: 12_12_53_A.jpg, 00:05:18
 21.8m, Crack, circumferential, from 5 to 10 o'clock

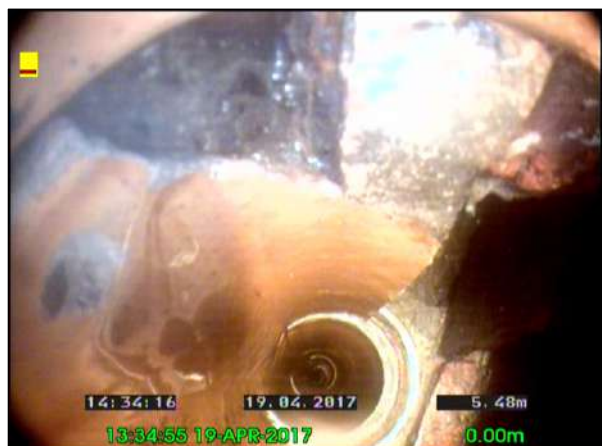
Structural defects			
Section	PLR	Grade	Fault description
12	C 4 X	4	Broken pipe, from 6 to 9 o'clock
13	C 5 X	4	Hole in drain/sewer, at 12 o'clock
16	C 20 X	3	Cracks, multiple, from 1 to 4 o'clock
24	FMH 1 X	4	Broken pipe, from 9 to 3 o'clock
29	C 1 X	4	Broken pipe, from 10 to 2 o'clock
30	C 4 X	4	Broken pipe, from 10 to 2 o'clock
34	C 34 X	3	Cracks, multiple, from 5 to 12 o'clock

Photo: 16_16_61_A.jpg, 00:04:14
 5.48m, Broken pipe, from 6 to 9 o'clock Remarks: IN CHAMBER

Grade 4: Best practice suggests consideration be given to a repair to avoid potential collapse

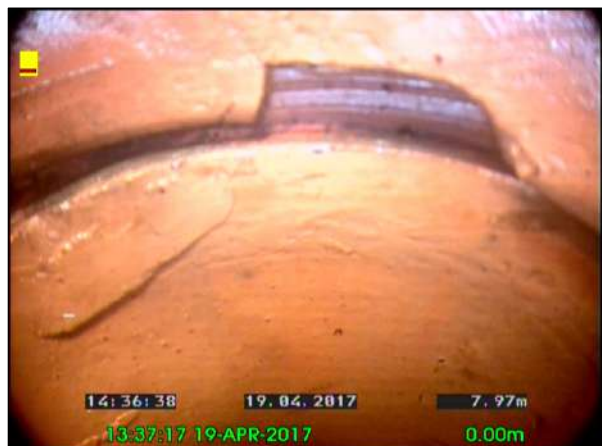
Photo: 16_16_63_A.jpg, 00:06:36
 7.97m, Broken pipe, at 1 o'clock

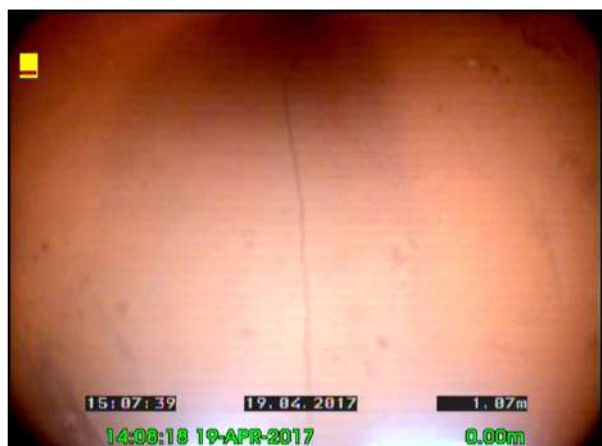
Photo: 17_17_84_A.jpg, 00:00:38
 1.07m, Crack, longitudinal, at 6 o'clock

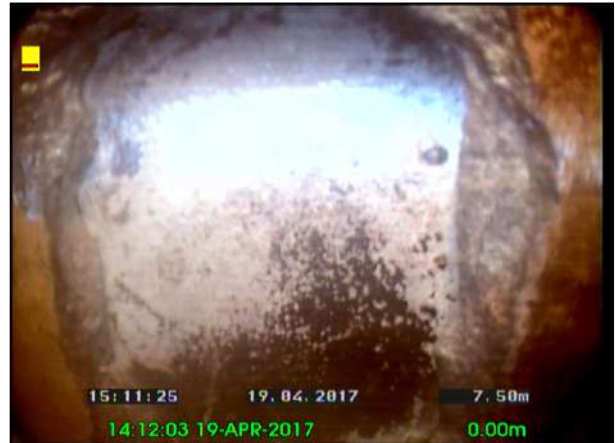
Photo: 17_17_88_A.jpg, 00:04:24
 7.5m, Hole in drain/ sewer, at 12 o'clock

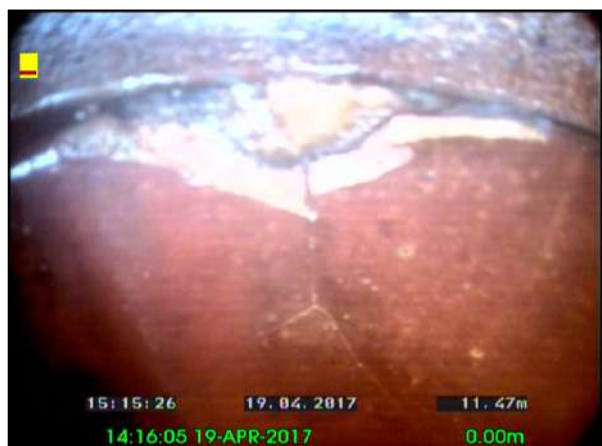
Photo: 17_17_96_A.jpg, 00:08:26
 11.47m, Broken pipe, at 10 o'clock

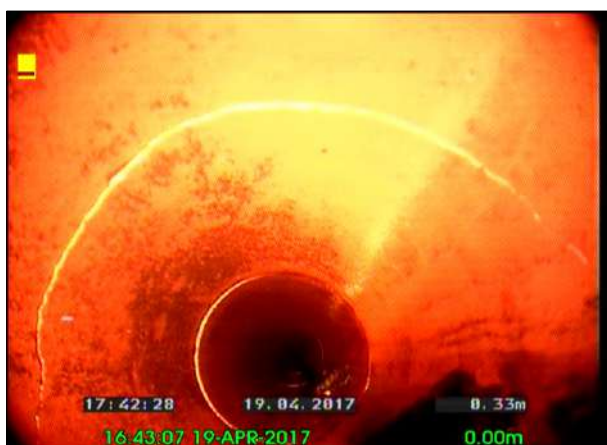
Photo: 20_20_112_A.jpg, 00:00:21
 0.33m, Crack, circumferential, from 10 to 6 o'clock

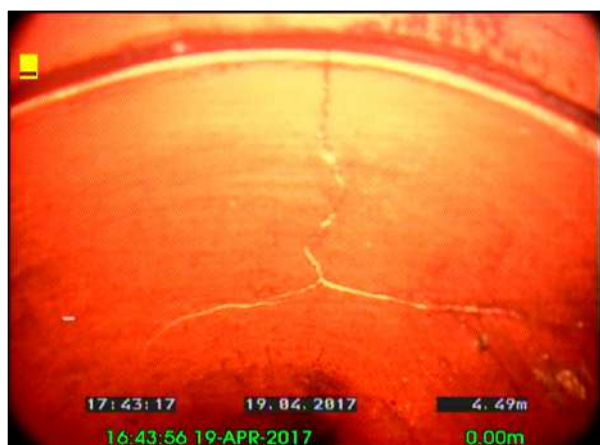
Photo: 20_20_113_A.jpg, 00:01:06
 4.49m, Cracks, multiple, from 1 to 4 o'clock

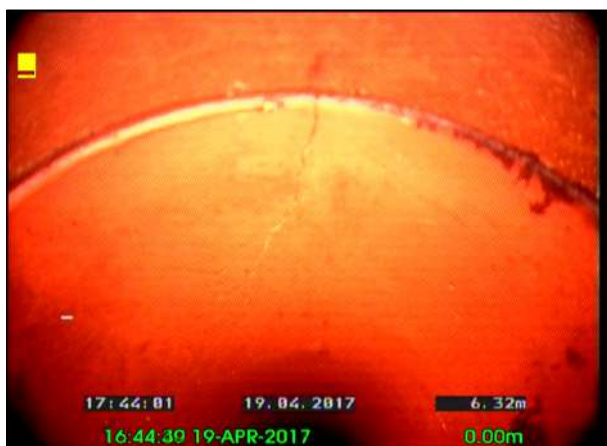
Photo: 20_20_114_A.jpg, 00:01:53
 6.32m, Crack, longitudinal, at 12 o'clock

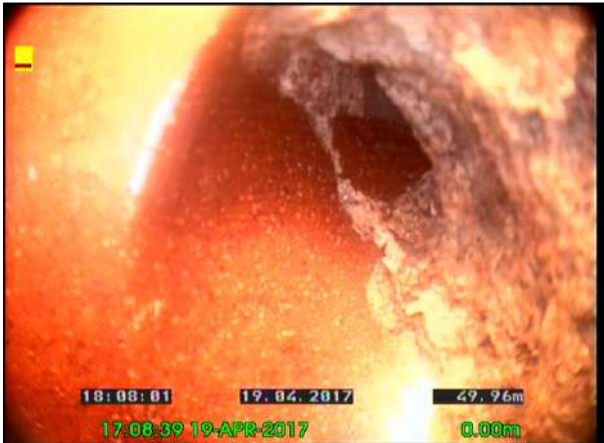
Photo: 21_21_133_A.jpg, 00:09:15
 49.96m, Connection defective, connecting pipe is blocked, at 2 o'clock, diameter 100mm, intrusion 10% Remarks: OBSTRUCTING CAMER A

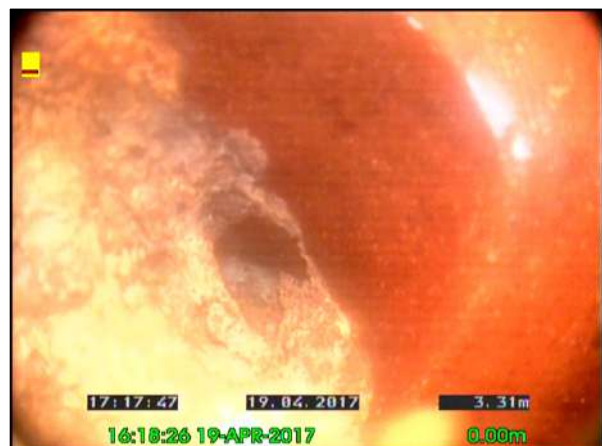
Photo: 22_22_139_A.jpg, 00:01:05
 3.31m, Connection defective, connecting pipe is blocked, at 10 o'clock, diameter 100mm

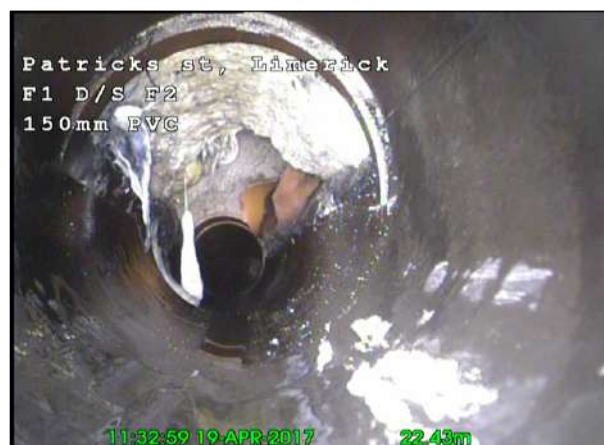
Photo: 28_28_166_A.jpg, 00:03:26
 22.43m, Broken pipe, from 9 to 3 o'clock Remarks: COMING INTO MANHOLE

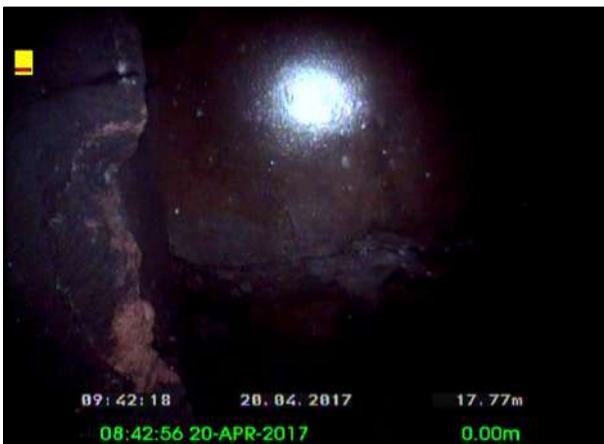
Photo: 33_33_199_A.jpg, 00:06:27
 17.77m, Broken pipe, from 10 to 2 o'clock Remarks: PIPE
 ROOF BROKEN AND CAPPED

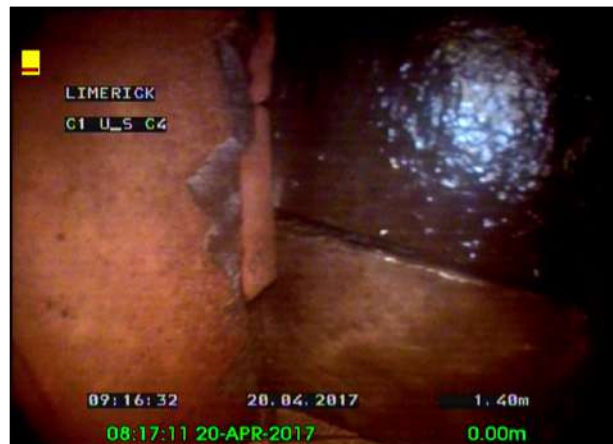
Photo: 34_34_209_A.jpg, 00:00:55
 1.4m, Broken pipe, from 10 to 2 o'clock Remarks: TOP OF PIPE MISSING AND CAPPED OVER

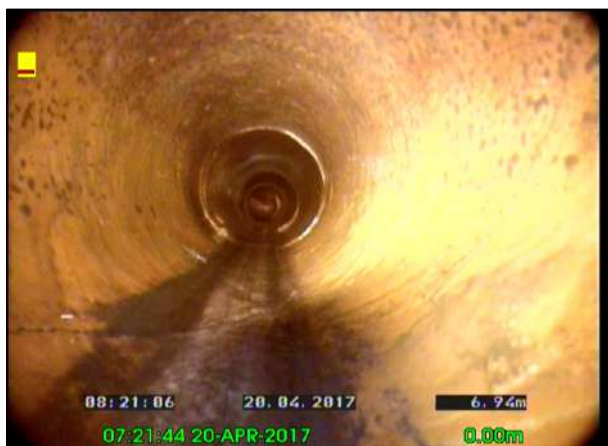
Photo: 35_35_221_A.jpg, 00:04:10
 6.93m, Crack, longitudinal, at 7 o'clock

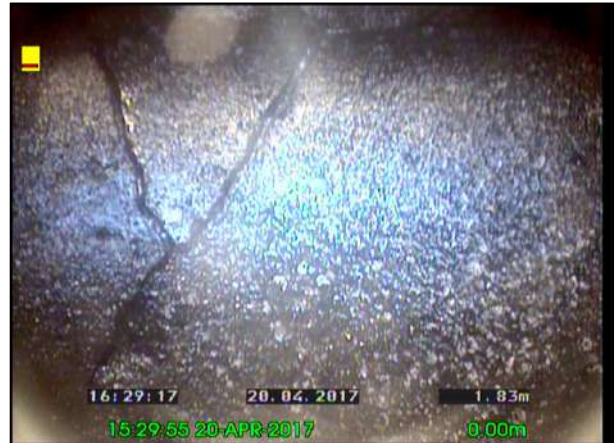
Photo: 38_38_238_A.jpg, 00:00:32
 1.83m, Cracks, multiple, from 5 to 12 o'clock

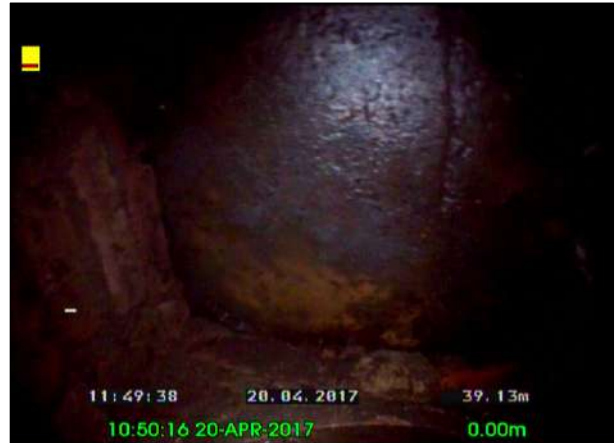
Photo: 41_41_277_A.jpg, 00:11:46
 39.13m, General remark Remarks: BURIED MANHOLE CHAMBER
