Chivers Factory Site, Coolock

Ground Investigation Report

Project Title	Chivers Factory Site, Coolock
Engineer	Casey O'Rourke
Project No	7068-09-17
Document Title	Ground Investigation Report

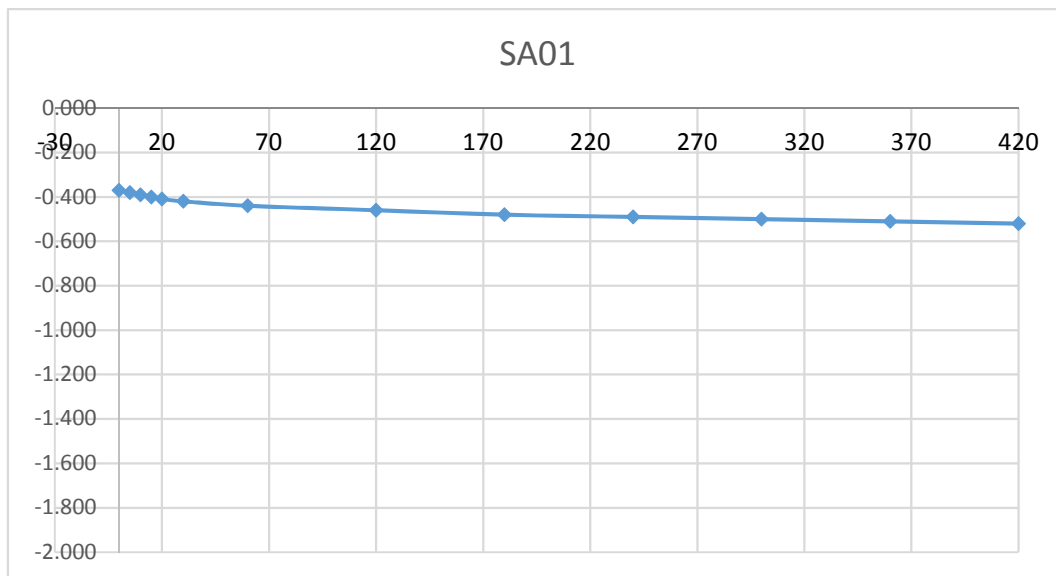
SA01

***Soakaway failed - Pit backfilled**

At all the soakaway locations the water level dropped too slowly to allow calculation of 'f' the soil infiltration rate. These locations are therefore not recommended as suitable for soakaway design and construction.

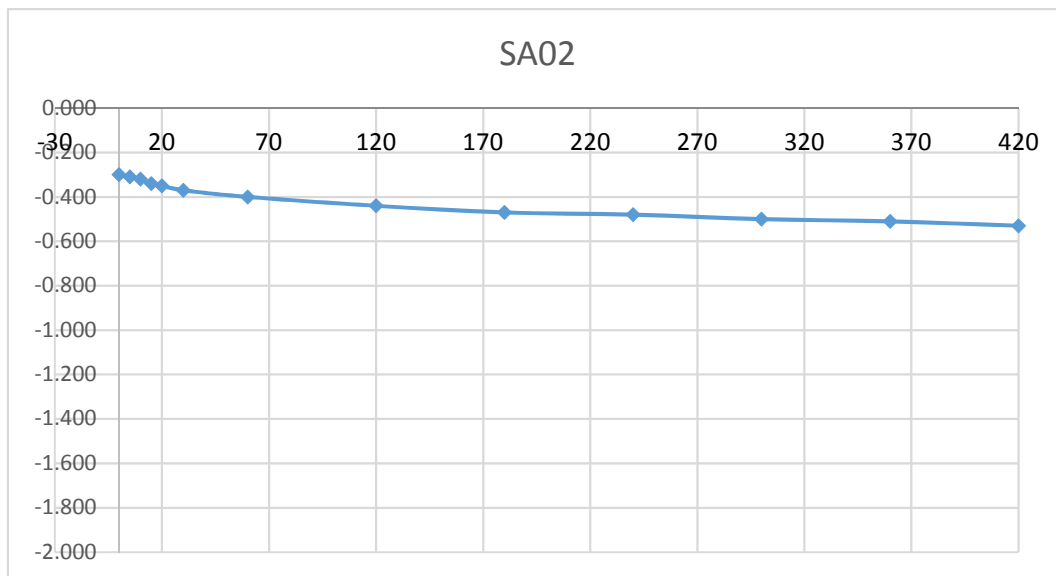
SA02

***Soakaway failed - Pit backfilled**

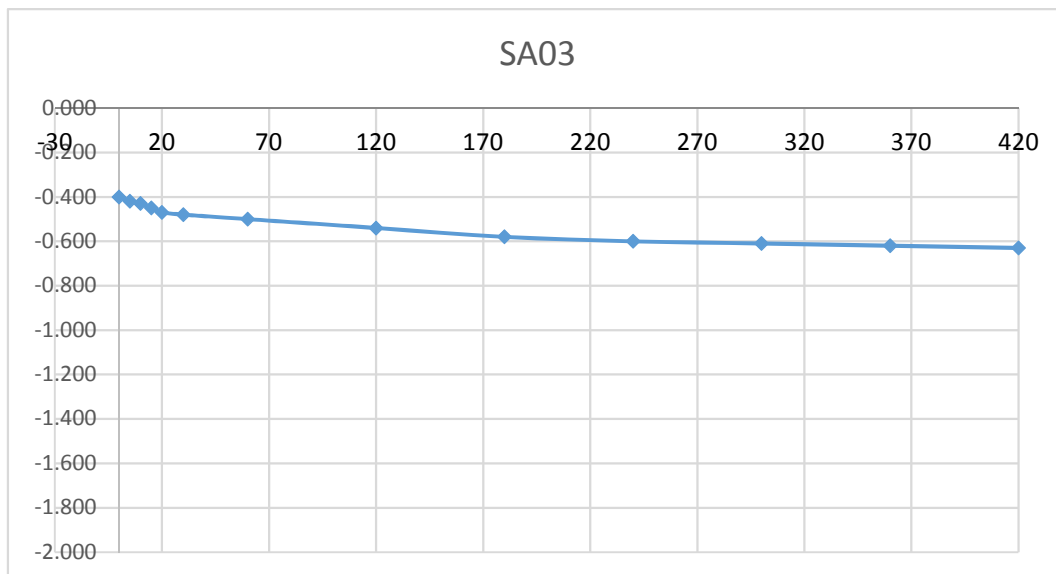
SA03

***Soakaway failed - Pit backfilled**

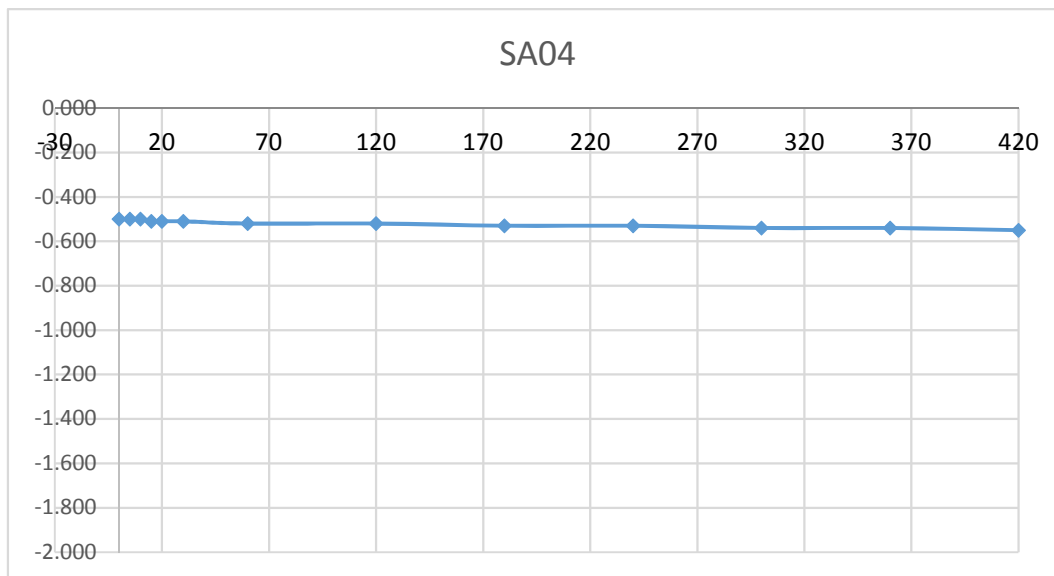
SA04

***Soakaway failed - Pit backfilled**
