## Cairn Homes Development - Castletreasure

### Road Safety Audit: Stage 1

April 2019

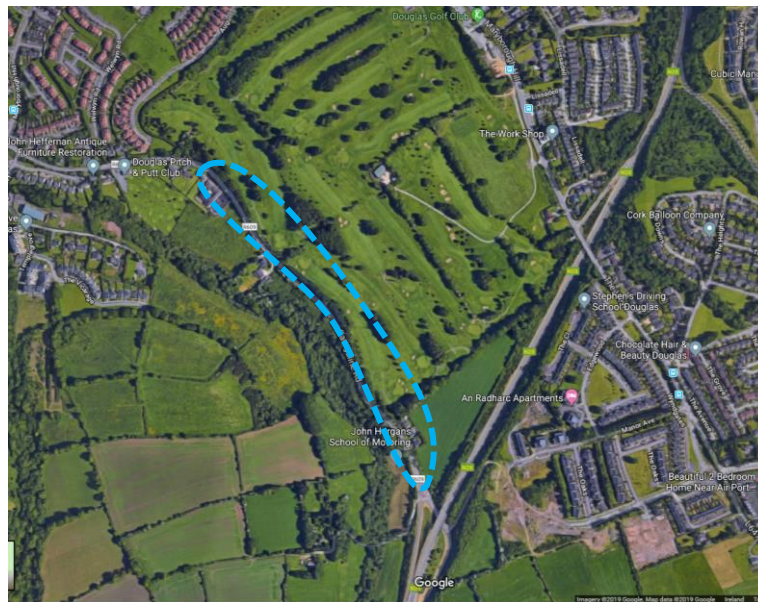
The proposed southern junctions on the Carrigaline Road are located at the interface of a high speed/ low speed, rural/urban divide and close to the interchange with the N28, a high speed national primary road. It is noted that the change in speed zone (from 60kph to 50kph) is to the north (on the village side) of the proposed new Junctions. Vehicles were observed travelling at high speeds, far in excess of the posted speed limit, along this stretch, in particular vehicles traveling from the N28 towards Douglas.

There is a risk that drivers, on approaching the new junctions for the development, may be travelling at inappropriately high speed and may not have sufficient distance to reduce their speed to safely negotiate the junction or stop. This increases the likelihood of vehicle collisions with other road users or fixed roadside objects.

Figure 6: Location of Carrigaline Road with Excessive Speeds

The 50kph speed limit zone should be relocated closer to the N28 to include the new accesses to the development.

Measures to reduce speeds, such as a gateway entry treatment, warning signage, street lighting and road markings etc. should be provided on approach to the new junctions to warning drivers of the change in road environment.

3.1	Yes	Yes - A gateway treatment has been designed to be located on the R609 in advance of the proposed junctions on the R609.		
3.2	Yes	Yes - The main access junction is a controlled junction, in any event there is in excess of 100m on the near side at this junction.  The apartment entrance is within the proposed 50kph zone, under Table 4.2 of DMURS forward visibility of 45m are required. The two parking spaces closest to the junction have been removed to achieve the required sightlines.

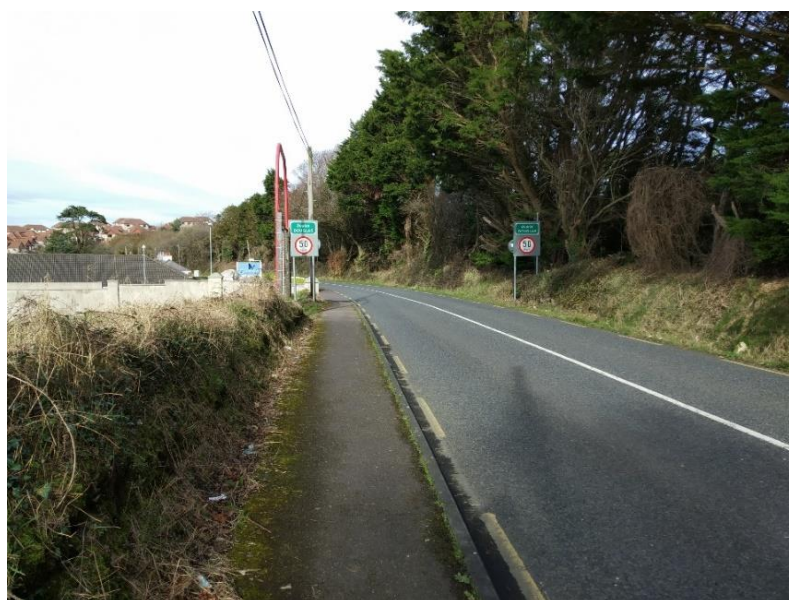
Figure 7: Carrigaline Road Speed Limit Signs

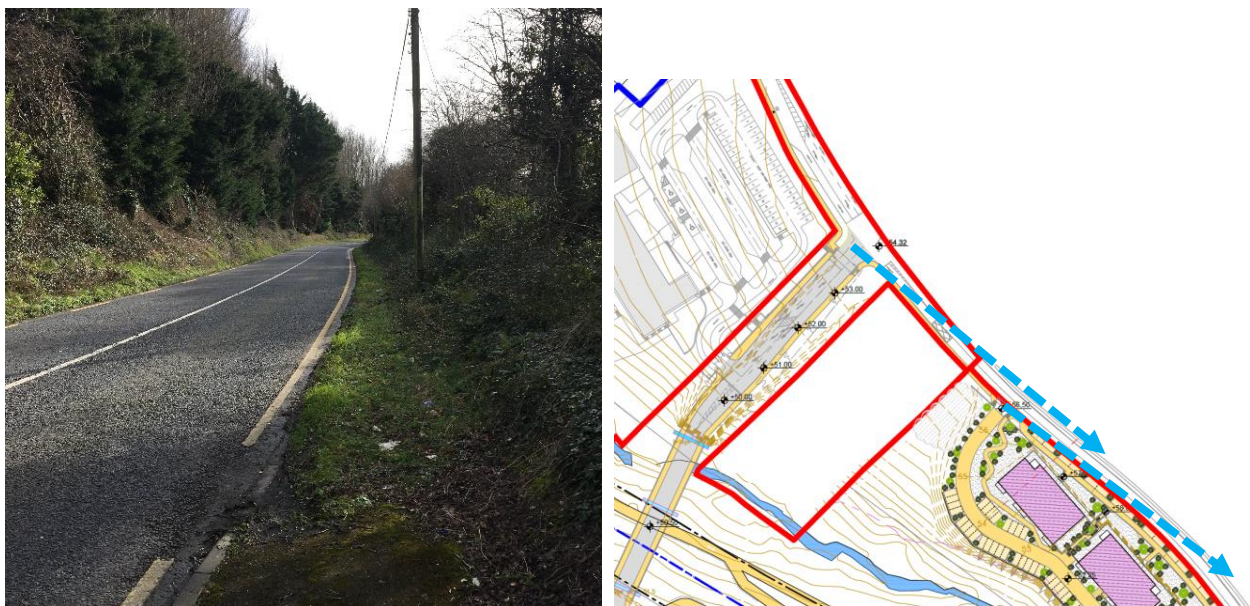
It is unclear if sufficient visibility has been provided at the two southern access/egress point. The sharp bends to the south-east of the Carrigaline Road may obstruct visibility for motorists exiting the development via the main entrance, and eastern apartment block entrance.

Failure to provide adequate forward visibility may result in vehicle-vehicle and vehicle-pedestrian conflicts.

**Figure 8: Visibility looking south-east on the Carrigaline Road from the main entrance and secondary entrance**

Visibility commensurate with the operational speed of the road should be provided at all locations throughout the site.

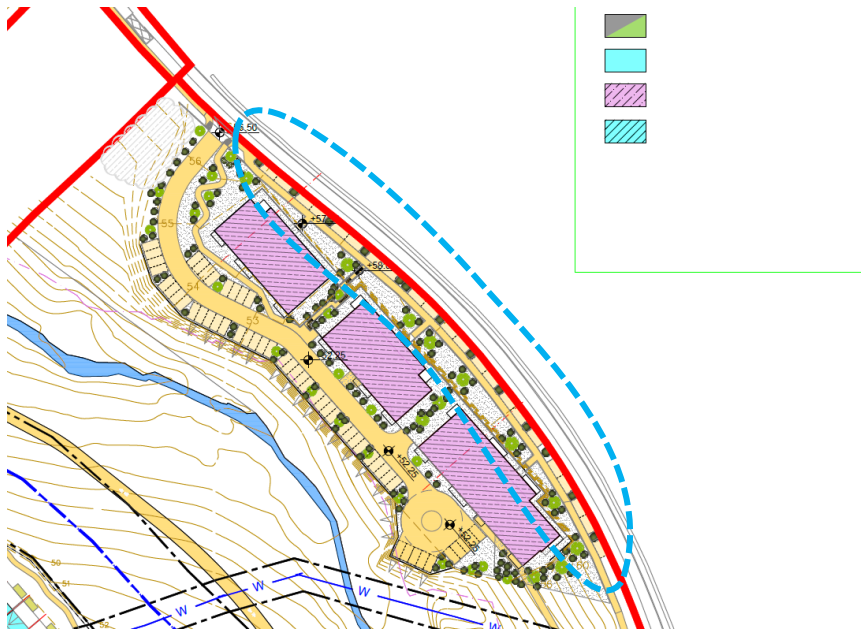
It appears that on street parking is to be provided along the Carrigaline Road for the north-eastern apartment blocks. Parked vehicles may present a road side hazard for drivers on the Carrigaline road, particularly when vehicles are manoeuvring in and out of the spaces. . Additionally, people exiting/entering parked vehicles are at risk of being struck by passing vehicles. Excessive speeds were observed along this road, further exacerbating the problem (See also problem 1.1).

**Figure 9: Dangerous On-Street Parking**

The on-street parking should be relocated within the development and removed from Carrigaline Road.

3.3	No	No	This issue is linked to Item 3.1, a gateway entry treatment has been designed south of the junctions on the R609 to create a gateway/entrance to Douglas. This will alter the nature of the roadway from rural to urban.  DMURS encourages on street parking to help reduce speed of vehicles along with the additional gateway entry treatments, warning signage, street lighting and road markings etc. The parking spaces are 2.5m x 5m with an additional 500mm setback from the road edge. There is also a 2m path inside the spaces.	Yes

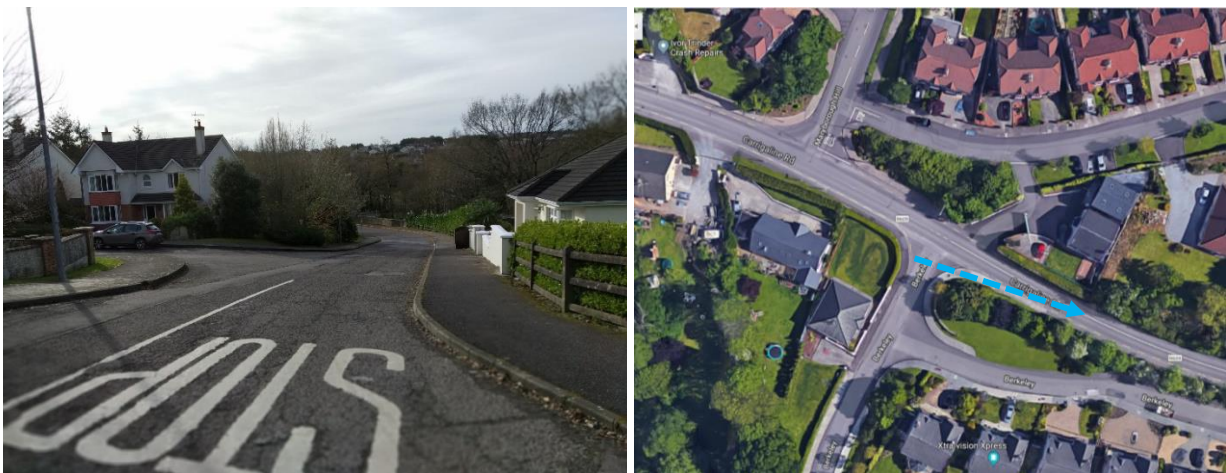
Visibility at the junction of Berkley Road and Carrigaline Road is limited, particularly for vehicles turning right onto Carrigaline road. Although a secondary entrance to the development, the junction will experience a significant increase in traffic volumes as a result of the proposed development.

The problem is exacerbated by the steep gradient on approach and lack of a dwell area provided for vehicles exiting from Berkley.

Insufficient visibility at junctions could lead to vehicles turning into oncoming traffic leading to side swipe collisions and rear end shunts.

**Figure 10: Steep gradient on approach to the secondary entrance**

Sightlines/Visibility commensurate with the operational speed of the road should be provided. Ensure the appropriate dwell area is provided on the immediate approach the junction.

3.4	Yes	Yes - This will be reviewed in consultation with the Management Company for the estate.		
3.5	Yes	Yes - This will be reviewed in consultation with the Management Company for the estate.

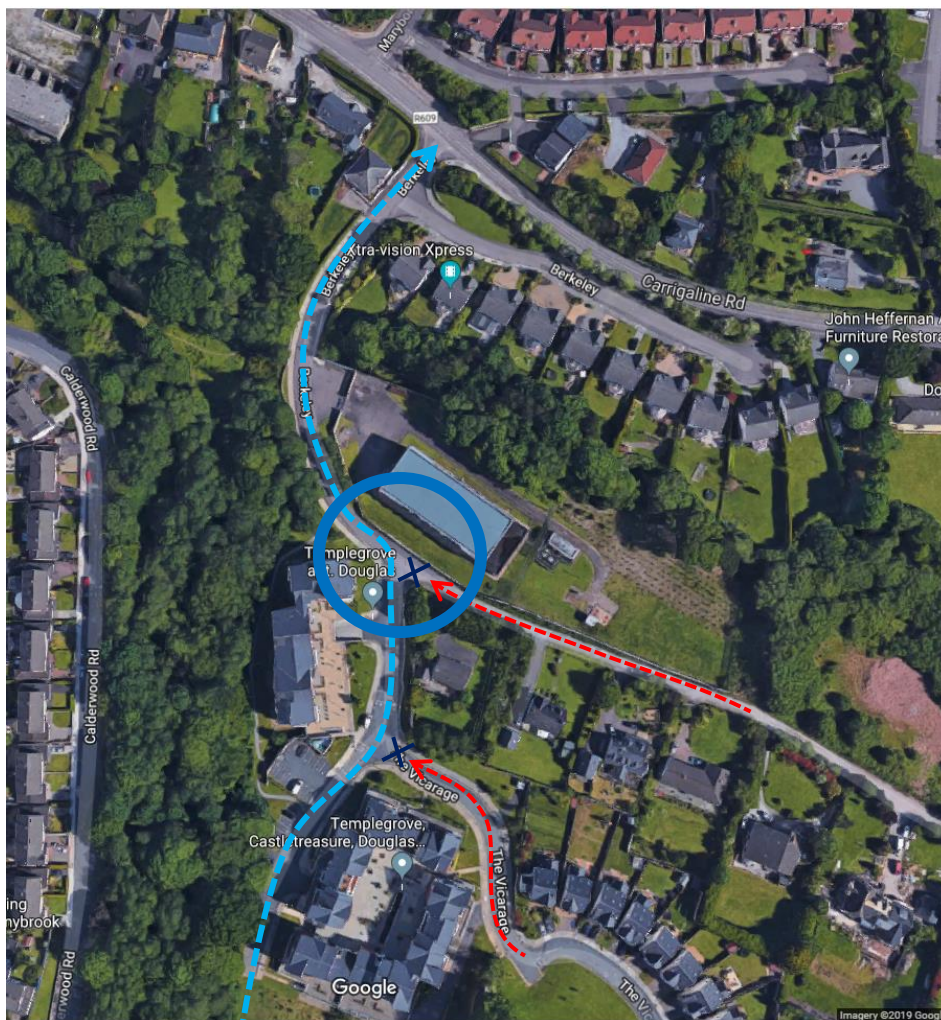
Currently along the secondary access route via Berkley road and Templegrove, priority is given to Berkley road and Vicarage road..

With very low volumes using the other roads along this route, vehicles traveling from the development will assume a priority and will not be expecting vehicle movements from The Vicarage or Berkeley. This behaviour will result in conflicts and an increased likelihood of vehicle collisions.

**Figure 11: Vehicle Priority (source: Google maps and annotation by JB Barry)**

Review the priority at on this access route to provide for the dominant flow of traffic. Stop Signs and Stop Road Markings should be introduced to confirm priority.

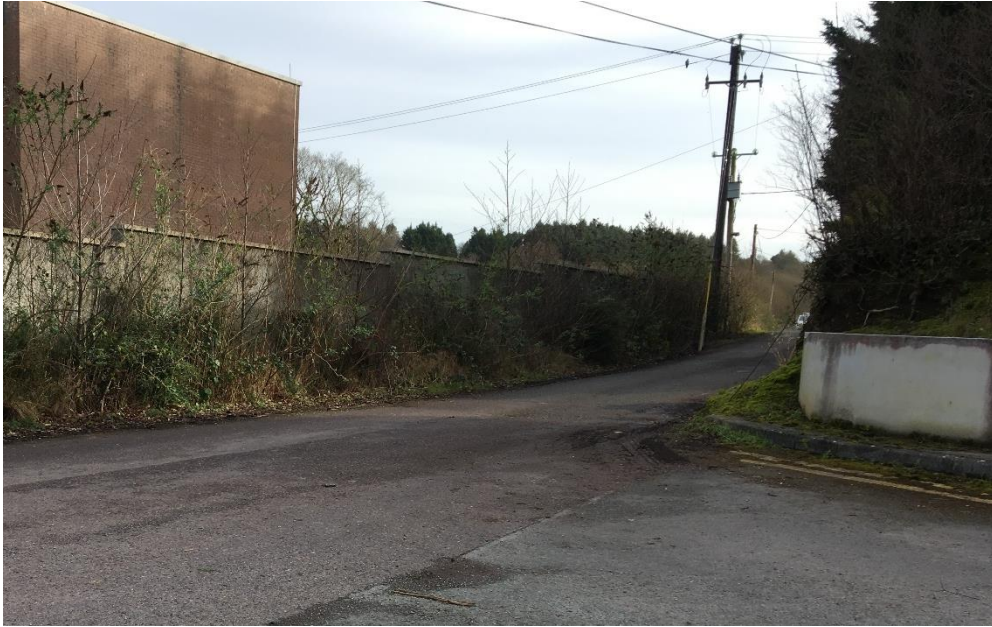
Sightlines at the junction of Berkley Road and Templegrove, for vehicles traveling from Templegrove (and the proposed development) are limited.

**Figure 12: Inadequate sightlines at Berkley road and Templegrove junction**

Sightlines/Visibility commensurate with the operational speed of the road should be provided.

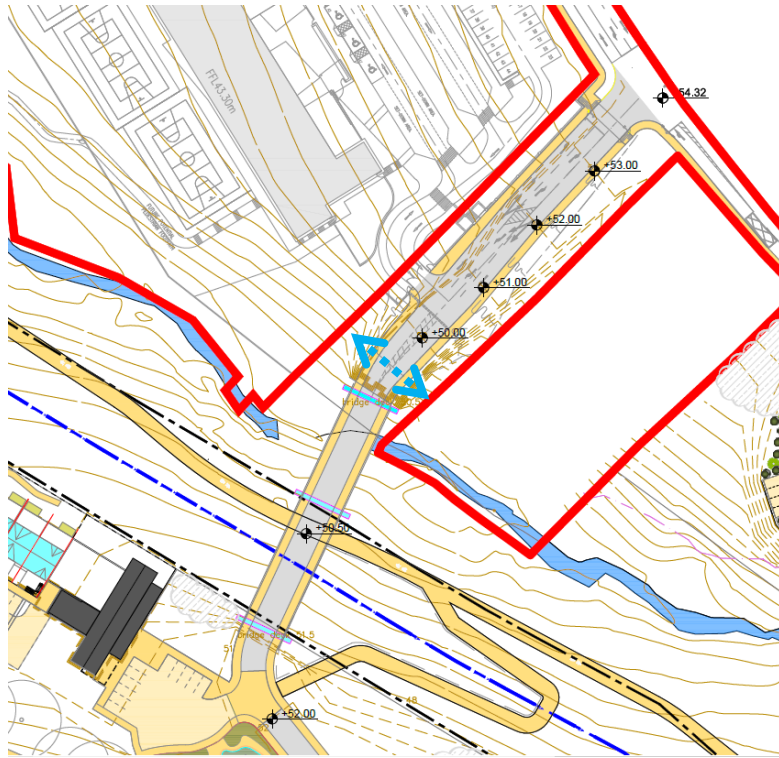
No pedestrian crossings have been provided to the west of the school. A crossing at this location would be on the desire line for pedestrians/cyclists coming to/from the proposed development and the proposed greenway to/from the new school. In the absence of a crossing, pedestrians will likely cross at an unsafe location resulting in possible conflicts with vehicles.

**Figure 13: Potential location for pedestrian crossing**

Provide a pedestrian crossing (raised table) to the west of the school.

3.6	No	No	The raised table (uncontrolled crossing) at the creche junction is close to the proposed location for a pedestrian crossing. There is no real destination on the eastern side of the carriageway, and we feel people will have crossed to the western footpath at the creche junction. This will be designed to accommodate pedestrians crossing at detailed design stage.	Yes

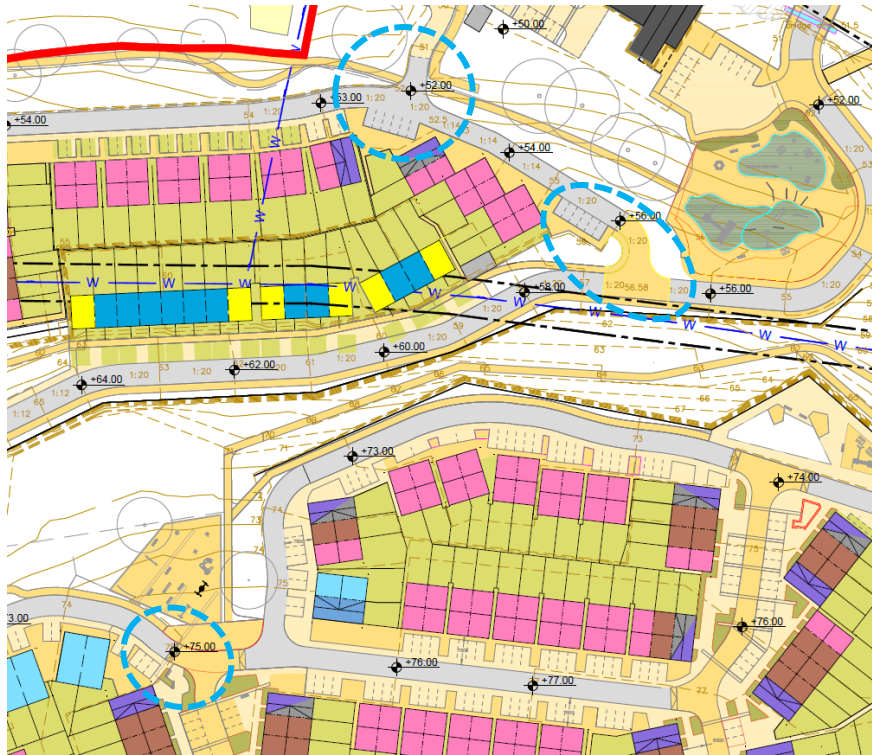
At a number of locations throughout the development, residential parking bays are situated adjacent junctions. Vehicles will have to reverse into the adjacent junction, increasing the likelihood of collisions with other vehicles entering the junction.

**Figure 14: Sample parking locations close to junctions**

Relocate the parking bays away from the junctions.

3.7	Yes	No	The proposed site layout has been designed in accordance with DMURS to encourage a more pedestrian friendly environment within the development.  Raised tables are proposed at junctions to reduce speed; we propose to increase the raised table at the main junction highlighted to extend to the parking bays highlighted and to introduce another raised table at the second junction highlighted.	Yes

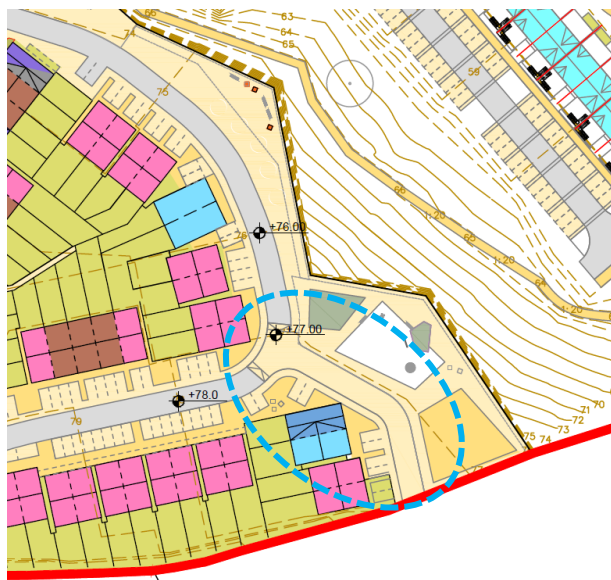
The cul-de-sac at the south-eastern corner of the development is missing a turning head. This will result in an increase in complex reversing manoeuvres, and an associated increased risk to vulnerable road users.

**Figure 15: No turning head**

Whilst it is noted that turning heads may not be required for short cul-de-sacs, a turning head should be provided for the longer more complex cul-de-sacs such as the one in Figure 15. Turning heads will minimise the requirement for vehicles, particularly larger goods or refuse vehicles, having to reverse long distances.

3.8	No	No	This is a short spur, cul de sac serving 4 no dwellings with a raised surface and play areas.  A turning area is not required in our opinion.	Yes

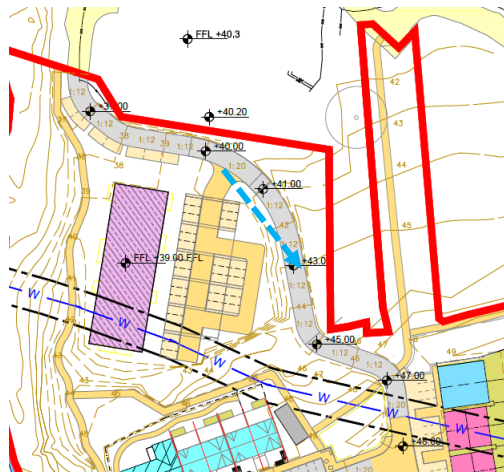
The internal junction for an apartment block along the southern access route is located on a bend. It is unlikely that sufficient visibility will be available for vehicles using this junction.

Insufficient visibility at junctions could lead to vehicles turning into oncoming traffic leading to side swipe collisions and rear end shunts.

**Figure 16: Sample obstructed visibilities**

Sightlines/visibility commensurate with the operational speed of the road should be provided at all junctions.

3.9	No	No	The access junction to the apartment highlighted is within a 30kph road zone, under Table 4.2 of DMURS forward visibility of 23m are required.  This is provided at this junction.	Yes
