# Arboricultural Assessment Report

Capdoo

Project No.	Project name	Date	Revision
TCAP001	Capdoo	26/03/19	A

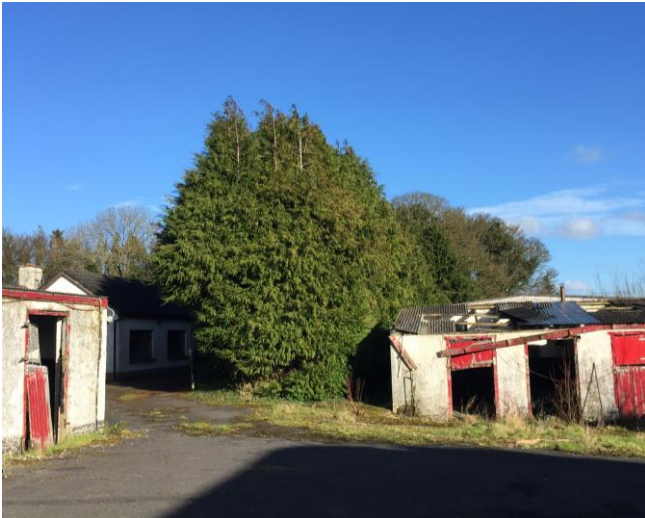
The trees and hedges around the house and stable area include a large Leyland cypress hedge (*xCuprocyparis leylandii*) along the entrance road to the house (image 2). The Leyland hedge is large, casts extensive shade and is a management liability. A large mature sycamore (*Acer pseudoplatanus*) is located at the entrance to the house on the eastern boundary (image 3) with further large mature ash (*Fraxinus excelsior*) and sycamore trees on the boundary with a neighbouring property near the eastern boundary of the site.

**Image 2.** Leyland cypress within stable yard

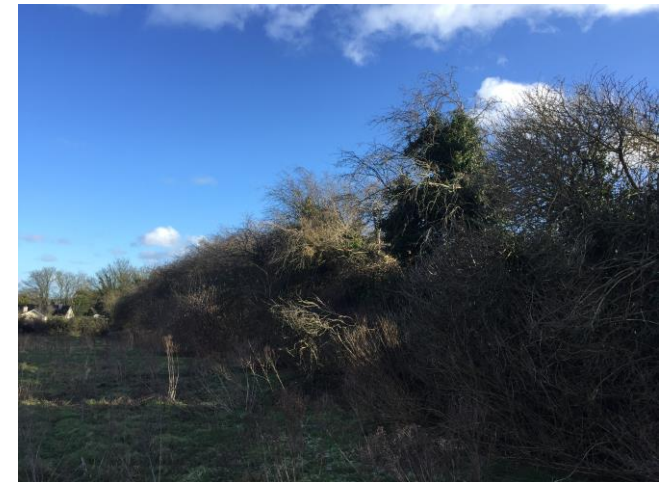
The extensive bramble (*Rubus fruticosus* agg) growth (image 6) which has developed due to limited management inputs has smothered out most of the potential ground flora within the hedgerows limiting these elements to occasional ferns and grasses. Ultimately the hedgerows are degraded in quality due to mismanagement and neglect.

Image 6. Typical hedgerow composition with hawthorn in poor condition and extensive bramble growth smothering ground flora
