REPORT

Structural Survey of the Officers Mess Building and
Water Tower at the Former Magee Barracks,
Hospital Street, Kildare Town, Co. Kildare.

May 2019

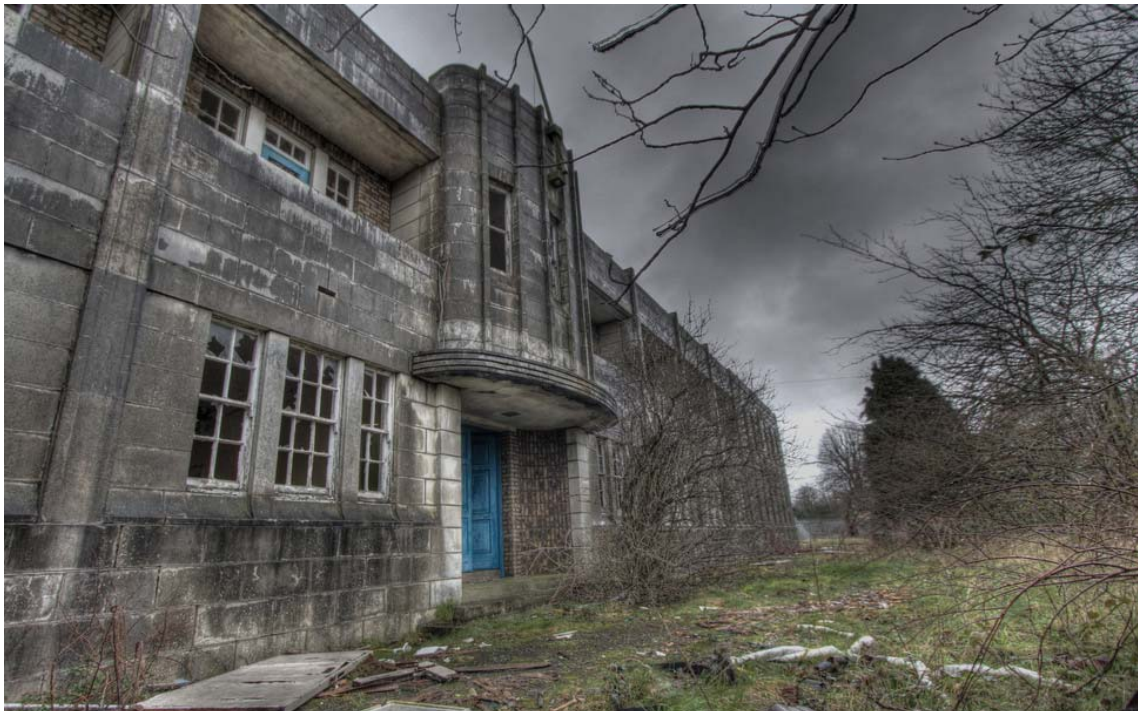
Photograph 1

The external façade of the building is constructed using a mixture of fair faced block and brick. The external skin of the building is showing signs of significant mortar loss, which will worsen and cause further deterioration with time. The brick sections of the façade are out of plane in some locations due to the loss of mortar. Mortar will continue to deteriorate due freeze thaw action.

All timber windows have significantly rotted and beyond reuse.

Lintels above windows in many locations are beyond repair and need to be replaced. There is currently propping to support some of these lintels.

The windows are broken allowing water ingress.

The structural timber visible throughout the ground floor level of the building has deteriorated and is beyond recovery. The upper internal floors were too dangerous to inspect but we expect the level of deterioration is similar to the ground floor levels.

The metal piping (soil vent pipe) fixed to the building has corroded and broken in some locations.

The building has deteriorated significantly and is showing signs of excess stress and local structural support failure. The design life of the roof, floor plates, stairs and lintels has been exceeded. The building would require significant structural improvement to the floor plates, stairs and roof. The timber windows structure is beyond reuse. The external façade has discoloured due to wear and salts in many locations. This façade would not be able to return to its original consistent colour. The building poses a health and safety risk to any persons in the vicinity of the building.

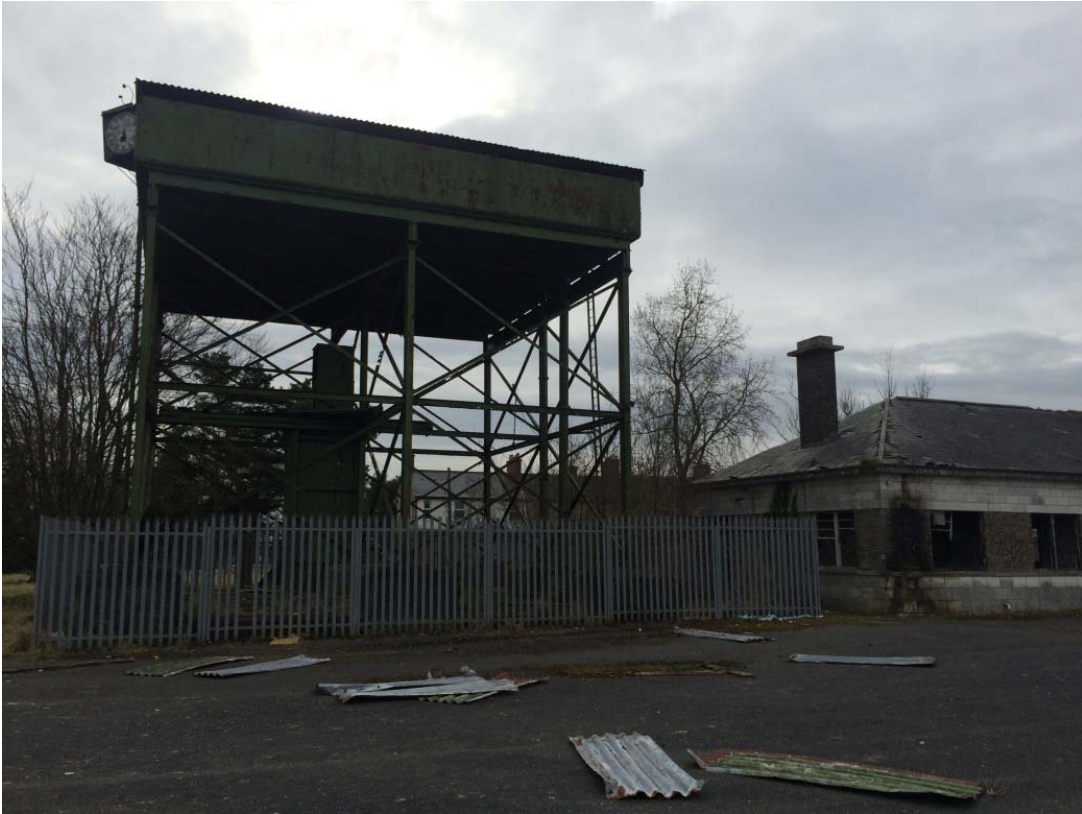
Photograph 6

The water tower was found to be in extremely poor structural condition. There is significant corrosion of all structural members and cladding. The protective coating to the metal has failed allowing for corrosion, deep pitting and loss of cross section.

The diagonal bracing which provides stability to the structural frame has failed at most connections. The failures at bracing connections are significant and the bracing to the water tower can no longer be considered to be providing the structural function for which it was designed.

The cladding around the water tower has corroded significantly and panels have come loose. From aerial photographs, it appears that some roof panels have also come loose.

Bracing members: The bracing members have failed in most locations. As the bracing members are thin in cross section, cleaning back the corrosion would significantly reduce the member's capacity and therefore they could not be re-proposed for the function they currently serve. New bracing would need to be provided.

Columns and beams: Corrosion testing would need to be conducted throughout to assess the loss in cross section due to corrosion. The beams and columns will require additional strengthening. It may be possible to strengthen the columns and beams by a weld build technique. Plating the beams and columns would increase the thickness of the members and make them look bulkier than they do presently.

Cladding: The cladding can only be viewed from the ground but it is evident that the corrugated cladding has already begun to significantly corrode. It is difficult to say how much of the original cladding could be reused, but considering the amount of pitting of the cladding panels closest to the ground; we estimate only very small sections cut from larger panels are fit for reuse. Examination of the aerial photos available it appears the roof cladding has already come loose.

The structure is at risk of collapse and if stabilisation works or repairs works are not being considered, an exclusion zone of approximately 20m in all directions should be placed around the water tower structure.

- a) Remove the water tanks as they no longer serve a purpose.
- b) Provide temporary supports to allow for the removal of bracing members.
- c) Clean back all structural members and assess residual capacity of structure. It is likely that the structural members will require plating or replacement of members.
- d) The cladding around the water towers will need to be replaced. We estimate that only small amounts of material can be salvaged.
