Road Safety Audit
Stage 1
for
PROPOSED MIXED USE DEVELOPMENT
AT
NEWTOWN, DROGHEDA, CO LOUTH

Date: July 2019

Report produced by: Road Safety Matters

Reference: RSM/MOB/080719/NEWTOWN RSA1

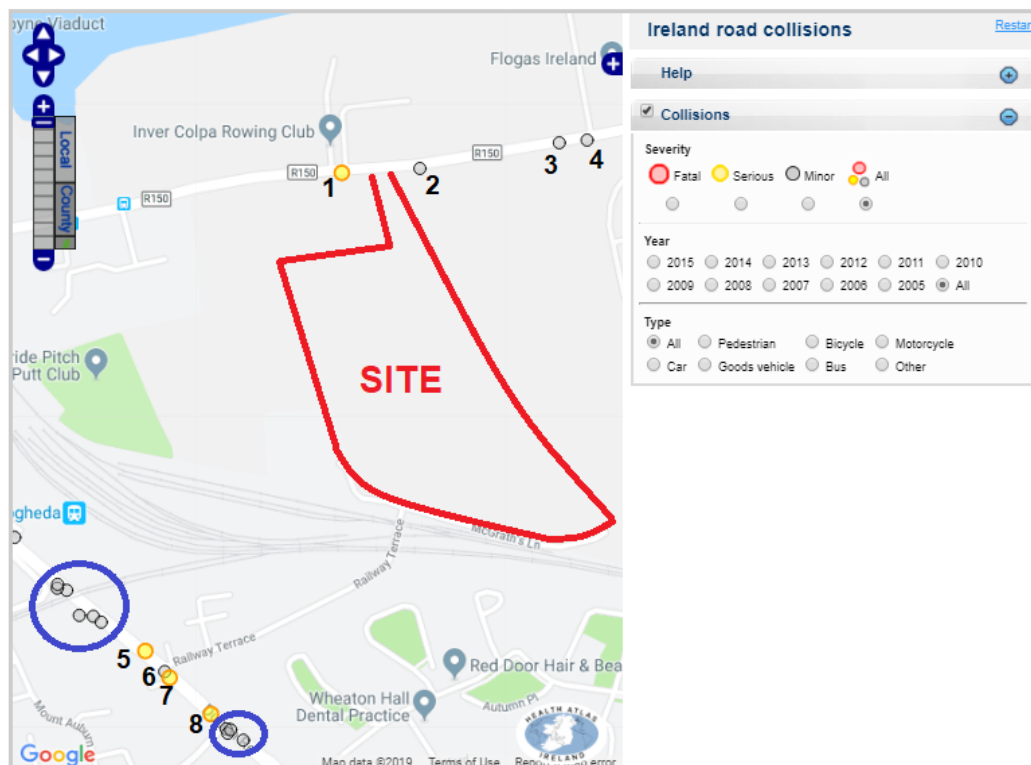
Figure 3¹

2.1.3 No information was provided on any existing collision statistics in the vicinity of the site. A review of the Road Safety Authority (RSA) online collision database indicates that there were a number of collisions recorded on the R150 in the vicinity of the proposed development site access between 2005 and 2015 inclusive, at the locations shown in figure 3, including a serious collision. There were a number of serious collisions also recorded at the intersection of Railway Terrace and the R132 Dublin Rd to the south of the site, with two additional clusters noted to the north and south of this location, as highlighted in figure 3. A summary of the characteristics of the collisions numbered 1-8 in figure 3 have been included in Table 2.

A cursory overview of the collisions characteristics indicates that there was a significant proportion resulting in high casualty severity, and a significant portion involving single vehicle collisions only, which can be indicative of inappropriate vehicular speeds. Two of the recorded collisions involved VRUs (Vulnerable Road Users – i.e. cyclists and pedestrians) and two of the recorded collisions involved a bus. Table 2 does not include an examination of the collision clusters recorded further north and south of the junction with Railway Terrace on the R132, however it is recommended that any potential safety issues on this link should be considered as the site design progresses, as the link and proposed shared surface on Railway Terrace is likely to be used by a relatively high proportion of VRUs travelling to and from the site and Drogheda town centre, including the railway station. It should be noted that the RSA database is not a comprehensive record of collisions, and should be reviewed in conjunction with the Local Authority / Gardaí records for the site, to include an investigation into installation criteria for the speed camera.

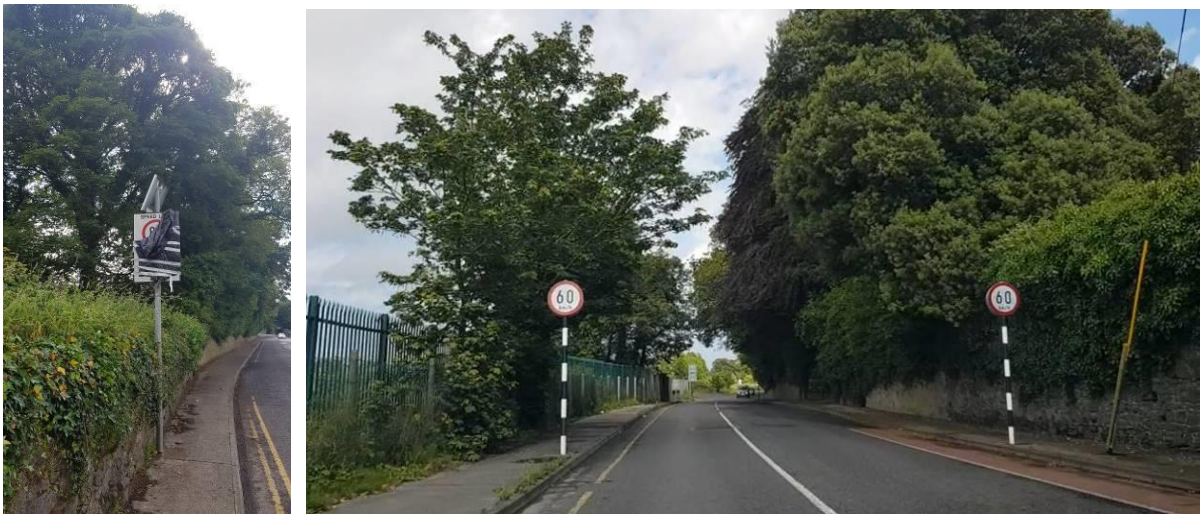
Figures 5 & 6

It was noted that new 80 km/hr speed limit signage has been installed on the R150 in the vicinity of the proposed junction with the new LIHAF link road, however this signage was partially covered at the time of the site visit, as shown in figure 5. The long term proposals for speed limit signage are therefore unclear, however the Audit Team considered that a rural speed limit of 80 km/hr would be inappropriate for the site and for the roads surrounding the site, based on the scale and urban nature of this proposed residential development. Inappropriate speeds will increase the risk of collision for all road users, particularly VRUs travelling to and from the site.

A review of the location and suitability of the current speed limit on the network surrounding the site is advisable on all approaches to the site at detailed design stage, to include an extension of the 50 km/hr speed limit zone to include the access to the site off the R150, along with suitable length transition zone and entry treatment, and traffic calming as necessary. All conflicting signage should be removed.

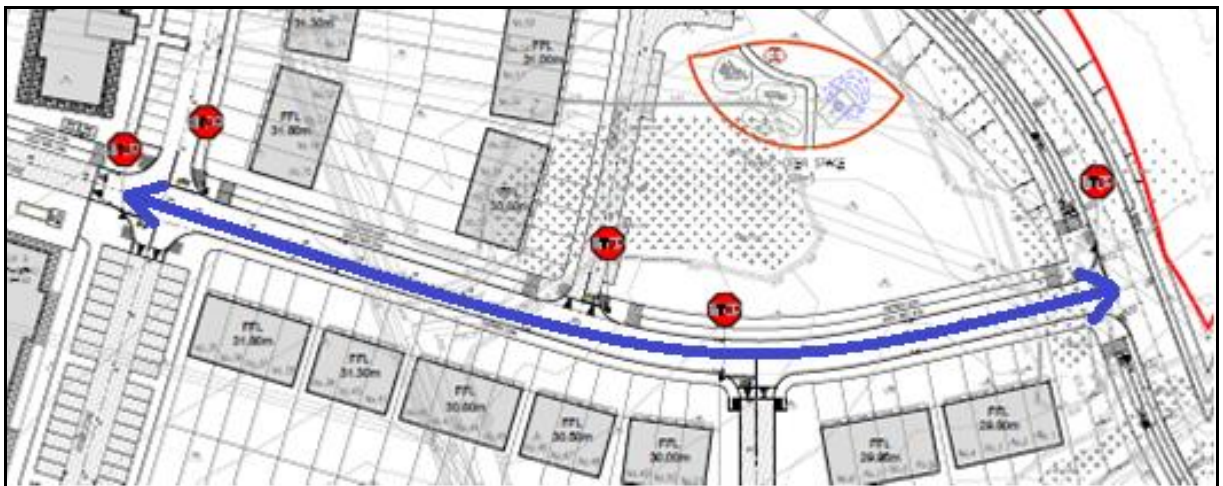
Figure 8

There is no provision for reduced speed limit signage (e.g. 30 km/hr) or ‘Slow Zone’ signage within the site. The posted speed limits of 60 km/hr and 50 km/hr on the network adjacent would be inappropriately high for the internal roads in a residential environment, where high proportions of VRUs should be anticipated, and where a number of relatively long links have been provided, with limited provision for traffic calming, e.g. figures 7 and 8, including on relatively steep access roads and links, although the design includes for raised tables/ramps at some locations on the proposed access road network throughout the site.

Lower advisory speed limit signage or slow zone signage is advisable on entry to the site, with additional signage as necessary in locations where child pedestrians are likely to play in the vicinity of the access roads or green areas. Supplementary and more frequent vertical deflection should also be considered where necessary on long straight links throughout the site, in addition to that shown on the preliminary layout plans, particularly on links where gradients exceed 5%.

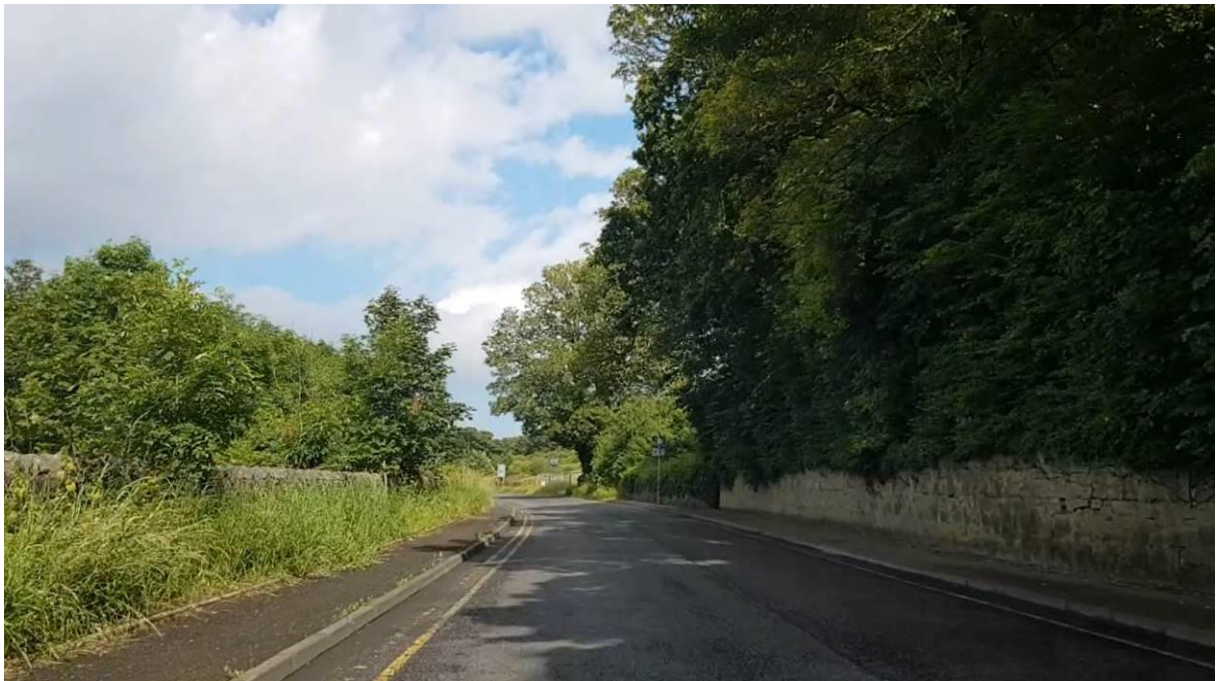
Dense hedging and overgrown verges are currently located along a significant proportion of the site boundary on the R150 and along McGraths Lane, with some overhanging trees and vegetation on the R150 on approaches to the site leading to the potential for slippery conditions on the adjacent carriageway and footways, as well as reduced conspicuity at the proposed access onto the LIHAF, particularly the large mature tree highlighted in figure 13, which is located relatively close to the carriageway edge.

Figure 13: Dense vegetation/mature trees overhanging carriageway on R150

Landscaping proposals should be clarified at detailed design stage, with all trees and landscaping to be located away from positions which could increase the risk of conflict or have a negative impact on intervisibility at VRU desire lines, or where shedding leaves may cause slip/trip hazards. Proposed or existing landscaping and boundary treatments throughout and surrounding the site, should be located outside visibility splays or provided at a height less than 1.05m above ground level. Internal boundaries, walls and landscaping should also be offset a safe distance from the edge of carriageway, and forward visibility and stopping sight distance on all links throughout and surrounding the site should be clear and unobstructed in accordance with traffic speeds. Earthworks proposals to be clarified at detailed design stage to include details of slope and heights, with provision for suitable fencing and vehicle restraint where necessary throughout the site. Demands for vehicular access from the south should be assessed to determine suitability of access proposals and requirements for boundary treatment.

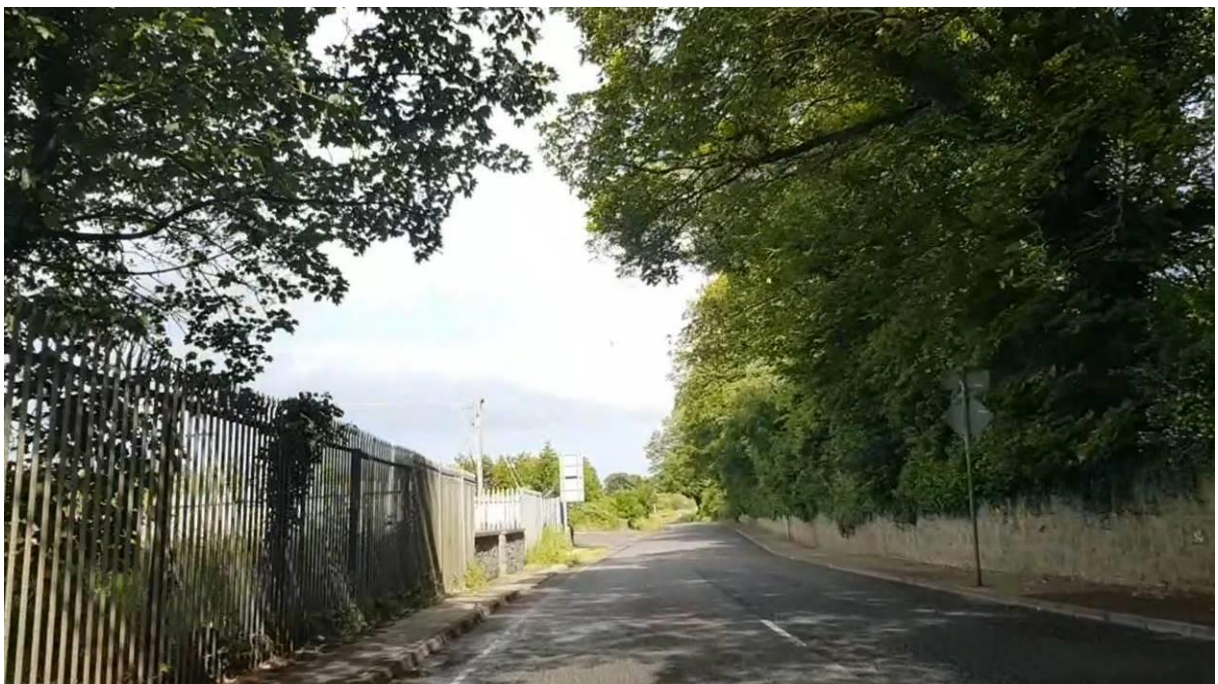
Figure 14: Dense vegetation/mature trees overhanging carriageway on R150

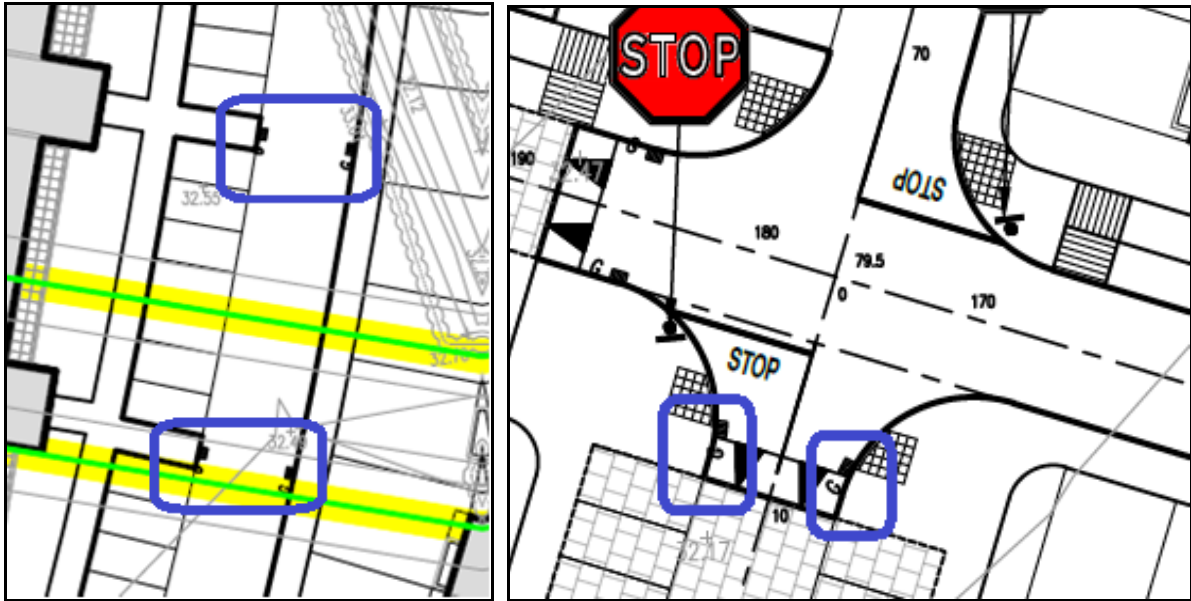
Figures 15 & 16

The preliminary design layout includes provision for gullies adjacent to kerbs throughout the site, however gullies have been provided on pedestrian desire lines at some locations, where they will present a hazard to pedestrians, with examples shown on figures 15 and 16. There were no gullies provided at some locations at the end of relatively steep gradients on links, where ponding may arise, including at ramps to basement car parking. Externally, the provision for gullies on the new shared surface along railway terrace is unclear, and there are no gullies provided along the new kerbline on the southern side of the R150, where the widened cross section will effect the current crossfall.

The detailed design drawings should include drainage details along all shared surfaces and along new kerblines of the R150, and throughout the site at locations where there are steep gradients, including access links into basement carparking. All new gullies throughout the site and on approaches to the site should be flush with the surrounding pavement, and placed in a location which is outside the desire line for pedestrians and two-wheeled vehicles.

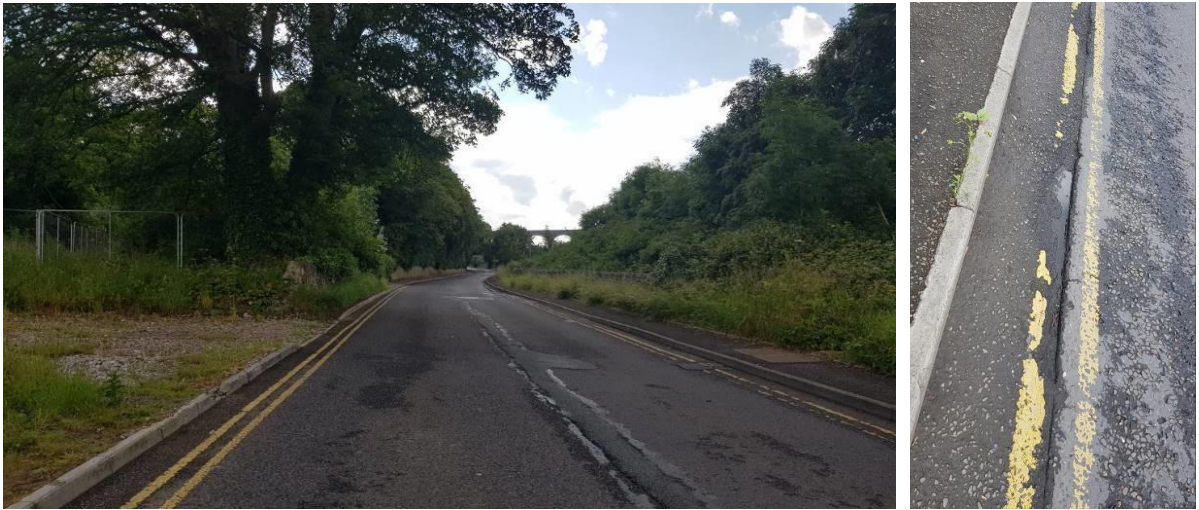
Figures 17 & 18

wheeltracks, particularly for two-wheeled vehicles. Existing joints in the carriageway at this location, which are shown in figures 17 and 18, will present hazards within the centre of the new narrower lanes at this location. It was noted that poor carriageway condition on Railway Terrace, which is shown in figure 19, should be addressed through provision of a new shared surface at this location along most of the length of the link, which should be clearly identifiable as a shared surface, with VRU priority, as with all of the homezones throughout the site.

Detailed design should include for long sections showing vertical design for all new links throughout the site and details of all new surfacing and carriageway construction and widening along the R150, with longitudinal joints between old and new carriageway to be avoided at any locations where the existing road is being widened. Suitable high friction surfacing should also be provided where necessary on all links throughout the site where gradients are relatively steep, particularly on the approaches to points of conflict.

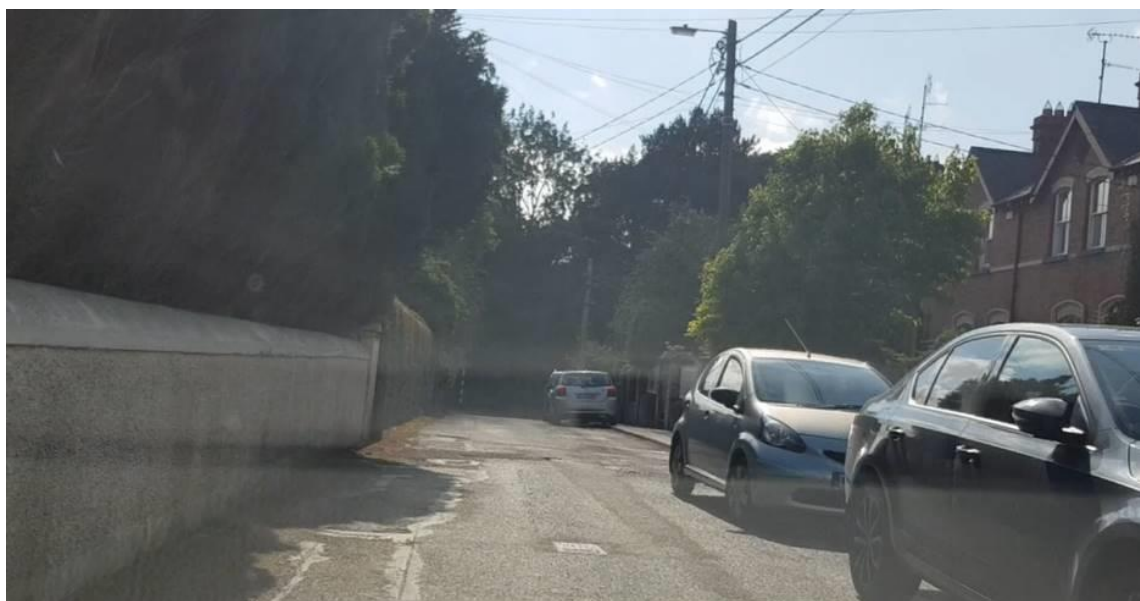
Figure 20

It was noted that existing solid boundary walls are located immediately adjacent to the running lane on Railway Terrace, as shown in figure 20, and particularly at the railway overbridge and there is no provision for a suitable offset on the proposed layout at these locations, presenting a risk that the walls will be struck by passing vehicles, or pedestrians will be vulnerable at locations where two vehicles are attempting to pass on the narrow cross section. New lighting columns have also been provided on the shared link, once again immediately adjacent to the running lane with no safe clearance or suitable kerbing provided. It was noted that the bridge parapet is cracked at present, as shown in figures 21 and 22, and the walls appear unstable, which will present additional risks to passing vehicles and VRUs.

All potential hazards throughout the site and on approaches to the site should be located at a sufficient offset from carriageway edges, particularly solid boundary walls, to minimise the risk that the hazard will be struck by passing vehicles. A recommended 600mm clearance should be provided to all solid boundaries within the site from the edge of carriageway, with a minimum 450mm clearance to be provided to all other boundaries, street furniture and signage. The alignment and integrity of the railway overbridge should also be examined in conjunction with the development of this site, with improvements to be made to safety and sightlines to address the likely increase in pedestrian flows on this link, arising as a direct result of the site proposals, and the resultant increased risk of conflict with vehicles.

2.1.9 Problem - Insufficient Clearance to Hazards	Partially	Yes, a full structural analysis of the railway over-bridge will be examined as part of the detailed design. All hazards within the development area will be set-back as appropriate.	In relation to potential hazards on approach to the site from Railway Terrace / McGraths Lane, these are existing local streets / lanes and the proposed development will not result in any increased vehicular traffic as there is no vehicular access to the development from this direction. Furthermore, Railway Terrace is a minor dead-end street providing access to circa. 30 houses. In this regard, traffic speeds & volumes will be low. The works proposed on Railway Terrace aim to increase pedestrian safety by widening the footpath and limiting traffic flows via a yield system. McGraths Lane improvement works involve prioritising pedestrians and cyclists through the provision of a widened shared surface with upgraded lighting. It is noted that traffic flows over the bridge will be very low as the only access is to the 2 No. existing properties.	Yes ³

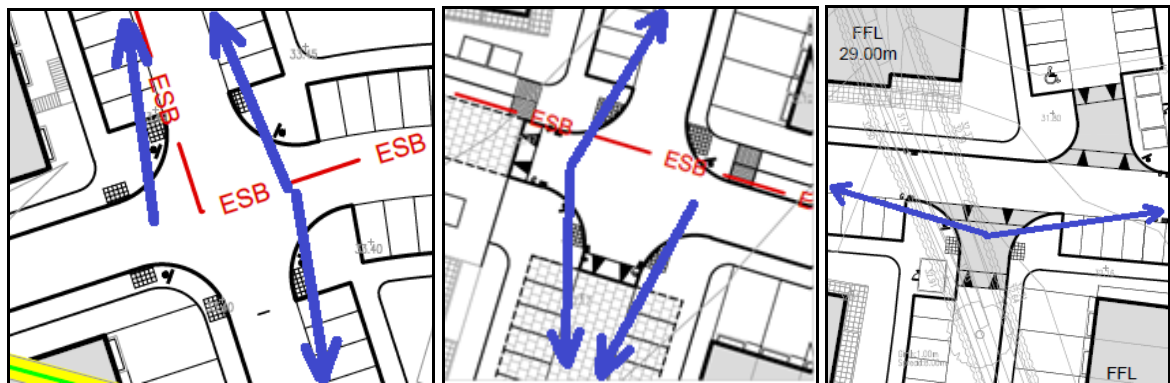
It was noted that a significant number of internal parking spaces are configured as perpendicular spaces, and are located in close proximity to junctions where vehicles will be queuing and turning, and where vehicles parked are likely to present obstructions in visibility splays, with examples of where this may occur shown in figures 23-25. Obstructions in visibility splays increase the risk of pulling out and right angled collisions. Vehicles parked adjacent to pedestrian desire lines can also restrict intervisibility between approaching motorists and pedestrians waiting to cross, increasing the risk of pedestrian/VRU conflict.

Figures 23-25: Perpendicular Parking near Junctions

Total parking demands for the site should be assessed, with on street parking to be removed or restricted adjacent to all junction visibility splays and at locations where intervisibility between road users could be compromised, and with visibility splays throughout the site, and on all approaches, to be clear and unobstructed at all times in accordance with traffic speeds. Parking configuration to be parallel where possible, with perpendicular parking and the potential for reversing manoeuvres to be avoided adjacent to junctions and likely pedestrian desire lines to cross the carriageway. Any parking demands on street should be closely monitored to ensure vehicles do not obstruct the safe passageway of pedestrians or restrict the turning movements and visibility of other vehicles.

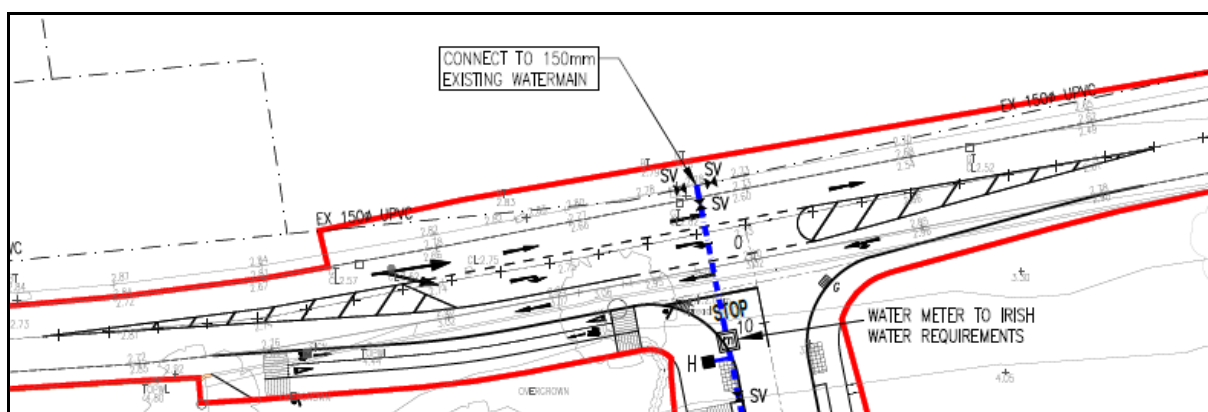
Figure 26

the site, as well as all internal junctions. The design for the access off the R150 includes provision for a right turn reservoir into the site, as shown in figure 26, through which all vehicular access will be achieved, although the provision for vehicular access to the south of the site is unclear, as outlined previously in paragraph 2.1.6. It was noted that there are proposals for committed development immediately southeast of the site (133 units) which will also require access from the same junction off the R150.

A TTA should be produced for the site to show the cumulative impact of all committed developments in the locality, and to demonstrate that the proposed geometry of all junctions will accommodate anticipated turning movements and vehicle sizes. The Designer should demonstrate that the total demand for right turners into the site off the R150 is satisfied by the proposed right turn reservoir length, and that traffic queuing to enter the development site will not obstruct the movement of through traffic on the regional road. The lane widths at the new access junction should also cater safely for all anticipated vehicle sizes, including HGVs and two wheeled vehicles. The minimum length of right turn reservoir should ideally be at least 35m, to allow for deceleration and suitable taper, with a longer length and taper required for higher approach speeds, and the reservoir length increased to allow for queuing traffic. The demand for right turners out of the junction should also be assessed in conjunction with examination of the AADTs on the major road, to determine any issues arising in respect of increased risk of right angled collision, with queuing vehicles within the reservoir obstructing visibility towards the left, towards vehicles approaching in the nearside lane eastbound.

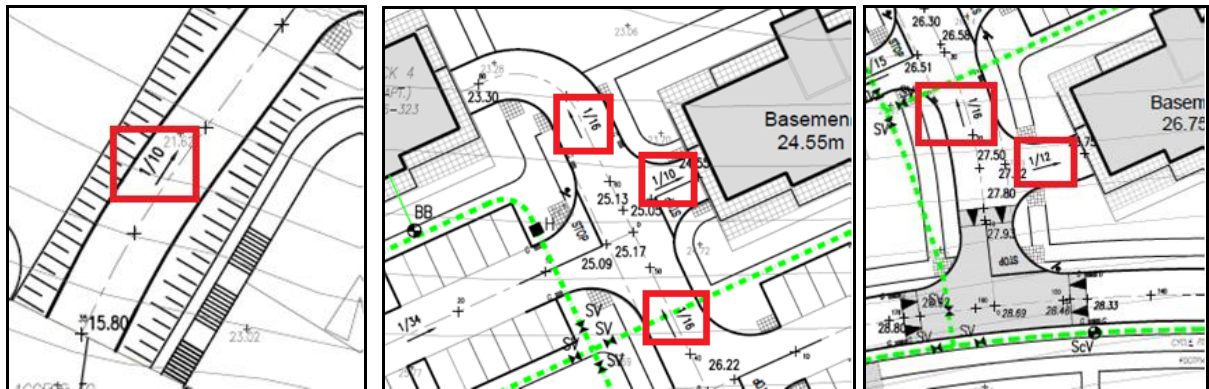
Figures 27, 28 & 29

The proposed vertical alignment on the LIHAF will result in gradients of almost 7%, which will present difficulties for some vehicles and for some VRUs in wet and icy conditions. Steeper gradients were noted on a number of other links throughout the site, including gradients exceeding 10%, which is a departure from standard. Examples of such locations are shown in figures 27-30. Figure 31 shows a location where the shallow gradient may cause drainage issues, as there is no provision for gullies along the link. Steep gradients were also noted on approaches to junctions/intersection points, which increases the risk of vehicular conflict and vehicular/VRU conflict at these locations. There was no horizontal or vertical alignment design provided with the preliminary design layout to determine any issues in respect of Stopping Sight Distance (SSD).

Horizontal and vertical design proposals should be included on detailed design plans, with long and cross sections, to demonstrate that the proposed alignments will safely accommodate anticipated traffic volumes and speeds with suitable sightlines and gradients. Gradients exceeding 5% should be avoided on routes to be used by VRUs, with gradients exceeding 7% (absolute maximum 8%) to be avoided. A relatively level dwell area (2.5-3% maximum) should be provided on the approach to all junctions and access points for a suitable distance back from the stop line/channel line to minimise the risk of larger vehicles overturning or overshooting the stopline, as well as rear shunt collision risk and collision with VRUs potentially crossing junction mouths.

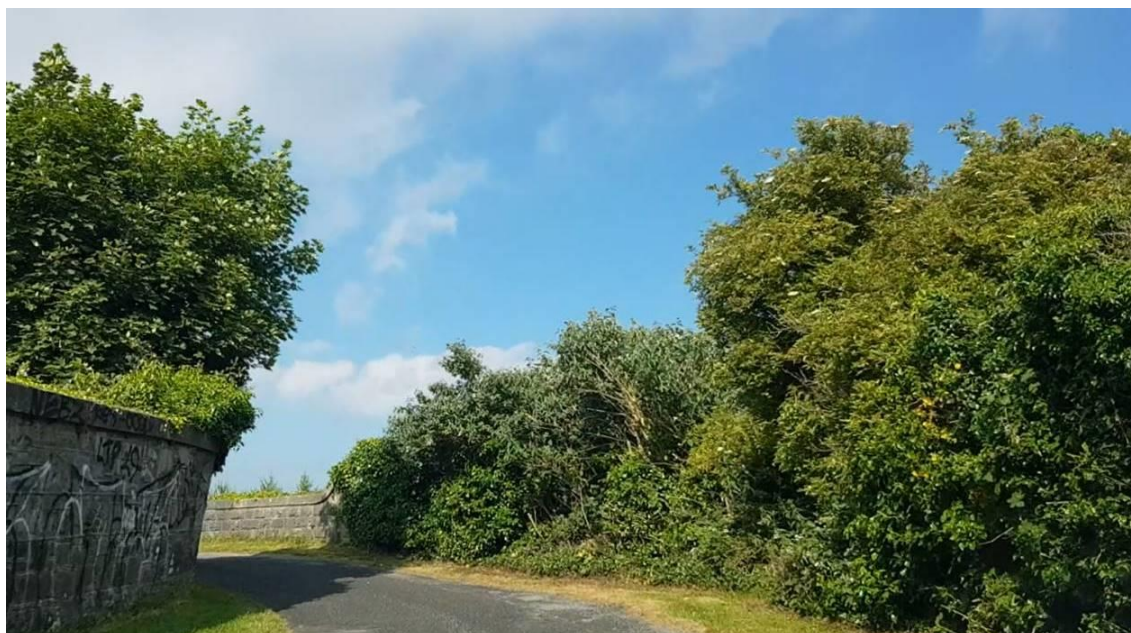
Figure 32

The current alignment on Railway Terrace is relatively straight, however a right hand curve with a relatively tight radius over the railway bridge and high bridge abutment walls to each side of the carriageway restrict forward visibility and SSD, as shown in figures 32-34, which will lead to an increased risk of collision with pedestrians or other vehicles using the link to access the site. The preliminary design does not include for alignment or SSD improvements at this location.

Suitable forward visibility and SSD should be provided along Railway Terrace and on all links through the site, including towards the rear of any anticipated queues at any of the proposed junctions and access points. Intervisibility between pedestrians and motorists should be clear and unobstructed at all times, especially on the shared surface links. Additional speed control and traffic calming measures should be installed at any locations where suitable SSD cannot be achieved.

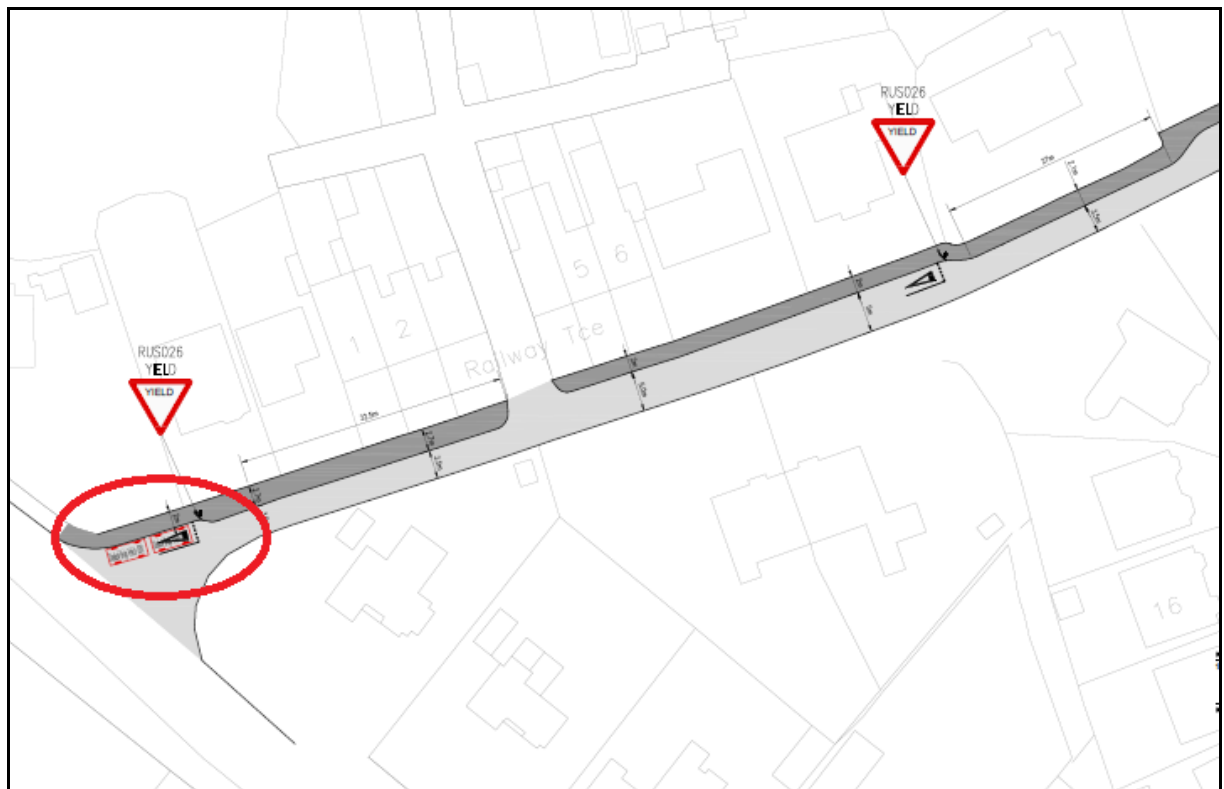
Figure 35

The design proposals show provision for a yield arrangement for vehicles entering Railway Terrace from the direction of the R132 to give way to vehicles exiting from the direction of the site, as shown in figure 35.

The Audit Team are concerned that there is a limited space for vehicles to wait at this location, with an increased risk of blocking back to the intersection with the R132. Visibility towards the rear of any queues forming will be compromised for vehicles travelling from the direction of the town centre (north) wishing to turn left onto Railway Terrace due to the nearside boundary treatment at this location (high wall and hedging), leading to a risk of rear shunt collision. Forward visibility towards the east along Railway Station at this point is also constrained by the vertical alignment and parked vehicles as well as the high boundary

The layout of the link should be examined along with the location of the proposed yield arrangements to ensure clear forward visibility can be provided to and from oncoming traffic at all times and towards the rear of any queues forming. Where on-street parking is compromising safe two way movement and forward visibility, parking should ideally be restricted and suitable replacement parking provided to cater for the demand. Clear signage should also be provided to limit vehicular access on this link.

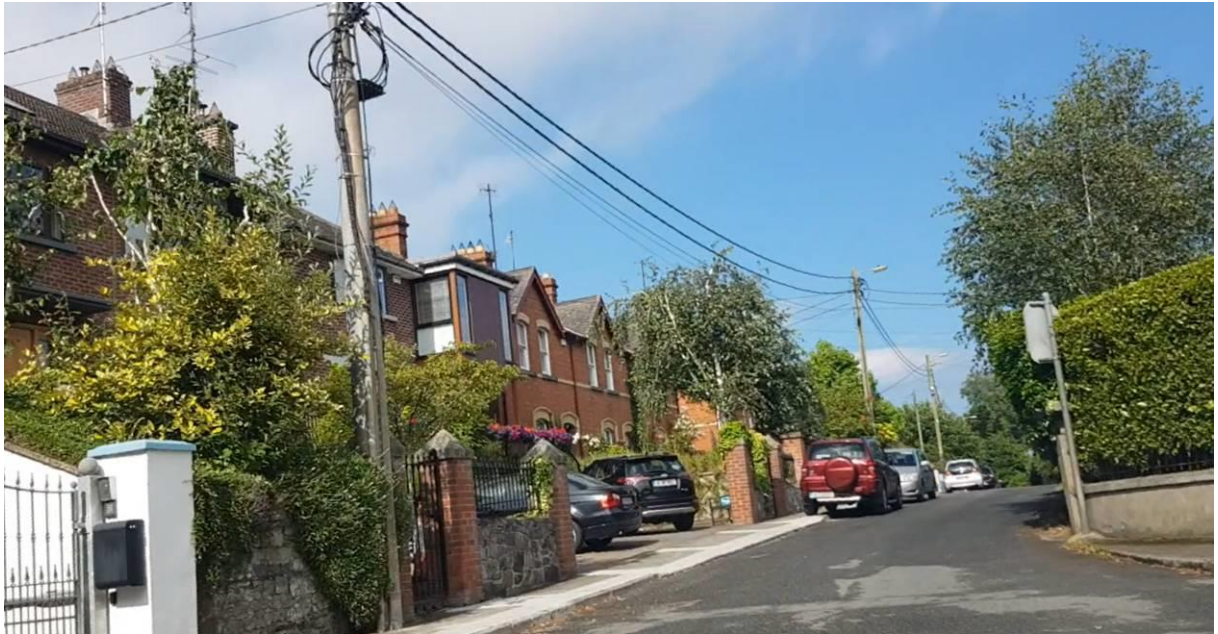
**Figure 36: Visibility eastbound on Railway Tce
for vehicles who have turned right from the R132**

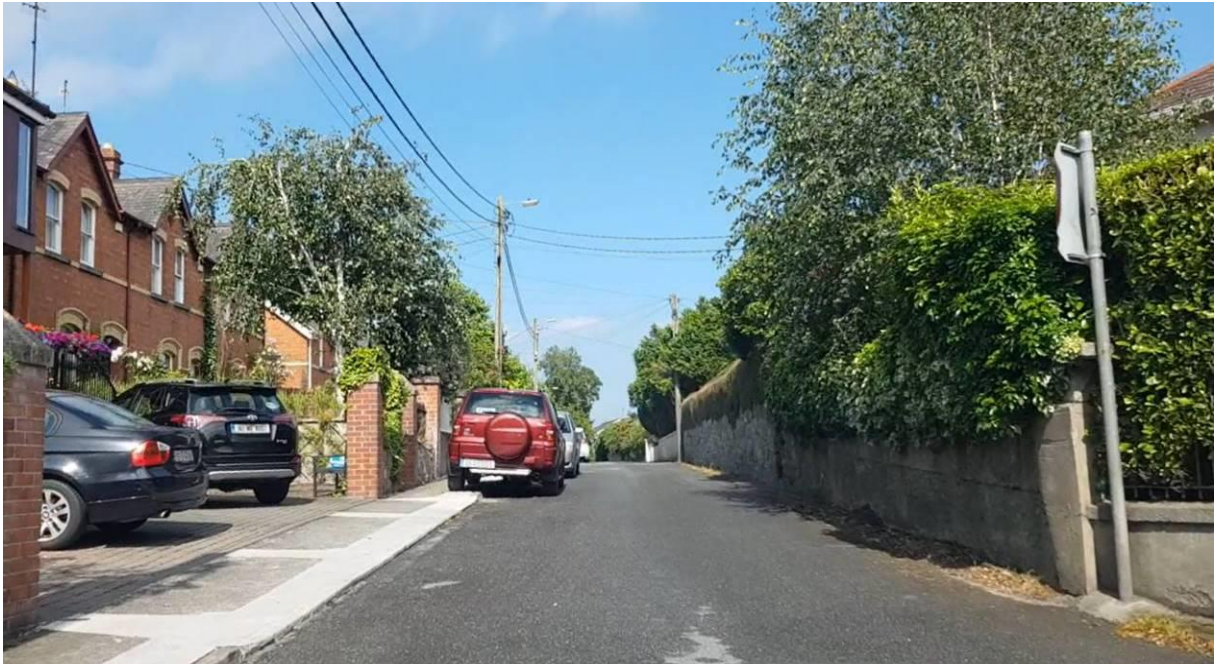
Figure 37

walls on the offside, to which there is no safe clearance provided, as outlined previously and as shown in figures 37 and 38. There were a significant number of parked vehicles noted along this street at the time of the site visit, which will impact on the safe operation of the proposed yield arrangements along the link, and which will also compromise clear forward visibility and safe two-way movement along the link, as well as increased risk to VRUs, particularly since many of the parked vehicles are currently partially obstructing existing footways along the link.

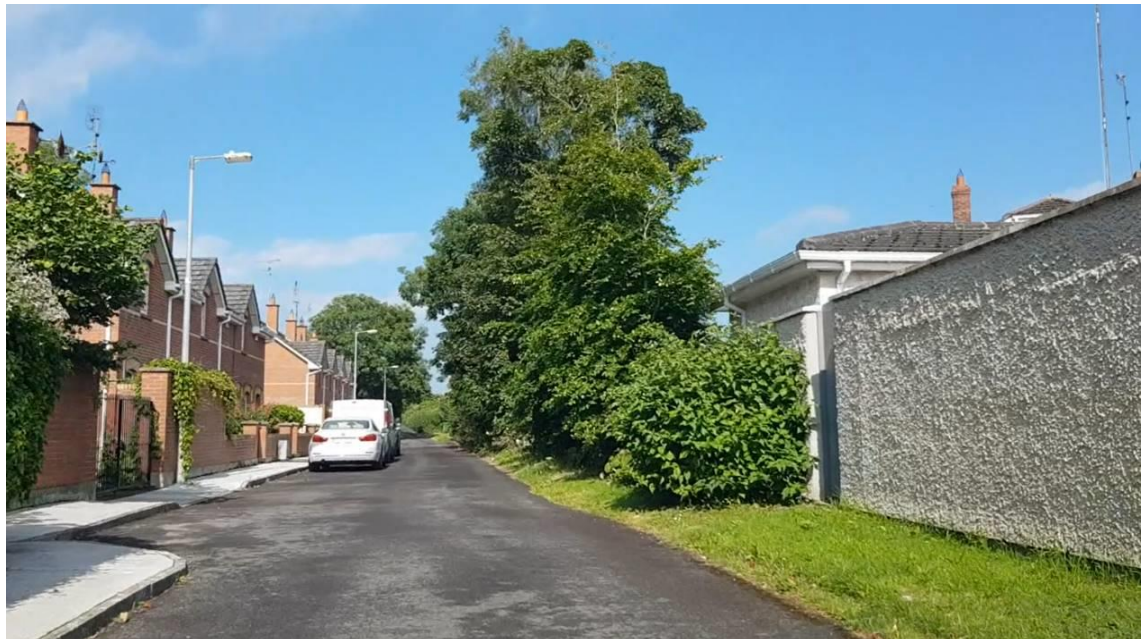
Figure 42

The proposals along this link include for for widening through removal of some of the vegetation within the verge(s), which is shown in figure 42, which should improve scope for safe passing, however the design proposals do not include allowance for the existing on street parking at this location.

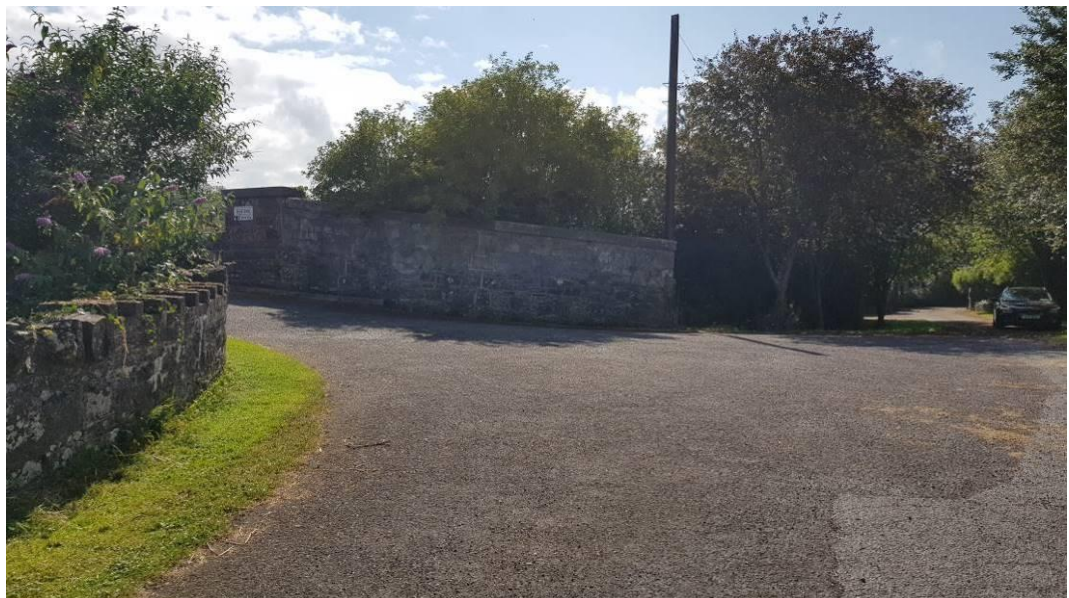
Figure 49

- Pedestrian connectivity into the site at McGrath's lane is unclear, with just one potential access point shown. Pedestrian activity was observed along the length of McGrath's lane at the time of the site visit, and more direct desire lines from different sections of the site are likely to emerge, particularly to the south, along the boundary shown in figures 47 and 48. At present the surface of McGrath's Lane is uneven, with multiple trip and slip hazards observed. Intervisibility on the approach to the bridge is also poor due to the high bridge parapet, as shown in figure 49, and as outlined previously.

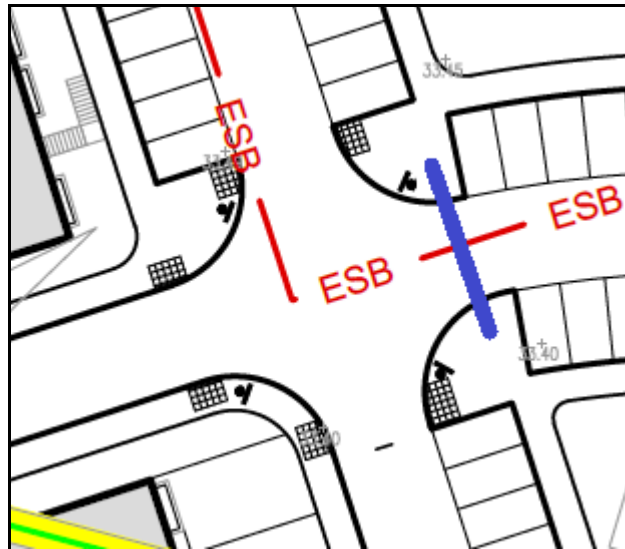
Figure 50

- Provision has been made for tactile paving/informal crossing points at most of the internal junctions throughout the site, however no provision has been made for dropped kerbs for the benefit of mobility impaired road users, and tactile paving is also missing from some desire lines to cross at junctions, as shown in figure 50.

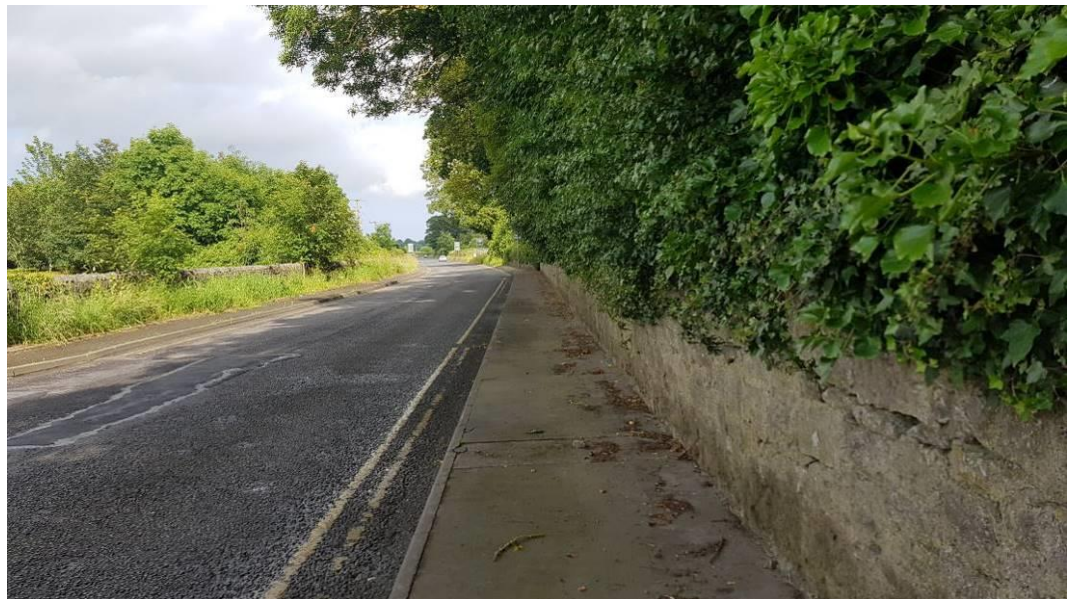
Figure 53

- It was noted that existing footways on the R150 are dark due to overhanging trees, with debris and potentially slippery conditions noted, as shown in figure 53. These existing pedestrian facilities are also narrow, on both sides of the carriageway, including directly opposite the proposed site access, as shown in figure 54. Pedestrian flows and desire lines to use these footways and to cross the R150 carriageway are likely to increase significantly as a direct result of the development proposals. There is no provision for a safe controlled crossing facility on this link on approaches to the site, and high traffic volumes at peak times, or high traffic speeds at off peak times, may present difficulties for some pedestrians to cross safely.

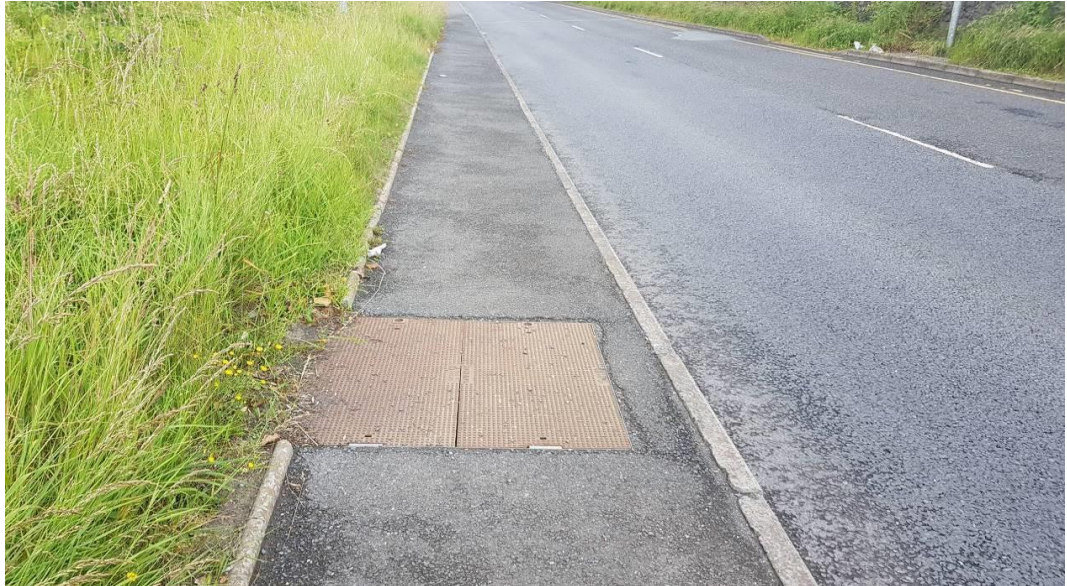
Figure 57

- Manhole covers were noted within the footways adjacent to the proposed site access off the R150, which can present a slip hazard to VRUs. A number of manhole covers

throughout the site will also be located within VRU desire lines where they may present a hazard.

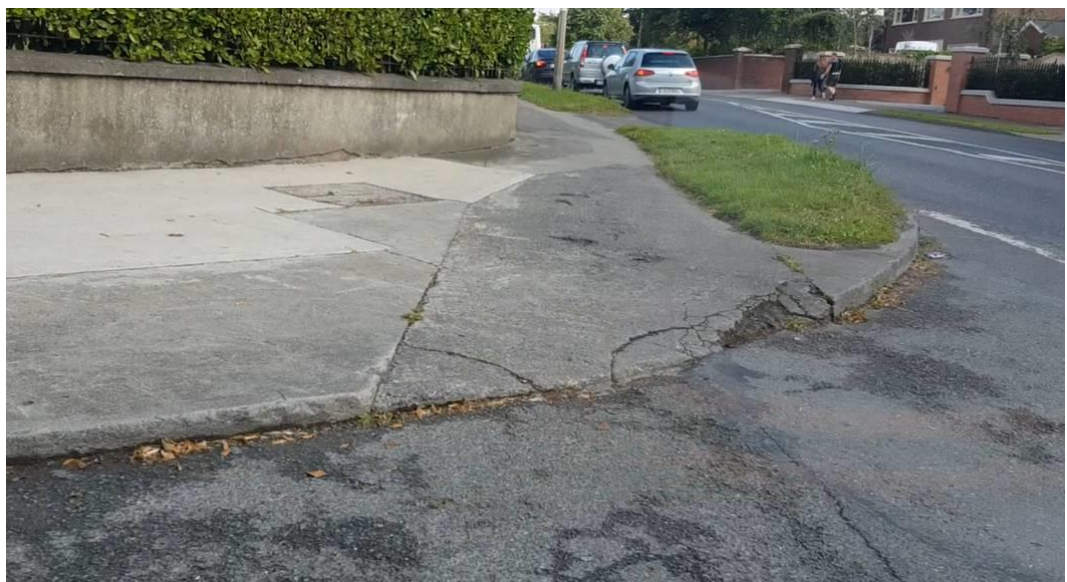
Figure 58

- It was noted that there is no provision for tactile paving/dropped kerbs at the mouth of the junction with Railway Terrace/R132 as shown in figures 58 and 59. The pavement is also cracked with potential trip hazards at this location. These existing issues will resent risks to any pedestrians accessing the site from this direction.

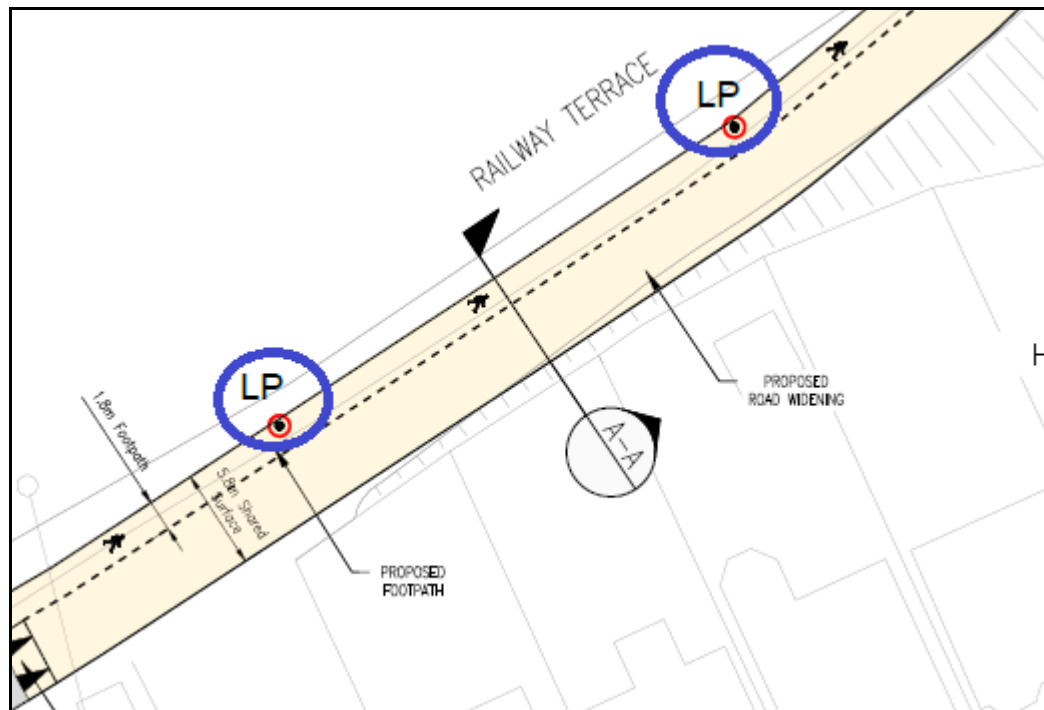
Figure 64

There were no proposed lighting details provided for the internal site. Inappropriate lighting can increase the risk of conflict during the hours of darkness, and inappropriately located lighting columns can obstruct footways and VRU movements, and can also present a hazard to errant vehicles if located too close to the carriageway edge. It was noted that a number of lighting columns will be provided along Railway Terrace within the proposed footway, as shown in figure

64, where they may obstruct the movement of VRUs and present a strike hazard to passing vehicles on a limited cross section. The columns on the railway bridge, highlighted in figure 65, may also, if struck, present a hazard on the railway line underneath.

2.4.1 Problem - Lighting	Yes	Lighting design will be carried out at detailed design stage and will comply with Local Authority Standards whilst noting the recommendations outlined in the RSA. The position of the lighting column on the railway over-bridge has been amended to mitigate associated risks.		Yes

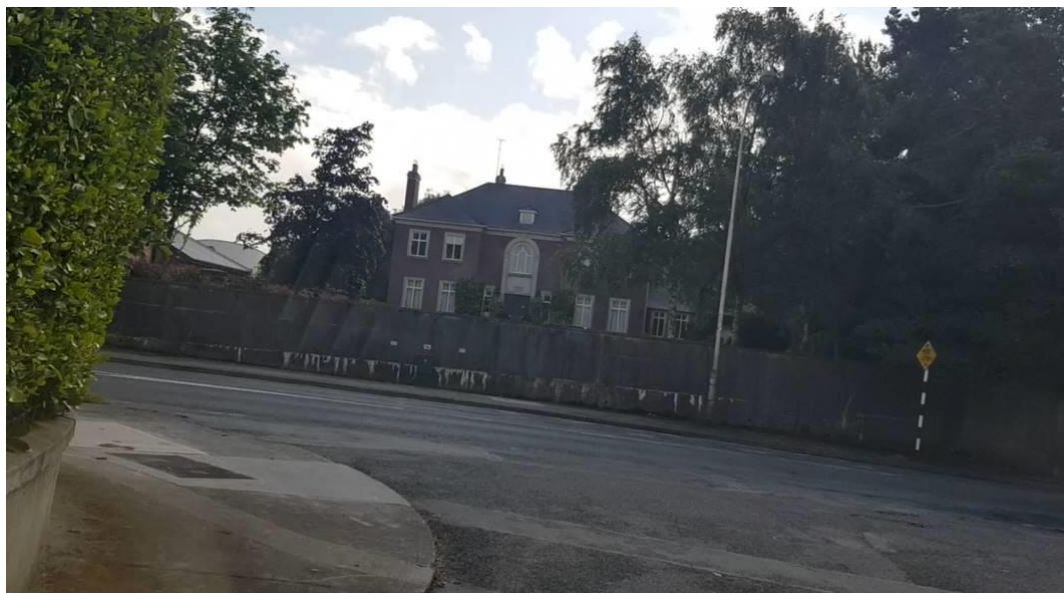
Figure 66

- There are no centrelines at present on the R150, however there are double yellow lines on both sides of the carriageway, which have not been shown on the preliminary design layout. These markings should be reinstated on the new layout, and at any location where parked vehicles will present safety issues. Provision should also be made for solid centrelines on approaches to the junction with the R150 to ensure vehicles do not attempt to overtake on approaches to the point of multiple potential conflict.
- It was noted that there is no provision for a stopline or stop sign at the junction with the R132, as shown in figure 66, where there is a history of collisions occurring resulting in high casualty severity. Risks may increase at this location as a result of increased demands for pedestrian/cyclists and vehicular access to and from this direction.
