19117-01-001

# **Proposed Residential Development at Spencer North, Dublin Docklands**

# **QUALITY AUDIT**

(incorporating a walking and road safety audit)

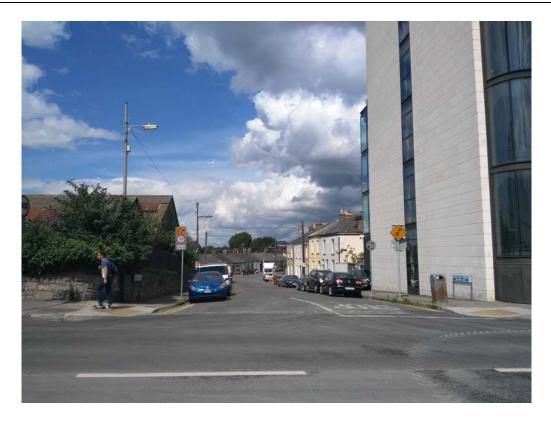
#### 4.5 Issue:

New Street, on the west side of the development, forms a crossroads junction with Abercorn Road. This may increase the number of pedestrians crossing Sheriff Street at this location. The street is wide and straight so speeds may be relatively high at times. Crossing may be difficult for less able pedestrians.

#### Suggestion:

Provide crossing facilities appropriate to the predicted pedestrian demand.

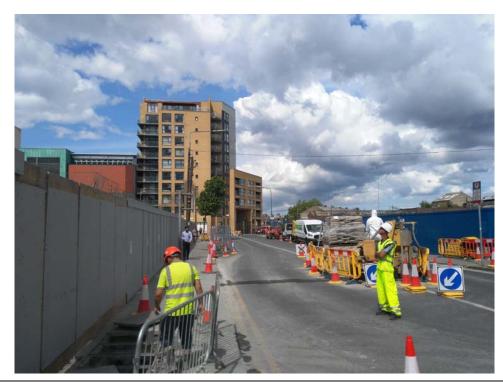
#### 4.9 Issue:

Roadside parking on New Wapping Street would, if retained, reduce visibility of drivers exiting the proposed underground carparks.

#### Suggestion:

Ensure that adequate visibility splays are available to drivers exiting the car parks in accordance with DMURS.

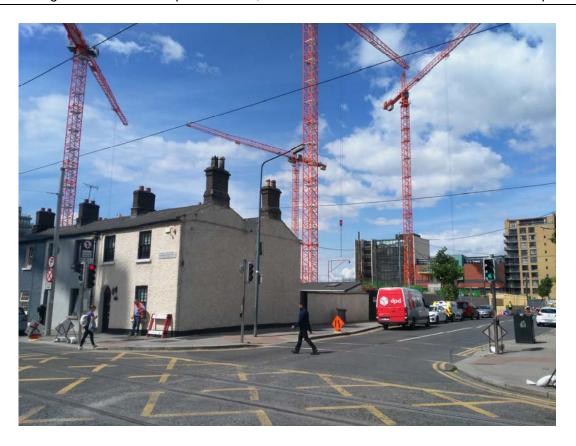
#### 4.26 Issue:

Entry to Mayor Street from New Wapping Street junction is restricted but has a plated exception for access only. On opening of New Street drivers are likely to presume that the access only exception permits them to travel onto Mayor Street to access New Street. Rat-running to avoid the Sheriff Street / New Wapping Street traffic signals could occur. This could lead to an increase in vehicular traffic on Mayor Street and These and increased risk of collision with tram traffic.

#### Suggestion

Clarify the signage so that it clearly informs and regulates driver behaviour. Ideally measure would be provided to prevent trips between the Mayor Street / New Wapping Street junction and the New Street / Sheriff St junction.
