Quality Audit
Inclusive of Stage 1 Road Safety Audit
for
PROPOSED RESIDENTIAL DEVELOPMENT
AT
THE GRANGE
BREWERY RD, STILLORGAN, DUBLIN 18

Date: August 2019

Report produced by: Road Safety Matters

Reference: RSM/MOB/080719/GRANGE-QA1

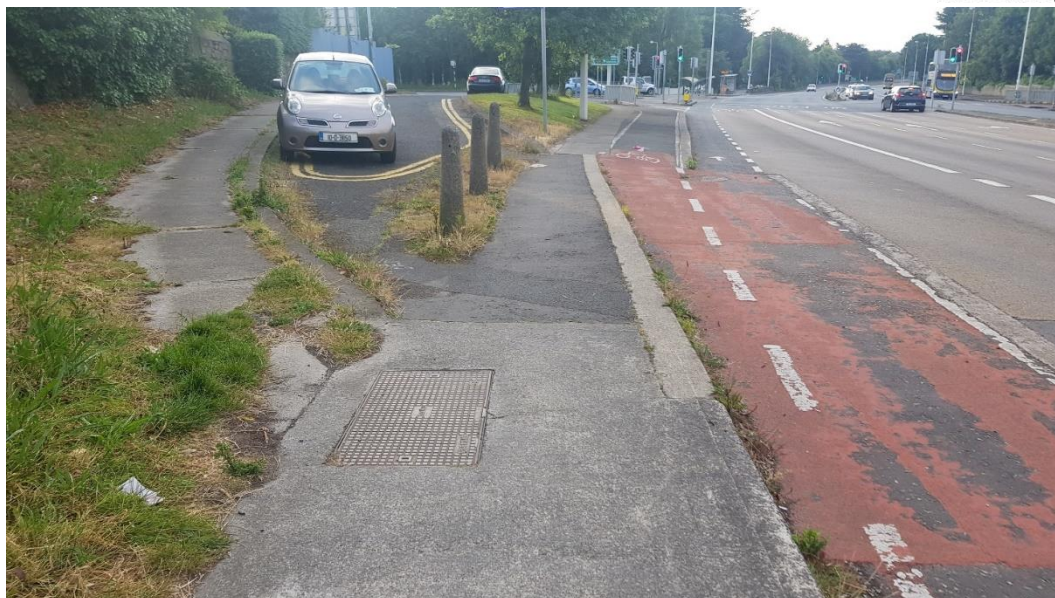
Figure 4

- Poor surface condition was noted at some locations on the current pedestrian access routes to and from the site, as shown in photos in figures 4 - 6. The extent of new surfacing is not clear from the plans supplied. Poor uneven surfaces can lead to trip hazards and ponding, which can lead to an increased risk of pedestrians slipping during wet and icy conditions.

- The condition of the pavement on all footways and cycle lanes/tracks should be assessed and repaired where necessary surrounding the site. All debris and trip hazards should also be cleared from pedestrian desire lines.

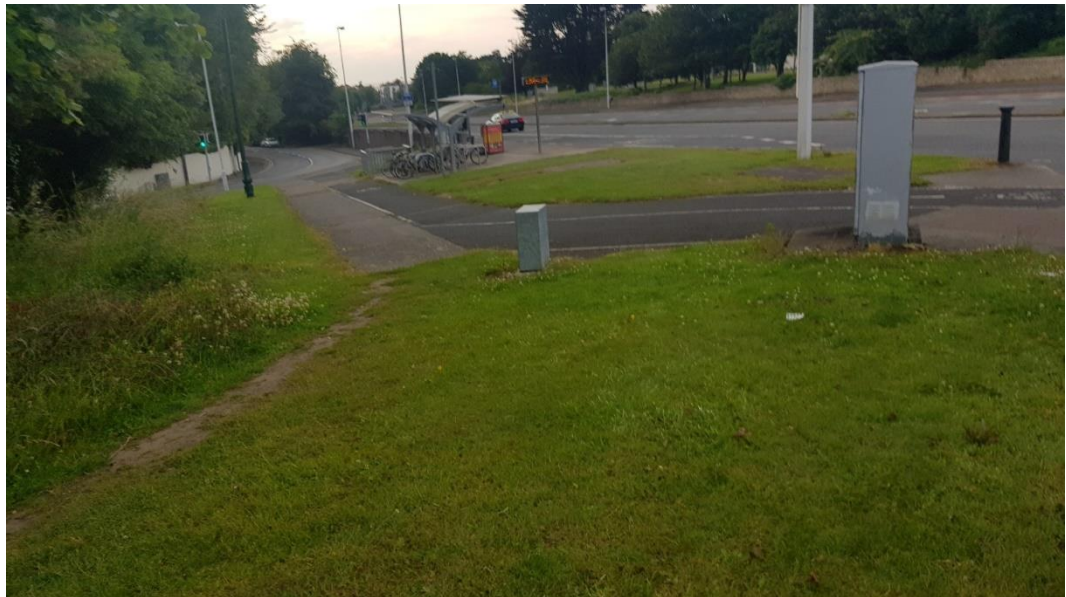
Figure 7

- Pedestrian desire lines were noted in the locality, which were not catered for in the current or proposed layout, as shown in figure 7, which represents the most direct desire line to the bus stop located on the western side of the N11, which caters for all citybound bus routes.

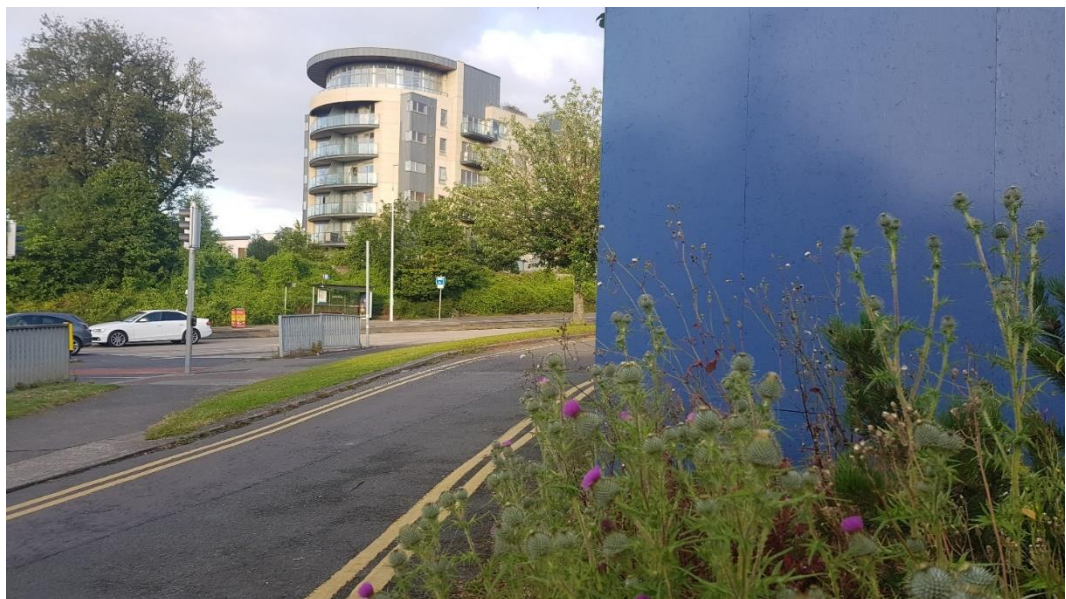
Figure 9

- Intervisibility between pedestrians and motorists is poor at some locations surrounding the site, and there are no proposals for improvements on the preliminary design layout. Potential intervisibility issues were also noted on the proposed layout, including at an existing access on the eastern side of the site, which is shown in figure 8, and at crossing points adjacent to hoarding surrounding the site, as shown in figure 9.

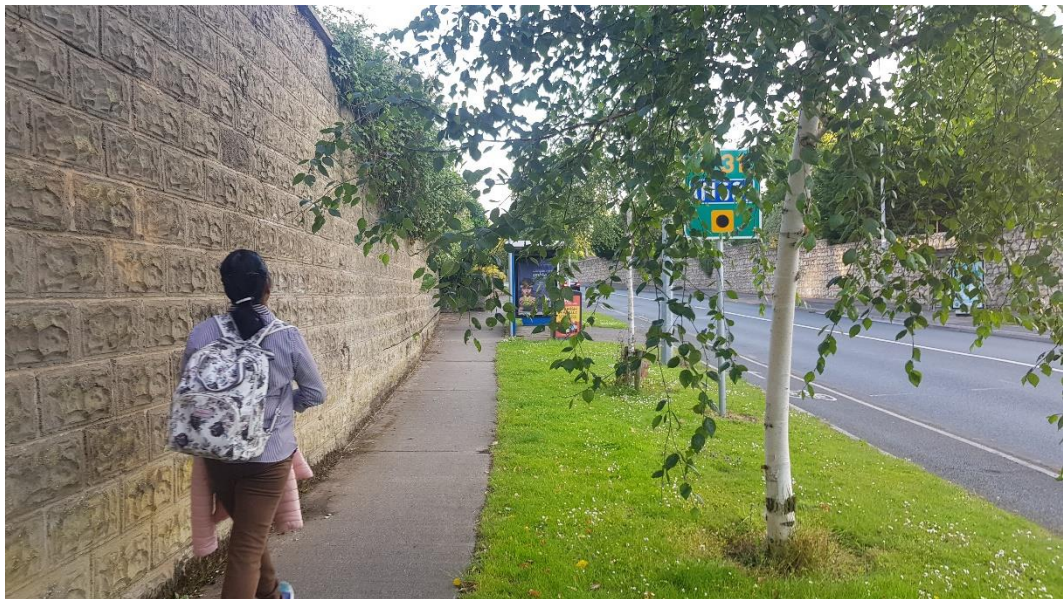
Figure 10

- Trees within the verges on the existing layout present a good separation distance between pedestrians and motorists on the N31, however issues may arise in respect of tree roots damaging pavements and creating trip hazards on the footways surrounding the site, with shedding leaves and shadowing creating potential slippery conditions. A number of the trees on the routes to the site may present overhead hazards, as shown in figure 10. As these are general maintenance issues they will require monitoring by the Local Authority, and are unlikely to cause any significant increase in risks to pedestrians accessing the development site from these directions.

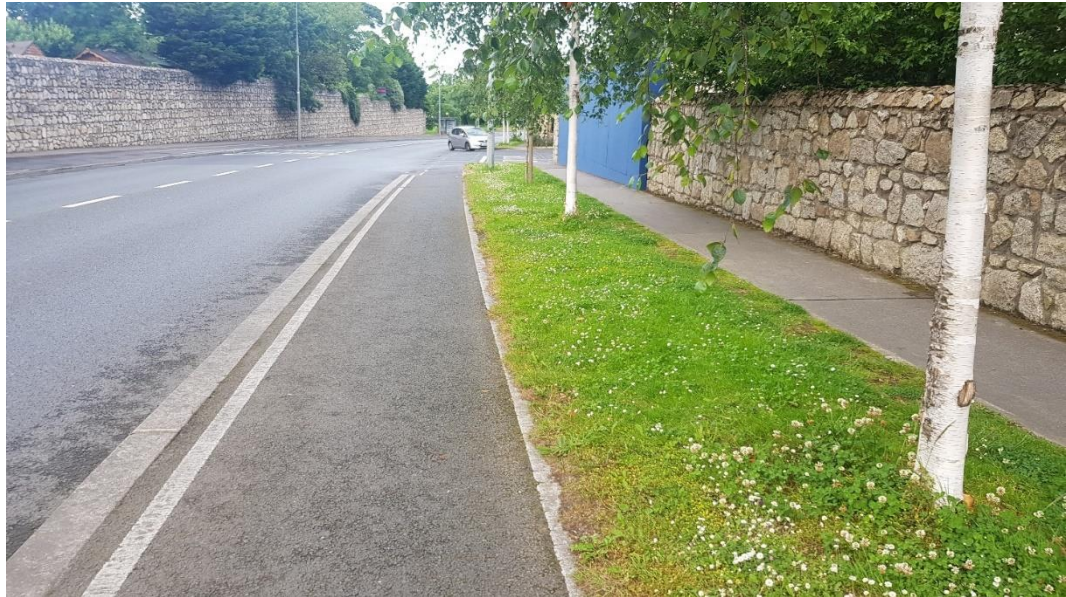
Figure 11

- Provision has been made for a segregated cycle track on approaches to the reconfigured site access junction from both directions, as shown in figures 11 and 12. The proposed design has included for continuity of this facility across the mouth of the reconfigured access junction with transition from off to on road facility with highlighted surfacing, which should assist in highlighting the presence of these vulnerable road users at this location. The Audit team noted that the provision of markings and coloured surfacing at this location is likely to require ongoing maintenance due to ongoing vehicular overrun, and it was noted that existing cycle lane markings across the existing junction mouth are very well worn and virtually illegible.

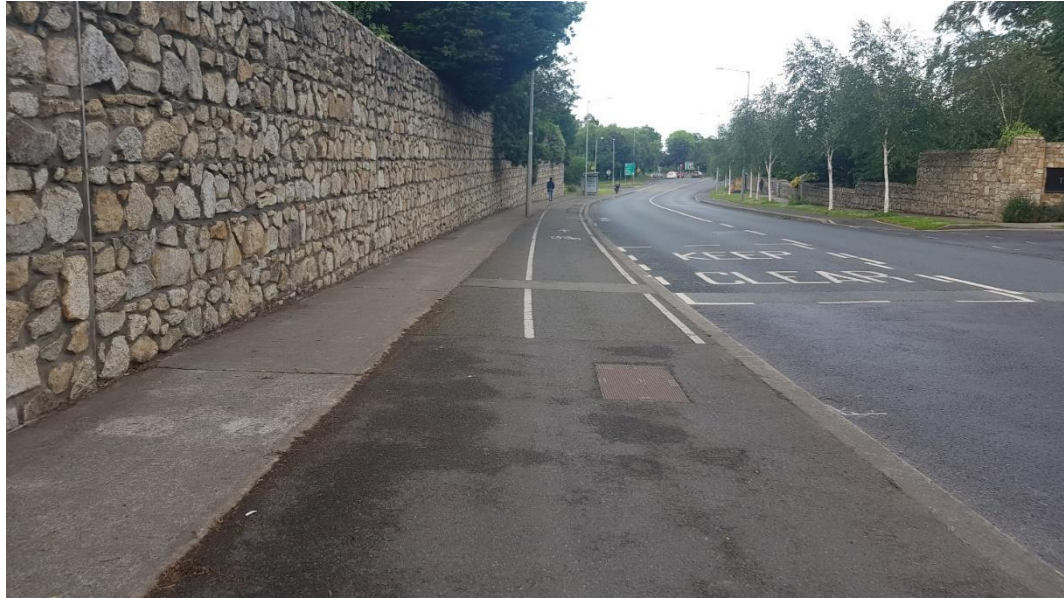
Figure 13

- The off road cycle track is currently discontinuous opposite site, with large manhole covers also presenting slip hazards at this location and elsewhere on the cycling network. There is no provision for cyclists to cross the N31 carriageway at present to turn right from the site to connect to the one way off road cycle track on the opposite side of the carriageway, and there is no provision for this within the proposed design.

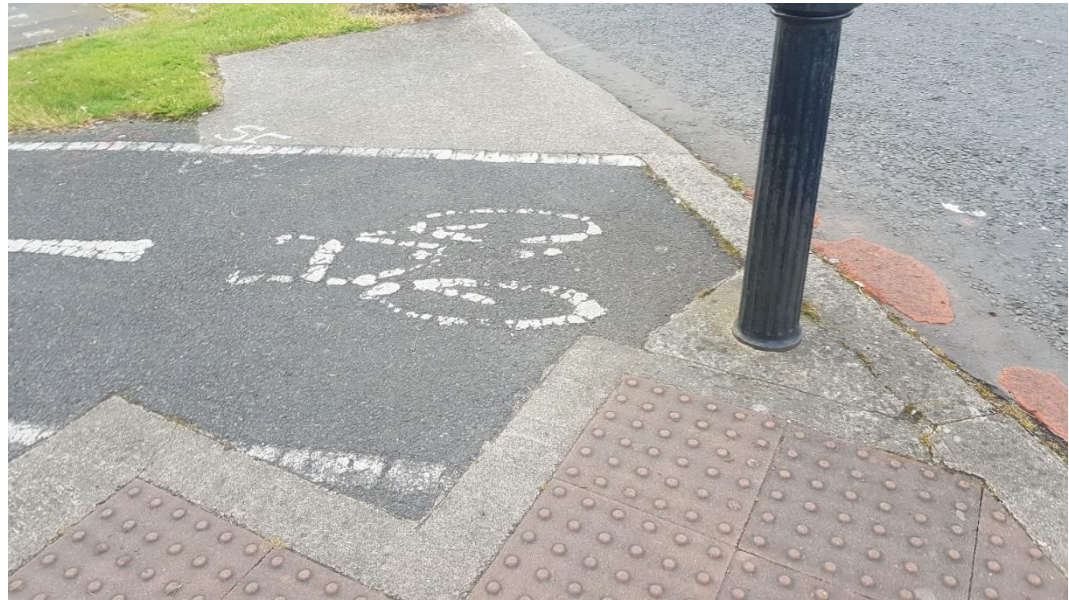
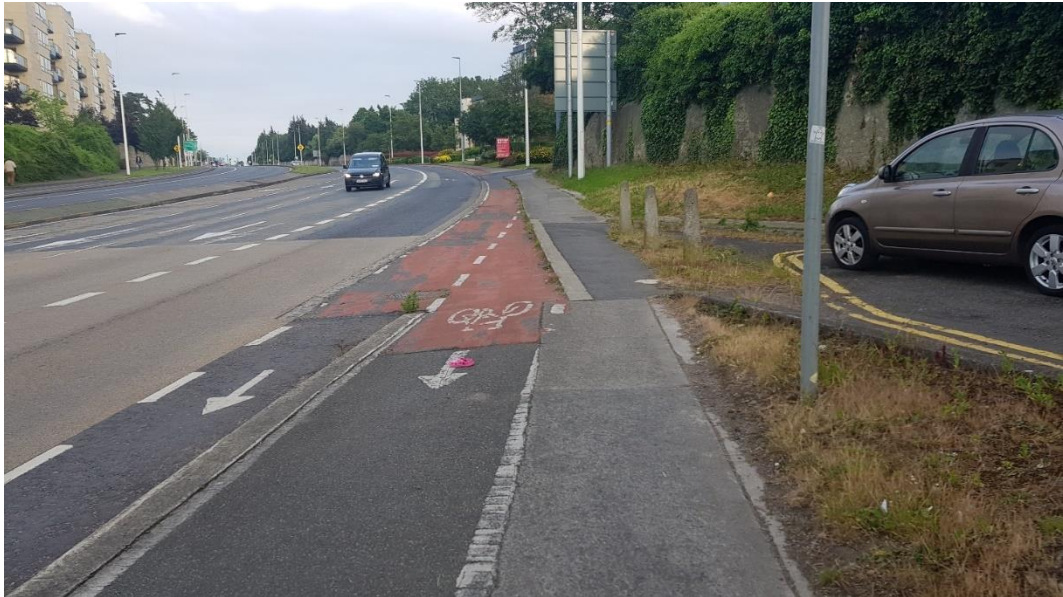
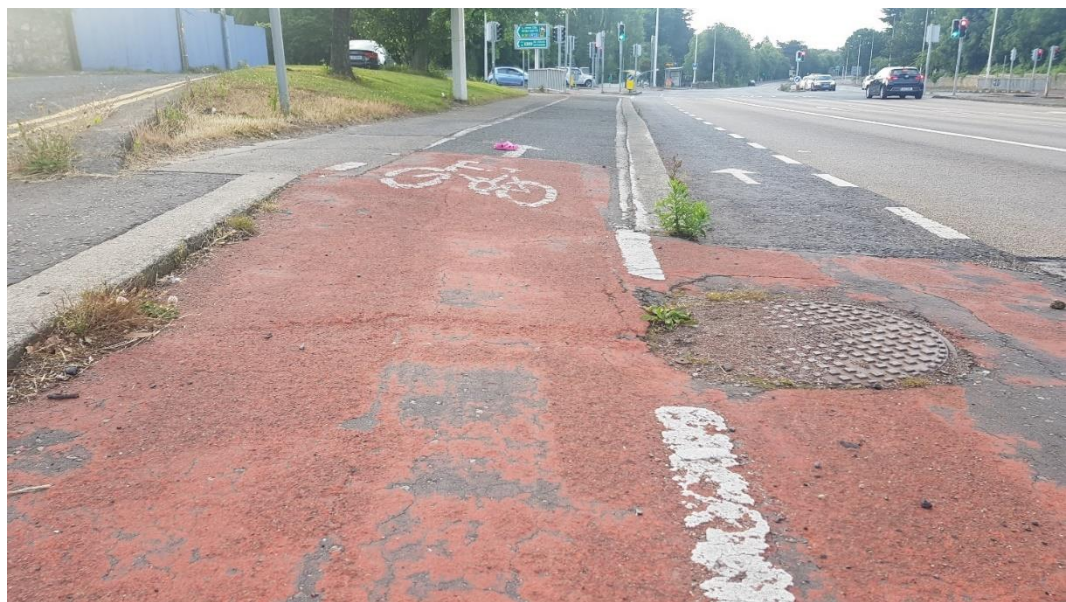
- Uneven surfacing and hazards were noted within cycle lanes and adjacent footways on the surrounding network, and markings are very well worn and illegible. Surface condition within the lanes is also poor and slippery at some locations. Examples of some of the hazards have been shown in photos presented in figures 14-21.

Figure 20: Trip hazards and poor surfacing within VRU facilities

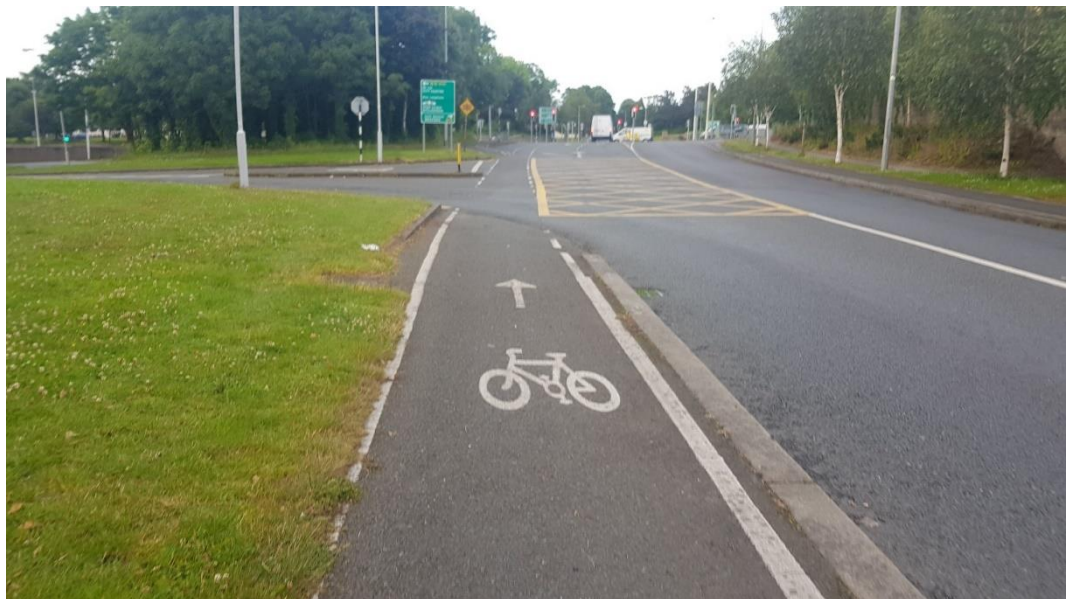
Figure 22

- Figures 22 -24 show the current arrangements for cyclists at the intersection with the N31 and St Brigid's church Rd and the connectivity towards the signalised crossroads at the N31. There are no proposed changes to the design at this location arising as a direct result of the development proposals, however it is recommended that the layout be reviewed at detailed design stage to determine the need for any remediation, bearing in mind the proportion of collisions at this location involving cyclists, as detailed further in the RSA section of this report.

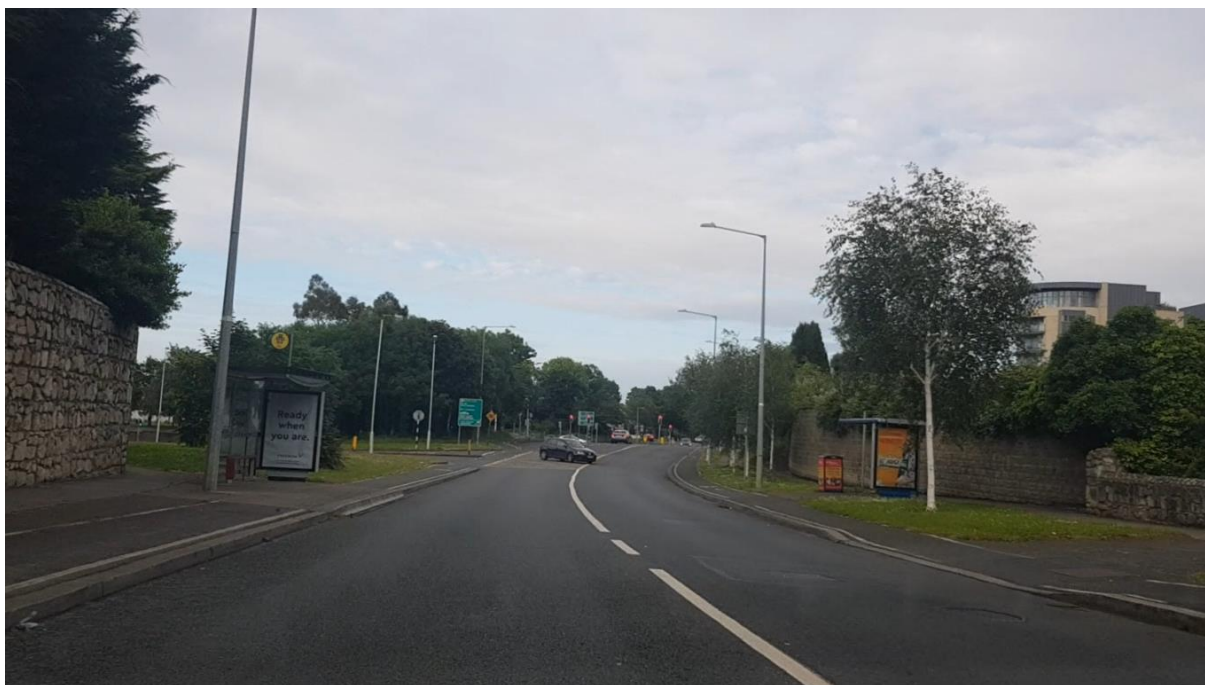
Continuous footways are provided facilitating access to and from nearby bus stops on the N31 and the N11, with the closest existing bus stop located on the N31 to the east of the access junction. Figures 26-29 show the location and configuration of the closest bus stops to the site. Footway widths and waiting areas at bus stops in the vicinity of the site were deemed to be good quality and of sufficient width to cater for observed demands at the time of the site visit. All bus stops had shelters however seats were missing at some locations, and some of the bus stops were configured for disabled user access, with kassel kerbing, whilst others were not.

Figure 26: Closest Bus Stops to site (N31)

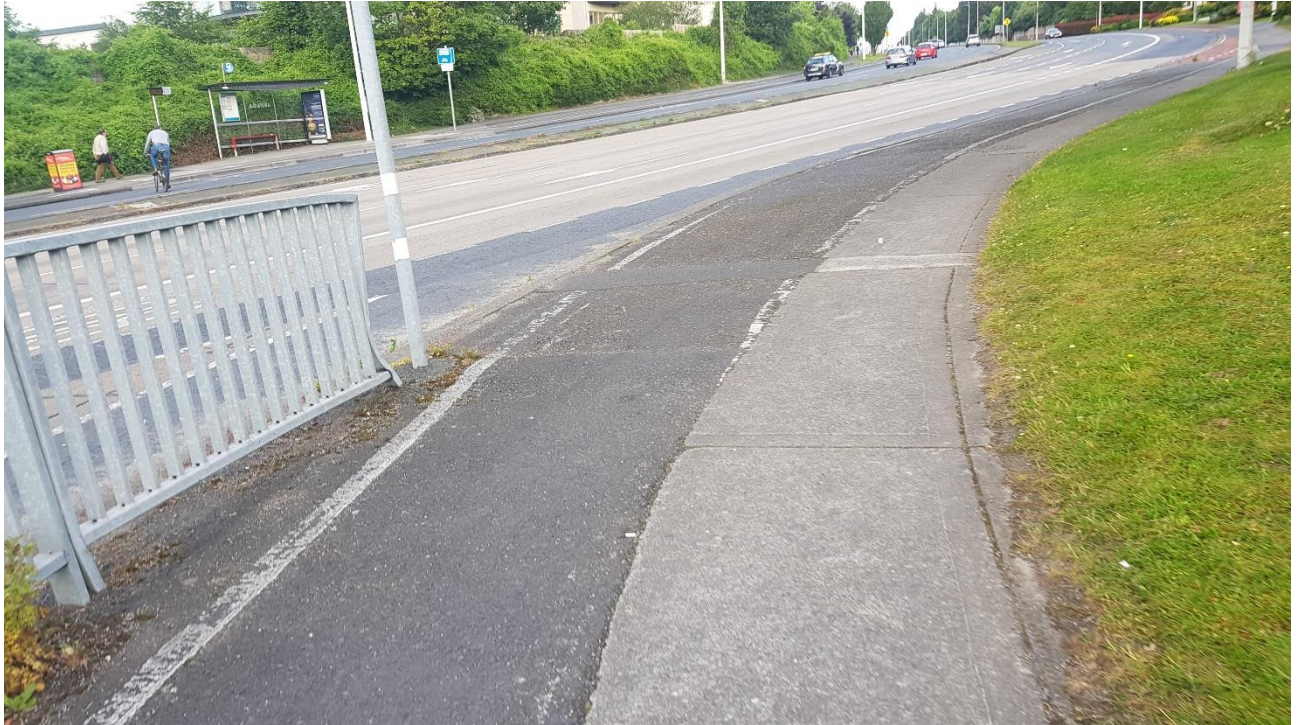
Figure 27: Closest Bus Stop to site (N11 southbound)

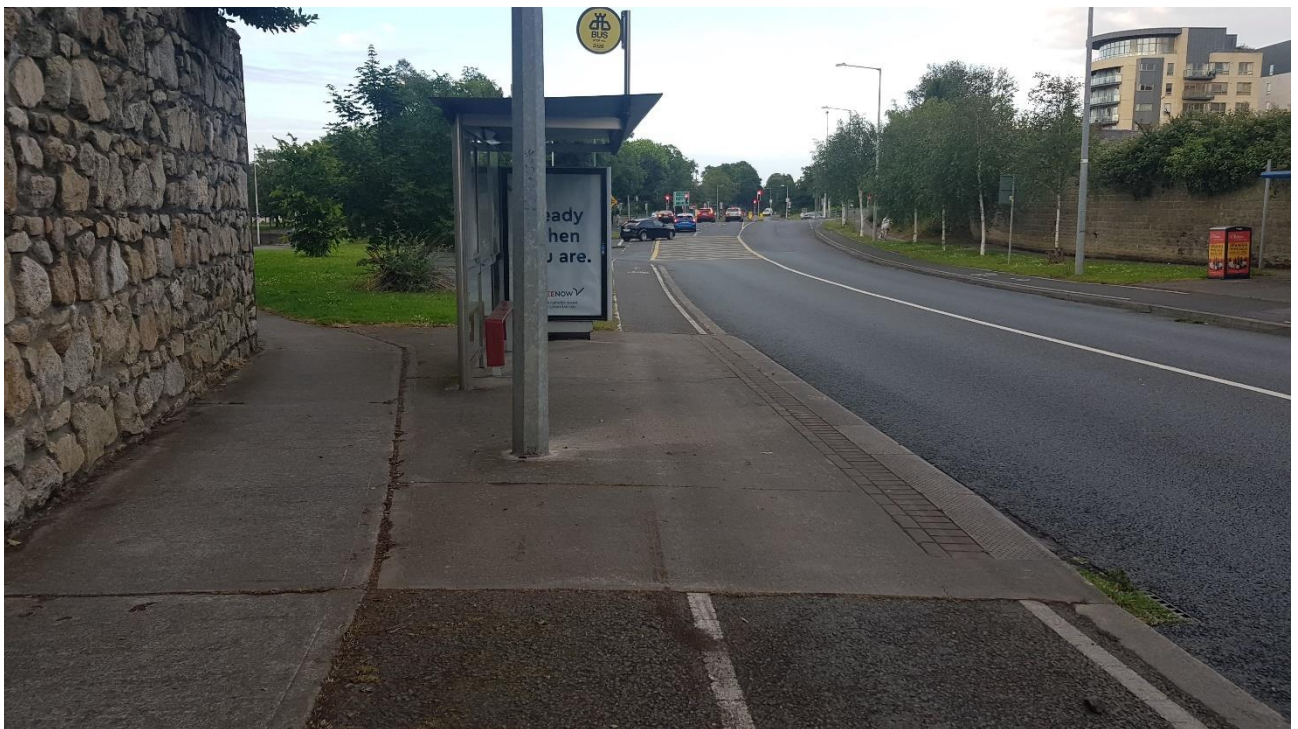
There is no provision for bus laybys on the N31, and stopped buses will obstruct the path of though traffic on this link, which leads to a risk of inappropriate overtaking manoeuvres, as well as potential for blocking back to junctions and pedestrian crossing points, which can present additional safety risks.

Figure 28: Layout at Bus Stop on Brewery Rd, N31

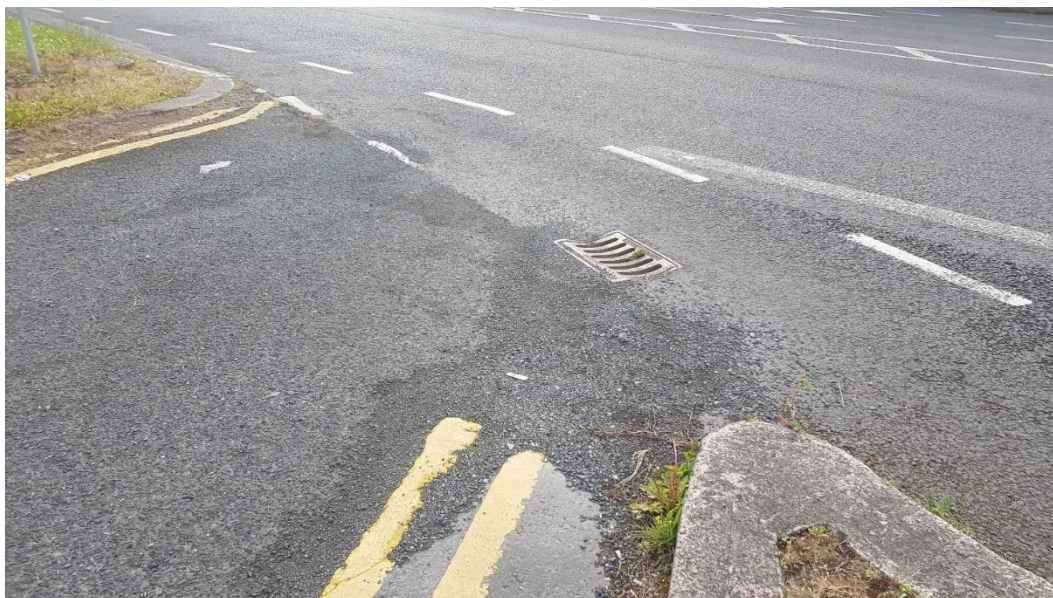
Figure 30

- It was noted that current carriageway condition in the vicinity of the site was in a state of disrepair at a number of locations, as shown in figure 30. Any increase in levels of traffic using the surrounding links as a direct result of the development may increase risks to all road users arising from defective pavement conditions. There was no information provided on the skid resistance of the existing surfaces surrounding the site, particularly on approaches to controlled crossing points. Insufficient surface friction will increase the risk of vehicles overshooting the stopline at crossings, and a resultant pedestrian/vehicular conflict. Insufficient skid resistance also increases rear shunt collision risk.

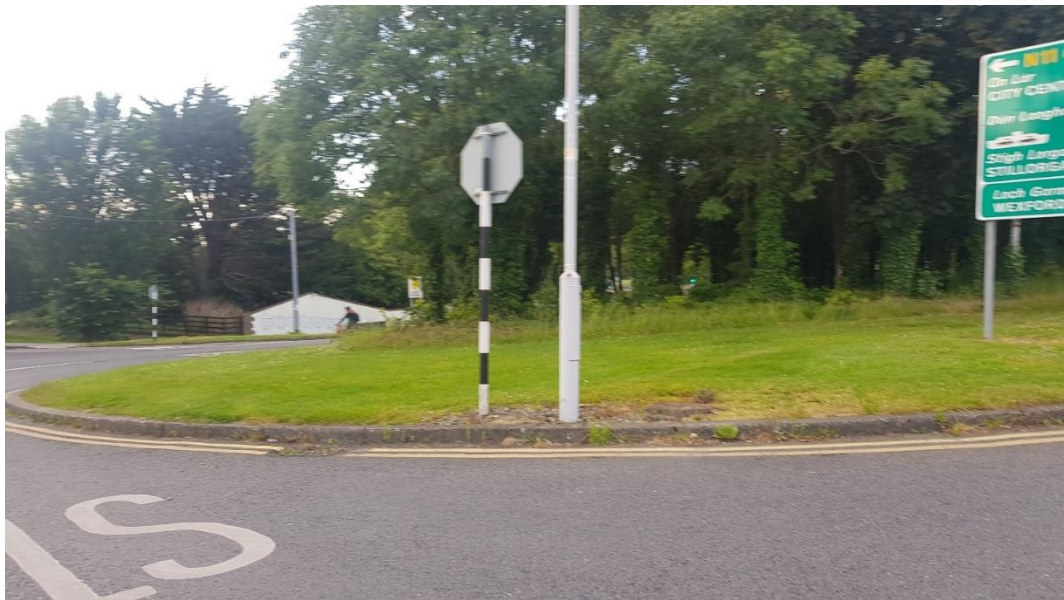
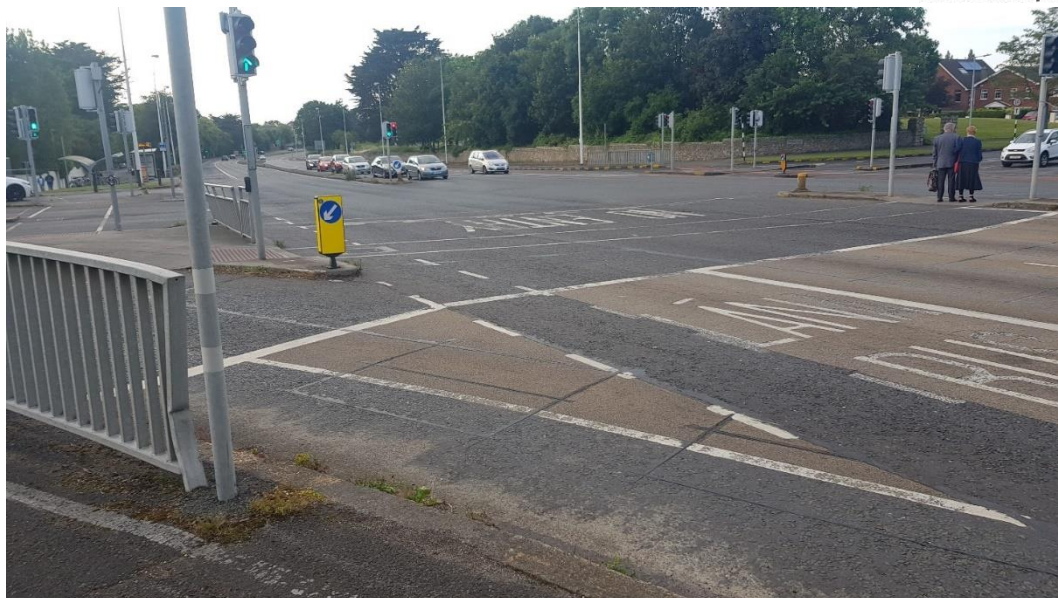
- It was noted on the site visit that some of the street furniture is located too close to the kerb edges, presenting an increased risk that the hazard will be struck by passing vehicles. Figure shows a lighting column located immediately adjacent to the carriageway edge. There are no proposals for relocation of this street furniture on the preliminary design plans for the site, and the provision for location of other street furniture such as signage and lighting columns, which may also obstruct footways as well as present a hazard to passing or turning vehicles, is not clear from the design plans supplied. It was noted that a number of existing signs are located too close to the carriageway edge at some locations, with evidence that signs have already been struck by passing vehicles, e.g. figures 31 and 32. Guardrails have also been struck at the signalised crossroads, as shown in figure 33. The geometry and layout should therefore be reviewed at this location, in conjunction with a swept path analysis and examination of all damage only records at the site.

Figure 33: Signs and Guardrails Struck

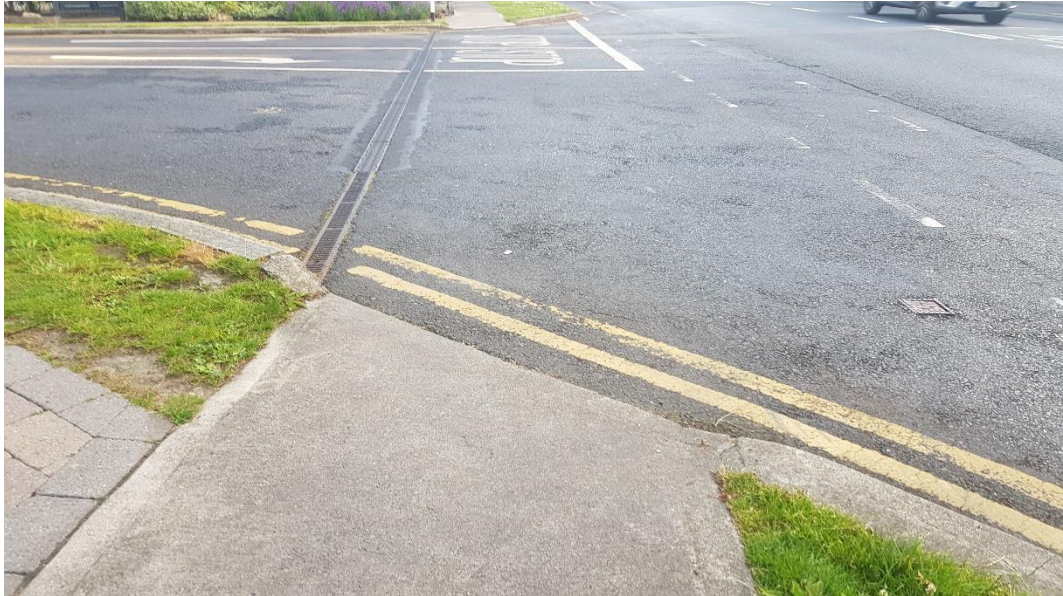
Figure 34

- There is no provision for tactile paving at the mouth of the existing access junction into the site, as shown in figure 34, however this has been addressed on the proposed layout.

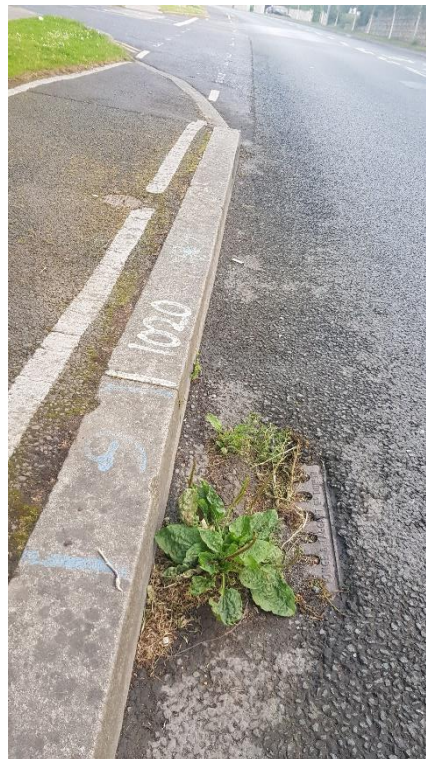
Figure 41

The details for treatment of existing drainage and gullies along realigned sections of kerb within the site is not clear from the plans supplied. Kerb realignment and setback will impact on the location of existing gullies. Insufficient surface water drainage can increase the risk of ponding which can present a hazard to motorised and non-motorised road users, particularly two-wheeled vehicles, and a potential trip/slip hazard for pedestrians. It was noted that all gullies on the N31 on the approach to the site were blocked, with examples shown in the photos in figures 41-44, which is likely to lead to an increased risk of ponding and skidding and loss of control collisions on the approaches to the site access junction, with higher risks for two-wheeled vehicles.

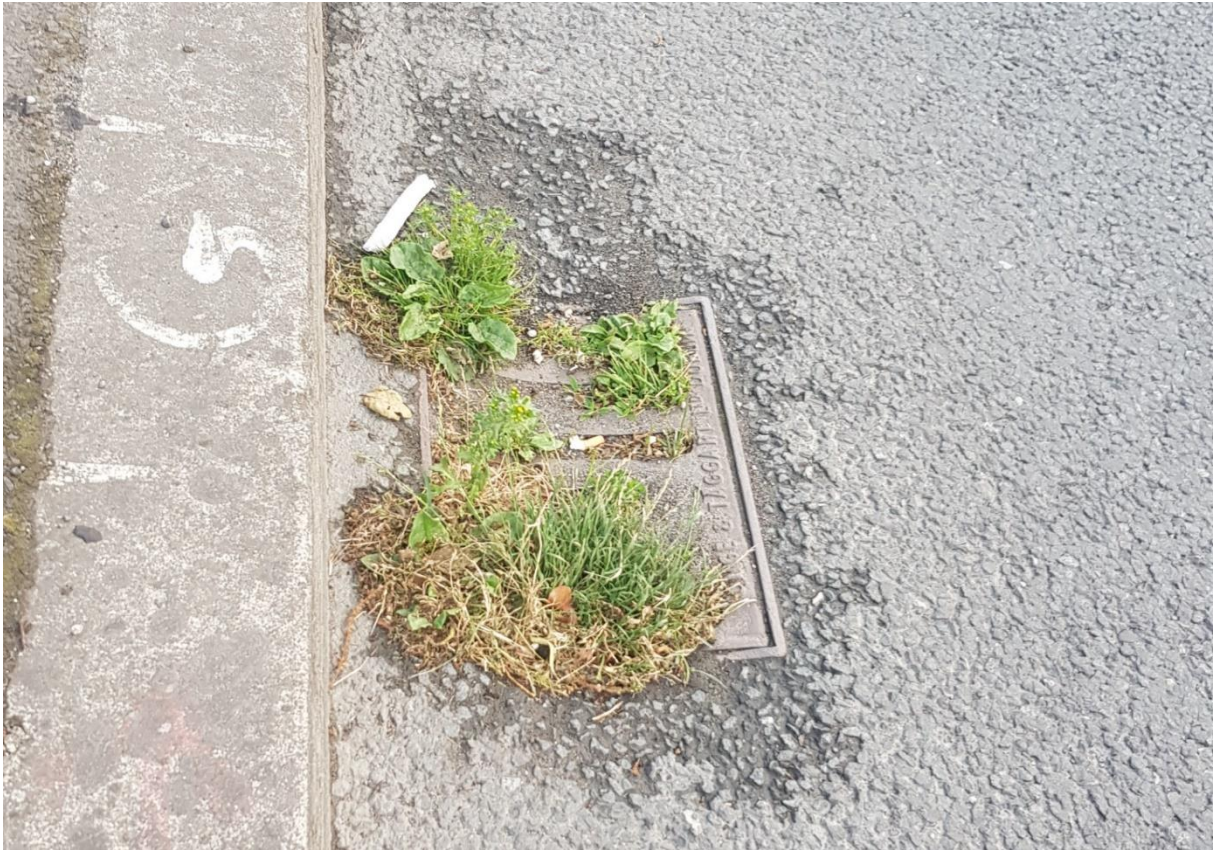
Figure 44: Blocked Gully on N31 adjacent to site

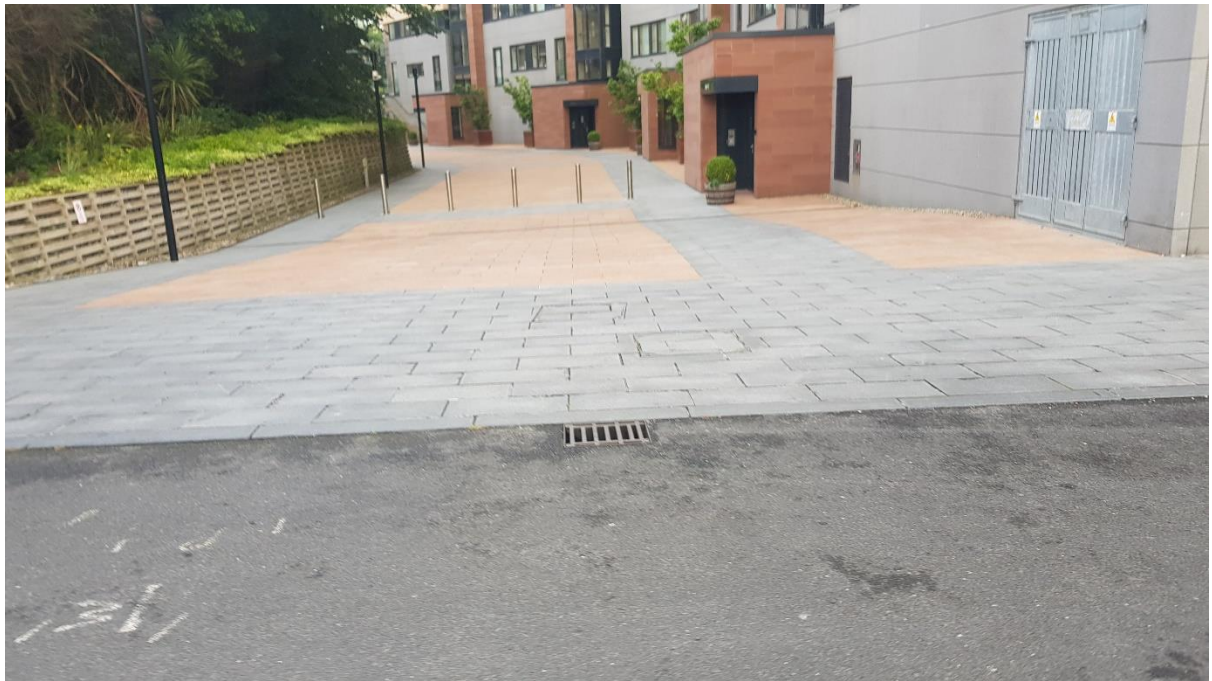
Vehicular access to the basement car park will be provided via an existing pedestrianised area where vehicular access is currently restricted by bollards, as shown in figure 45. A similar arrangement is currently provided at the proposed access to the car parking area for the proposed creche, with the existing layout in this area shown in figure 46. It is unclear if this existing paving surface on the site will be sufficient to withstand loading from ongoing vehicular access, as pavements typically exhibit greater settlement over a shorter space of time than full depth standard carriageway construction and flexible pavement.

Figure 45: Existing Access towards proposed ramp to basement car park

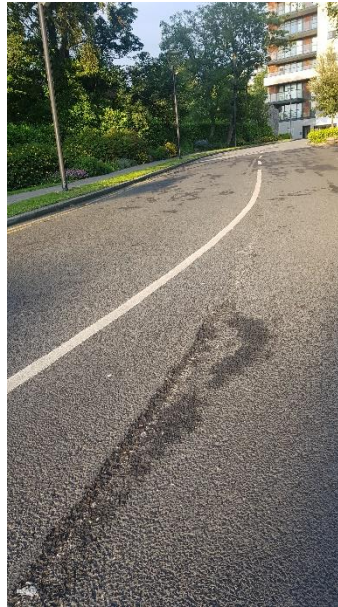
Joints were noted within the carriageway on the access road at present, as shown in figure 47, which are prone to cracking and ingress of water. Realignment of the access road is likely to create new longitudinal joints and potential hazards in the carriageway, which should be considered at detailed design stage. It was noted that a number of existing manhole covers at the site will be displaced by the access proposals and will be in the centre of the realigned road, which may present a hazard in the vehicle wheel tracks, particularly for two-wheeled vehicles.

Figure 47: Existing Joints unravelling on Access Road

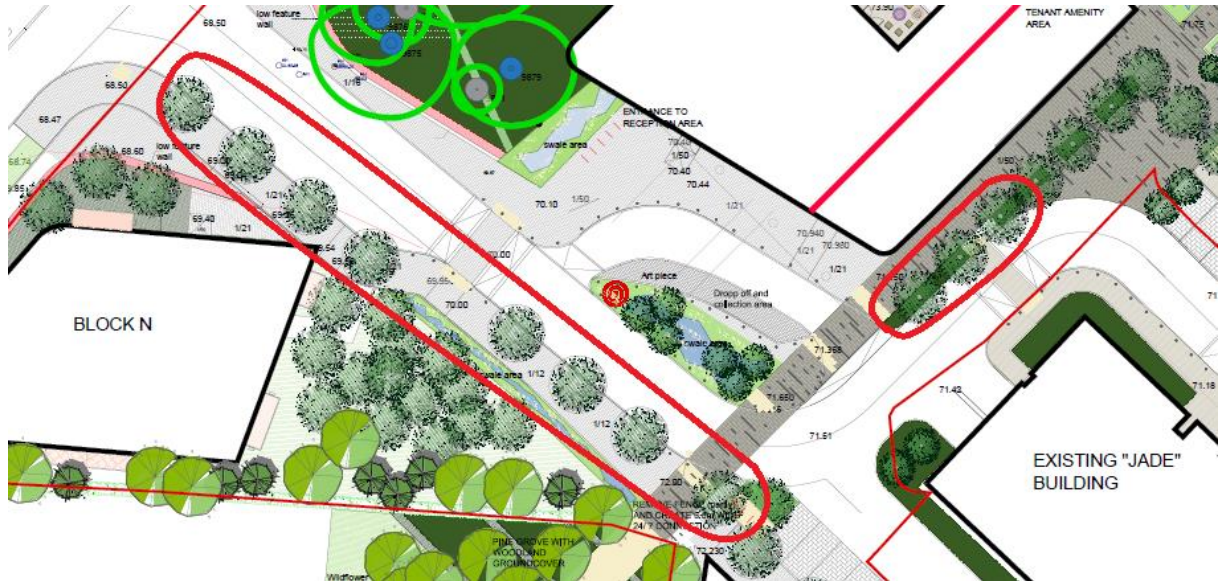
effect pavement stability, creating trip hazards and uneven / broken surfaces, thus increasing safety risks for VRUs / NMUs.

Figure 48: Trees located too close to carriageway edge

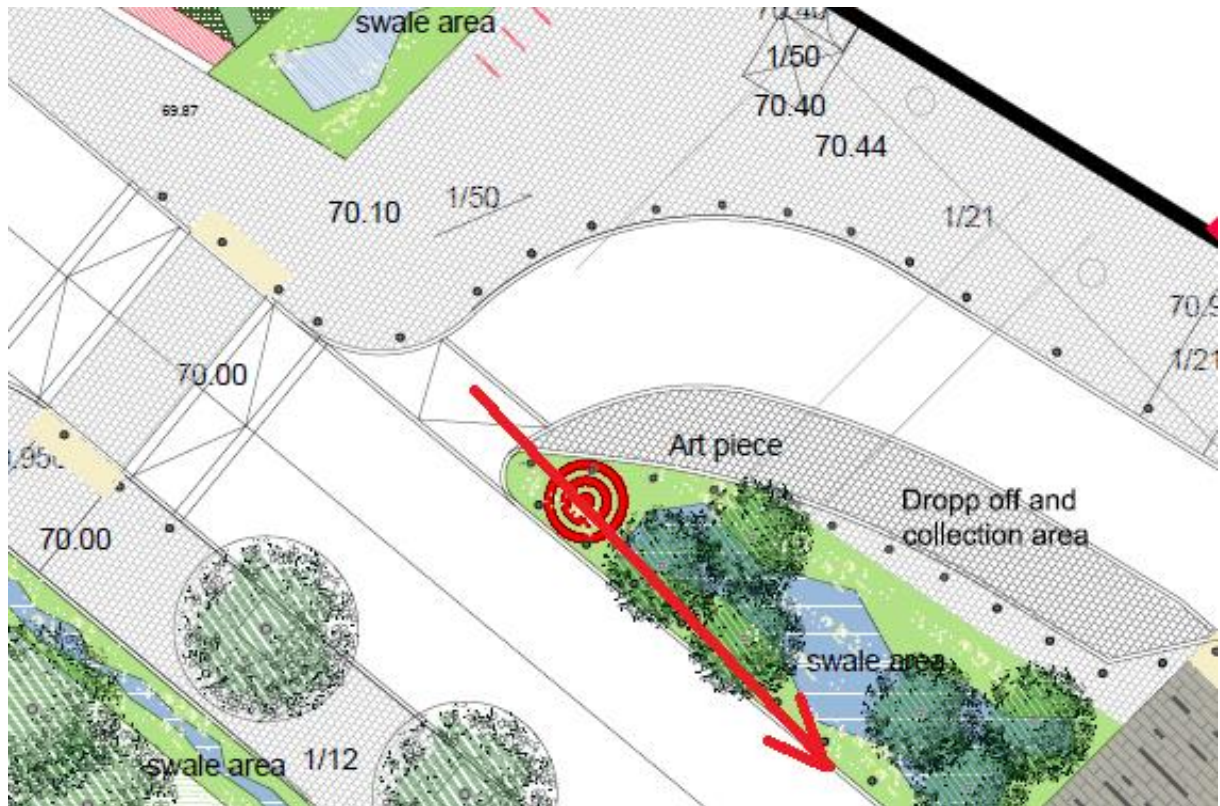
Figure 49: Landscaping/Sculpture potentially obstructing visibility

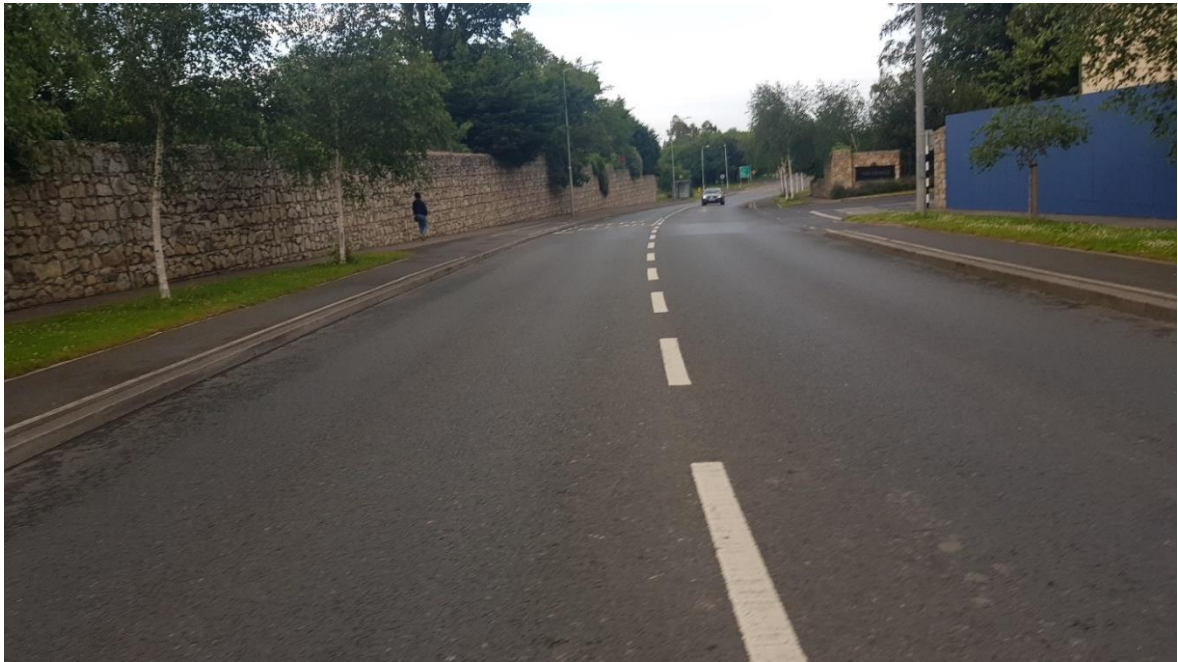
and may attempt to egress with insufficient gaps, leading to an increased risk of right angled collisions and rear shunt collisions on the major road.

Figure 53: Limited Space for right turning vehicles into site

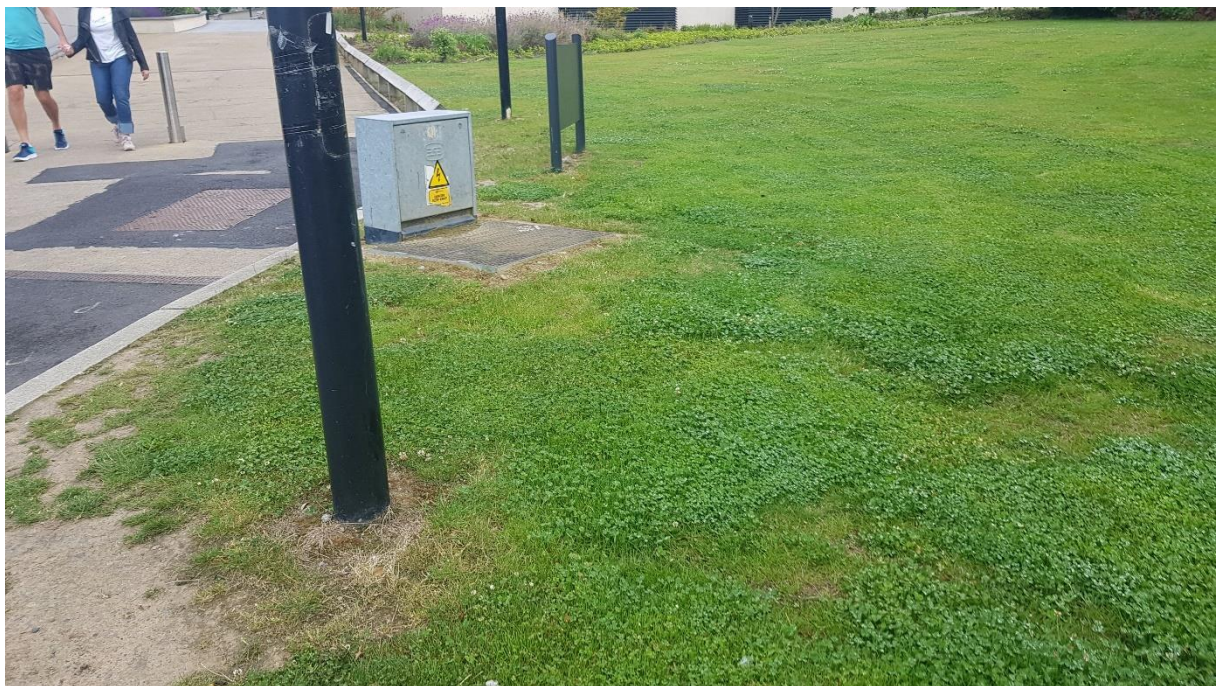
Proposed design will impact on signage, walls, lighting columns, mature trees, bollards, utilities and buildings within the existing site.

Figure 57: Items displaced by design proposals

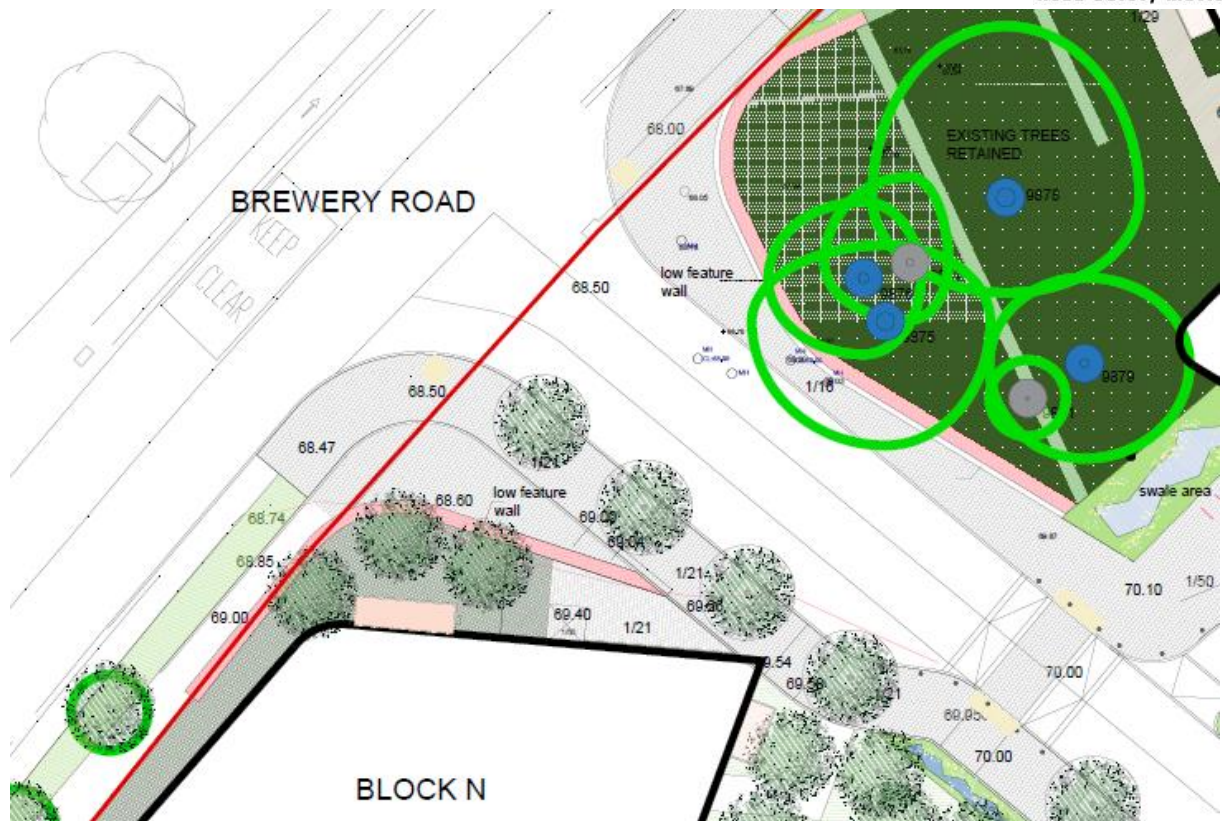
The design appears to include for retention of a two lane egress from the site, with carriageway widening and kerb setback on the nearside, as shown in figure 58. Provision of two lanes of egressing traffic at the stop line on the minor arm of the access junction will increase the number of simultaneously turning traffic streams at the junction, with vehicles queuing in the adjacent lane also potentially reducing visibility to and from traffic approaching from each direction on the N31, as indicated in figures 59 and 60, leading into an increased risk of pulling out type collisions, right angled collisions and rear shunt collisions. Two wheeled vehicles are also more vulnerable on this arrangement, particularly those wishing to turn right, with insufficient space to queue and move alongside larger vehicles in particular.

Figure 58: Proposals for two lane egress from site

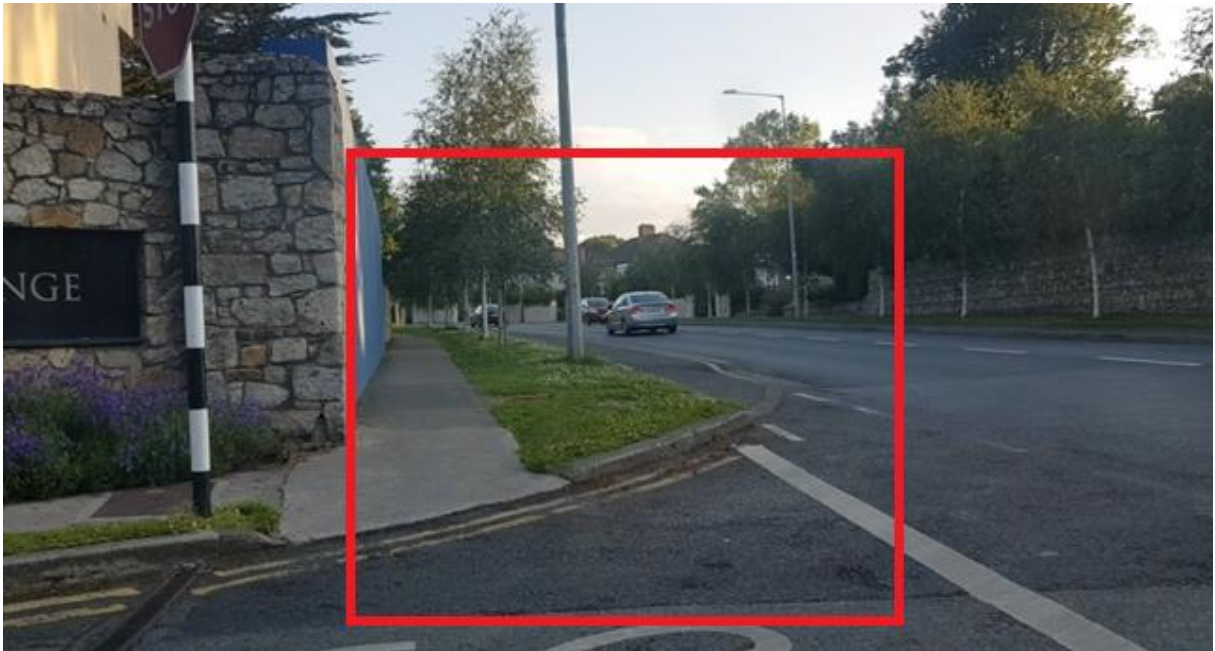
Figure 60: Waiting Vehicle potentially obscuring visibility to left

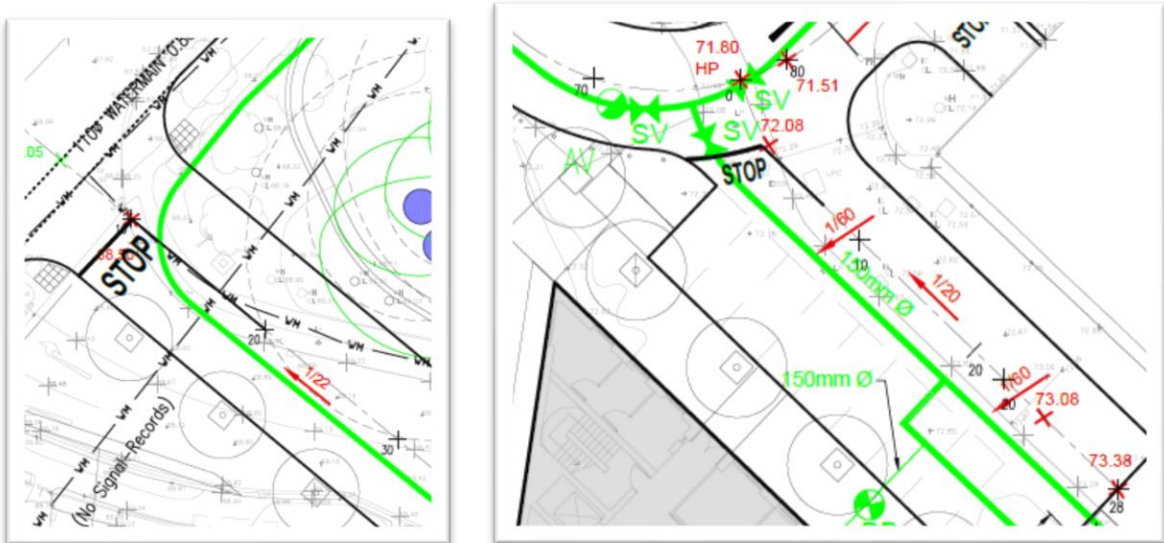
unclear if sufficient dwell area has been provided to minimise the risk of overshooting the stoplines, and collision with passing traffic. There were no gradients provided for the ramped access to the basement car park, to determine any potential safety issues arising.

Figures 61 & 62: Step Gradients on Approaches to Stoplines
