Quality Audit
Inclusive of Stage 1 Road Safety Audit
for
PROPOSED RESIDENTIAL DEVELOPMENT
AT
THE GRANGE
BREWERY RD, STILLORGAN, DUBLIN 18

Date: August 2019

Report produced by: Road Safety Matters

Reference: RSM/MOB/080719/GRANGE-QA1

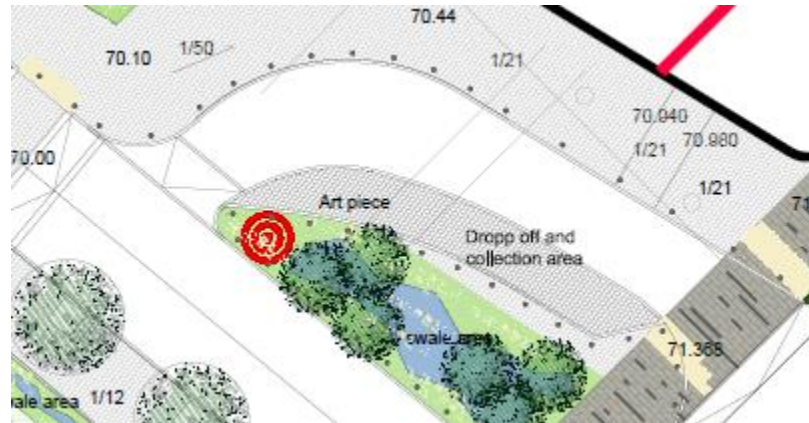
It was noted that there is insufficient space on the footway adjacent to the drop off and collection point, on the passenger side, to accommodate safe waiting or alighting for passengers, and there is insufficient space for disabled passengers and wheelchair users at this location. A number of bollards at this location are likely to present a hazard, and the adjacent swale may also present a hazard. The connectivity to the surrounding network of footways from this point is also unclear.

Figure 63: Drop Off Area

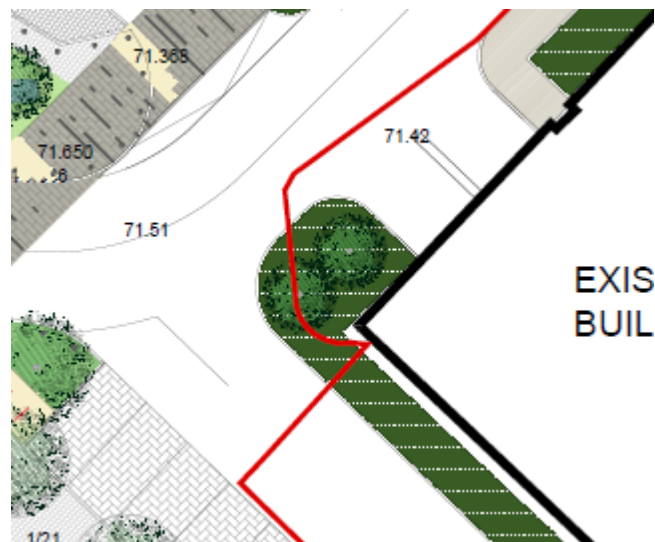
A number of the internal junctions are very closely spaced, as shown in figure 64. Closely spaced junctions can lead to increased conflict due to simultaneous turning manoeuvres occurring in close proximity, and the lack of clarity regarding rights of way and priority. In the case of these junctions, it is acknowledged that traffic movements to and from the creche and set down areas are likely to be low, hence the level of risk is also likely to be low, however the provision of landscaping between the access points may reduce intervisibility and increase risks arising.

Figure 64: Closely Spaced Junctions with trees compromising intervisibility

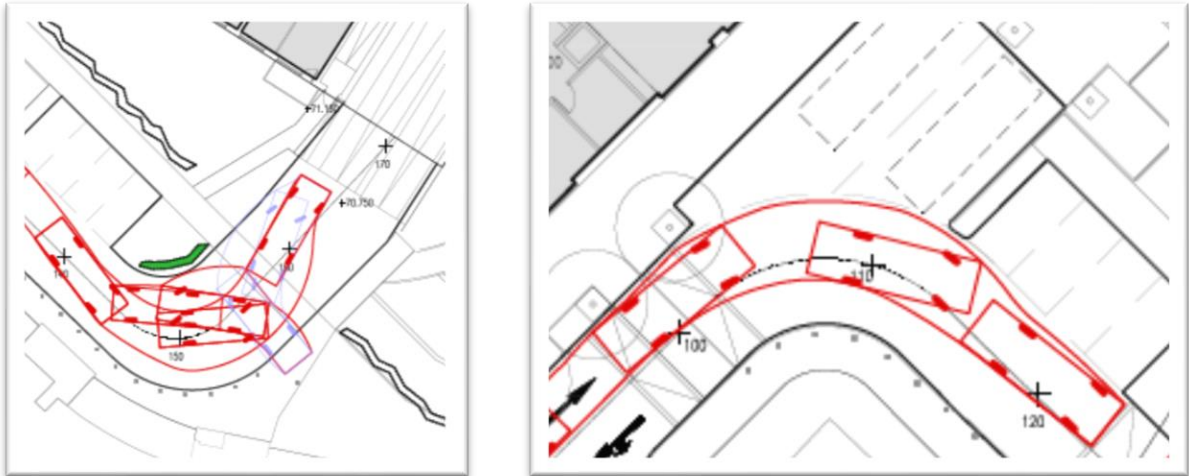
The swept path analysis supplied for the site demonstrates that the proposed geometry is somewhat restrictive for emergency vehicles on the tight turns on the access route to and from the basement car park, as shown in figures 65 and 66. It is unclear if these turns will be possible for more frequent vehicle types, such as SUVs, in the event of a demand for simultaneous two way traffic movements, which is likely, particularly at peak times. Insufficient space for vehicle manoeuvres will lead to an increased risk of side swipe and head on collisions, with turning vehicles also more likely to strike street furniture or encroach into the VRU zones, increasing risks for such road users.

Figures 65 and 66: Tight radii on access route to site

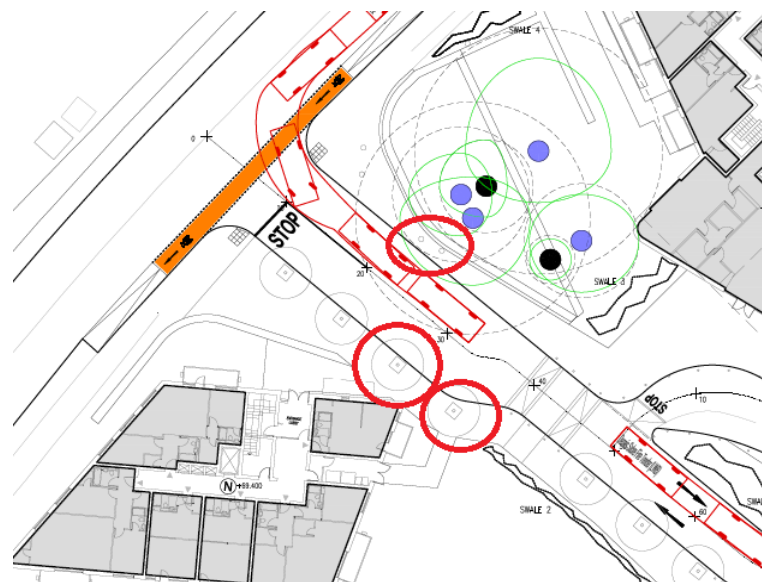
- A number of potential pinch points were noted on footways, including adjacent to proposed landscaping and trees, which are likely to obstruct movement for pedestrians, particularly if spaces are to be shared with cyclists.

Figure 69: Potential Pinch Points on Footways

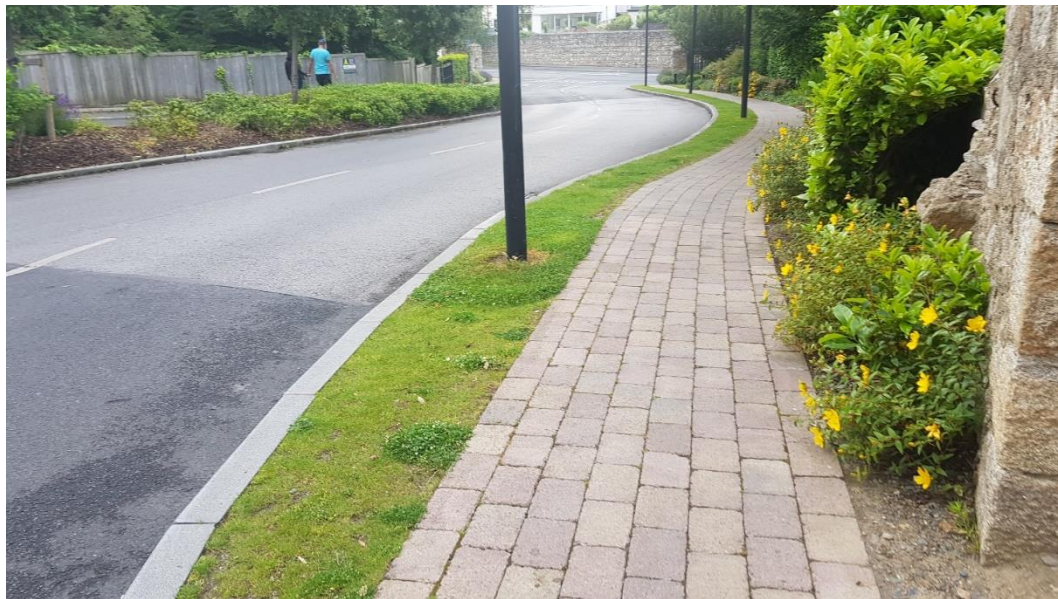
- It was noted that existing footway widths are relatively narrow, and connectivity to the existing footways and verges is not clear from the plans supplied.

Figure 70: Connectivity to narrow Existing Footways Unclear

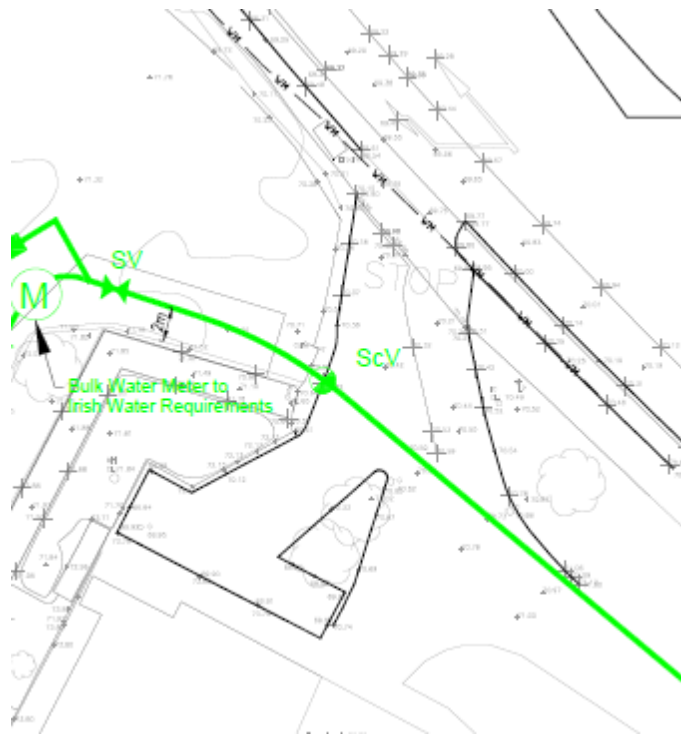
- The potential for poor Intervisibility was also noted at some locations within the site, including at the tie-ins on the N11, where pedestrians egressing the site will be brought directly out into a junction where there is no current footway provision, and where the risk of conflict with turning and waiting vehicles will be higher, as shown in figure 71. There are a number of locations throughout the site where landscaping is proposed in close proximity to crossing points and potential desire lines, with examples shown in figures 74-76. Insufficient intervisibility can increase the risk of pedestrian/vehicular conflict.

Figure 71: Connectivity to Footways on the N11 Unclear

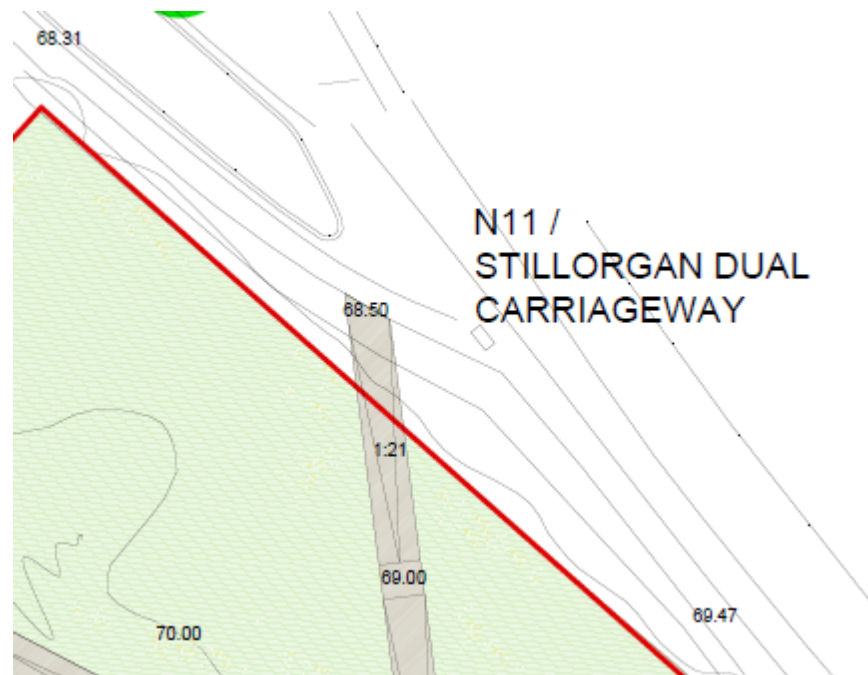
Figure 77: Connectivity at ramp unclear

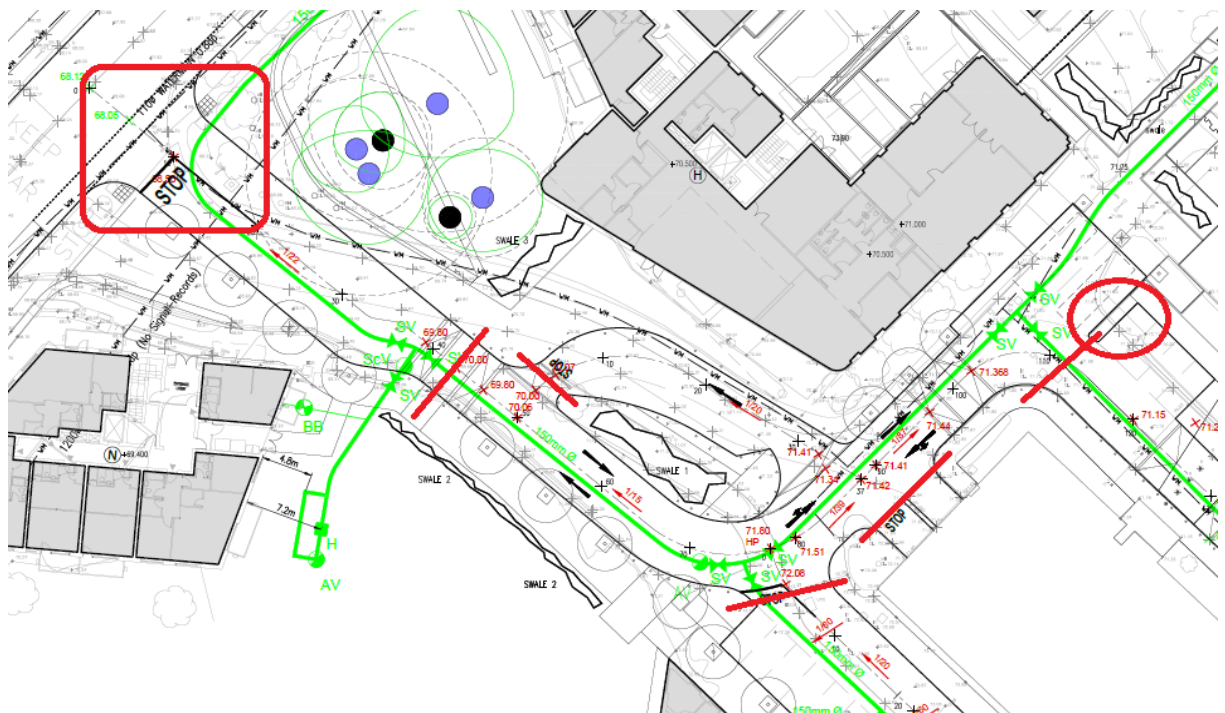
Design plans show steps at a number of locations throughout the site where there is no provision for tactile paving at the top and bottom to alert visually impaired pedestrians to the presence of the hazards. Ramps have also been provided at some locations, however the ramps widths appear narrow, and the provision for ramped access for wheelchair users, buggy users or other mobility impaired pedestrians throughout the site is not clear from the plans supplied. Tactile paving has been provided across the mouth of the reconfigured access junction, however is absent at crossing points at other locations throughout the site, as highlighted in figure 78.

Figure 78: Lack of tactile paving across internal access points

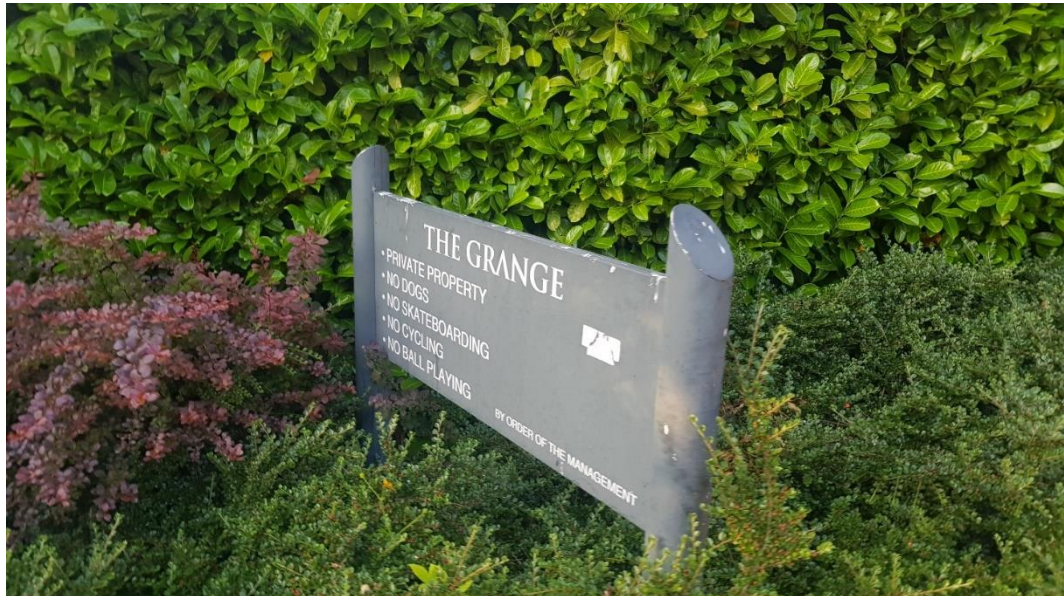
Figure 79

- Existing signs indicate that cycling is prohibited in the Grange development, as shown in figure X, which may present difficulties, due to the high proportion of cyclists which will be expected at this site.

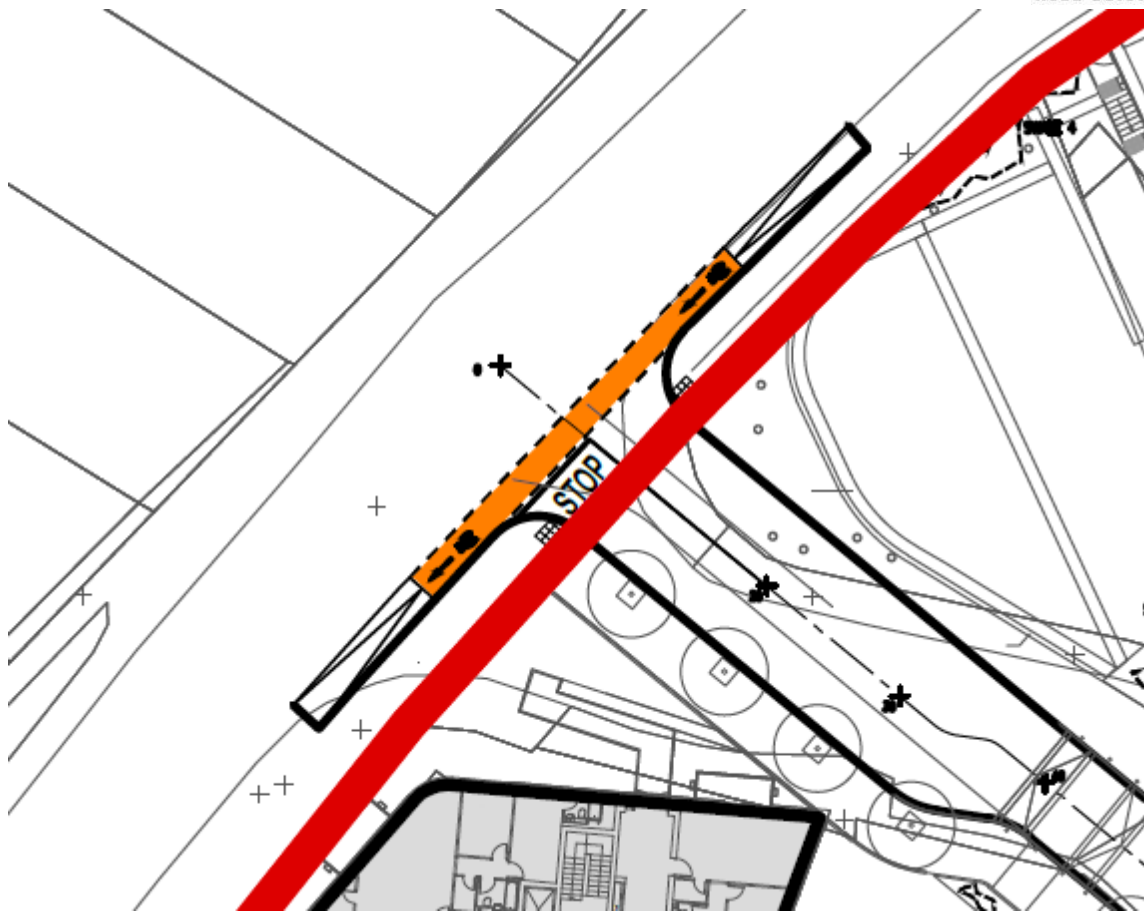
Figure 80

- Provision has been made for coloured surfacing and road markings for the continuity of the off road cycle track across the mouth of the access junction, as shown in figure 80, however the connectivity of the facility on the western side does not appear to line up with the existing kerbline.

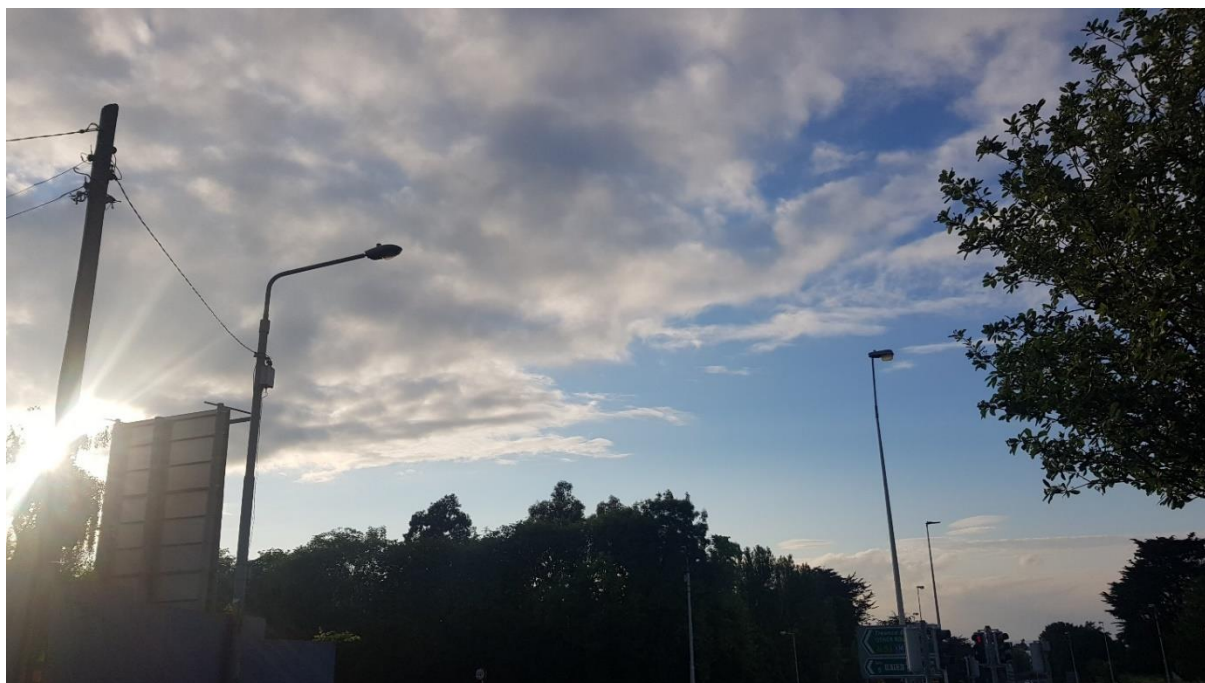
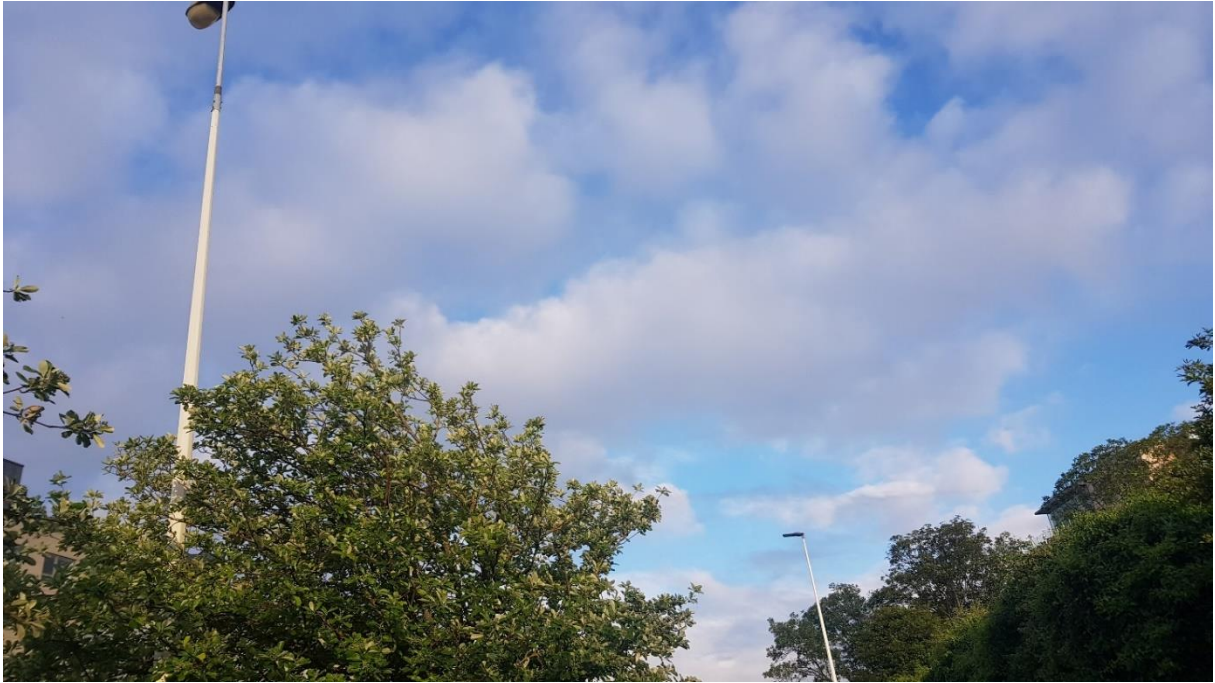
There was no information provided to the Audit Team on proposed lighting within or adjacent to the site. A significant number of existing lamp columns will be displaced by the scheme proposals, and will require relocation at detailed design stage. It was noted that a number of existing columns are located close to the carriageway edges, which present an increased risk of vehicle strike. Current lighting on the network surrounding the site varies from new LED lamps to old incandescent lamps, as shown in figures 81 and 82, which may effect lighting levels in the locality. Inappropriate lighting will have an impact on the collision risk arising during the hours of darkness.
