Arboricultural Report
Lands adjacent to The Grange
Brewery Road/Stillorgan Road,
Stillorgan,
Blackrock,
Co Dublin
August 2019

The Tree File Ltd
Consulting Arborists
Ashgrove House
Kill Avenue
Dun Laoghaire
Co Dublin
01-2804839

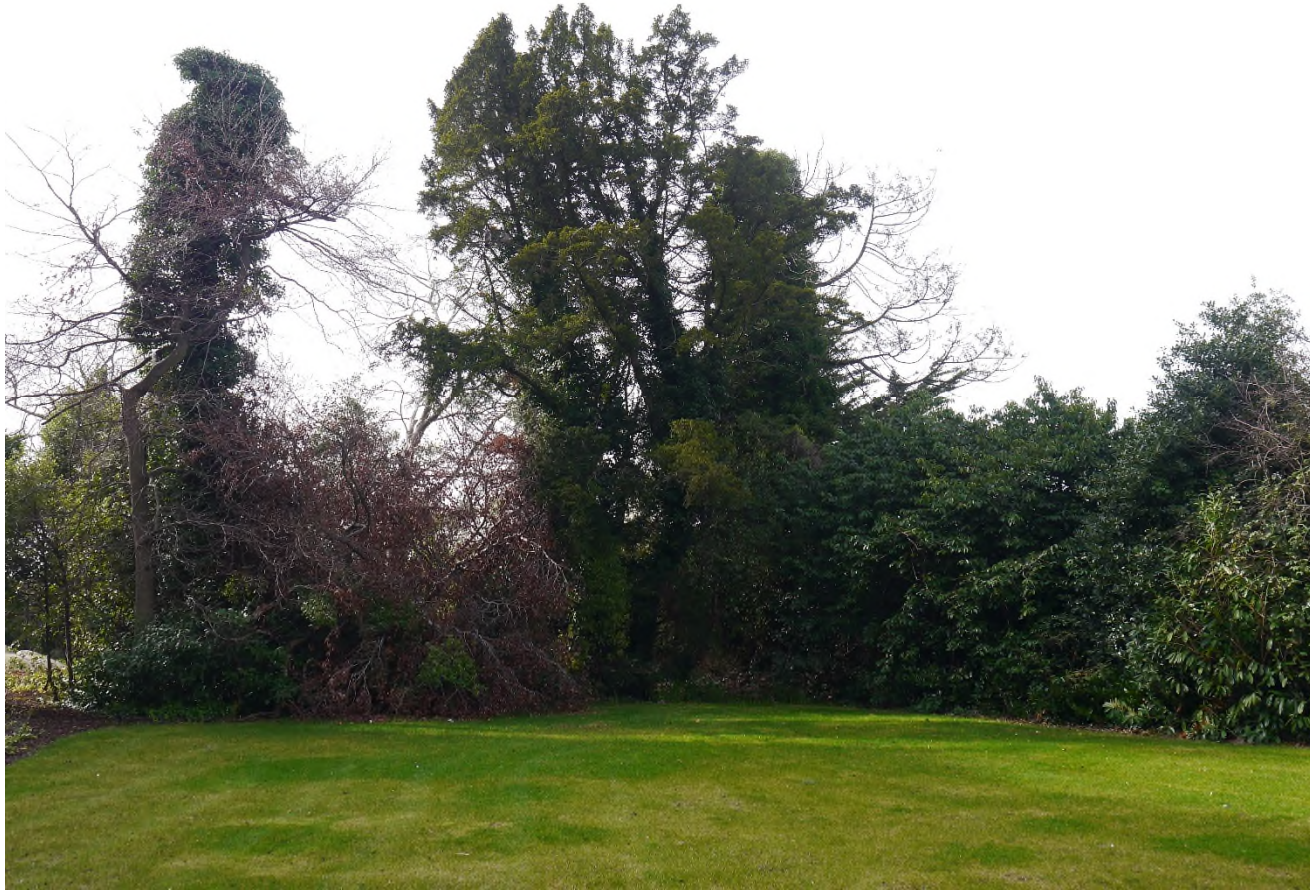
Photo 1

This area of the site, adjoining the southern boundary with the neighbouring public Park supports of variable population of highly variable conditions. Several trees require removal and others are in a state of decline such as to suggest limited sustainability. There are however a small number of specimens in this area that would appear to offer substantial longevity. Issues of exposure and shelter loss are well illustrated here, in the recent failure and breakage of trees such as tree 9773 and 9774, an issue compounded by the severe decline of adjoining trees such as Nos 9770, 9771 and 9772.

This photograph illustrates the storm damage decapitation of Beech 9773 and the partial collapse of Beech 9774, as well as the chronic decline of Western Red Cedars 9770 and 9771.

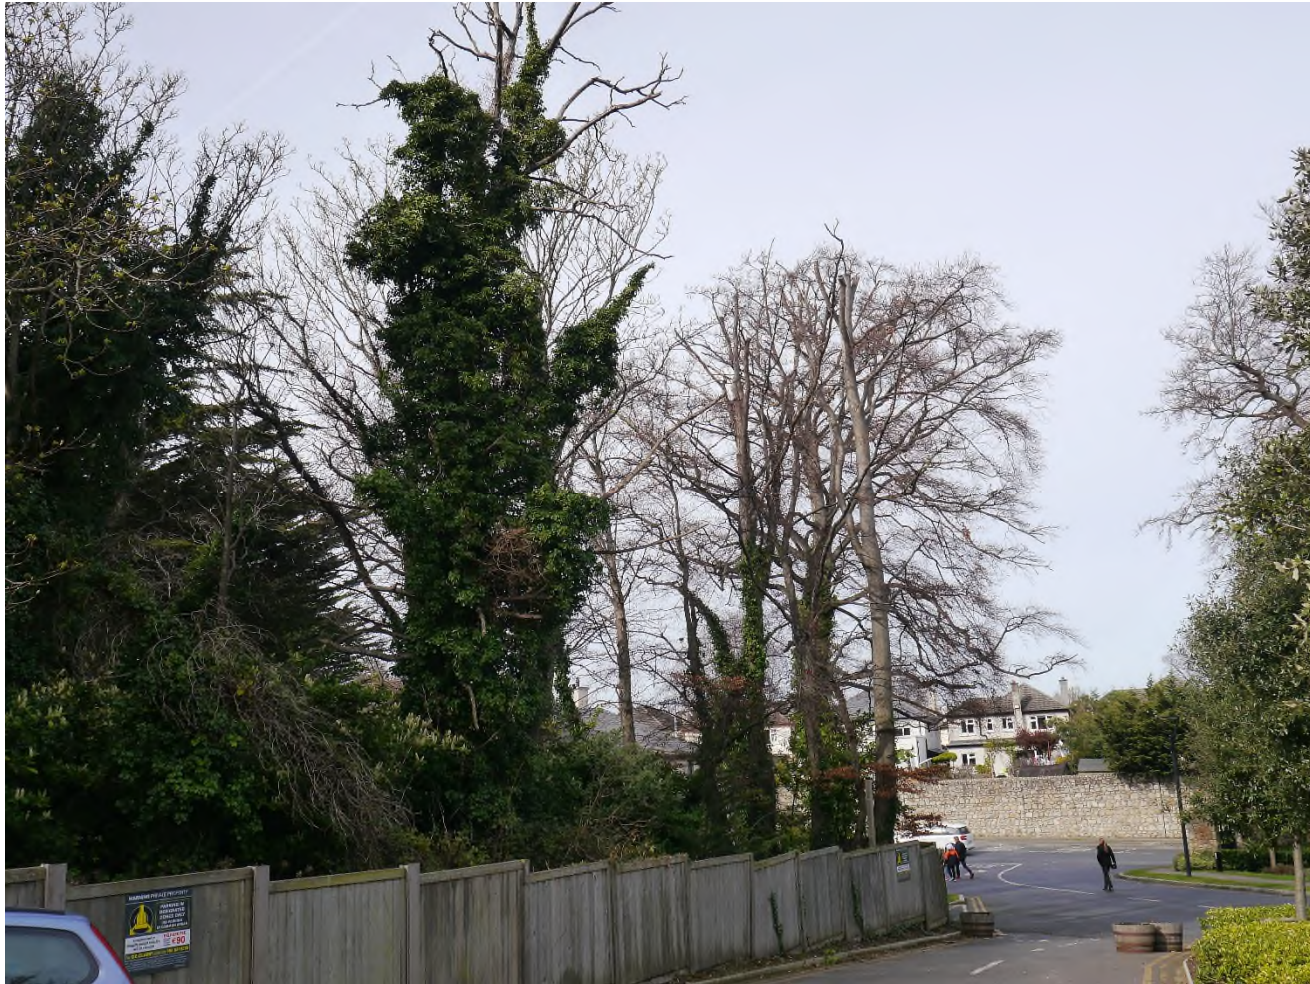
Photo 2

Located to the south of the “Brewery Road” site entrance road supports a broadly poor and apparently deteriorating tree population.

There are several particularly large, dead or dying specimens that must be removed on the grounds of site safety. Additionally, a notable proportion of the population appears to be exhibiting evidence of decline and deterioration, likely to be attributable to environmental change associated with previous development works. Such trees are considered unsustainable, potentially dangerous and must be removed.

This photograph illustrates the poor quality of tree within the group to the south of the Brewery Road entrance road. This group contained many dead and partially collapsed trees that currently constitute a tangible threat through failure. This entire group is of minimal sustainability.

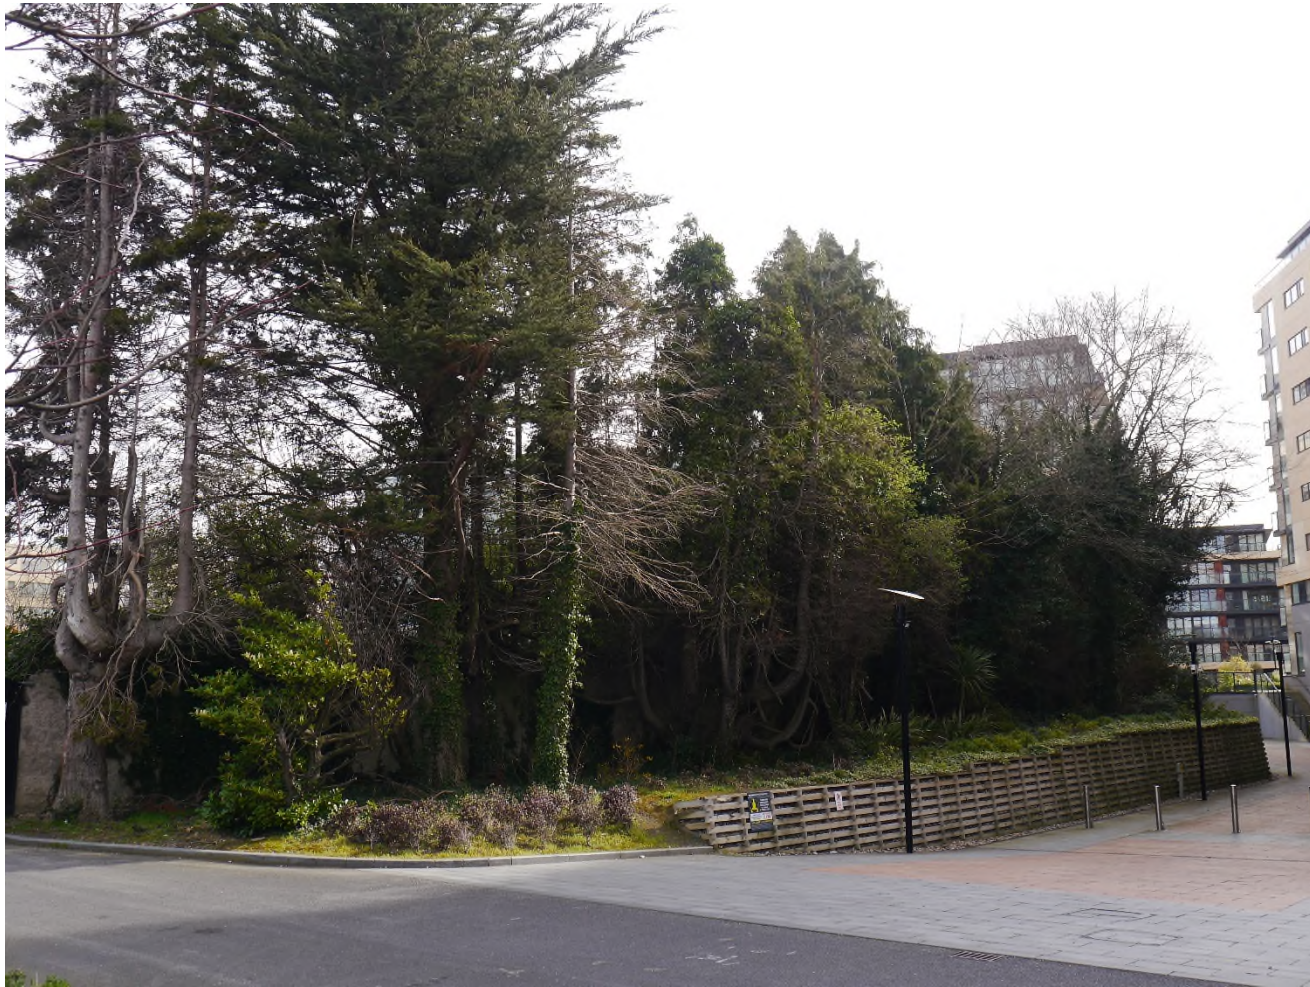
Photo 3

This group of trees appears to have comprised a belt located to the south of the original walled garden. The once broader alignment was heavily affected, on its southern side by the fire tender access to “Block G” and a crib-wall, apparently affecting drainage and leading to drying-out. This means that substantial number of trees are either dead or at such a stage of deterioration as to make them unsuitable for retention.

This photograph illustrates the trees retained after the excavation of the fire tender access opposite the completed “Block G”. Environmental change including exacerbated drainage and drying has resulted in widespread death and decline within the overall population. This group is of minimal sustainability.

Accordingly, this entire group should be regarded with caution and in respect of the benefits to be gained by way of replacement as opposed to retaining the material noted at present.

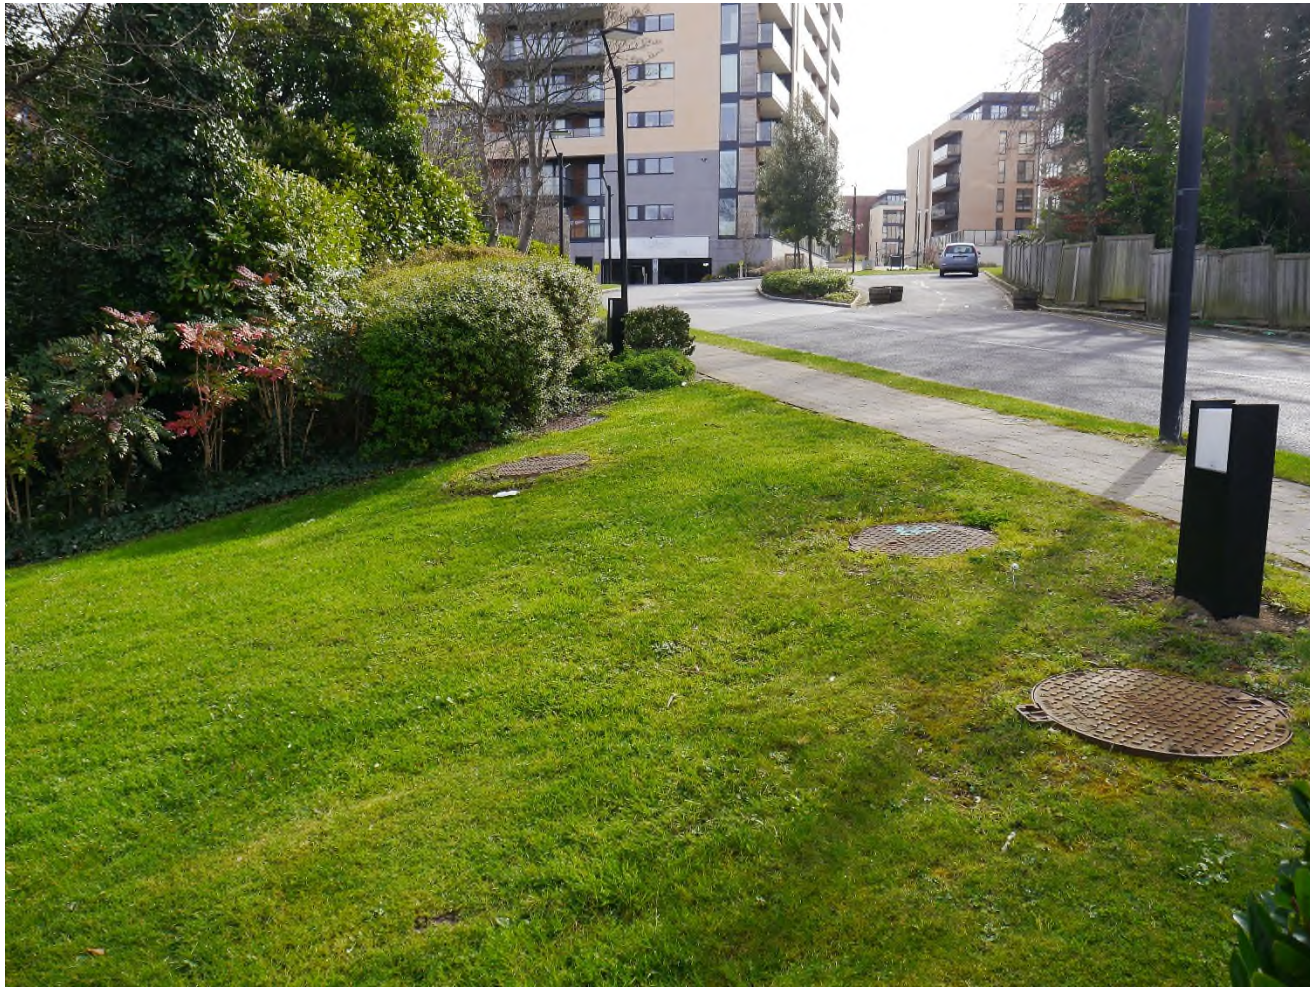
Photo 4

This photograph illustrates the “built-up” nature of ground to the south and south-west of Beech 9876, where the previous installation of underground services, combined with raising of ground levels has created a substantially artificial scenario and a pre-existing imposition on what would be the nominal root protection area.
