Proposed Housing Development
in Farrankelly, Co. Wicklow

Stage 1 Road Safety Audit

Document Ref: P18-067-RP-001

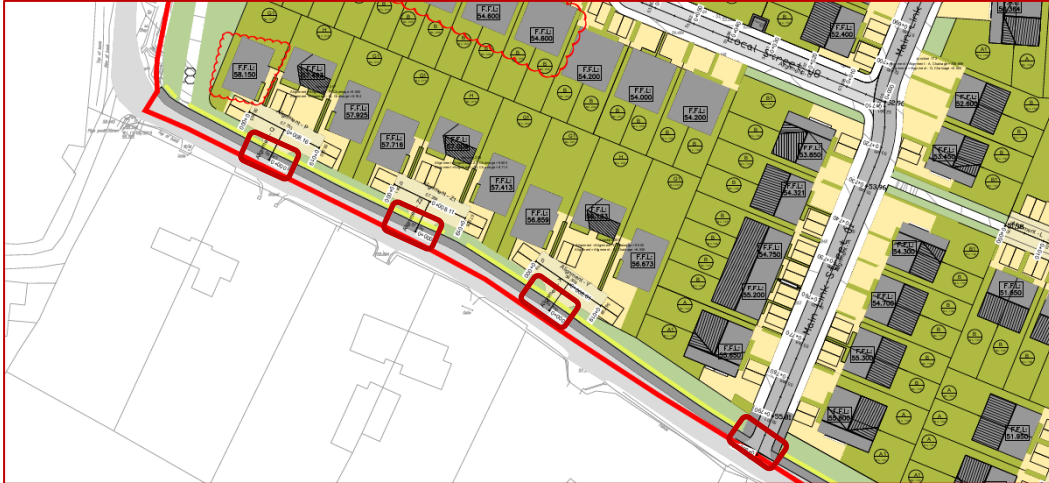
Location: Priory Road

Summary: Several direct accesses onto Priory Road may increase the risk of side-on or rear-end-shunt collisions.

The proposed development includes three separate direct accesses onto Priory Road, as well as a new junction between Main Link Street 01 and Priory Road. The three accesses facilitate nine residential properties and 18No parking spaces. Having several direct accesses onto Priory Road, and within a relatively short distance, may lead to an increased risk of rear end shunt and side-on collisions. This issue is exacerbated by existing property accesses to the south of Priory Road, the horizontal alignment, and the rural character of Priory Road.

The proposed development should remove the three direct accesses onto Priory Road through the provision of a service lane that connects with internal residential streets.

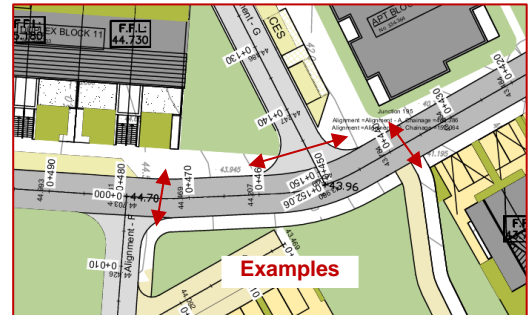
Summary: Designated crossing points within the residential road network have not been indicated at junctions.

Pedestrian crossing points, including dropped kerbs and tactile paving, have not been indicated at all junctions within the proposed development. A failure to provide dropped kerbs at crossing points, and along pedestrian desire lines, could result in mobility impaired pedestrians being unable to safely and independently enter the carriageway to cross to the opposite footpath. This could result in slips, trips or falls as these pedestrians attempt to descend the kerb, or an increased risk in visually impaired pedestrians unintentionally entering the carriageway where they could be struck by vehicles.

Pedestrian crossings, including dropped kerbs and tactile paving, should be provided across all junctions within the proposed development. Also, hazard paving should be located at the top and bottom of steps within the development.

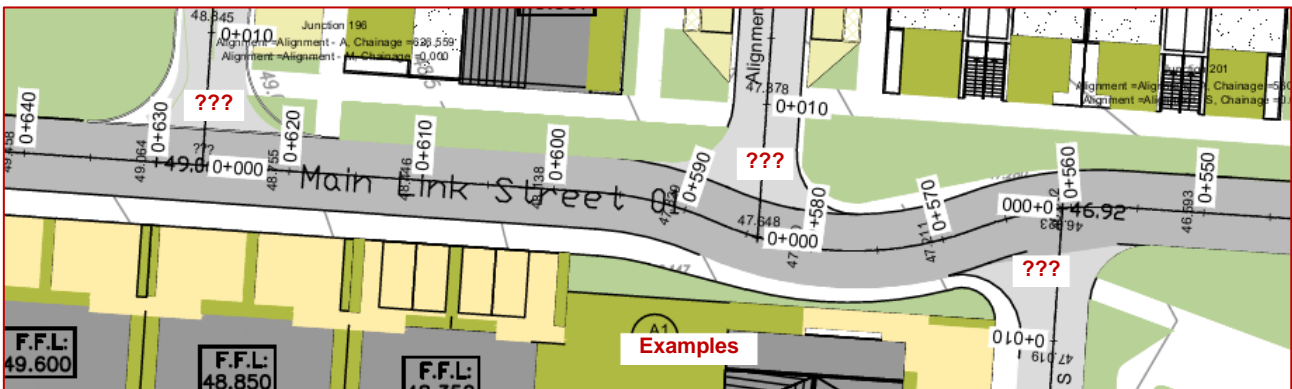
Summary: No junction control or priority type has been indicated at junctions within the development.

The junction control (stop, yield etc.) at junctions within the proposed development has not been indicated. It is therefore unclear who has priority at these junctions. This could result in driver confusion and hesitation leading to collisions should drivers assume that they have priority over vehicles in adjacent roads leading to low speed collisions and material damage.

Ensure the junction control at all junctions is clear and that drivers are sufficiently advised of the priority at junctions.

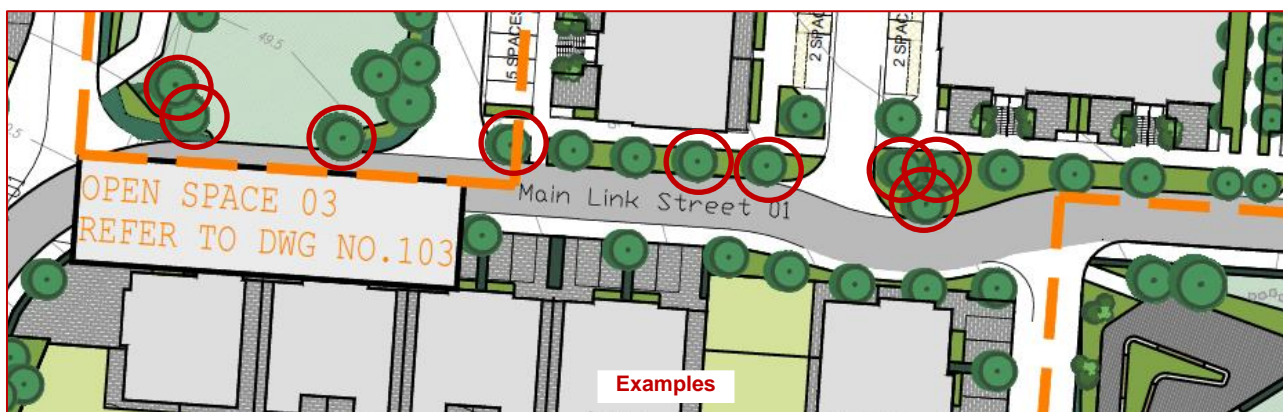
Examples: Main Link Street 01 junctions with Local Streets 10 and 12

Summary: Visibility exiting side roads could be restricted by trees within the footpath.

Trees have been indicated within the footpath adjacent side road junctions throughout the scheme. These trees could restrict a driver's visibility towards approaching vehicles when stationary at the junction. This could result in drivers entering the carriageway ahead of oncoming vehicles when it is unsafe to do so leading to side-on collisions.

Ensure the trees within the scheme do not impede a driver's visibility when exiting side roads. The trees should be relocated if necessary.

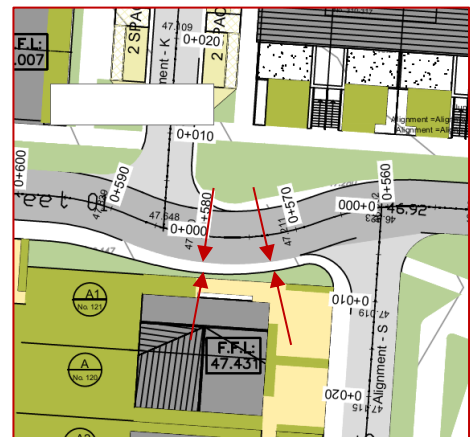
Location: Main Link Street 01 junction with Local Street 06

Summary: Footway width appears to include localised narrowing or pinch point.

The footway width appears to fall below the desirable 2m width, which may result in pedestrians being unable to pass each other, especially where mobility impaired or visually impaired pedestrians are using the footway. This may force pedestrians onto the road where they are at a greater risk of being struck by a cyclist or vehicle.

A footway width of at least 1.8m (preferably 2m) should be provided throughout the development, ensuring there are no pinch points or local narrowings.

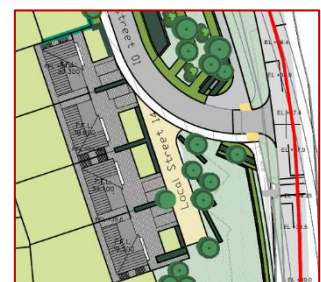
Locations: Local Street 08 and Local Street 14

Summary: Junction mouth width may encourage high entry/exit speeds.

The junction mouth at Local Street 08 and Local Street 14 is wide and may promote high entry and exit speeds. This may lead to loss of control collisions where drivers fail to reduce their speed on approach to the junction. Additionally, the wide junction mouth may lead to longer crossing times for pedestrians, particularly for visually impaired pedestrians, increasing the risk of pedestrians being struck by a vehicle.

The junction mouth should be reduced to passively encourage slower entry/exit speeds, and to minimise the time a pedestrian travels within the carriageway.

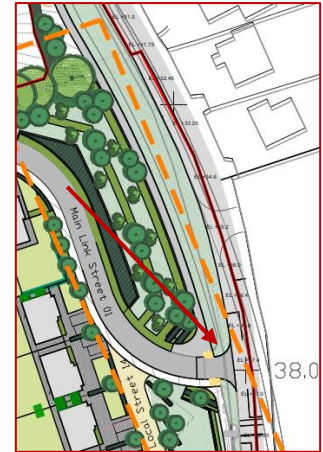
Location: Development access at R761

Summary: Visibility to junction control signage may be reduced as a result of the approach alignment.

Drivers exiting the development via the access onto the R761 may have limited visibility to the junction control sign, as the horizontal alignment includes two high demand bends. Failure to see the junction control sign (i.e. Stop or Yield) may lead to high approach speeds, and possible overshoot collisions with pedestrians or cyclists using the raised table crossing, or with vehicles on the R761.

Ensure drivers have sufficient visibility to the junction control sign (i.e. Stop sign) on approach to the R761. If required, an advance Stop sign and supplementary distance plate should be provided in advance of the junction.

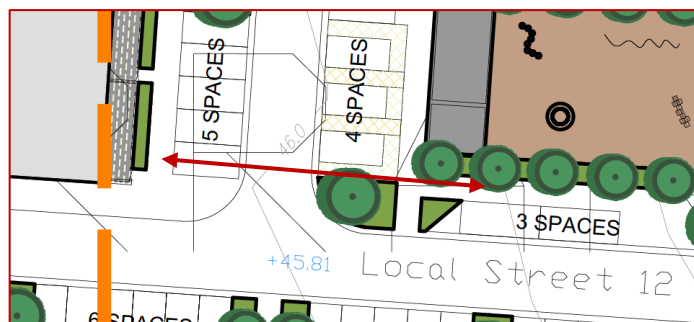
Location: Local Street 12 junction with Local Street 13

Summary: Mobility parking provision appears to obstruct or restrict pedestrian movement across the side road.

Mobility parking spaces are provided at the junction of Local Street 12/Local Street 13. However, the mobility parking spaces appear to block pedestrians from continuing along Local Street 12. This may force pedestrians into the carriageway, where there is an increased risk of being struck by a vehicle.

Pedestrians should have unobstructed access across the side road junction, allowing them to safely continue their journey through the development.

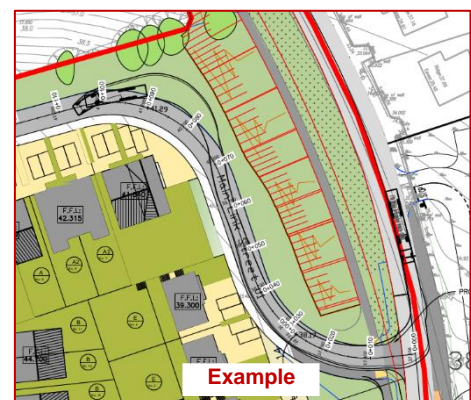
Summary: It is unclear if there is sufficient swept path for vehicles within the development.

It is unclear if the proposed layout can accommodate the swept path of large vehicles at each junction within the development (i.e. buses using the active open space facility, refuse truck, etc.). If insufficient space is provided this may lead to vehicles mounting the inside kerb when undertaking turning manoeuvres, thus increasing the risk of vehicles striking pedestrians.

Swept path analysis should be undertaken to ensure sufficient turning space is provided for vehicles within the development, and where horizontal radii is less than outlined in DMURS.

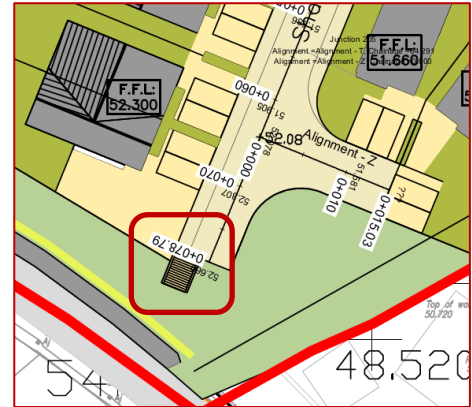
Location: Shared Local Street 06

Summary: Proposed steps located at the end of Shared Local Street 06 direct pedestrians into the carriageway.

Steps are located at the end of Shared Local Street 06, and appear to lead pedestrians into the carriageway. Should large vehicles use the turning head to exit the shared street, they may not expect pedestrians to enter the carriageway from the steps, leading to vehicle/pedestrian collisions.

Pedestrians using the steps should be directed onto a dedicated footway, away from turning vehicles.

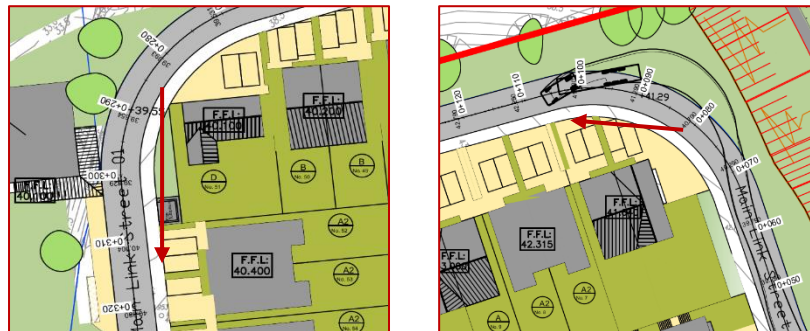
Summary: Visibility at private accesses to off-street parking may be insufficient in locations.

The visibility to private accesses is limited in locations due to the proposed horizontal alignment and a strip of vegetation which is used to separate properties. Insufficient visibility to vehicles reversing out of private driveways may lead to possible side-on collisions, as drivers exit their property and enter the carriageway.

A similar issue exists at the ESB substation, as the small building may block visibility to drivers exiting units 52 and 53, which is exacerbated by the horizontal radius on approach to the ESB building.

Ensure vegetation between property driveways does not restrict visibility to exiting vehicles.

Additionally, the ESB Substation should be relocated so that it does not block visibility to property accesses.
