**PROPOSED STRATEGIC HOUSING DEVELOPMENT  
'THE CONNOLLY QUARTER': DESIGNERS' RESPONSE  
TO QUALITY & ROAD SAFETY AUDITS**

**OXLEY HOLDINGS LIMITED**

**PROJECT NO. 0635**

**30<sup>th</sup> SEPTEMBER 2019**

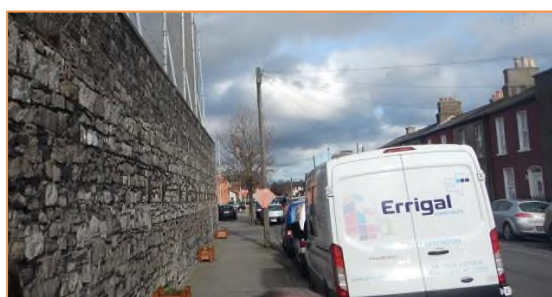
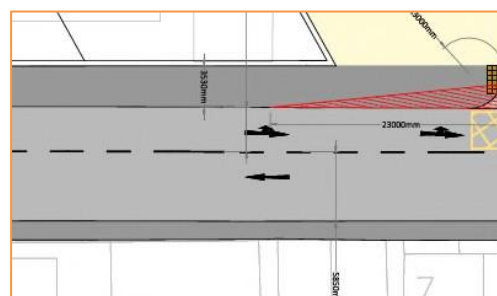
#### Problem 3.1

**Location:** Preferred Junction Option – Oriel Street Plan Layout.

**Problem:** There is currently on-street parking on both sides of Oriel Street Lower. The drawing shows that parking will be removed on the development side of the street. This may lead to locals parking partially on the footpath if they do not have alternative parking facilities. This could lead to hazards for pedestrians and blocking of sightlines for drivers exiting the new development.

**Recommendation:** It is recommended that a parking review be carried out to ensure that enough parking space is retained for local residents. If sufficient capacity is not provided, then alternative additional parking should be provided, and prohibitive measures be provided to avoid parking on footpaths or close to the proposed access.

**Response:** The applicants are satisfied to undertake a Parking Review locally as recommended. Oriel Street is 125 m long from Oriel Hall to Commons Street and accommodates 25 parallel parked vehicles on either side of the road along with some further vehicles between Oriel Hall and Seville Place. The sightline requirements for the proposed access will result in the loss of 5 no. spaces on the north side of the street i.e. about 10% of the on-street total. Off-street in-courtyard parking is provided for the DCC residential development on the southwest end of the site which will be unaffected by the development, as will the on-street parking on Oriel Hall. In that context the overall impact on on-street parking is considered to be minimal.

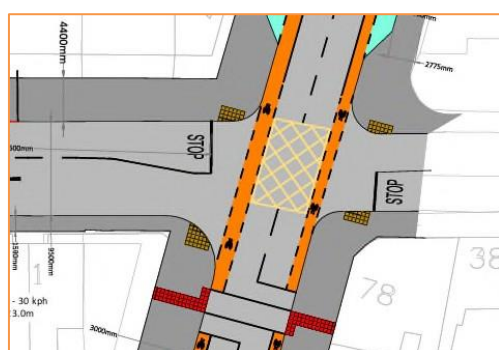
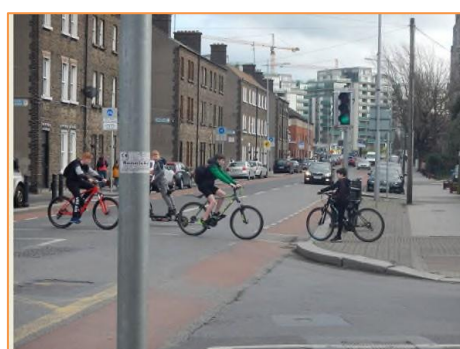
### Problem 3.2

**Location:** Preferred Junction Option – Oriel Street Plan Layout.

**Problem:** It is envisaged that the proposed development will attract cyclists from the Amiens Street direction that will travel south-west on Seville Place and turn right onto Oriel Street Lower. Currently cyclists have to enter the carriageway to turn right or travel to the toucan crossing on the opposite side of the junction. It is unlikely that cyclists would undertake the latter due to the extra journey time and the former would put them at greater risk of being struck by a passing motorised vehicle.

**Recommendation:** It is recommended that the Seville Place /Oriel Street Upper/Oriel Street Lower junction be signalised with a toucan crossing facility on the northeastern leg of the junction. Any adjustments to this strategic regional road should take into account knock on effects at other junctions as part of an overall traffic review as excessive delays at one location could lead to other safety issues at adjacent junctions.

**Response:** The applicants are satisfied to work with the Roads Authority to investigate the traffic impact of any signalisation on the Seville Place - Oriel Street junction with a view to introducing a Toucan Crossing as recommended.

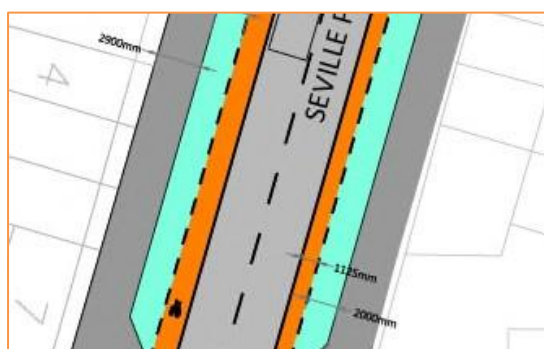
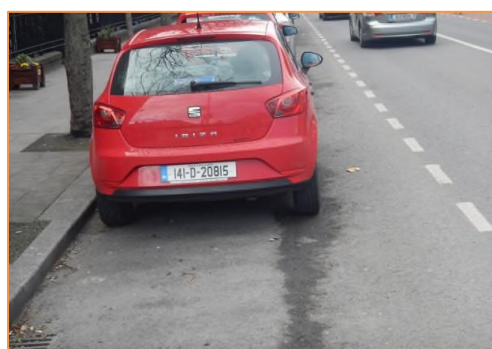
### Problem 3.3

**Location:** Preferred Junction Option – Oriel Street Plan Layout & Site Observation.

**Problem:** It was observed during the site visit that there is no buffer zone between parked on-street cars along Seville Place and the on-road cycle lane. A replica situation is presented in the drawing. This could lead to collisions between cyclists and opening car doors of parked vehicles or cyclists losing control as they swerve to avoid opening doors. The Audit Team acknowledge that there is limited road space available.

**Recommendation:** It is recommended that an assessment of the footpath width (2.9m) be undertaken relative to its existing and future use to see if the footpath could be reduced in width to enable a buffer zone to be provided between parked vehicle and cyclists. It was observed that there is a large amount of street furniture along Seville Place which may reduce the effective width of the footpath unnecessarily.

**Response:** The proposed development will bring about a net reduction in parking on the site from 425 spaces to 208 spaces. Traffic levels on Oriel Street are quite low as are roads speeds and neither will increase as a result of the proposed development. The designers are of the view that adequate footpath widths should be maintained in order to cater for the increased pedestrian flows that will be brought about by the development – particularly on foot of the reduced car park provision. In that context the designers are of the view that the current footpath width should be maintained. The issue of a cycle buffer will be raised with the Roads Authority.

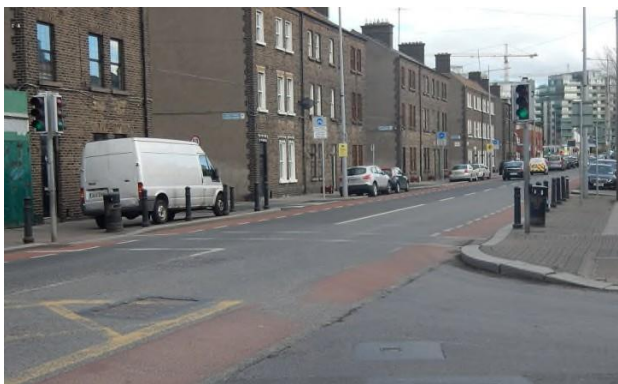
### Problem 3.4

**Location:** Preferred Junction Option – Oriel Street Plan Layout & Site Observation.

**Problem:** It was observed during the site visit that the cycle lanes along Seville Place are advisory only and are not operational between 7pm and 7am. These restrictions make it necessary for cyclists to share space with vehicular traffic which increases the risk of collisions between those road user groups. It is noted that the Seville Place cycle lanes lead to the Grand Canal/spencer Dock/Samuel Beckett Bridge Greenway. Continuity of dedicated cycle facilities would be beneficial.

**Recommendation:** It is recommended that that where feasible, the cycle lanes should be upgraded to mandatory cycle lanes on Seville Place.

**Response:** The designers and applicants concur with this recommendation and will raise same with the Roads Authority during the course of the planning process.

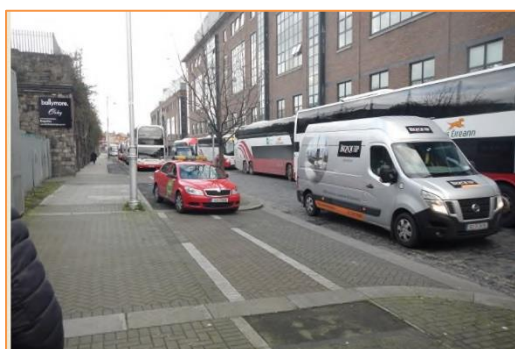
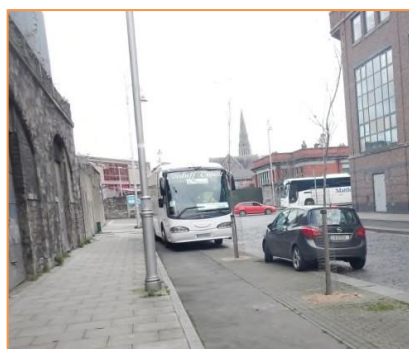
### Problem 3.5

**Location:** Sheriff Street Lower

**Problem:** It was observed during the site visit that buses and taxis queued on Sheriff Street until they move into the official bus stops/Busárus/taxi ranks. Those vehicles were partially parked on the existing cycle lanes and footpaths along Sheriff Street Lower. It is unclear if there are any other locations that these vehicles could queue when the proposed development is complete. If the practice continues after the development is complete there is a greater risk that there would be collisions with pedestrians or cyclists given the greater number of those vulnerable road users.

**Recommendation:** It is recommended that the bus and taxi waiting areas be relocated away from the new development as the mixing of pedestrian and cyclists with these commercial vehicles will lead to collisions with the vulnerable road users. The nature of the roads in this area (Sheriff Street Lower, Commons Street and Oriel Street Lower) will be changed by the nature of the development into a mainly pedestrian area and the street scape should reflect this with priority given to pedestrians through the removal of large buses and the introduction of formal and informal pedestrian crossing points at all desire lines.

**Response:** The designers and applicant concur with this recommendation. Two possible locations for a formal crossing are noted at the Commons Road junction or the gated access to Harbour Master Place – see Figure 4 over. The preferred location is at the access to Harbour Master Place as it would be on a desire line between the Docklands employment area and Connolly Station. The applicants are satisfied to fund the design and construction of this crossing.

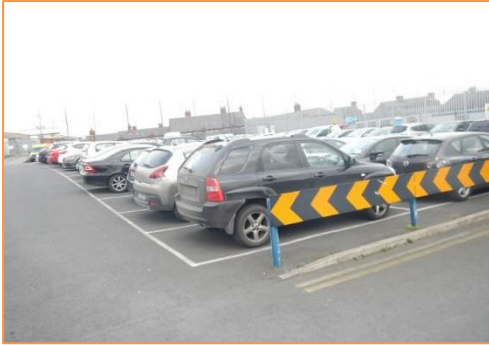
### Problem 3.6

**Location:** Existing Connolly Station Car Park

**Problem:** The existing Connolly Station Car park will be replaced by a basement carpark. There is currently no provision for a drop off area. This will lead to drivers stopping in traffic lanes, mounting footpaths or cycle tracks.

**Recommendation:** It is recommended that a drop off area be provided along Sheriff Street Lower.

**Response:** There is ample room on either side of Sheriff Street to accommodate a Drop Off Area. It is proposed that an area on the north side, close to the bridge be provided as shown in Figure 5 below.

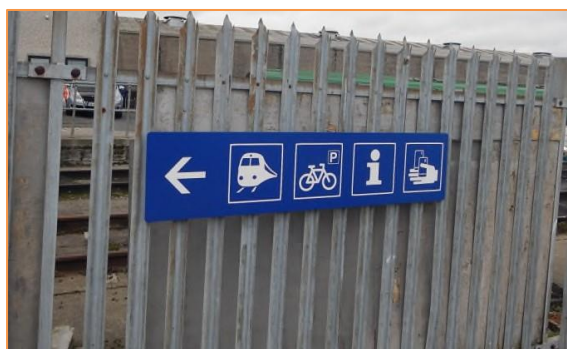
### Problem 3.7

**Location:** Existing Connolly Station Bicycle Park.

**Problem:** With increasing bicycle usage, additional bicycle parking will be required for Connolly Station. A lack of bicycle parking spaces could lead to cyclists locking bicycles to items of roadside furniture which could create hazards for pedestrians.

**Recommendation:** It is recommended that a review on the requirements for bicycle parking associated with Connolly Station be undertaken and ample bicycle parking to be provided as a result.

**Response:** The applicants are satisfied to liaise with Iarnród Éireann in respect of assessing cycle parking demand at the station and in identifying a potential suitable location for the provision of same within CIÉ's land ownership. It is noted that there is a distinct lack of Dublin Bikes stands in the Connolly Station – IFSC quarter of the City. There appears to be just a single stand located at North Wall Quay to serve this entire area of the City – see Figure 6 over.

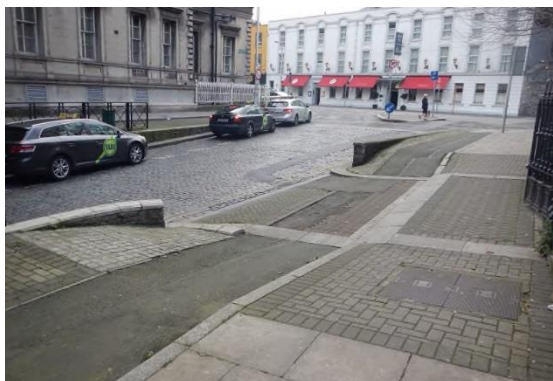
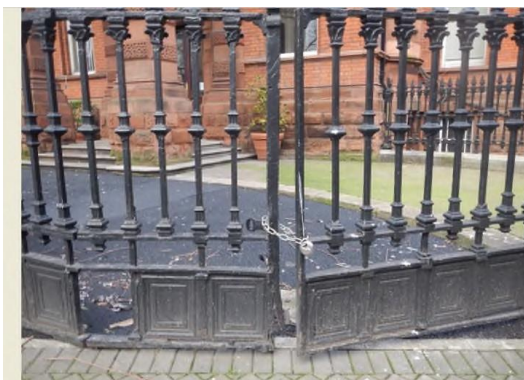
### Problem 3.9

**Location:** Sheriff Street Lower, existing Cycle Track.

**Problem:** The existing cycle track along Sheriff Street Lower at the Amiens Street end has a steep vertical alignment at the access to the Irish Rail property and may be difficult for cyclists to maintain balance, particularly younger cyclists.

**Recommendation:** It is recommended that the alignment of the cycle track be reviewed and that the need for the access to Irish Rail property that is currently locked be reviewed.

**Response:** The applicants are of the view that it will not be possible to secure an agreed closure of the occasional vehicular access to the IÉ property. In that context it is expected that a reduced level will have to be maintained at the access point off Sheriff Street Lower.

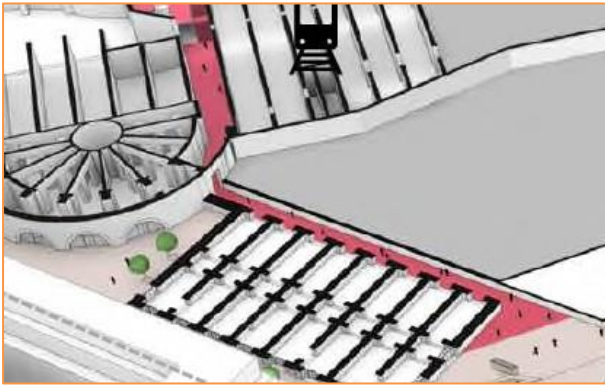
### Problem 3.10

**Location:** Access to Connolly Station from the new development.

**Problem:** There appears to be access to the platforms of Connolly Station at two levels. It is unclear if the accesses are wide enough to cater for the volumes of people that may use the station at the same time as trains arrive/depart. Inadequate space for pedestrians may lead to squashing of vulnerable road users such as the mobility impaired, the elderly and the young.

**Recommendation:** An analysis should be carried out of likely user volumes of Connolly station from and through the new development and adequate route widths should be provided with suitable ventilation and lighting.

**Response:** The applicants are in detailed discussions with Iarnród Éireann in relation to providing a pedestrian link between the proposed development (at Connolly Square) and the DART commuter platforms in Connolly Station. An initial route for the proposed connection is shown in Figure 8.

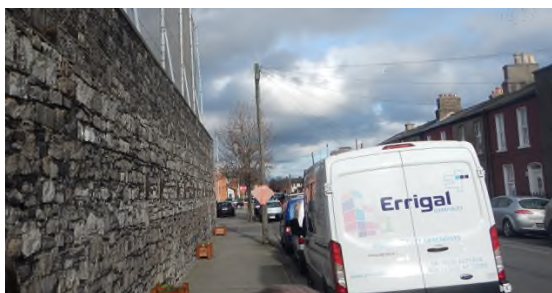
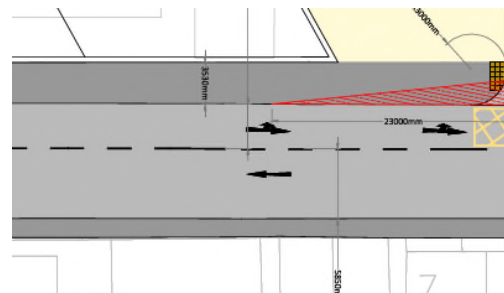
There is currently on-street parking on both sides of Oriel Street Lower. The drawing shows that parking will be removed on the development side of the street. This may lead to locals parking partially on the footpath if they do not have alternative parking facilities. This could lead to hazards for pedestrians and blocking of sightlines for drivers exiting the new development.

It is recommended that a parking review be carried out to ensure that enough parking space is retained for local residents. If sufficient capacity is not provided, then alternative additional parking should be

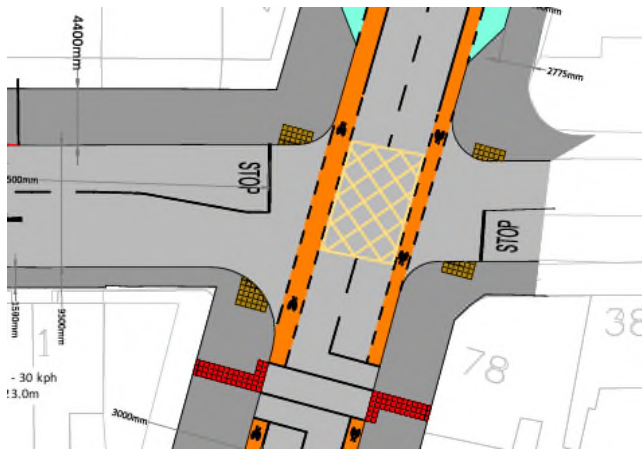
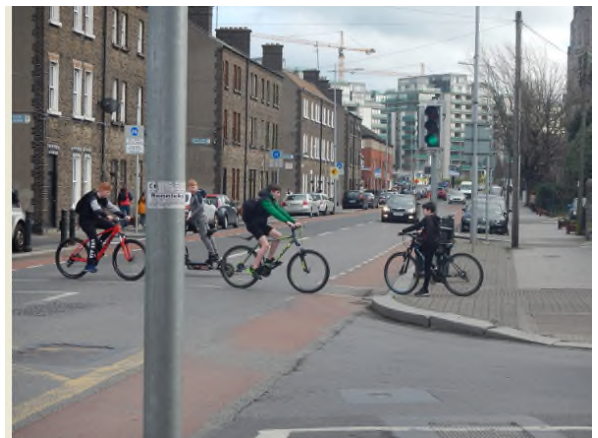
It is envisaged that the proposed development will attract cyclists from the Amiens Street direction that will travel south-west on Seville Place and turn right onto Oriel Street Lower. Currently cyclists have to enter the carriageway to turn right or travel to the toucan crossing on the opposite side of the junction. It is unlikely that cyclists would undertake the latter due to the extra journey time and the former would put them at greater risk of being struck by a passing motorised vehicles.

It is recommended that the Seville Place /Oriel Street Upper/Oriel Street Lower junction be signalised with a toucan crossing facility on the northeastern leg of the junction. Any adjustments to this strategic regional road should take into account knock on effects at other junctions as part of an overall traffic review as excessive delays at one location could lead to other safety issues at adjacent junctions.

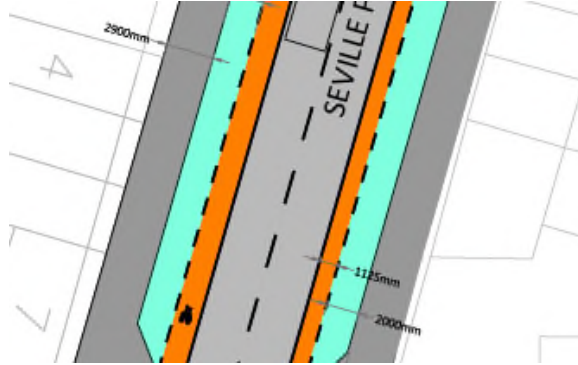
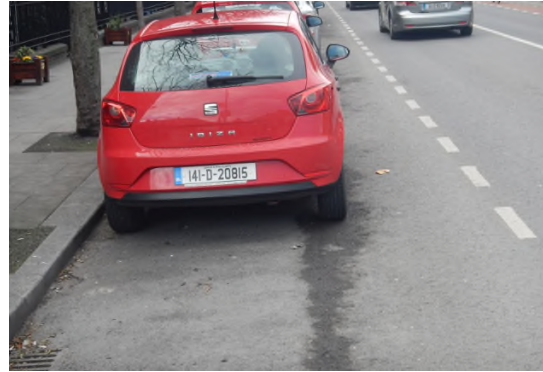
It was observed during the site visit that there is no buffer zone between parked on-street cars along Seville Place and the on-road cycle lane. A replica situation is presented in the drawing. This could lead

to collisions between cyclists and opening car doors of parked vehicles or cyclists losing control as they swerve to avoid opening doors. The Audit Team acknowledge that there is limited road space available.

It is recommended that an assessment of the footpath width (2.9m) be undertaken relative to its existing and future use to see if the footpath could be reduced in width to enable a buffer zone to be provided between parked vehicle and cyclists. It was observed that there is a large amount of street furniture along Seville Place which may reduce the effective width of the footpath unnecessarily.

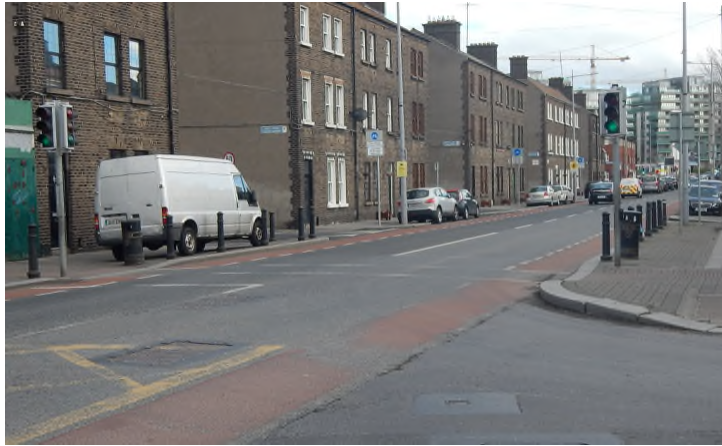
It was observed during the site visit that the cycle lanes along Seville Place are advisory only and are not operational between 7pm and 7am. These restrictions make it necessary for cyclists to share space with vehicular traffic which increases the risk of collisions between those road user groups. It is noted that the Seville Place cycle lanes lead to the Grand Canal/spencer Dock/Samuel Beckett Bridge Greenway. Continuity of dedicated cycle facilities would be beneficial.

It is recommended that that where feasible, the cycle lanes should be upgraded to mandatory cycle lanes on Seville Place.

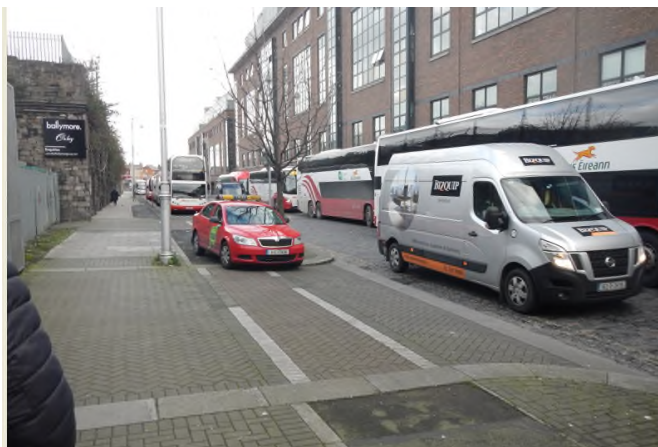
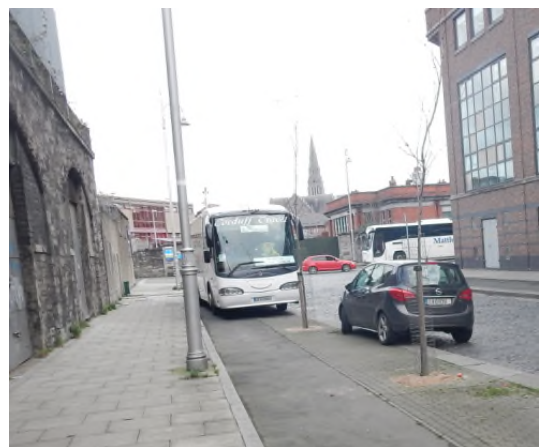
It was observed during the site visit that buses and taxis queued on Sheriff Street until they moved into the official bus stops/Busáras/taxi ranks. Those vehicles were partially parked on the existing cycle lanes and footpaths along Sheriff Street Lower. It is unclear if there are any other locations that these vehicles could queue when the proposed development is complete. If the practice continues after the development is complete there is a greater risk that there would be collisions with pedestrians or cyclists given the greater number of those vulnerable road users.

It is recommended that the bus and taxi waiting areas be relocated away from the new development as the mixing of pedestrian and cyclists with these commercial vehicles will lead to collisions with the vulnerable road users. The nature of the roads in this area (Sheriff Street Lower, Commons Street and Oriel Street Lower) will be changed by the nature of the development into a mainly pedestrian area and the street scape should reflect this with priority given to pedestrians through the removal of large buses and the introduction of formal and informal pedestrian crossing points at all desire lines.

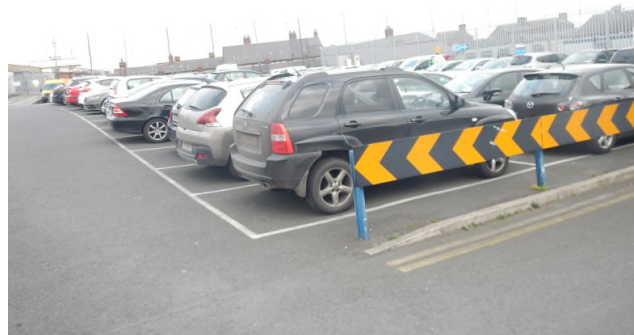
The existing Connolly Station Car park will be replaced by a basement carpark. There is currently no provision for a drop off area. This will lead to drivers stopping in traffic lanes, mounting footpaths or cycle tracks.

It is recommended that a drop off area be provided along Sheriff Street Lower.

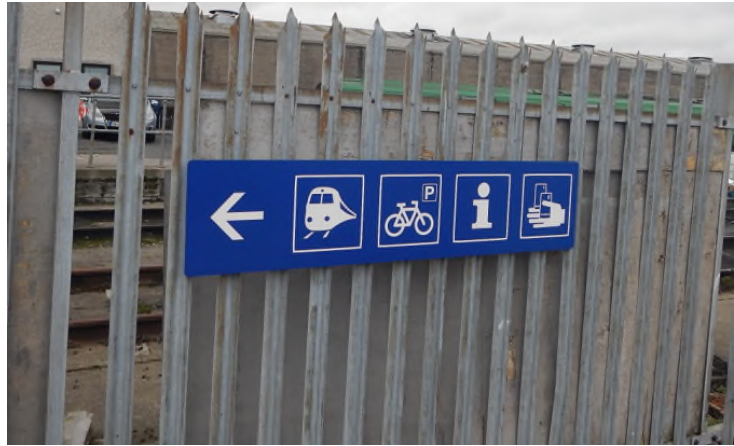
With increasing bicycle usage, additional bicycle parking will be required for Connolly Station. A lack of bicycle parking spaces could lead to cyclists locking bicycles to items of roadside furniture which could create hazards for pedestrians.

It is recommended that a review on the requirements for bicycle parking associated with Connolly Station be undertaken and ample bicycle parking to be provided as a result.

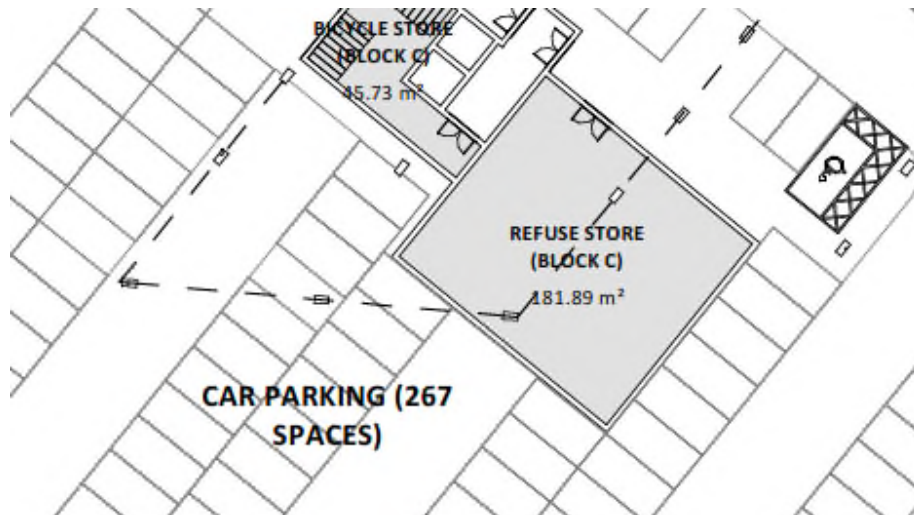
Allowance must be made for structural columns and electric vehicle charging points in the basement car park layout. Structural columns will reduce the available space for parking and could be hazards for drivers. Electric charging points may require additional spaces and should not be located where charging leads are trip hazards for pedestrians.

It is recommended that as the design develops that adequate provision be made for structural columns and electric vehicle charging points.

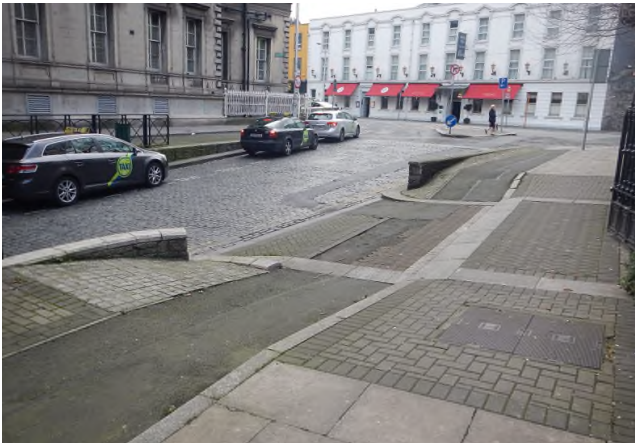
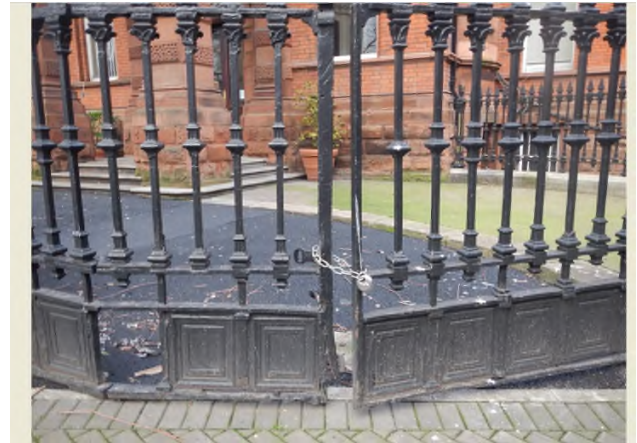
The existing cycle track along Sheriff Street Lower at the Amiens Street end has a steep vertical alignment at the access to the Irish Rail property and may be difficult for cyclists to maintain balance, particularly younger cyclists.

It is recommended that the alignment of the cycle track be reviewed and that the need for the access to Irish Rail property that is currently locked be reviewed.

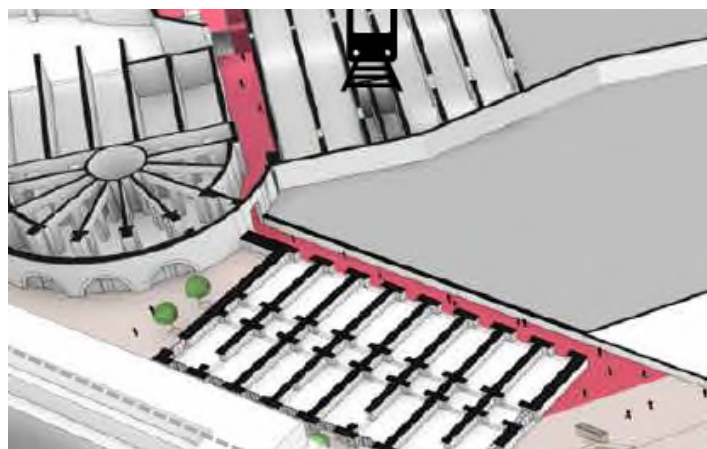
There appears to be access to the platforms of Connolly Station at two levels. It is unclear if the accesses are wide enough to cater for the volumes of people that may use the station at the same time as trains arrive/depart. Inadequate space for pedestrians may lead to squashing of vulnerable road users such as the mobility impaired, the elderly and the young.

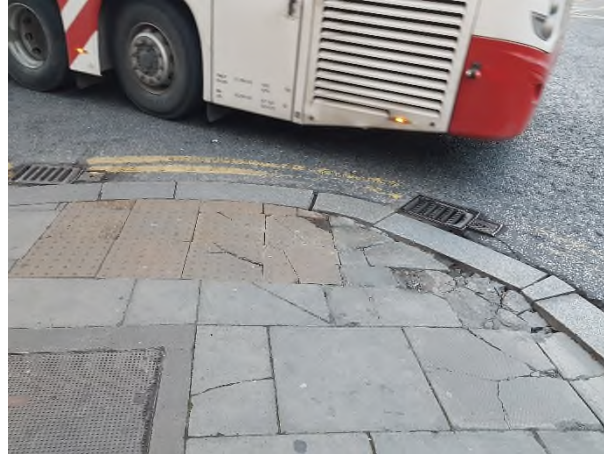
Damage to footpath at Store Street Junction
