Title: **STAGE 1&2 ROAD SAFETY AUDIT**

Colpe Road, Drogheda, Co. Meath

Client: **DBFL Consulting Engineers.**

Report reference: **0583R02**

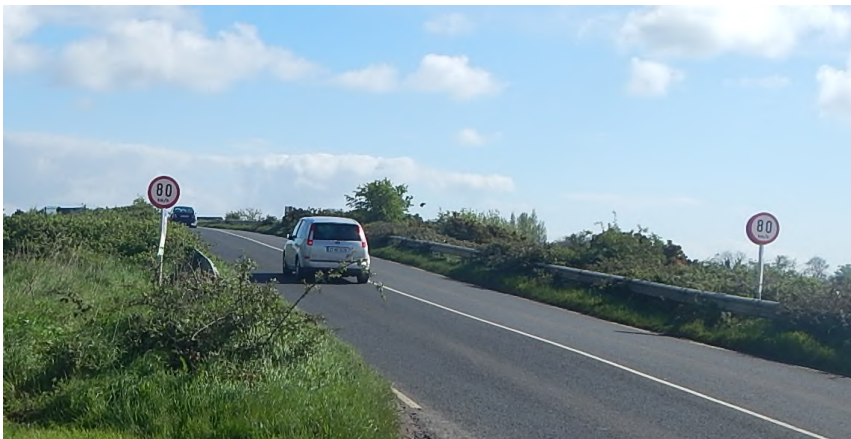
Colpe Road.

The existing speed limit on Colpe Road is 80km/hr outside the existing developed area where it is 60km/hr. It is noted that the posted speed limit on the new link Road is to be 50km/hr. A speed limit of 80km/hr on Colpe Road would lead to risks for the cyclists and pedestrians along that route. Especially with the hog curve over the Dublin Belfast railway line with has a low K- value.

It is recommended that the speed limit be reduced to 50km/hr on Colpe Road until a point West of the proposed Roundabout and continued all the way to Southgate Shopping Centre. Mill Road speed limit should also be reduced to 50km/hr.

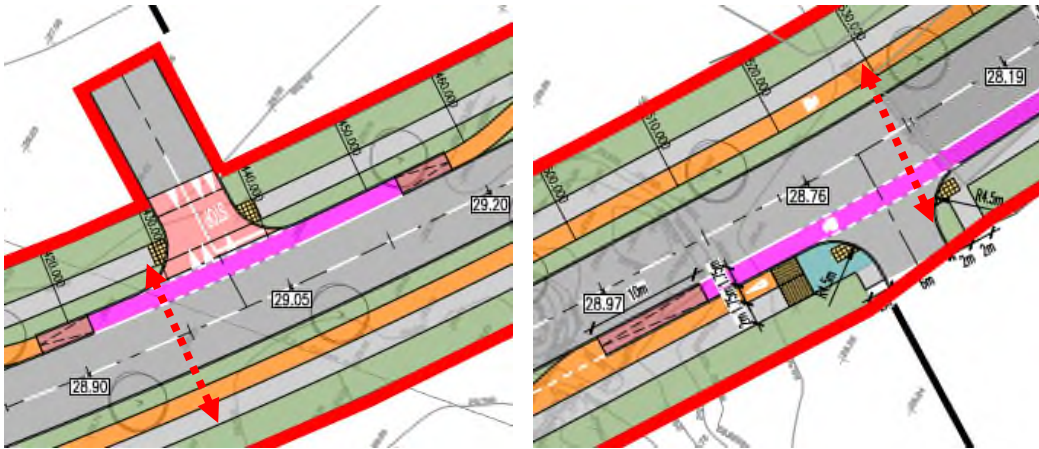
Drawing 170092-2054, Colpe Road, pedestrian & cyclist crossings.

There are no facilities for cyclists and pedestrians to cross Colpe Road East of the railway Bridge to access the areas on the opposite side of the road. The footpaths and cycle tracks are set back behind grassed verges. Without adequate crossing provision these vulnerable road users may attempt to mount/dismount the high kerbs and may trip and fall or may slip in the grassed area.

It is recommended that suitable uncontrolled crossing points be provided.

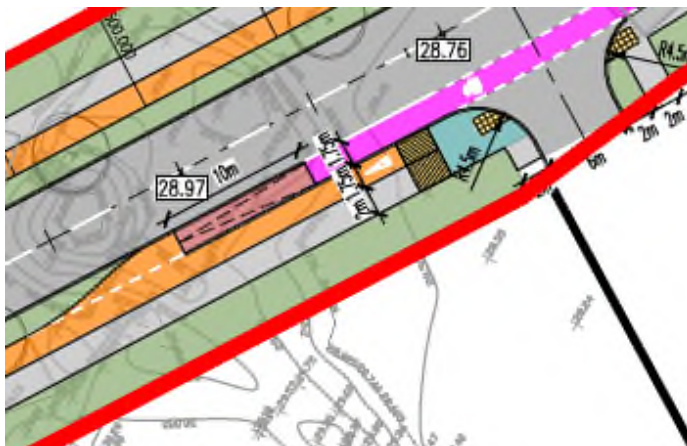
Drawing 170092 – 2054, Colpe Road, Chainage 1510.

It is unclear if the cycle track on the southern side of Colpe Road is to be a two-way cycle track. The detail at the junction may be confusing for some cyclists. The cycle track does not appear to be wide enough to cater for two-way cycling and could lead to collisions between cyclists and pedestrians.

It is recommended that the cycle track be one-way only. Similar details have been provided at junctions on the link road.

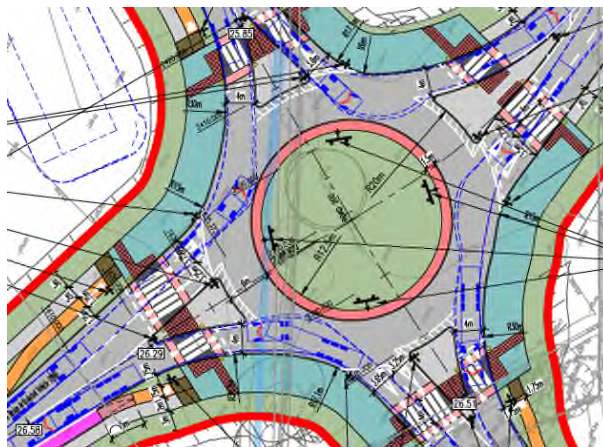
Drawing 170092-2054.

No directional signage has been proposed on approach to, and at the roundabout. This could lead to sudden braking on the circulating carriageway and rear-end shunts. This may particularly be the case as the existing through route is to Donacarne/Bettystown and the straight through at the roundabout now leads to Mill Road and Marsh Road.

It is important that signs can be accommodated in the verges and splitter islands of the roundabout such that they have adequate 'x' height text to be clearly legible, have adequate off set clearance to passing vehicles and do not obscure visibility.

Sign poles in footways and cycle tracks can be hazards to pedestrians and cyclists.

It is recommended that directional signs are designed and their locations agreed and assessed in advance of construction. Where required the splitter island layouts should be revised or localised verge widening should be undertaken.

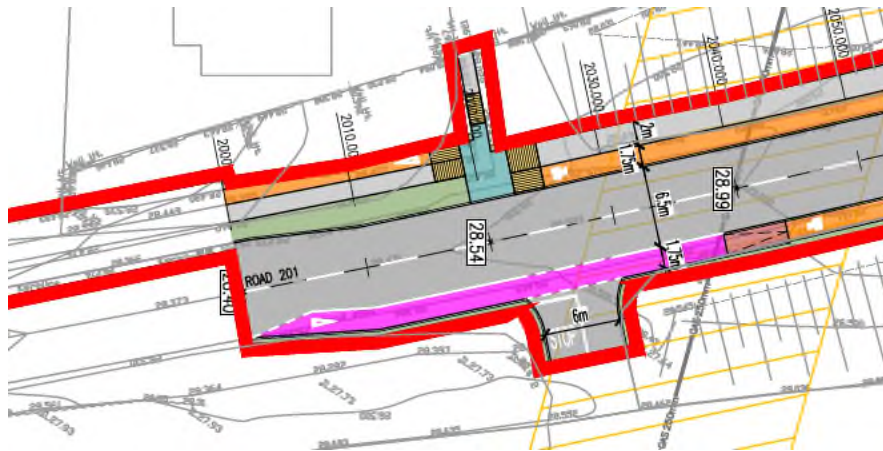
Drawing 170092-2056

The cycle lane on Colpe road inbound towards Southgate shopping centre terminates at the end of the scheme and cyclists have to share the carriageway with vehicular traffic. Drivers may not be fully aware that they have to share the space with cyclists and may not take due cognisance of those vulnerable road users.

It is recommended that a warning sign (TSM Ref W143) is placed in advance of the merge point.

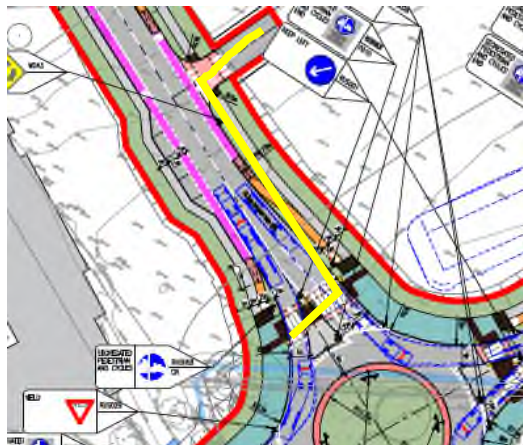
Drawing 170092-2057

Cyclists travelling northbound wishing to access the proposed school site will have to cross at the toucan crossing and travel contra flow along the southbound cycle lane. This could lead to collisions with southbound cyclists as the facility is only wide enough to cater for one-way cycling.

It is recommended that the cycle track be made two-way between the toucan crossing and the entrance to the school site.

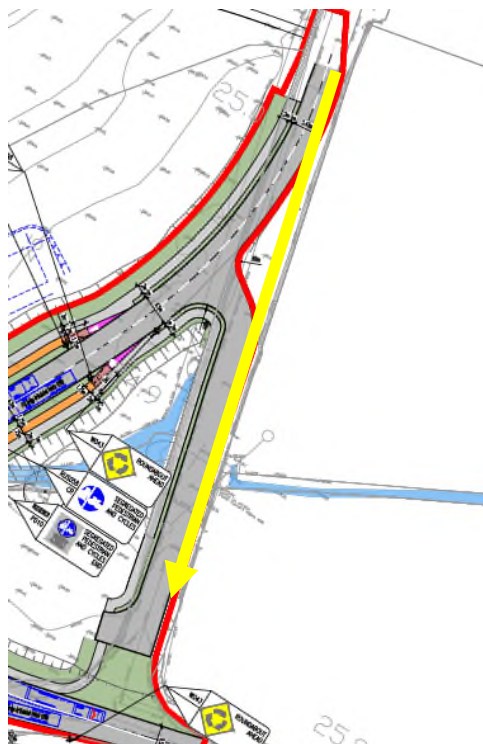
Drawing 170092-2057

There may be a potential sight-through for southbound drivers on Mill road onto the dead-leg cul-de sac depending on the landscaping and warning provided. This could lead to sudden braking and rear-end shunts.

It is recommended that suitable landscaping and chevron signage be provided at the new horizontal bend on Mill Road.

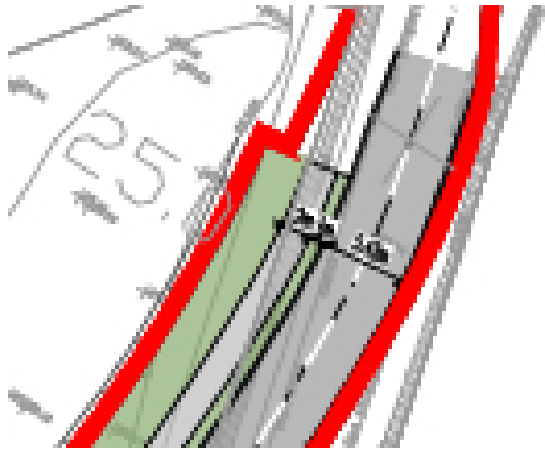
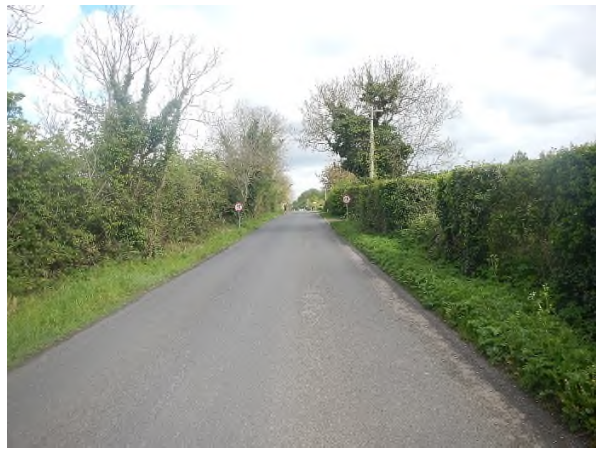
Drawing 170092-2057

The existing Mill Road has no pedestrian facilities. The proposed realigned section has a footpath behind a narrow grassed verge. Without a suitable transition from off-road to on-road there may be cases where pedestrians step onto the carriageway and cannot be seen by approaching drivers. There could also be slips and falls where pedestrians have to dismount high kerbs.

It is recommended that suitable visibility is provided to the crossing point/termination of the footpath and that a dropped kerb is provided.

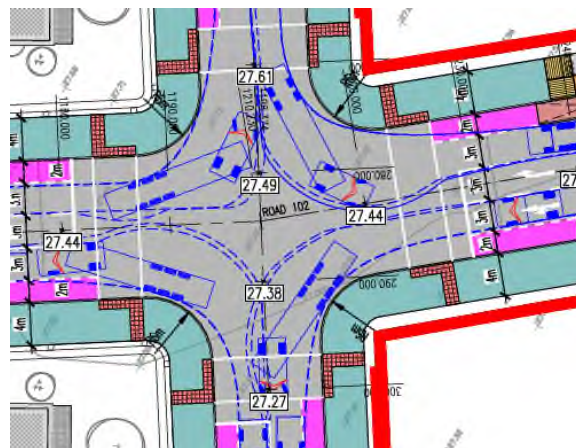
Drawing 170092-2051

Cyclists wishing to turn right at the signalised junction will not get a chance to start their manoeuvre in advance of vehicular traffic. This could lead to cyclists being squeezed by turning vehicles and possibly being knocked from their bicycles.

It is recommended that advance stop lines be provided for cyclists.

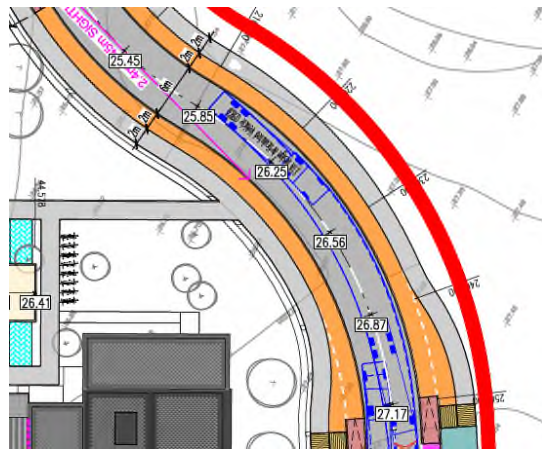
Drawing 170092-2051, chainage 220, East -West Side road to link Road

The swept path analysis for a HGV travelling West towards the link road signalised junction shows that it crosses the centerline of the carriageway for a substantial distance. It appears that a car could not pass a HGV at this location. This could lead to side-swipe collisions. It is assumed that when the link road is complete there may be a substantial number of HGVs including this route. This is also an area where queuing would occur on approach to the junction and this may lead to a road block leading to drivers having to reverse which could lead to collisions with other vehicles.

It is recommended that the horizontal alignment be modified at this location and possibly East where a swept path analysis has not been shown.

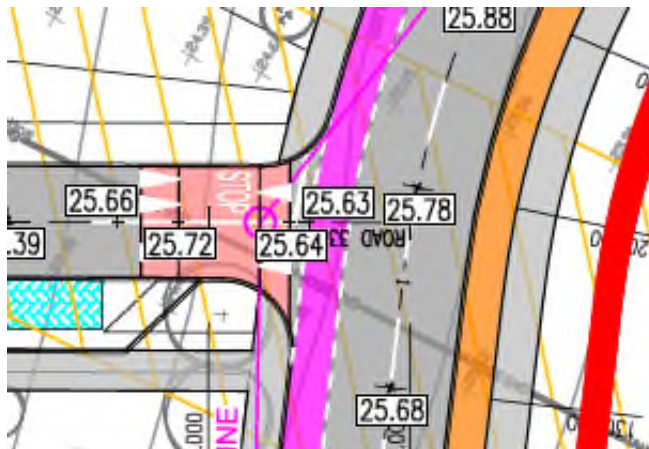
Drawing 170092-2051, chainage 120.

There is no pedestrian crossing provided across the priority junction at Chainage 120 on the Link Road. This could lead to pedestrians crossing on the ramp of the raised table and losing balance as they cross or having to mount high kerbs and not being able to do so if they are mobility impaired.

It is recommended that the layout is changed so that the mobility impaired can cross easily.
