Title: **STAGE 1 QUALITY AUDIT**

Sandyford Central.

Report reference: **0653R01**

This report was prepared in response to a request from Mr. Patrick Raggett, OCSC on behalf of Sandyford GP Limited (Acting in its capacity as general partner for Sandyford Central Partnership) for a Stage 1 Quality Audit of the proposed residential development at the former Aldi site, Commonhall Road, Sandyford Business District, Sandyford, Dublin 18.

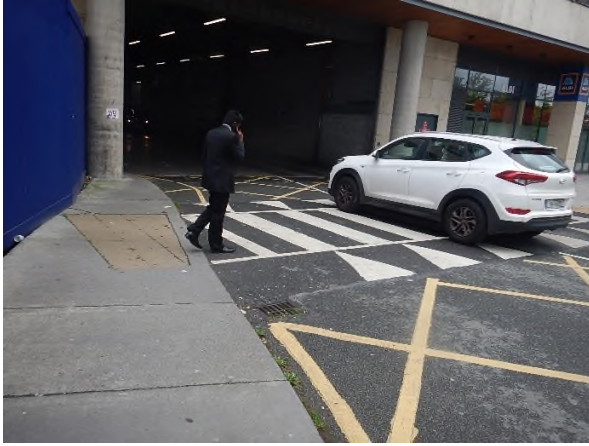
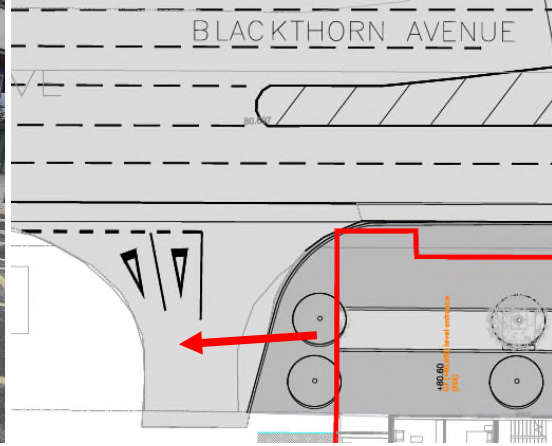
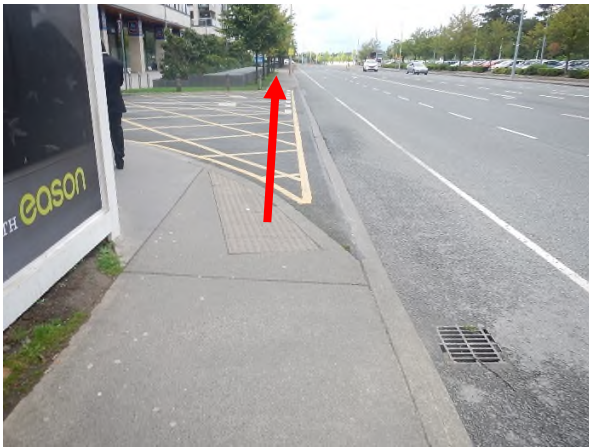
Drawing SFC-OCSC-00-00-DR-C-0001 A1, C01

There are inadequate crossing facilities for pedestrians wishing to cross the car park to the West of the proposed development on Blackthorn Avenue. Without suitable tactile paving, partially sighted pedestrians may inadvertently enter the carriageway resulting in a greater risk of a collision with vehicular traffic.

The existing crossing has black (pavement) and white strips that may make it look like a zebra crossing however it is an uncontrolled crossing. This may lead to pedestrians thinking that they have right of way over vehicular traffic and may enter the crossing without due caution.

There are existing tactile paving slabs and dropped kerbs at the Blackthorn Avenue edge of the existing footpath. This may lead pedestrians to cross here where it is not as safe as crossing at a greater setback given the width of the car park access.

It is recommended that the crossing is upgraded to a zebra crossing or that the white strips are removed.

It is further recommended that the appropriate tactile paving is provided.

Lastly, it is recommended that the existing tactile paving at the carriageway edge be removed and a full height kerb be provided to deter pedestrians from crossing at that location.

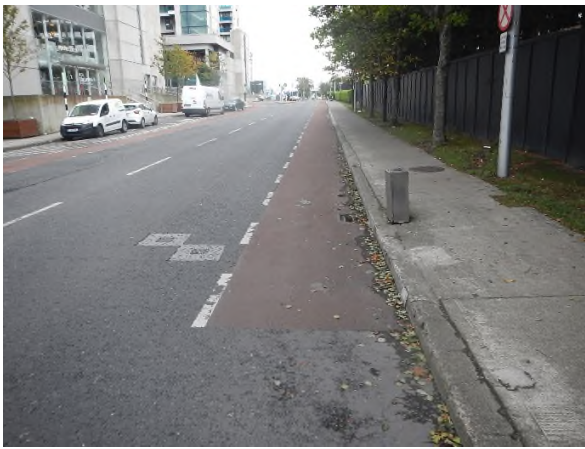
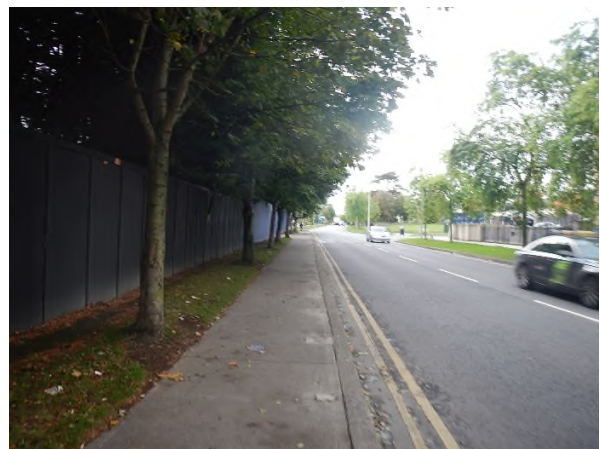
Drawing SFC-OCSC-00-00-DR-C-0002 A1, C01

There is an existing advisory cycle lane on northern side of Carmanhall Road to the West of the proposed development. There are no facilities for cyclists along the site boundary. The lack of cycle facilities will lead to drivers being less aware of the presence of cyclists and a greater risk of collisions between the road user groups.

It is recommended the cycle lane be continued along the front of the development to the existing signalised toucan crossing East of the proposed site.

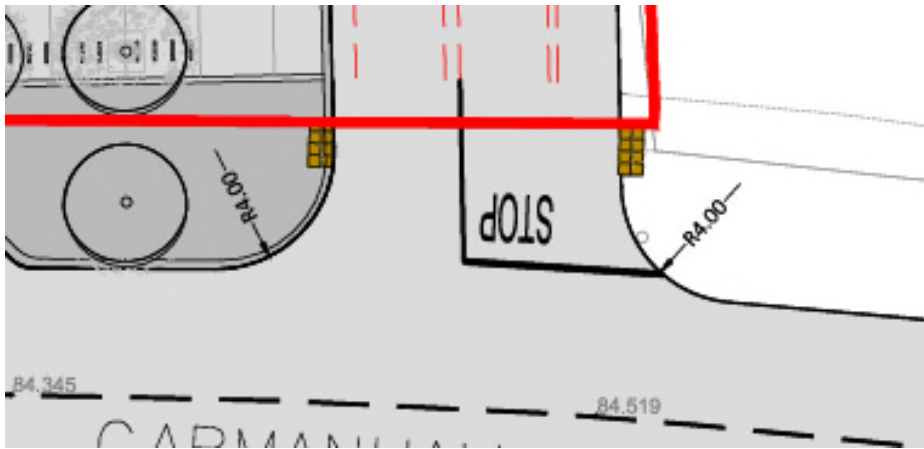
Drawing SFC-OCSC-00-00-DR-C-0002 A1, C01

The drawing shows tactile paving at the crossing of the access to the basement on Carmanhall Road. This is an in-line crossing and there is a risk that blind or partially sighted pedestrians may step over the tactile paving and inadvertently enter the carriageway where they would be at greater risk of being struck by a vehicle.

It is recommended that the tactile paving for in-line crossings be at least 1.2m deep.

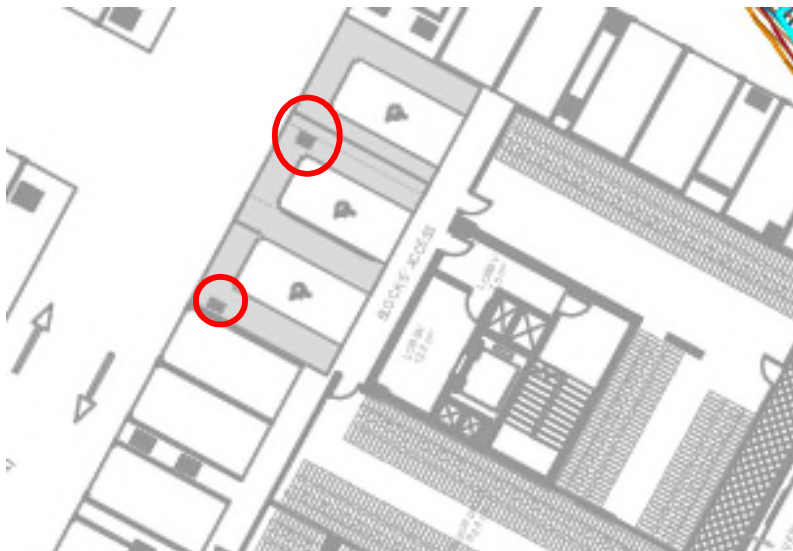
Drawing SFC-OCSC-00-00-DR-C-0006 A1, C02

There are a number of disabled parking bays that have structural columns located within the space required for disabled drivers to enter/exit their vehicles. This could lead to disabled drivers being trapped and unable to get to their destination.

It is recommended that the columns be relocated.
