Academy Street Development, Navan,  
Co. Meath

Quality Audit

<b>Document Ref:</b>	<b>P19-106-RP-001</b>
----------------------	-----------------------

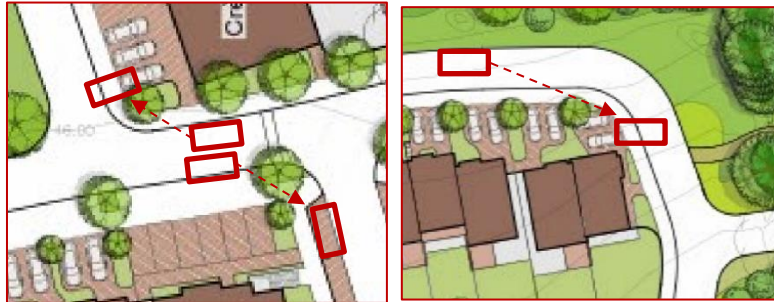
### 3.2.1 Problem

*Summary:* Insufficient forward visibility to parking arrangements

It is proposed to provide parking for residential units at bends and junctions within the development. The Audit Team are aware this is a low speed environment however, it is unclear if sufficient forward visibility is provided to drivers entering/exiting proposed parking spaces. Should insufficient visibility be provided, this may result in side-on collisions.

Ensure sufficient inter-visibility is provided between drivers continuing along main routes and cars entering/exiting parking spaces throughout the development.

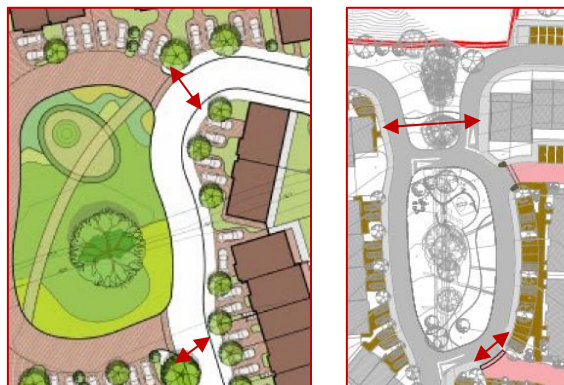
### 3.2.2 Problem

*Summary:* Designated crossing points within the residential road network have not been indicated at junctions.

Pedestrian crossing points, including dropped kerbs and tactile paving, have not been indicated at several locations within the proposed development. A failure to provide dropped kerbs at crossing points, and along pedestrian desire lines, could result in mobility impaired pedestrians being unable to safely and independently enter the carriageway to cross to the opposite footpath. This could result in slips, trips or falls as these pedestrians attempt to descend the kerb, or where tactile paving is not provided, an increased risk of visually impaired pedestrians unintentionally entering the carriageway where they could be struck by vehicles.

Pedestrian crossings, including dropped kerbs and tactile paving, should be provided across all junctions within the proposed development, and should be located to reflect desire lines.

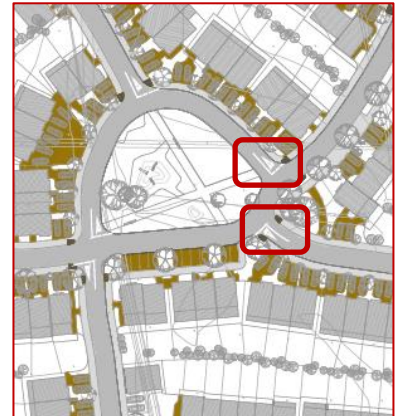
### 3.2.3 Problem

Summary: *Unclear if Yield controlled junctions can meet the more onerous visibility requirements*

Throughout the internal layout of the scheme, yield controls are indicated at a number of junctions. The use of yield/give-way controls may encourage drivers to approach at a speed that leads to them failing to stop when required. Four arm junctions may be particularly susceptible to vehicle overshoot incidents due to its layout. Additionally, it may not be possible to meet the more onerous visibility requirements associated with a Yield control junction, which may exacerbate this problem.

'Stop' controls should be provided at the internal junctions with the associated signs & markings so that drivers are clear on the relative priorities.

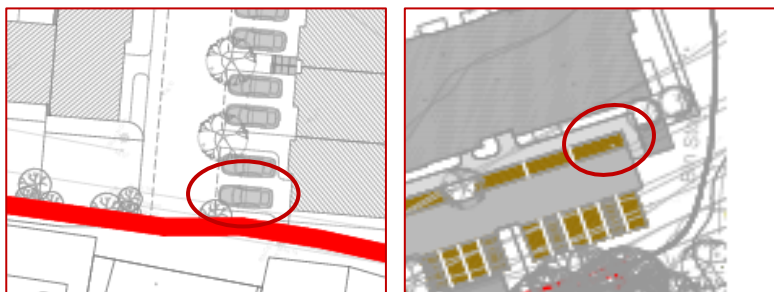
### 3.2.4 Problem

Summary: *It is unclear if there is sufficient swept path for vehicles entering/exiting parking spaces throughout the scheme.*

There are a number of locations throughout the scheme where insufficient swept path may be provided to vehicles entering/exiting parking spaces. This may result in vehicles having to undertake complex turning manoeuvres to access the parking spaces, leading to material damage collisions.

Swept path analysis should be undertaken to ensure sufficient turning space is provided to all car parking spaces. Where necessary, the layout should be adjusted to accommodate swept path.

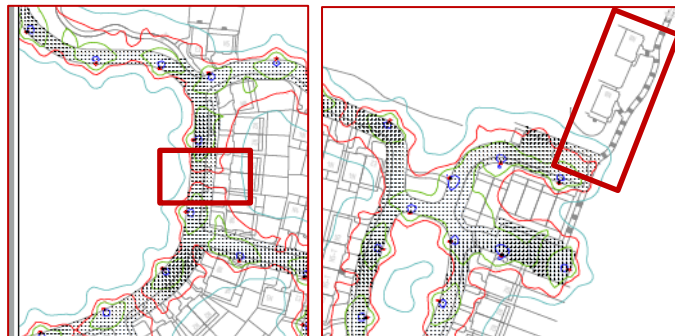
### 3.2.5 Problem

*Summary: Potential dark spots within carriageway and pedestrian footpaths.*

Lighting columns are proposed throughout the scheme, however, the spacing of lighting columns along carriageways may result in dark spots. Dark spots within the carriageway could result in drivers being unable to see vulnerable road users at crossings or to distinguish the edge of carriageway from the footpath leading to VRUs being struck by a vehicle or to vehicles colliding with the kerb and sustaining material damage.

Additionally, lighting columns have not been indicated along all pedestrian routes. Insufficient lighting within walkways may result in pedestrians conflicting with other pedestrians and/or cyclists, resulting in slips, trip or falls.

Sufficient lighting should be provided within pedestrian walkways and the carriageway. Lighting columns should be located to the back of the footway to maximise the effective footway width.

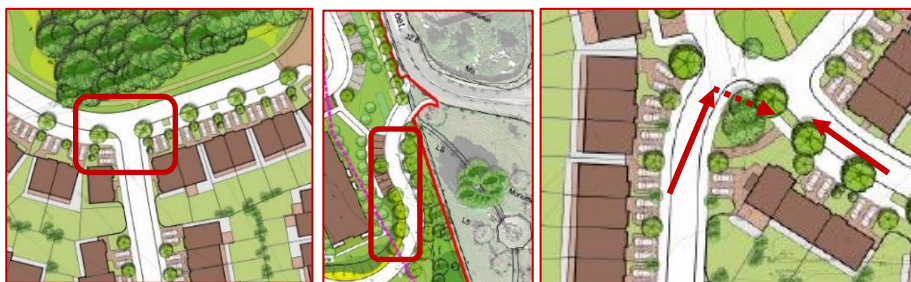
### 3.2.6 Problem

*Summary: Proposed trees may block visibility at junctions, pedestrian crossings and to parked vehicles within the development.*

It is unclear if the proposed location of trees within verges throughout the scheme shall obstruct visibility for drivers exiting junctions and proposed parking within the proposed development. This could result in drivers exiting side roads and driveways when it is unsafe to do so ahead of oncoming vehicles leading to side-on collisions.

Additionally, the location of trees may block visibility to pedestrians attempting to cross which may result in vehicle/pedestrian collisions.

Ensure sufficient visibility is provided at all junctions, parking arrangements and pedestrian crossings within the proposed development.

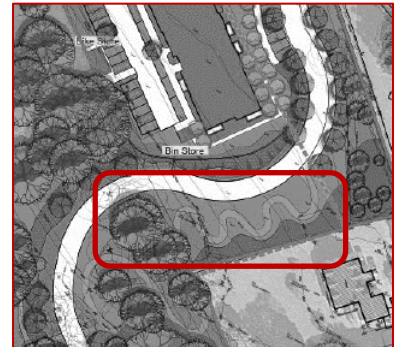
### 3.2.7 Problem

Summary: Insufficient information regarding gradients provided.

Insufficient information regarding gradients have been provided to the Audit Team. Steep gradients within pedestrian facilities may lead to pedestrians/cyclists being unable to safely access areas within the development. This may result in fatigue, resulting in slips, trips, falls and mobility impaired pedestrians losing control while attempting to traverse inclines.

Additionally, it is unclear if guardrails (or other measures) are provided throughout the development. Without the provision of guardrails (or other measures) down steps/stairwells, there is an increased risk of pedestrians and cyclists falling from height, leading to serious personal injury.

Ensure gradients on footpaths are in accordance with national disability authority guidelines and provide measures that protect pedestrians and cyclists from height hazards.

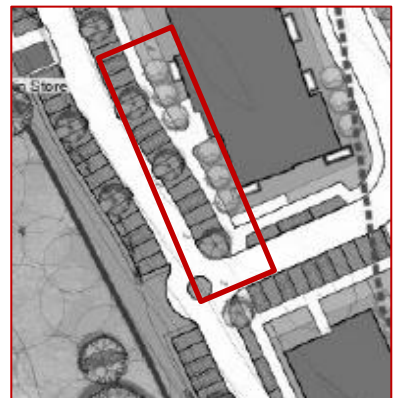
### 3.2.8 Problem

Summary: Parking bay may overhang the footpath, reducing the effective footway width

Perpendicular parking bays are proposed within the development. Vehicles parking within these parking bays may overhang the adjoining footpath. This may result in a reduced effective footpath width, where pedestrians may have to step into the grass verge, resulting in slips, trips and falls as a result of an uneven surface.

Provide measures to ensure the effective footpath width is not reduced below 1.8m.

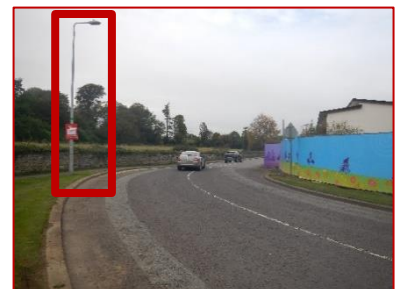
### 3.2.9 Problem

Summary: Information regarding lighting along Academy Street not provided to the Audit Team

A lighting column exists where the proposed southern access to the development onto Academy Street is located. No public lighting columns have been indicated at the proposed access. A lack of public lighting provision may lead to drivers being unable to see vulnerable road users on the footway or in the carriageway during the hours of darkness, resulting in an increased risk of collisions between vehicles and vulnerable road users.

Ensure sufficient lighting is provided on Academy Street where changes are proposed.

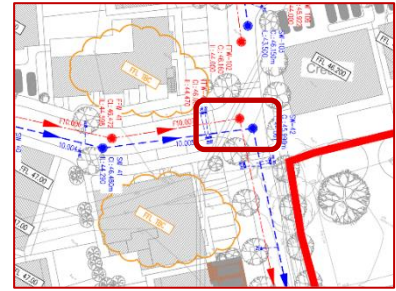
### 3.2.10 Problem

Summary: Chamber covers within the carriageway may result in loss of traction.

The proposed drainage layout indicates chamber covers located within the carriageway. Chamber covers located within the carriageway may result in a loss of traction for vehicles during wet or icy conditions leading to loss of control type collisions, a particular concern for powered two-wheeled vehicles and where the chamber covers are located within junctions.

Where possible, chamber covers should be located within the grass verges.

Alternatively, chamber covers with anti-slip surfacing could be provided.

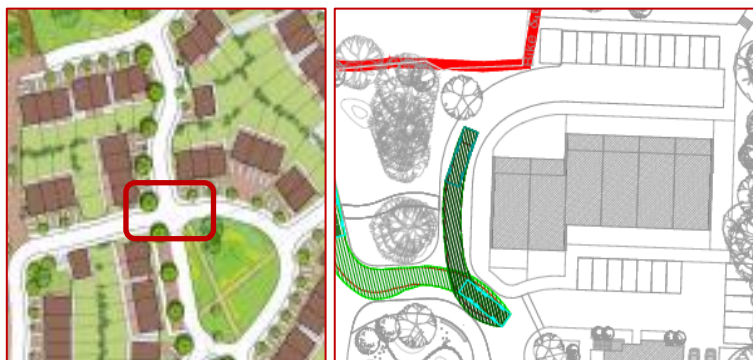
### 3.2.11 Problem

Summary: Junction layout strategy may lead to unsafe vehicle manoeuvres

The proposed road layout within the development results in unclear and potentially unsafe junction arrangements including;

- Crossroads - Crossroad junctions should be avoided where possible, as drivers approaching the Yield line may be unable to discern the crossing road at the junction, leading to vehicles entering the crossing road without slowing/stopping. This could result in overshoot incidents and side-on collisions with vehicles travelling on the major road.
- Cul-de-Sac – It is unclear how large vehicles will perform a 180° turn. If HGV drivers are unable to turn their vehicle, they may be forced to reverse along the road where there is an increased risk of a rear-end-shunt, vehicle/pedestrian, vehicle/cyclist or material damage collision.

A high-level review should be undertaken to identify junction forms and arrangements which are more consistent with DMURS, and better mitigate the problems identified above.

Additionally, the designer should determine if the number of junctions proposed is required, and where possible, seek opportunities to simplify the number of junctions within the development and ensure side road drivers have sufficient visibility at junctions with advance warning to priority junctions.

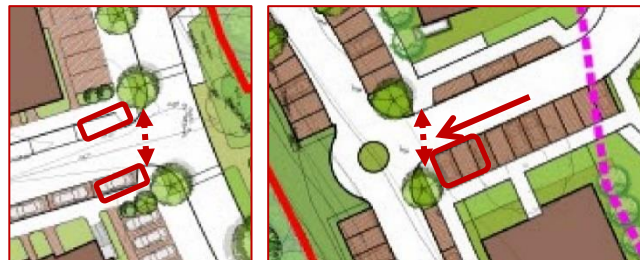
### 3.2.13 Problem

Summary: Visibility to pedestrians may be impeded by parked cars

It is proposed to provide parking within close proximity to junctions which may result in reduced visibility to crossing pedestrians. This may result in vehicle/pedestrian collisions, particularly where high sided vehicles are parked in parking bays.

Ensure parking arrangements are sufficiently set back from junctions and pedestrian crossings to provide sufficient inter-visibility to pedestrians.

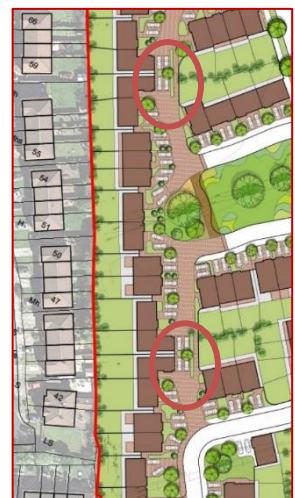
### 3.2.14 Problem

Summary: Shared surface indicated adjacent to house may be too narrow for a vehicle

Shared surfaces are proposed between a number of houses within the scheme. There is a concern that drivers may attempt to continue where insufficient width is provided leading to material damage collisions

Where insufficient width is provided for shared surfaces, amend the layout to a footpath and provide measures to reduce the risk of drivers continuing along pedestrian routes.

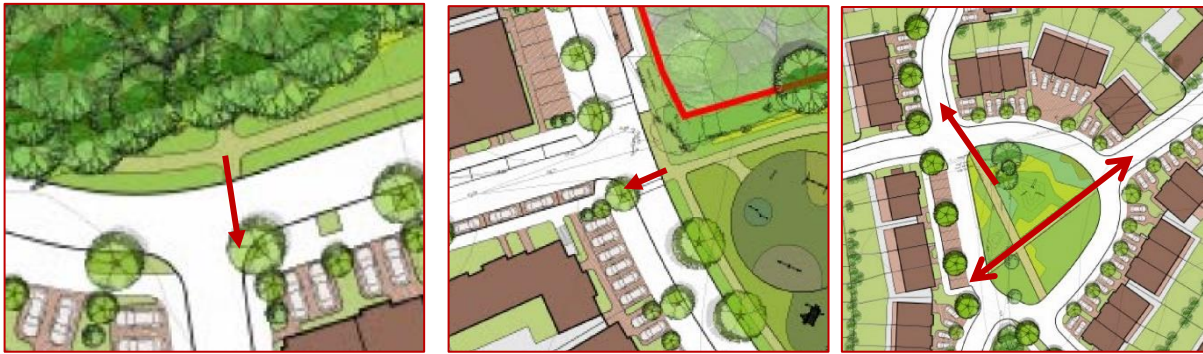
### 3.2.15 Problem

*Summary: Unclear pedestrian links leading into junction mouth.*

Several footpath links are proposed throughout the scheme that do not have an adjoining footpath, or effectively direct pedestrians into the mouth of junctions. This may result in pedestrians being unable to access the footway on the opposite side of the carriageway, and be forced to travel along the road edge until dropped kerb access is provided. This may result in an increased risk of a pedestrian/vehicle collision.

Ensure pedestrians are directed to safe and direct crossing points which are supported by dropped kerbs and tactile paving.

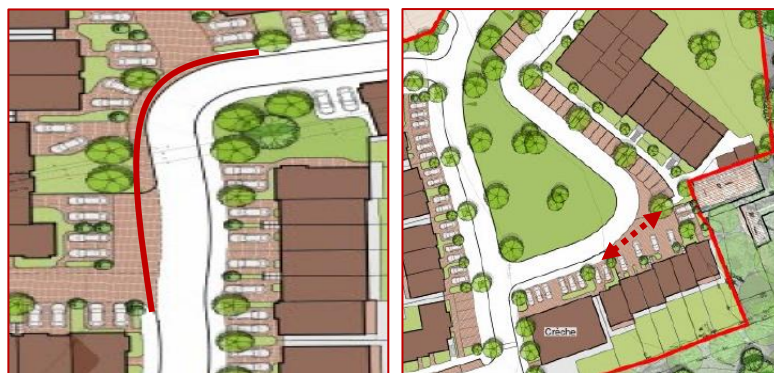
### 3.2.16 Problem

*Summary: Visually impaired pedestrians unable to cross shared surfaces.*

It is proposed to provide shared surfaces at a number of locations with the scheme with adjoining footpaths. Without sufficient warning, visually impaired pedestrians may continue across shared surfaces and be unable to locate the adjoining footpath. This may result in visually impaired pedestrians walking into the carriageway resulting in a vehicle/pedestrian collision.

Provide a continuous footpath across proposed parking arrangements and ensure visually impaired pedestrians are sufficiently warning of change of surfaces using tactile paving.

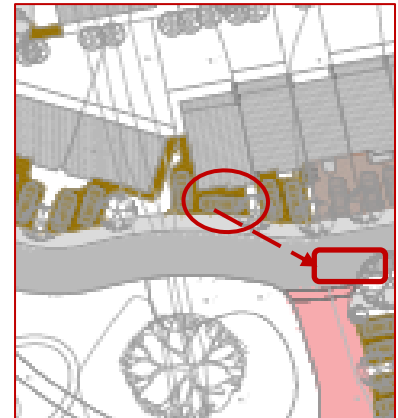
### 3.2.17 Problem

*Summary:* Unsafe entering/exiting manoeuvres to proposed car parking space.

It is unclear how drivers will adequately enter/exit the proposed car parking space and if sufficient visibility is provided to approaching vehicles. Insufficient swept path may lead to drivers having to undertake complex turning manoeuvres over the footpath to access the parking spaces, leading to vehicle pedestrian/material damage collisions. Additionally, insufficient visibility to approaching drivers may result in a side swipe collision.

The proposed parking arrangement should be amended to ensure ease of access to/from the residential unit and sufficient inter-visibility is provided to approaching vehicles.

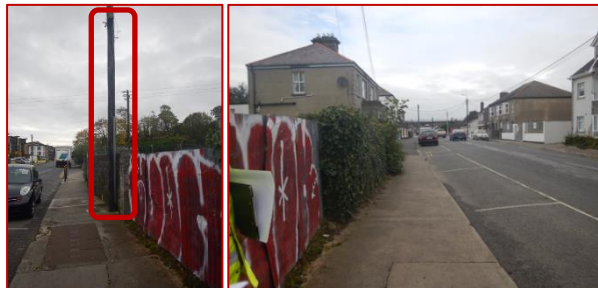
### 3.2.18 Problem

It is unclear to the Audit Team if an existing utility pole at the proposed access and parallel parking on Academy Street is to be removed where visibility spays may be impeded. Insufficient visibility could result in unsafe exiting manoeuvres and reduced reaction time for drivers on Academy Street, resulting in side-on collisions.

Ensure sufficient visibility splays are provided at accesses, and that parking spaces/utility poles are removed/relocated where necessary.

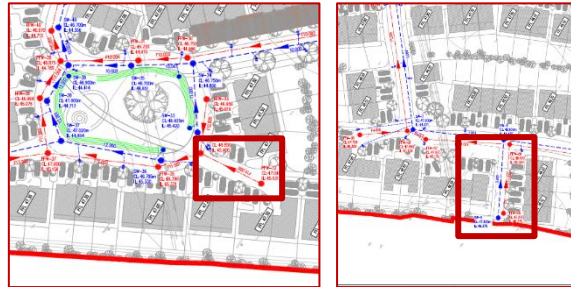
### 3.2.19 Problem

It is unclear if sufficient drainage provision has been provided within the development, particularly on shared surfaces Road No. 9B and 5B. Should inadequate drainage measures be provided, this could lead to ponding on the footpath or carriageway resulting in slips, trips and falls during wet or icy weather.

Ensure that the footpath and carriageway is adequately drained.

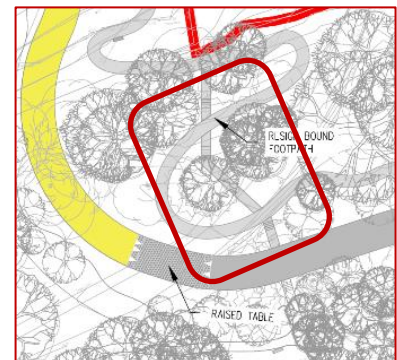
### 3.2.20 Problem

*Summary: No Hazard Tactile paving at top and bottom of steps*

It proposed to provide a spiralling footpath with an alternative footpath (with steps) crossing at a number of locations. Without hazard tactile paving at these crossings, visually impaired pedestrians may continue along the footpath with steps and be insufficiently aware of the vertical hazard. This may result in slips trips, falls and serious injuries.

Warning tactile paving should be provided at the top and bottom of steps.

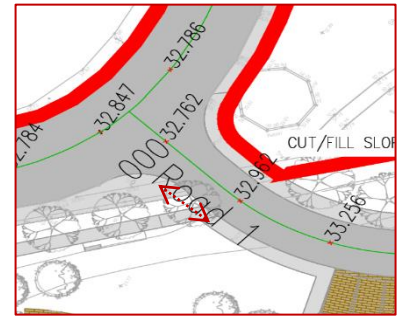
### 3.2.22 Problem

The proposed pedestrian footway at the southern access to the development is not linked to Academy Street and it is unclear if there is a pedestrian crossing at this location. A lack of safe crossing facilities or a link between footpaths for pedestrians, particularly partially sighted or mobility impaired pedestrians, may lead to pedestrians crossing where it is unsafe to do so or continuing along uneven surfaces leading to slips, trips and falls.

Provide a link between the internal footpath, and the footpath on Academy Street.

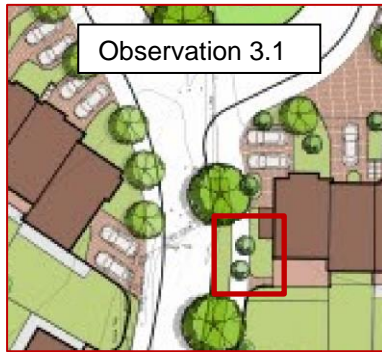
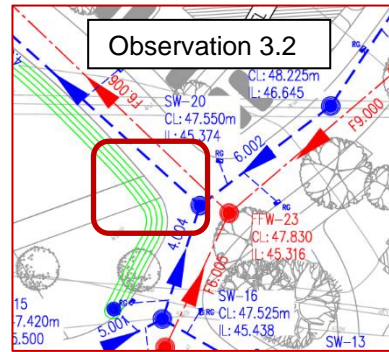
- 3.3.1 Trees are indicated within pedestrian footpaths. It is assumed this is a CAD error and trees are to be located within grass verges.
- 3.3.2 It is proposed to provide swales along the carriageway edge at open spaces. Swales are indicated within pedestrian footpaths and it is assumed this is a CAD error. It is assumed drainage will be underground for a sufficient distance either side and underneath footpaths to ensure no vertical hazards are located along pedestrian desire lines.

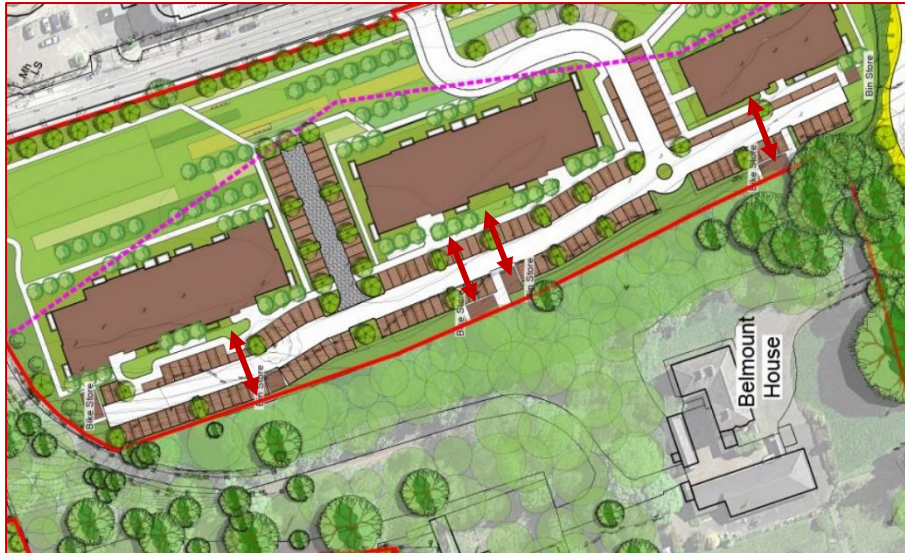
It is unclear if sufficient access is provided to bin stores located outside apartments blocks. Without adequate pedestrian links, pedestrians, particularly mobility impaired may be unable to access bin stores where no dropped kerbs are provided, and they may be required to travel between parked vehicles.

Ensure sufficient links are provided to the bin stores from apartment blocks and are unobstructed by parked vehicles.
