**Cornelscourt Site – Dublin 18**

**Report Title:** Ground Investigation Executive Summary

**Project Number:** 180208

**Report Ref:** COR-DBF-ZZ-XX-PR-S-0001

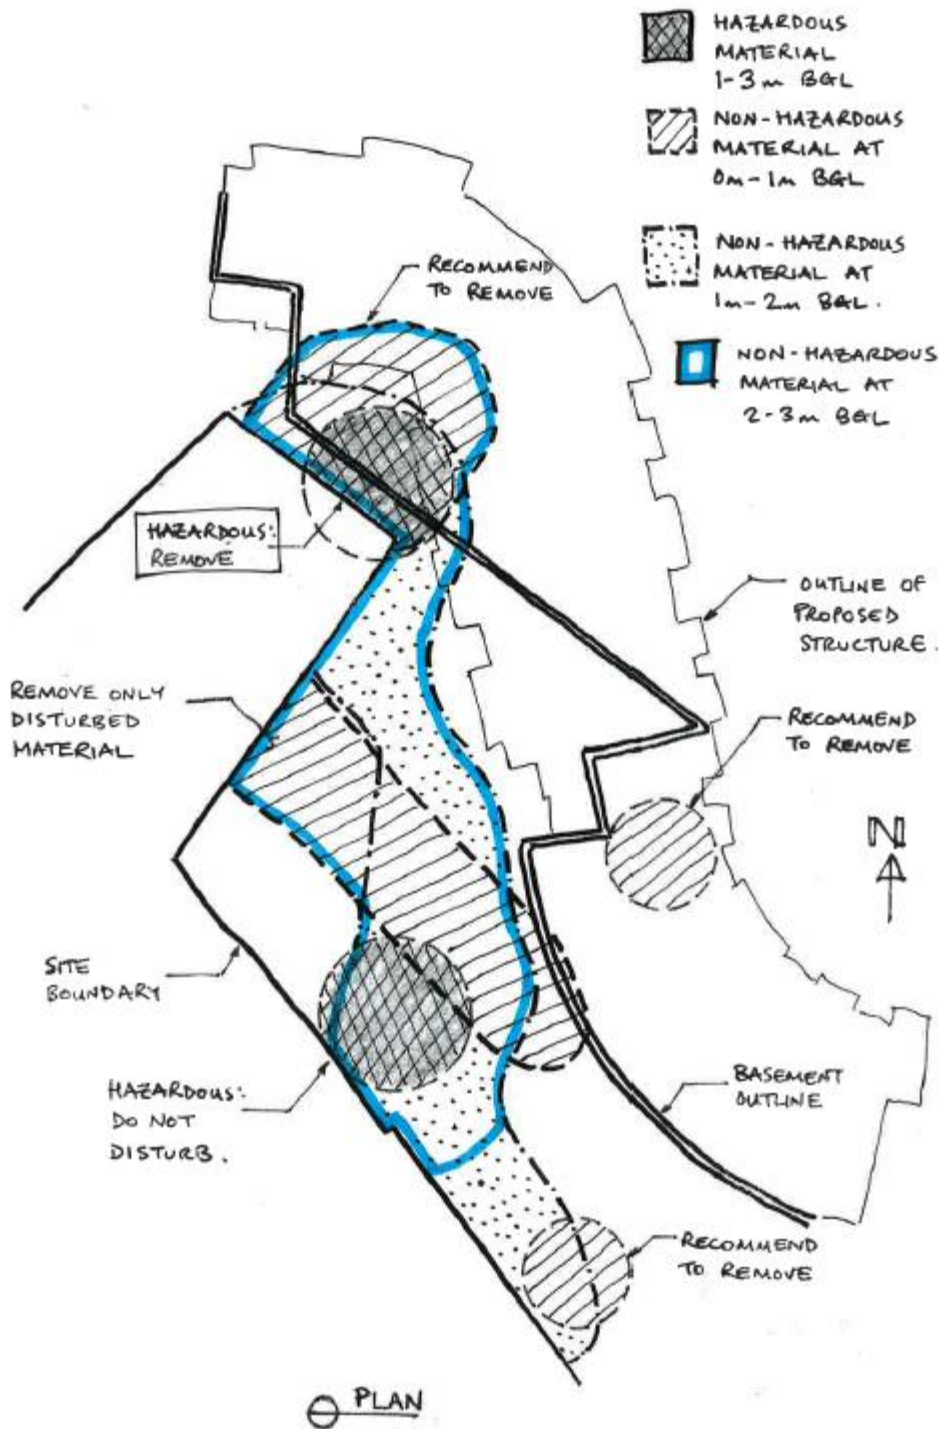
**Figure 6.1: Location of Hazardous & Contaminated Material**

In this area, the results for TP-14 and WS-11 have demonstrated that the material in these locations is hazardous. The affected material is at between 1m and 3m BGL, and assuming a 5m radius from each testing point results in approximately 315m<sup>3</sup> of hazardous material. Only disturbed material needs to be removed from the site. This amounts to approximately 95m<sup>3</sup> of hazardous material. Note that bedrock in this area is at 3m BGL.

There are two other areas of contaminated material that coincide with the basement structure, outlined in Figure 6.1. The volume of these areas is approximately 300m<sup>3</sup>. Note that this material is classified as non-hazardous for the purposes of disposal to a licenced facility.

There are two areas of contaminated material outside the proposed structural footprint of the basement, at depths of 0m-1m BGL, that will be public areas or residential structures/gardens. As the proposed development has significant basement excavation and no ground level areas requiring

The disturbed hazardous material as outlined above should be removed from the site (approximate volume 95m<sup>3</sup>). See Figure 6.1 below.

- Hazardous Material: 95m<sup>3</sup> (excavated for basement);
- Contaminated Non-Hazardous Material: 320m<sup>3</sup> (excavated for basement);
- Contaminated Non-Hazardous Material: 210m<sup>3</sup> (excavated for houses/gardens);
