Residential Development, Cornelscourt, Dublin 18

Preliminary Design Stage Quality Audit

Cornel Living Ltd.

Report Ref: p180208-Rep-007

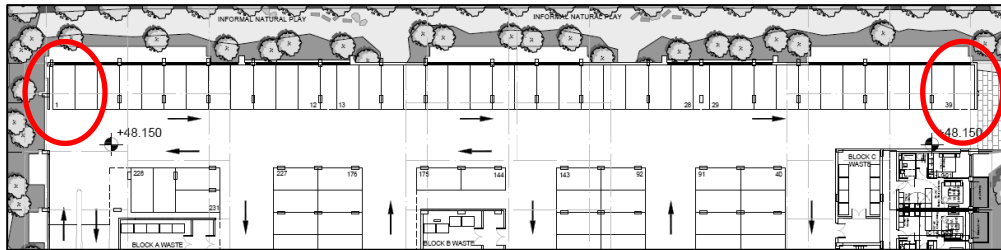
It is unclear to the audit team if all of the parking bays within the residential development are accessible when the car parking spaces adjacent and perpendicular are occupied by vehicles. Failure to provide adequately sized parking bays with aisles of sufficient width could result in material damage incidents as vehicle drivers try to manoeuvre into/out of parking bays.

A tracking analysis should be undertaken to determine if all spaces are accessible. Sufficient side clearance to structures should be provided.

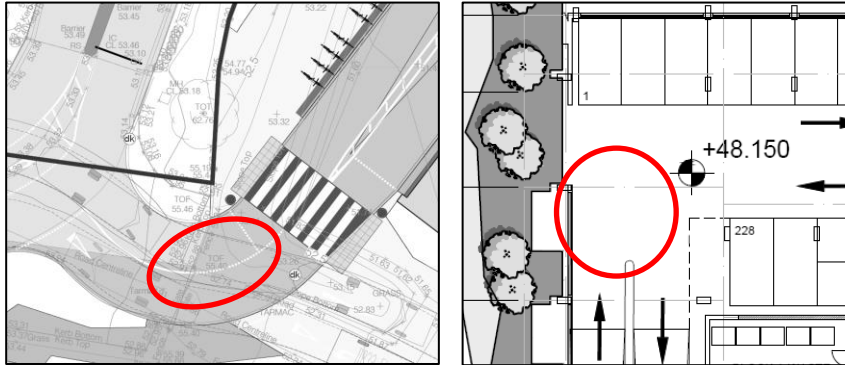
Due to the sharp bend at the entry/exit to the car park the auditors are concerned that there may not be sufficient space for a vehicle to enter at the same time as another vehicle exiting the car park leading to potential conflict.

The design team should confirm that a vehicle can enter the car park at the same time as a vehicle exiting. A tracking analysis should be undertaken for the largest vehicles expected to use the carpark.

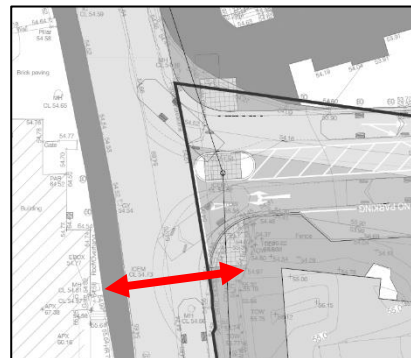
The audit team have concerns regarding the lack of pedestrian crossing facilities at the priority junction at Bray Road/AIB access road. Pedestrians may attempt to cross at the priority junction which is the immediate crossing desire line to reach the shops/office blocks on the western side of Bray Road. This could result in pedestrians entering into the Bray Road carriageway when it is unsafe to do so, resulting in conflict with vehicles (or cyclists) travelling along Bray Road.

Appropriate pedestrian crossing facilities should be provided in close proximity to the Bray Road/AIB access junction to enable pedestrians cross the Old Bray Road carriageway.

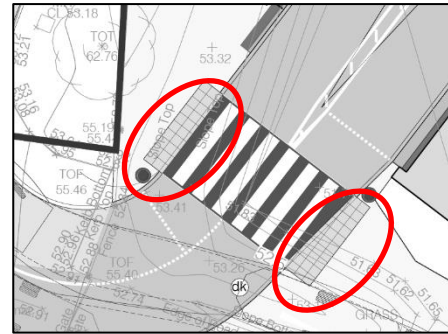
The audit team have noted the use of zebra crossing road markings with buff coloured tactile paving supplemented with illuminated beacons (belisha beacons). The zebra crossing road marking & the belisha beacons indicate that pedestrians have priority at the

crossing and vehicle drivers must stop. However, the use of buff tactile paving (and the associated configuration) indicates that the crossing is an uncontrolled crossing. The use of the zebra road markings and beacons with buff tactile may cause confusion to both pedestrians and vehicle drivers as to who has priority, there is potential for pedestrian and vehicle conflict.

It is recommended that the zebra markings and illuminated beacons are supplemented with the appropriate red tactile (and the associated configuration) and the regulatory lines (transverse & zig zag) in accordance with the requirements of the Traffic Signs Manual.

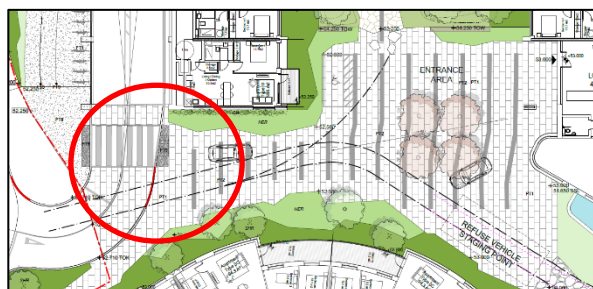
The auditors have interpolated the scheme drawings as illustrating a lightly trafficked 'Service Vehicles Only' approach to the 'Entrance Area' and vehicle turning area.

Through the specification of different surface treatments vehicle drivers are directed upon entering the development site to the basement car parking area thereby minimising the number of vehicles that may travel into the internal courtyard 'shared' zone. Whilst this approach is welcomed, the auditors are concerned that in the absence of a specific surface treatment specification the scheme may be constructed with a similar surface finish applied to both the vehicle access to/ from the basement AND the 'shared surface' to the front of the building. In such a situation additional vehicular traffic may enter the 'shared surface' thereby (i) increasing the potential of conflict with pedestrians, and (ii) increasing the potential conflict with other vehicles using the set-down area at building entrance.

The auditors request the design team to confirm the specification of the surface treatments internally for (i) the vehicle route to/ from the basement ramp, and (ii) the internal shared zone. It is recommended that the design of both these surface treatments provides a strong visual contrast (in both wet/dry conditions and during day / night times) with the objective of portraying to the vehicle driver the indented different/contrasting function of both areas / routes.

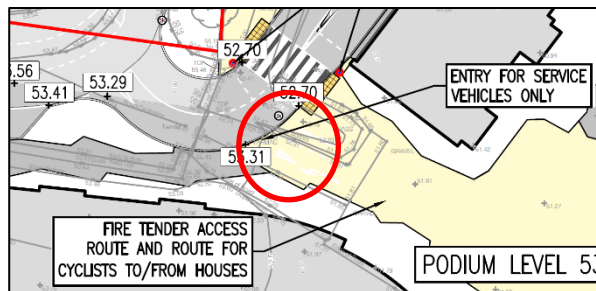
The auditors have concerns that the road marking on the 'Service Vehicle Only' approach to the internal courtyard 'Entrance Area' may confuse resident/visitor drivers who may

in turn drive through service vehicle access/'share surface' thereby (i) increasing the potential of conflict with pedestrians, and (ii) increasing the potential conflict with service vehicles using the set-down area at building entrance.

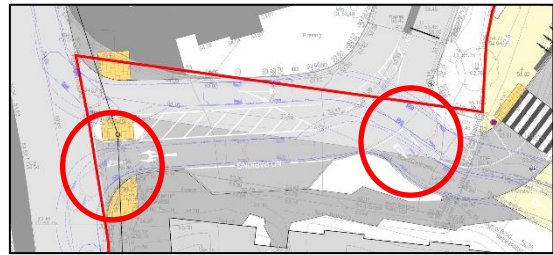
The 'Yield' road marking at the AIB access road and at the residential access site should be replaced with 'Stop' line & Sign. This is due to the fact that:

- (1) Bray Road is a busy urban road with high vehicle speeds and
- (2) The residential access junction has a number of potential vehicle movements and conflict points.

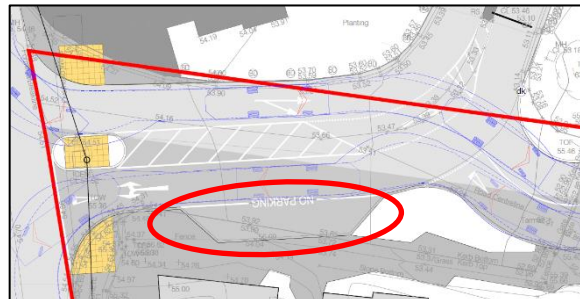
An indented kerbside layby facility is proposed on the southern side of the internal access between the Old Bray Rd junction and the access routes to/from the proposed residential

development. The auditors request clarification regarding how the adopted design vehicle can conveniently gain safe access into or from this kerbside facility without the need to undertake a three point (or more depending upon vehicle type) u-turn manoeuvre on the internal road carriageway in the general area where the access roads diverts to the northwest (AIB car park) and southeast (development basement car park – podium access). Vehicle drivers undertaking turning manoeuvres in this general area could come into conflict with other vehicles or result in localised congestion leading to a queue of inbound vehicles extending back onto the Old Bray Road carriageway (where the potential for rear-end shunt incidents increases).

Clarification is required outlining how safe and convenient vehicle access can be achieved to the proposed kerbside layby facility in its present location. Should it prove difficult to achieve a safe and convenient access arrangement (e.g. one that does not require a u-turn manoeuvre on the main internal vehicle road carriageway) it is recommended that the kerbside bay is relocated to an appropriate location on Old Bray Road. Appropriate regulations may also need to be implemented to safeguard the availability of the kerbside bay (for its intended function) considering the existing demand at the neighbouring AIB facility.

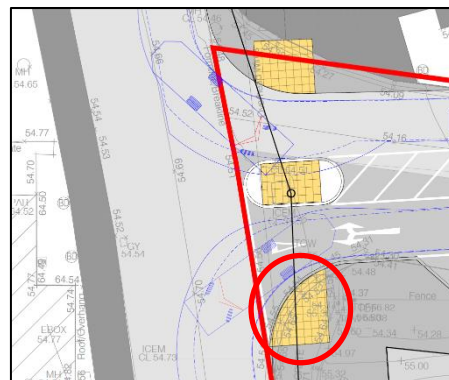
The auditors are concerned that the generous radii (approx. 5m) of the proposed site access junction layout could; (i) contribute to excessive vehicle speeds entering and exiting the site, and (ii) result in a longer (length) than necessary road crossing for pedestrians walking along the Bray Road footpath

and who are required to walk across the proposed minor arm of this junction / access.

In the context of the modest number and size (predominately cars with no more than 1-3 LGV's per day and 2 HGV's per week) of vehicles that is predicted to travel through this site access junction, it is recommended that a tighter radius in the order of 3m is adopted at the site access junction to achieve a greater balance between pedestrian and vehicle access requirements.

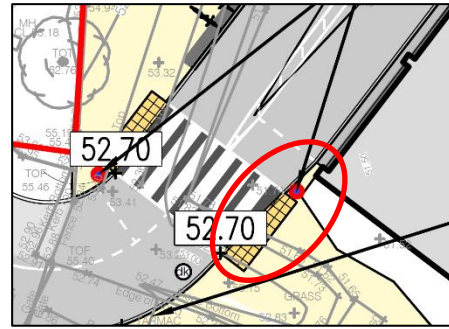
There is a pedestrian crossing route at the entrance to the basement car park. It is unclear if there will be sufficient inter-visibility between pedestrians and drivers due to (i) the presence of the wall/structure adversely impacting exiting vehicle drivers and (ii) landscaping impacting inbound drives. A lack of inter-visibility could lead to collisions between those user groups.

It is recommended that sufficient inter-visibility be provided on the approaches to the proposed zebra crossing.

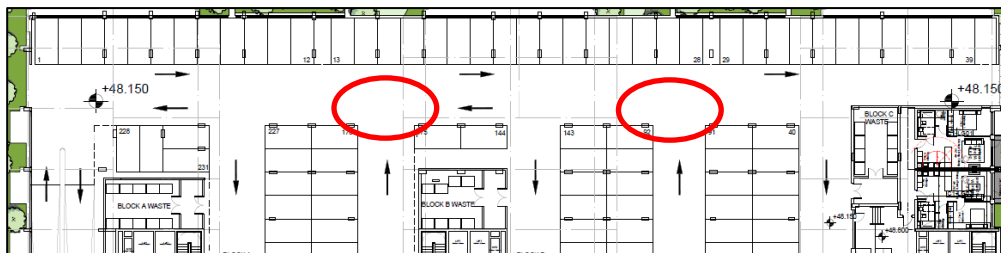
The proposals do not detail the provision of 'No Entry' road markings and associated signage at the basement car parks internal junctions. In the absence of these control measures vehicle drivers may become confused regarding one-way roads and priority, this may result in vehicular collisions.

In reference to the Traffic Signs Manual the appropriate vehicle control measures should be provided within the basement car parks internal junctions.

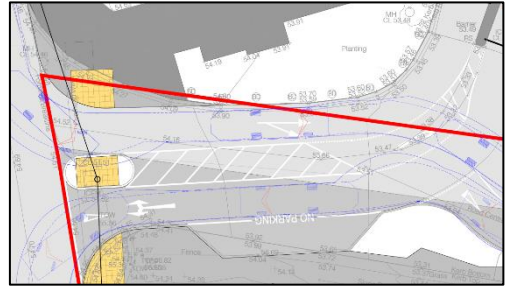
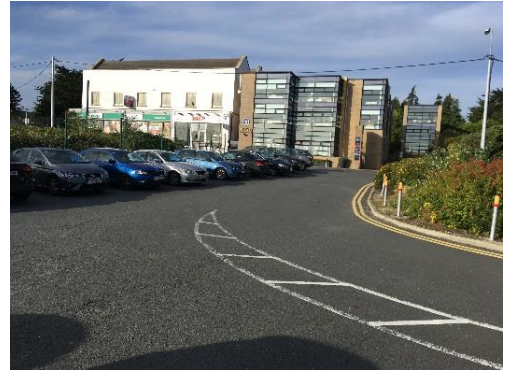
The auditors note that there are no parking restrictions proposed at the AIB access. During the site visit it was observed that cars were parked haphazardly on the southern side of the access. The auditors are concerned that vehicles parked kerbside within the vicinity of the site access junctions may adversely impact the availability of unobstructed visibility splays for vehicles exiting the junctions. This could potentially contribute to the generation of side-impact collisions between vehicles exiting the subject site and the AIB access.

It is recommended that parking restrictions are implemented in the vicinity of (i) the Old Bray Road/AIB access junction and the internal access route leading to/from both the existing AIB car park entrance/exit and the proposed site access junction with the objective of safeguarding the appropriate visibility splays and (ii) keeping the internal vehicle access route free from inappropriate car parking practices.

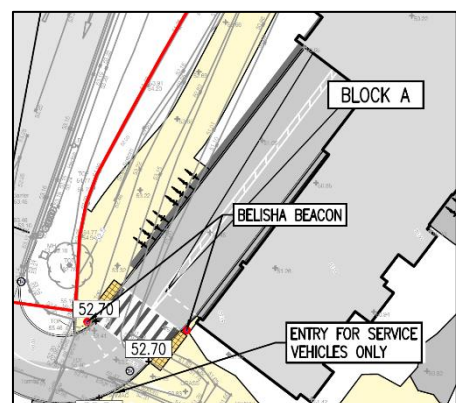
Parking restrictions (barrier or bollards) to the basement, to prevent access for non-residents have not been provided. During the site visit it was observed that cars were parked haphazardly on the southern side of the access. The auditors are concerned that non-residents such as AIB customers may park (i) in the basement or (ii) at the podium level courtyard. Such practices could result in residents having to park

haphazardly on the surface level footpaths/shared surface, which could lead to vulnerable road users having to enter the carriageway leading to greater likelihood of conflict with motorised vehicles or could lead to slip and fall as pedestrians mount/dismount kerbs or walk through grassed area.

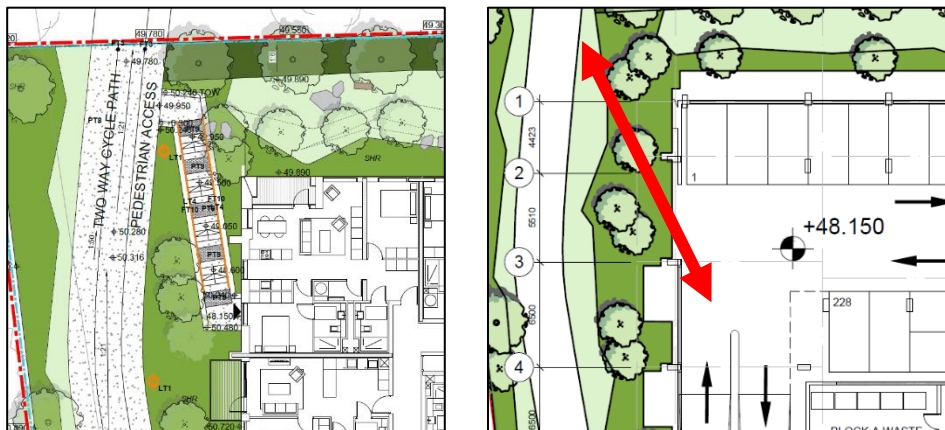
The auditors are concerned that the proposed pedestrian/cycle access/egress into the basement (northwest corner) may result in an insufficient level of clear unobstructed visibility being provided between vehicle drivers and pedestrians/cyclists access the basement. In such instances conflicts between vehicle and pedestrians/cyclists could arise with pedestrians/cyclists suddenly appearing within the path of vehicle drivers exiting/accessing the basement ramp.

It is recommended that either (i) the location of the ped/cycle doorway to/from the basement is relocated to a more appropriate location, or (ii) the design of vehicle ramp (access/egress point) is redesigned to ensure that an adequate level of visibility is provided between pedestrians/cyclists and opposing vehicles approaching the bottom of the basement's vehicle ramp.

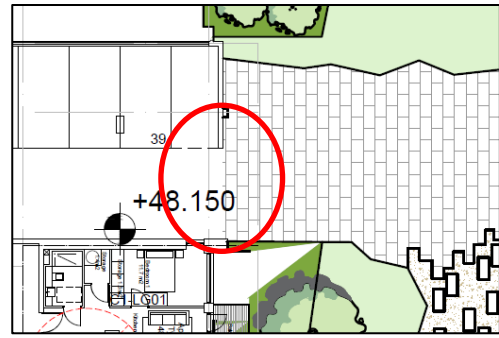
The audit team acknowledges that access to the external pedestrian/cyclist 'shared surface' from the basement car park may have to be maintained to accommodate emergency vehicles. However, the wide unobstructed access point may encourage inappropriate encroachment

of private vehicles into this sensitive lightly trafficked/'shared surface' area. This could result in collisions between vehicles and pedestrians in addition to impeding the pedestrian routes.

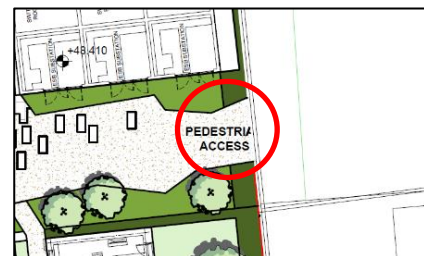
There is no tie-in between the proposed pedestrian/cycle route on the eastern side of the development and Willow Grove. There could be a risk of slips and falls in the green area during wet conditions.

It is recommended that a hard surface (of appropriate width and gradient) is provided through the green area to provide a link to Willow Grove.

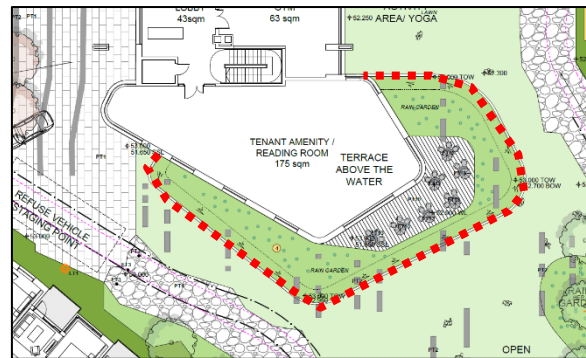
The auditors are concerned about the potential depth/gradient of the internal open watercourse features. There is no protection for young children who may fall into the open water features. There is no kerb or landscaping buffer to restrict access. Falling into the open deep channel with a sudden drop could lead to drowning incidents.

It is recommended that a management regime is implemented and in the absence of a tapered gentle gradient at the watercourse edge treatment, protection is provided around all sides of the water feature to restrict young children from falling into the rain garden.

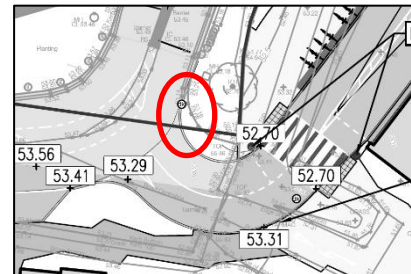
There is a proposal for dropped kerbs at the site access with no pedestrian crossing facilities (tactile paving) or corresponding crossing point/dropped kerb (on the other side of the carriageway). This could result in pedestrians entering the carriageway at an inappropriate location or time, and result in conflict with vehicles.

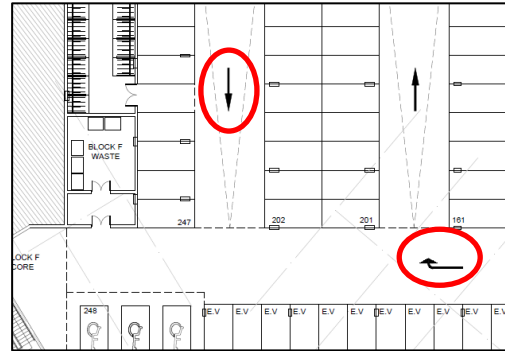
Vehicles which were parked within the first 'western' section/row of car parking spaces and wanting to exit the car park will have to drive against traffic (over a short two-way section) to exit via the next row of car parking spaces. This could result in head-on collisions between vehicles.

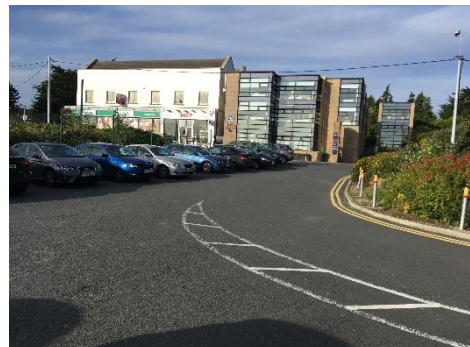
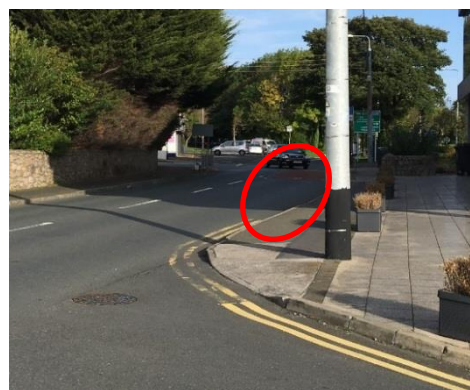
During the site visit it was observed that cars were parked haphazardly on the southern side of the access. The auditors are concerned that due to the new junction layout, vehicles will no longer be able to park on the southern side of the existing AIB access and may decide to park along the eastern side of Bray road in close proximity to the junction. Haphazard parked cars along Bray Road at the AIB access junction may obstruct driver's visibility at the junctions. Failure to provide sufficient visibility for vehicle drivers at the junctions could result in overshoot incidents or side impact collisions with vehicles/cyclists travelling along the road.

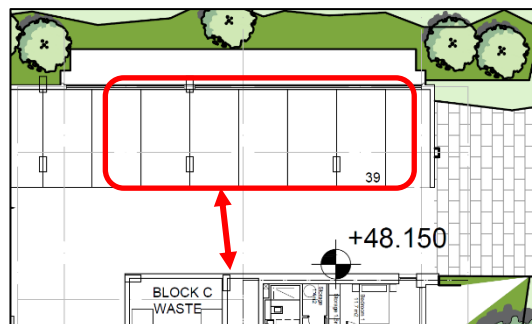
It is unclear to the audit team if the aisle with or parking bays located in the north-eastern corner of the basement are of sufficient width to enable a vehicle to enter/exit the bay when the parking space adjacent it occupied. The vehicle aisle width has

been reduced due to the apartment block (approx. width 4.5m). Failure to provide sufficient width and associated side clearance to a permanent structure could lead to vehicle drivers experiencing difficulty in navigating a car to/from a space, which could result in material damage incidents.

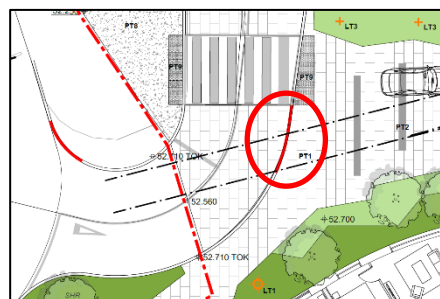
Due to the dropped kerb for 'service vehicle access' the 'shared surface' exits directly onto the road carriageway without any warning being provided to visually impaired pedestrians. Accordingly, such pedestrians could find themselves continuing to walk from the 'shared surface' out into the path of moving vehicles accessing/exiting the basement car park.

It is recommended that a 50mm kerb is provided which will warn visually impaired pedestrians of the road carriageway. Or tactile 'warning' paving could be provided at the transition from the 'shared area' to/from the road carriageway. This will ensure that visually impaired pedestrians are provided with the necessary warning of 'to proceed with caution' or direct them along the footpath to the neighbouring zebra crossing facilities.

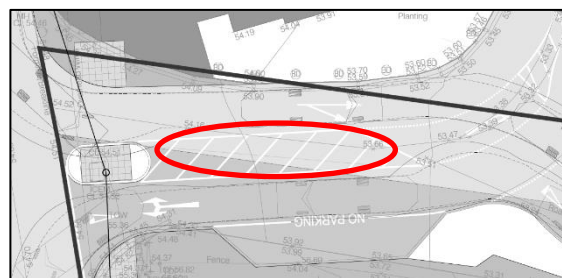
During the site visit it was observed that cars were parked haphazardly on the southern side of the access. The auditors are concerned that due to the new junction layout, vehicles (seeking to access AIB)

may park on the northern side of the access or on the hatched road marking. Haphazard parked cars at the AIB access junction may obstruct driver's visibility at the junctions. Failure to provide sufficient visibility for vehicle drivers at the junctions could result in overshoot incidents or side impact collisions with vehicles/cyclists travelling along the road.

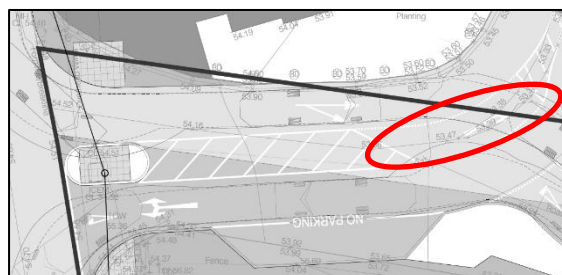
It is unclear if there is sufficient length available in the right turn pocket to enable cars/service vehicles to stop and wait for an available gap in oncoming vehicles,

without the vehicle overhanging onto the inbound lane of the road carriageway leading to the AIB car park. This could lead to waiting vehicles being struck by vehicles travelling through to the AIB car park.

Further to S24, it is recommended that the right turn pocket is extended (4 to 6m) towards the pedestrian refuge island, ensuring there is sufficient space available for a large vehicle to wait, without overhanging onto the inbound lane leading to the AIB car park.

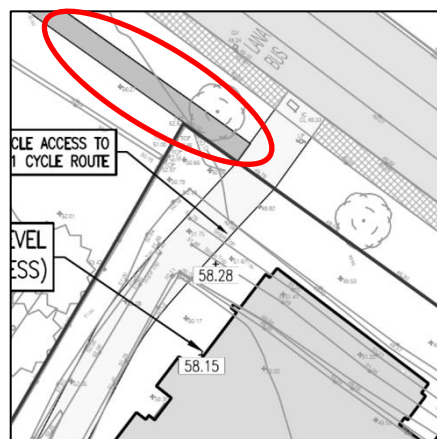
Cyclists who are travelling out from the city centre/UCD direction (e.g. southbound) along the N11 and wish to access the subject site would most likely cross at the signalised crossing (northwest of the site) and use the proposed new footpath along the N11 to connect to the shared surface access to the site. This may result in collisions between cyclists and pedestrians due to the inadequate width of the new footpath facility to cater for both pedestrians and cyclists.

It is recommended that the footpath is upgraded to a formal shared surface facility and widen to 3-3.5m to also cater for outbound cyclists (from the city centre) seeking to access the proposed development along the most convenient travel desire line.

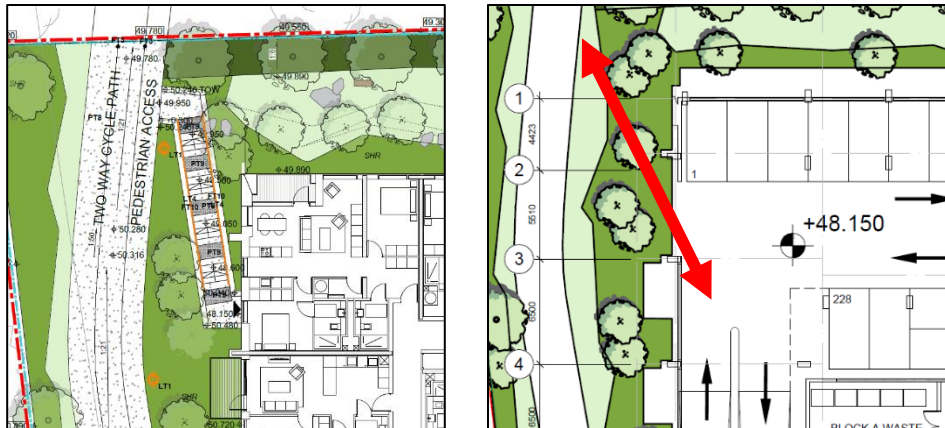
basement car park via the vehicle access which is not on the cyclist's desire line to/from the N11. The basement ramp will be the main access for both vehicles and cyclists and will therefore result in a high frequency of vehicle and cycle interactions which may result in collisions. The steep basement ramp (1:10) may be inconvenient for many bicycle users, who may then choose to walk their bike up the ramp (rather than cycle), which in turn will cause delays and frustration to vehicle users.

It is recommended that the design team explore the opportunity to provide a ramp to cater for both pedestrians and cyclists. Should this prove not viable, as an absolute minimum wheel channels for bicycles should be provided adjacent to the steps and landings.

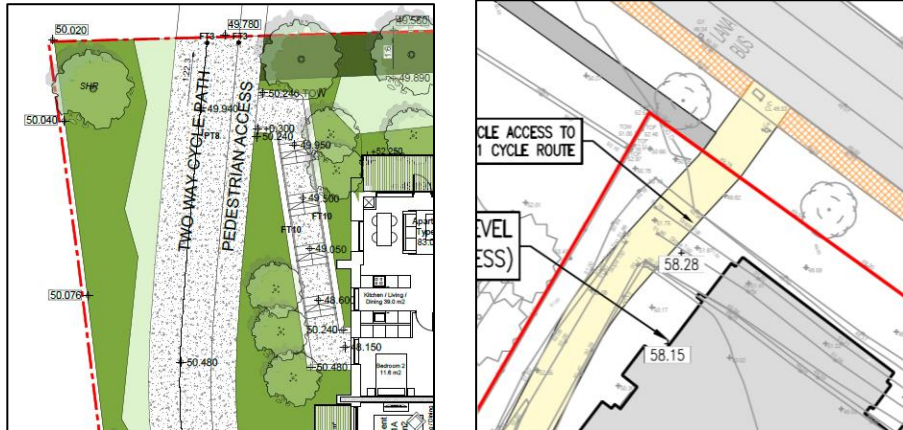
There is inconsistency between drawings, the landscape drawing shows a segregated two-way cycle path & footpath to the N11 while another roads drawing shows a Shared Surface.

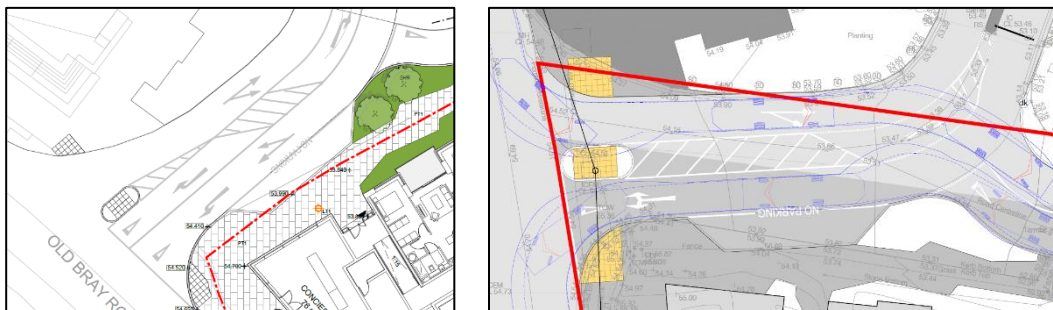
5.1.2 Comment (C2) AIB access junction

There is inconsistencies between drawings, the access junction layout is different in the landscape and the road layout drawings.
