Tree Survey Report

Limerick City and County Council

King's Island Flood Relief Scheme

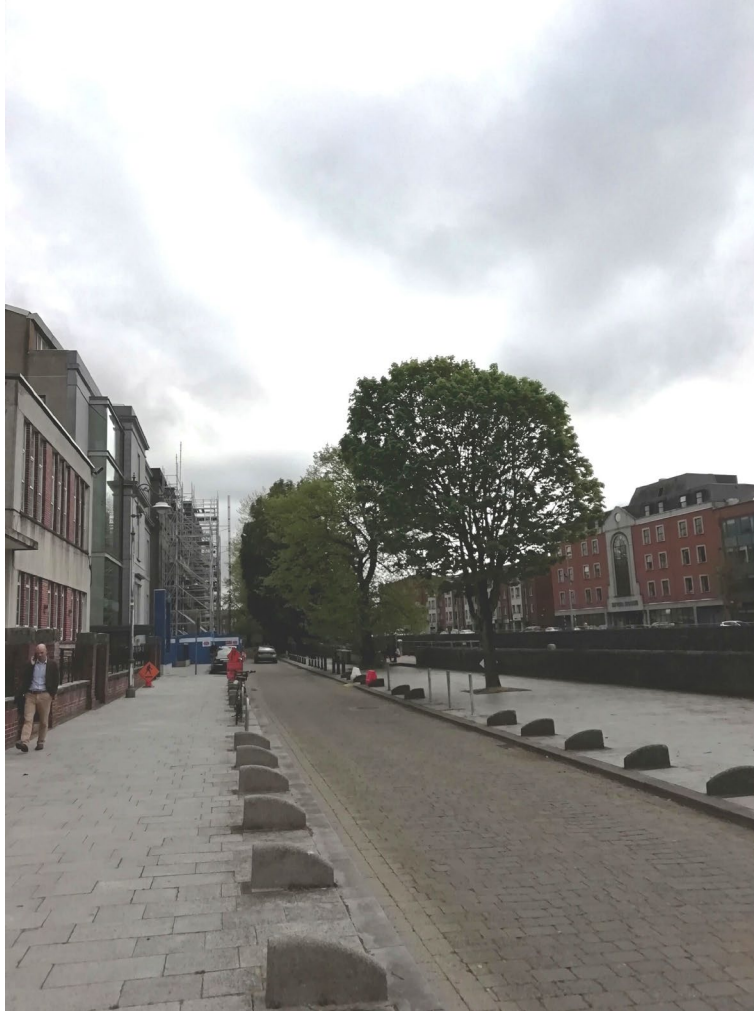
Figure 1. Displays trees 480-485

Tree #	Species Botanical Name	Age class	Size (mm)	Height (M)	Crown Sp. (M)	Crown Cl.(M)	Condition	Structural/Physiological Observations	Impact of the development	PMR	Category	R.P.A. Meters
480	<i>Tilia x europaea</i> Common Lime	M	660	24	N=5 S=5 E=5 W=5	2	Good	A large mature lime, displaying a good overall condition. A tree of high aesthetic and amenity value	Unknown	<ul style="list-style-type: none"> Retain Crown raise the lowest whorl of branches 	A2	7.6m
481	<i>Platanus orientalis</i> Oriental Plane	M	1100	26	N=8 S=8 E=8 W=8	2	Good	A large mature Plane, displaying a good overall condition. A tree of high aesthetic and amenity value	Unknown	<ul style="list-style-type: none"> Retain Crown raise the lowest whorl of branches 	A2	12m
482	Oriental Plane	M	120	28	N=4 S=6 E=8 W=9	2	Good	A large mature Plane, displaying a good overall condition. A tree of high aesthetic and amenity value	Unknown	<ul style="list-style-type: none"> Retain Crown raise the lowest whorl of branches 	A2	12m

483	Common Lime	M	680	24	N=5 S=5 E=5 W=5	2	Good	A large mature lime, displaying a good overall condition. A tree of high aesthetic and amenity value	Unknown	<ul style="list-style-type: none"> Retain Crown raise the lowest whorl of branches Removal basal suckers 	A2	8m
484	Oriental Plane	M	1080	28	N=5 S=6 E=8 W=8	2	Good	A large mature Plane, displaying a good overall condition. A tree of high aesthetic and amenity value	Unknown	<ul style="list-style-type: none"> Retain Crown raise the lowest whorl of branches 	A2	12m
485	<i>Aesculus hippocastanum</i> Horse chestnut	M	920	30	N=6 S=6 E=6 W=6	2	Good	A large mature Chestnut, displaying a good overall condition. A tree of high aesthetic and amenity, ecological value	Unknown	<ul style="list-style-type: none"> Retain Crown raise the lowest whorl of branches 	A2	12m

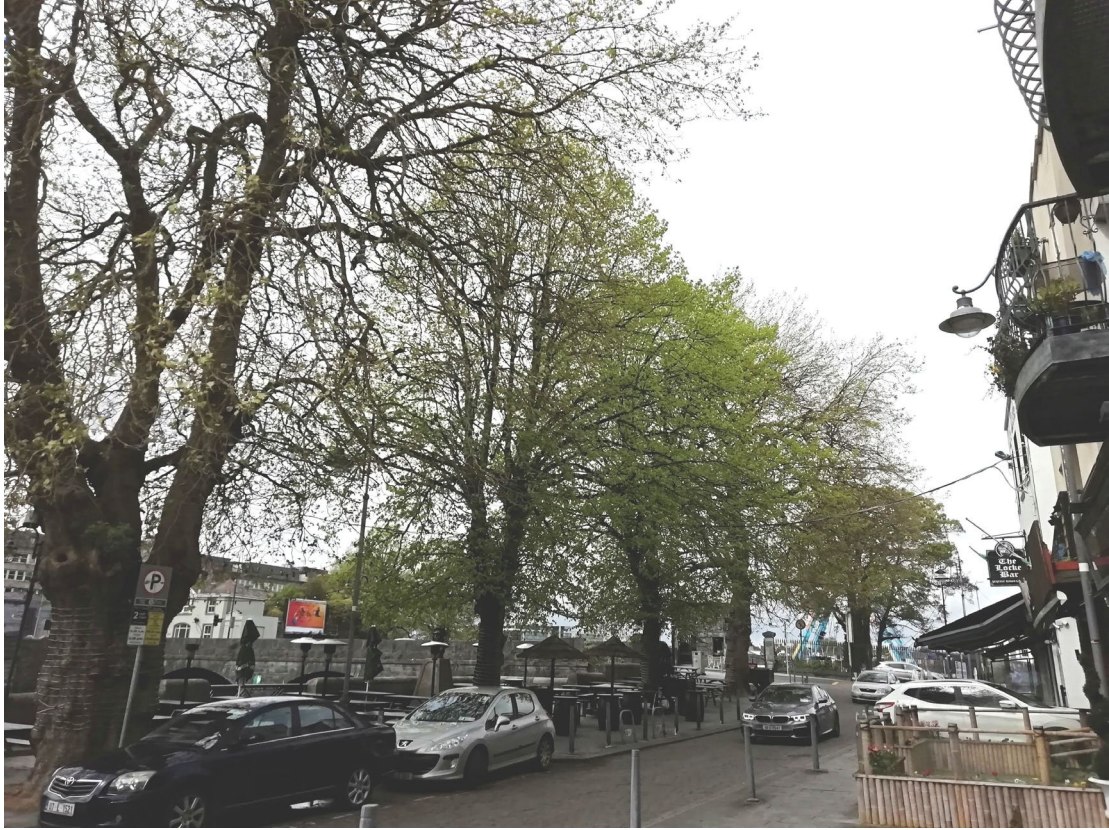
Figure 2. Displays trees 480-485. Note their high amenity value

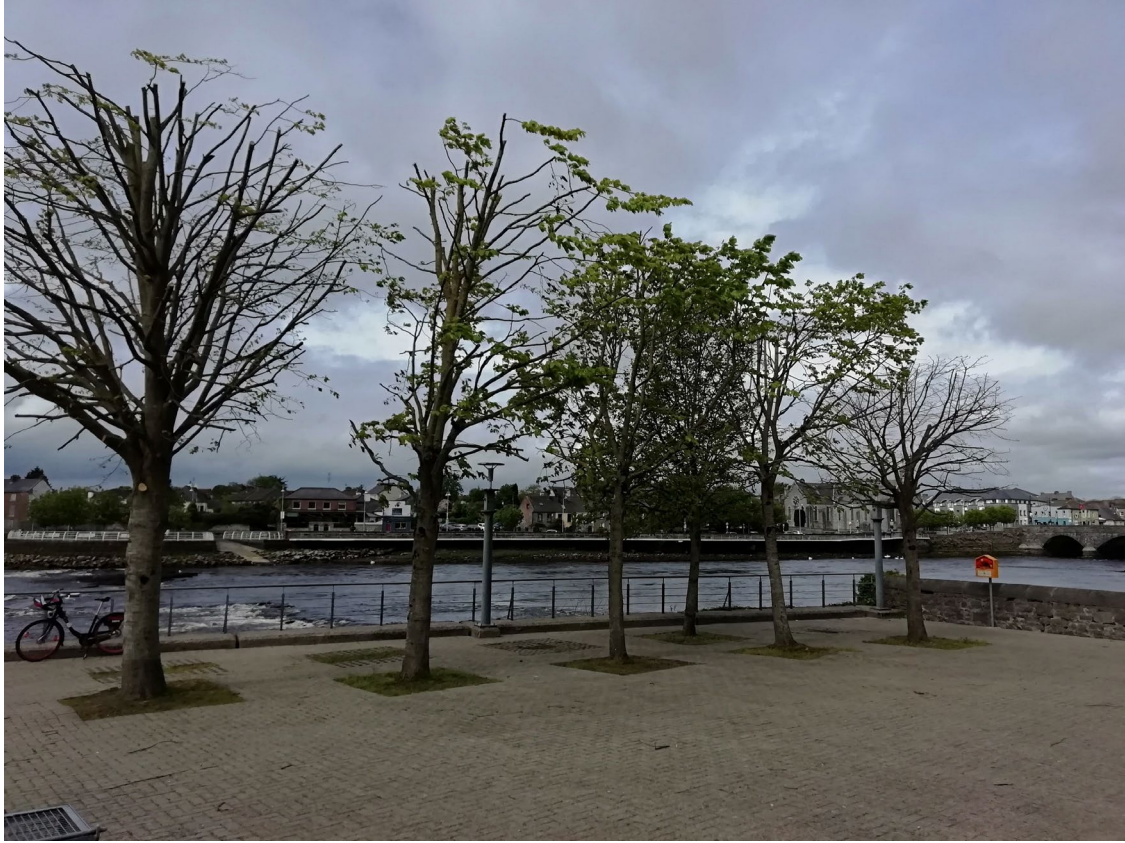
Figure 3. Displays 492-493

Tree #	Species Botanical Name	Age class	Size (mm)	Height (M)	Crown Sp. (M)	Crown Cl.(M)	Condition	Structural/Physiological Observations	Impact of the development	PMR	Category	R.P.A. Meters
492-493 x 6	Common Lime	EM	260	8	N=2 S=2 E=2 W=2	2	Fair	A cluster of early-mature Lime displaying fair overall condition they have been heavily pruned in the past	Remove to facilitate the development	<ul style="list-style-type: none"> Remove 	C2	
494-95	Whitebeam Cherry Norway Maple	EM	280	10	N=2 S=2 E=2 W=2	2	Fair	Three early mature trees located with the boat club all three trees have been negatively pruned to accommodate an overhead wire, which has resulted in the canopies being unbalanced. The cherry is in advanced decline	Remove to facilitate the development	<ul style="list-style-type: none"> Remove 	C2	
496	London Plane	M	750	28	N=5 S=5 E=8 W=8	2	Good	A large mature Plane, displaying a good overall condition. A tree of high aesthetic and amenity value. Located within Authlunkard Boat club	Unknown	<ul style="list-style-type: none"> Retain 	A2	8.5m

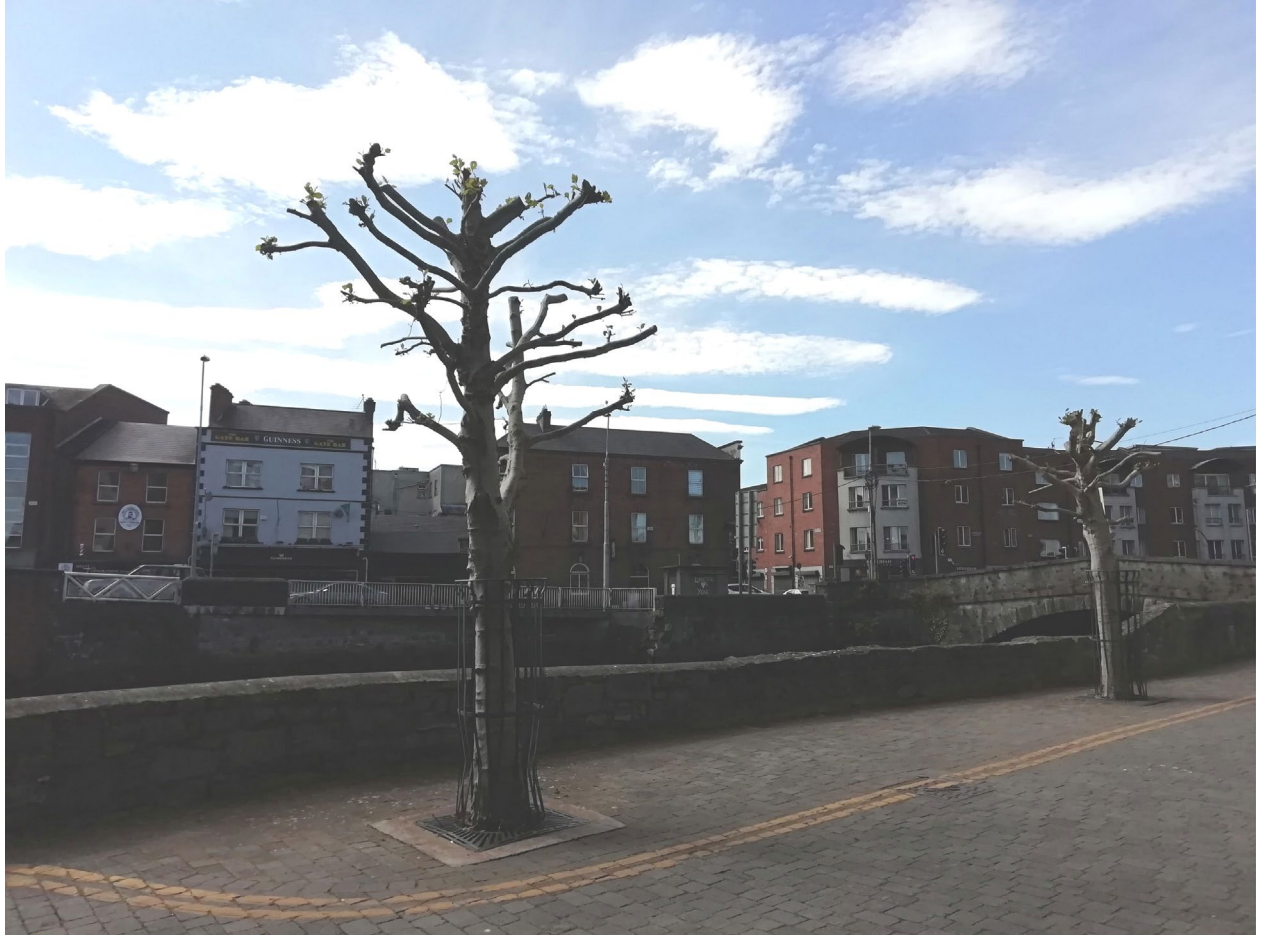
Figure 4. Displays tree 501. These trees have been over-pruned and have lost their aesthetic value
