**Title: STAGE 1 ROAD SAFETY AUDIT INCLUDING
QUALITY AUDIT**

**For;
Newtownmoyaghy SHD, Kilcock.**

Report reference: 0679R01

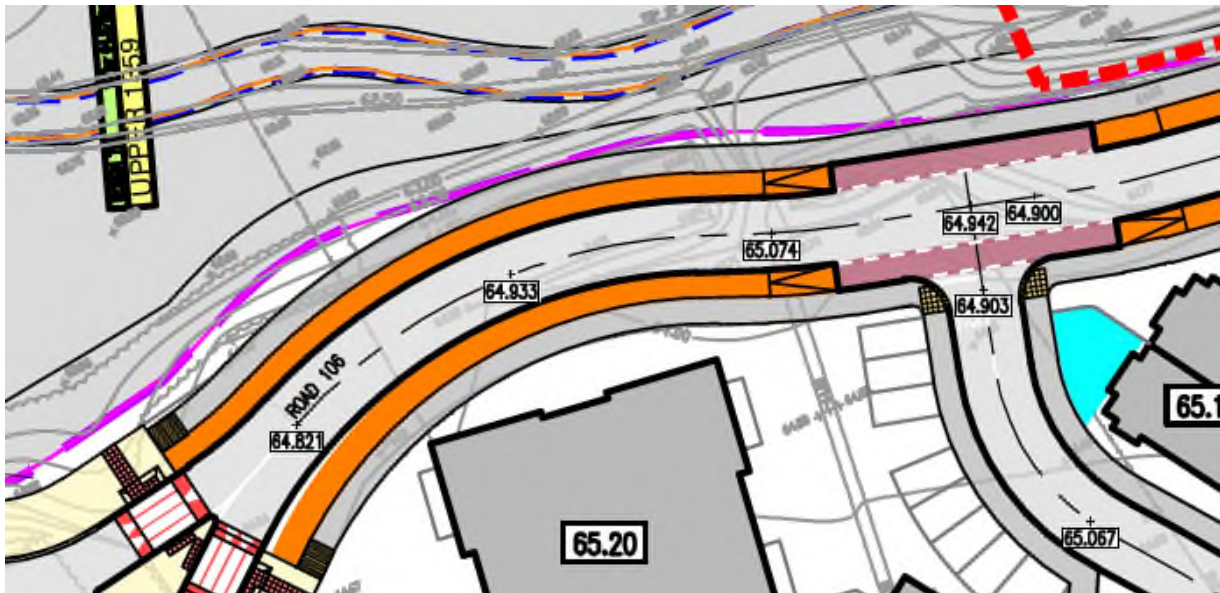
3.1 Problem

It is unclear on Road 106 to the East of the internal roundabout if the cycle track is to be vertically segregated from the footway between junctions. Without segregation pedestrian may stray into the footway and be at greater risk of being struck by cyclists.

It is recommended that the cycle track be vertically segregated and at the detailed design stage that the correct ladder and tramline tactile paving layout be provided at all areas where the two merge as a shared use area.

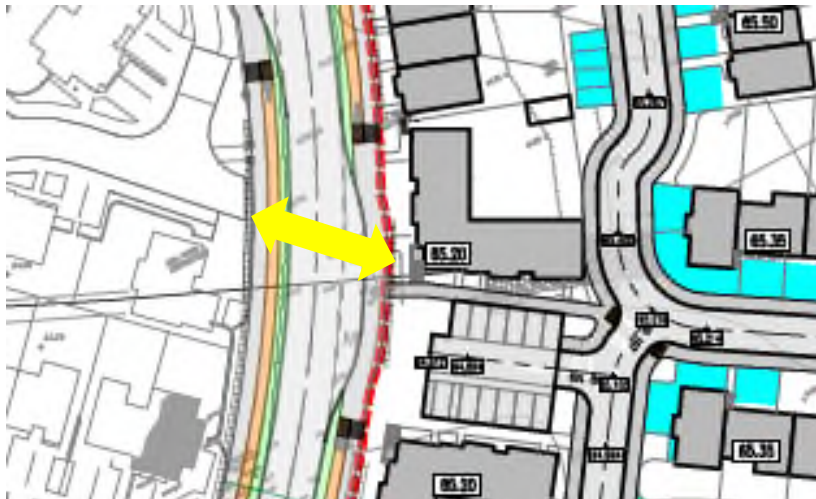
4.1 Problem

There are proposed bus laybys on the Link Road between the R148 roundabout and the internal roundabout. There is a footpath from the eastern portion of Newtownmoyaghy SHD to the bus stop on that side and there is a pedestrian link from the cul-de-sac in the occupied Millerstown Development adjacent to the bus stop on that side. There is however no crossing point for pedestrians to get the bus on the opposite side of the road or to cross after getting off the bus.

It is recommended that an informal crossing be provided adjacent to the bus laybys.

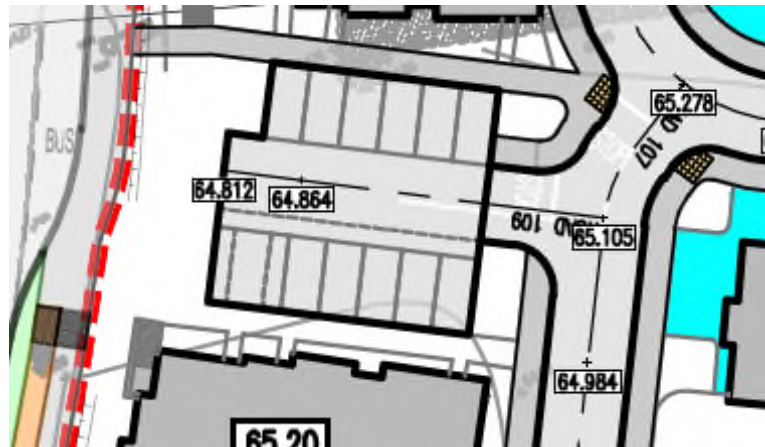
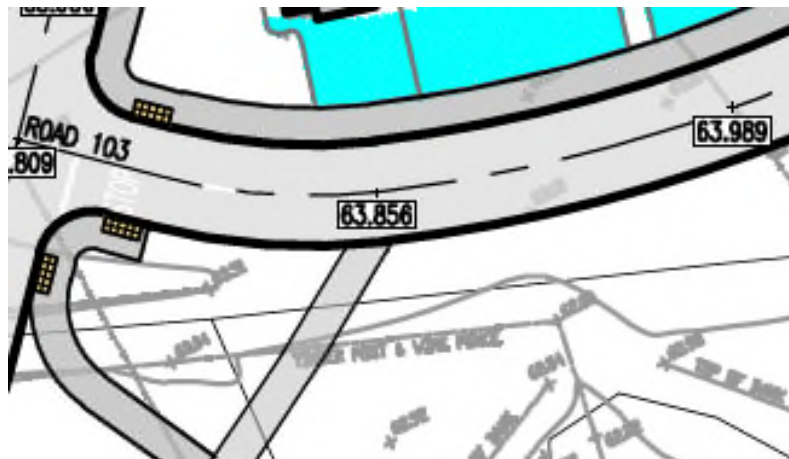
4.2 Problem

No pedestrian crossing points have been provided at some footpath junctions. For example the junction of Road 109 and Road 107. This could lead to triops and falls for pedestrians.

It is recommended that dropped kerbs and tactile paving is provided at all internal pedestrian crossing points.

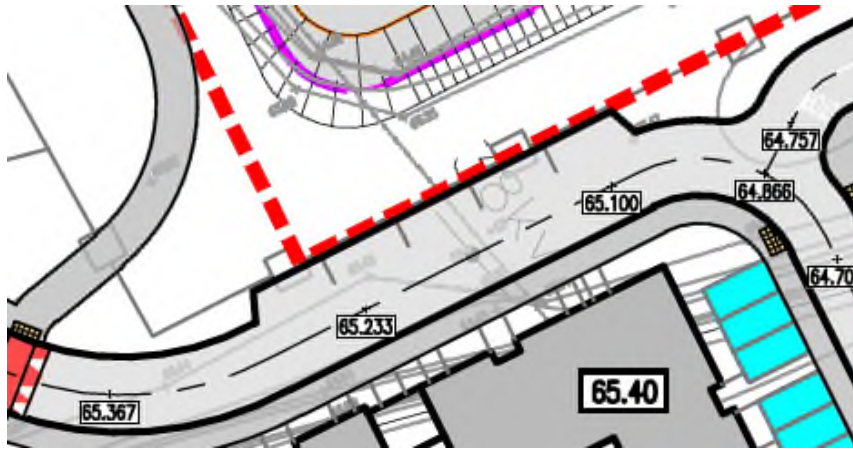
4.3 Problem

There is no hard standing to the rear of the parallel parking spaces on Road 105. This could lead to slips and falls for vehicle occupants leaving their vehicle on that side, especially during wet conditions.

It is recommended that a footpath be provided to the rear of the parking spaces.

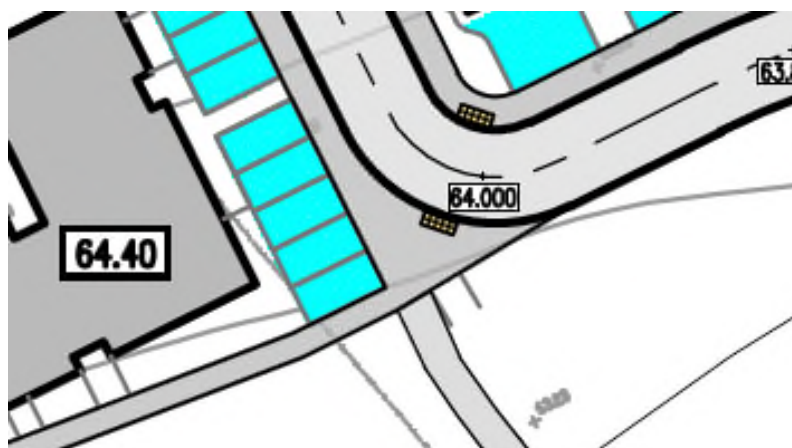
4.4 Problem

Vehicles reversing out of the parking spaces on the end loop at road 105 will cross the dropped kerb and tactile paving on the footpath which is also part of a recreational walking route. This would increase the likelihood of a collision with a pedestrian and also lead to damage of the paving slabs which could then become trip hazards.

It is recommended that the crossing point be relocated.

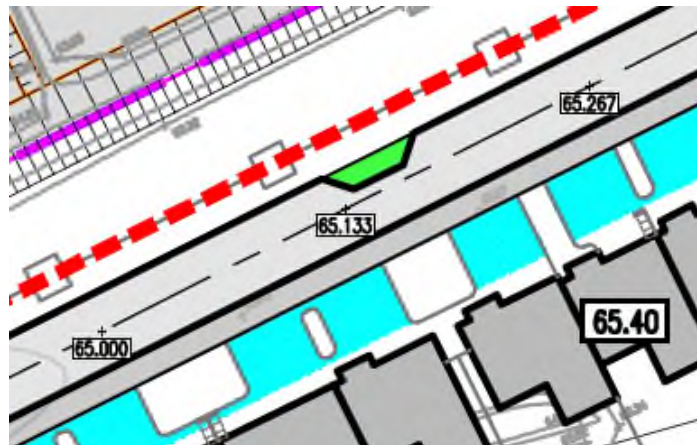
4.5 Problem

Drivers exiting the residential units opposite the chicane on Road 105 may find it difficult to undertake the manoeuvre due to the presence of the chicane. This could result in material damage to the chicane and the vehicles.

It is recommended that a swept path analysis be carried out to ensure the manoeuvre can be carried out easily by drivers of those units. A similar situation exists for the chicane on Road 102.

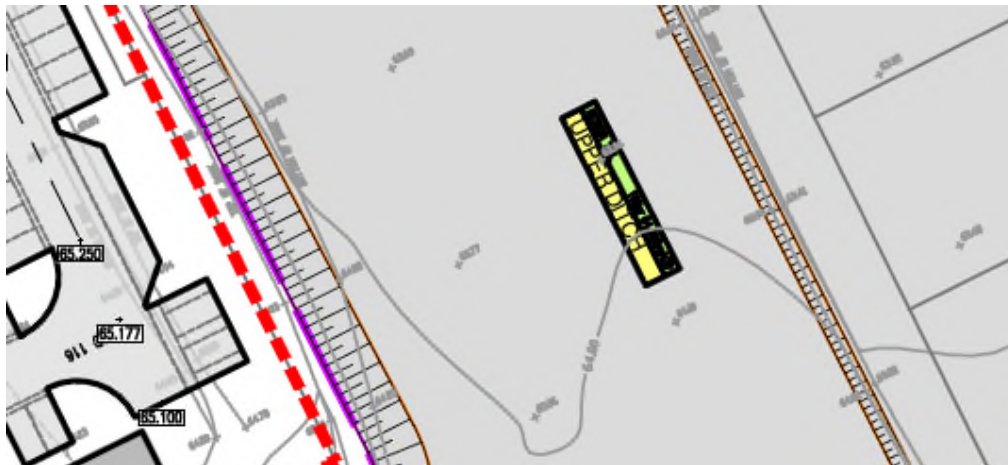
4.6 Problem

There are two disabled parking bays proposed at the GAA pitch car park. It is unclear where the entry to the pitch is for supporters. If the disabled parking bays are far away from the pitch entrance it may be an arduous journey for the mobility impaired.

It is recommended that the disabled bays be placed as close to the pitch entrance as practicable.

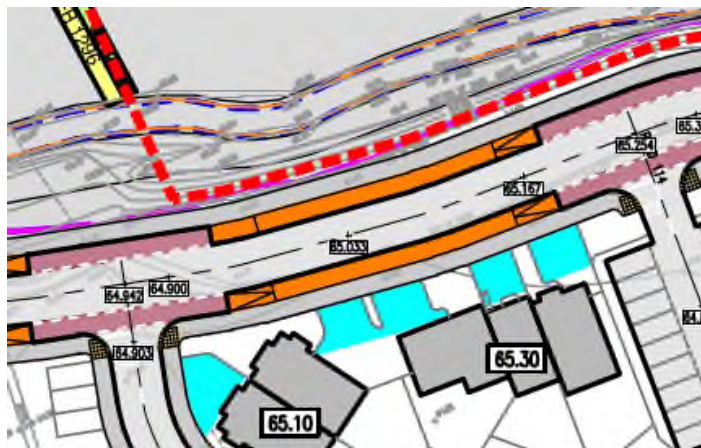
4.7 Problem

It is unclear how drivers will access the parking spaces for the units along the southern side of Road 106 given the presence of the raised cycle track.

It is recommended that the cycle track height be reduced so that vehicles can cross it.

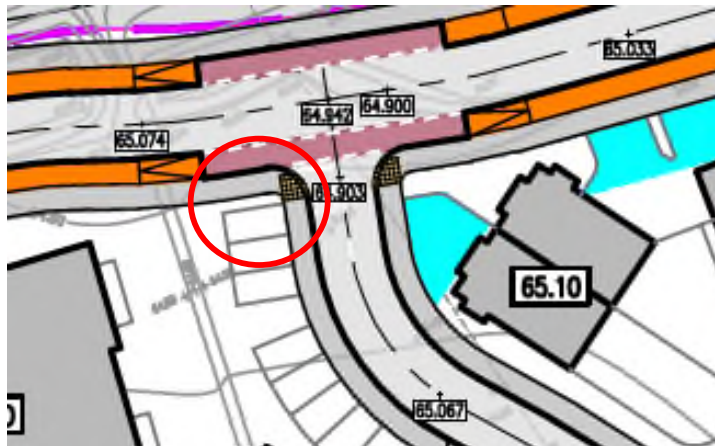
4.8 Problem

The first parking space on Road 101 at the junction with Road 106 is very close to the junction. A driver who is reversing out of this space will have to be alert of traffic turning from Road 106 and may not see a pedestrian behind the car.

It is recommended that the parking space be removed/relocated.

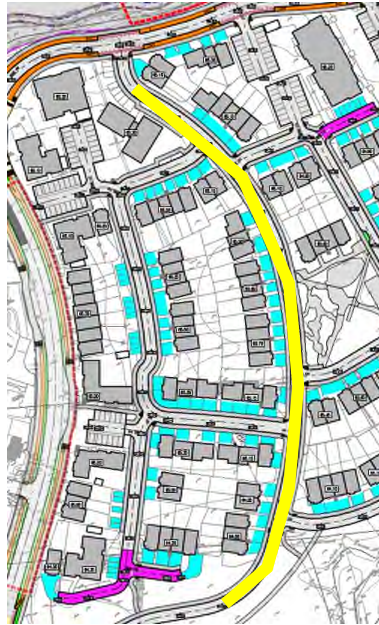
4.9 Problem

Road 101 has a large radius arc for most of its length and there is a risk that drivers may use it as a 'rat-run' from the R148 to the GAA pitch at peak times when traffic volumes are high. This would increase the likelihood of a collision with a vulnerable road user.

It is recommended that some traffic calming features are introduced along Road 101 after the initial sinusoidal portion of the alignment.

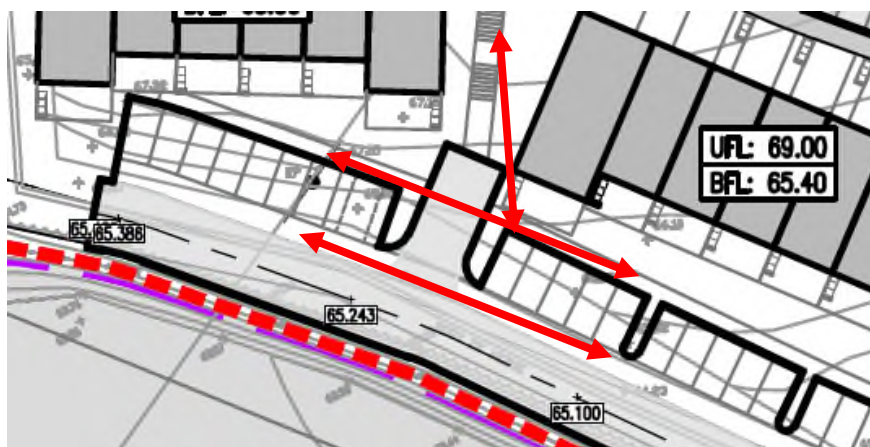
4.10 Problem

The footpaths on the northern side of Road 212 are not shaded. It is unclear if there are continuous pedestrian facilities along the front and rear of the perpendicular parking bays. The turning head may also truncate pedestrian routes.

It is recommended that the footpath network be clearly defined and that it is without discontinuities and pinch points.

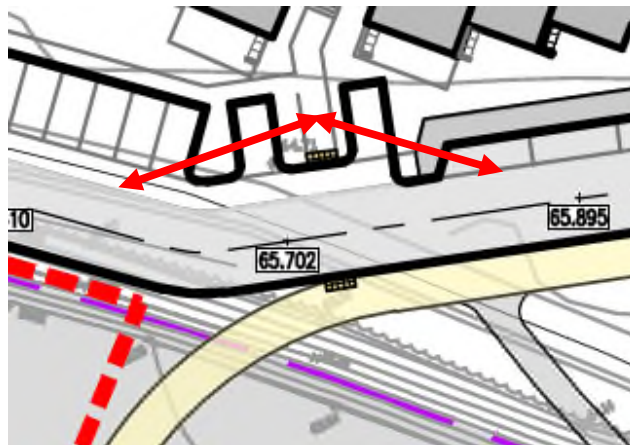
4.11 Problem

There may be a lack of inter-visibility between pedestrians and drivers at the informal crossing to the shared use track at Road 212 due to the presence of vehicles in the perpendicular parking spaces.

It is recommended that the visibility be checked and if necessary, the parking spaces be relocated.

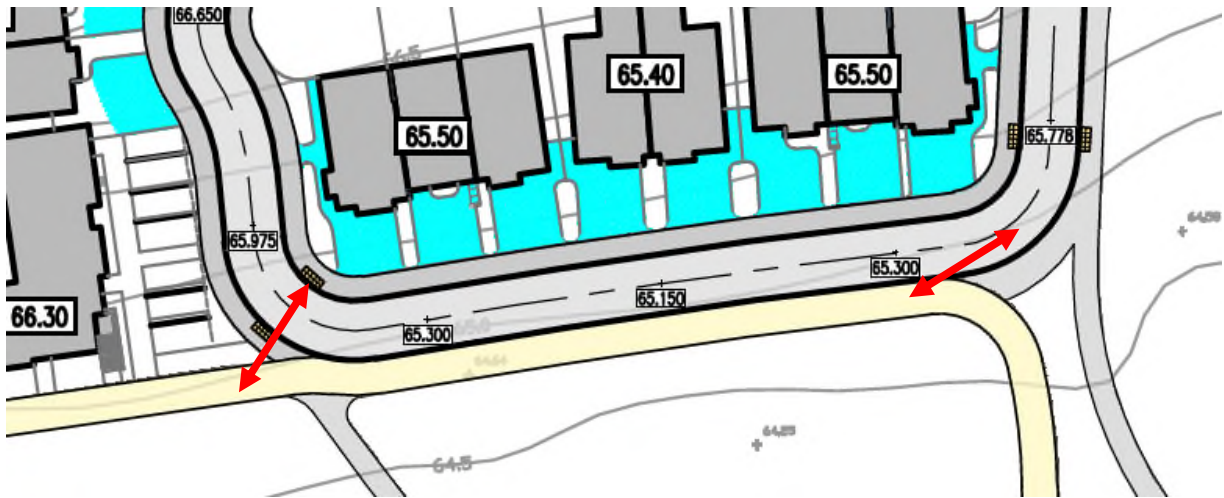
4.12 Problem

There is no transition from on-road cycling to the shared use cycle track on Road 203. This could lead to cyclists mounting the kerb and losing control.

It is recommended that suitable entry points to the shared use facility be made for cyclists at locations with adequate visibility and with suitable warning for pedestrians.

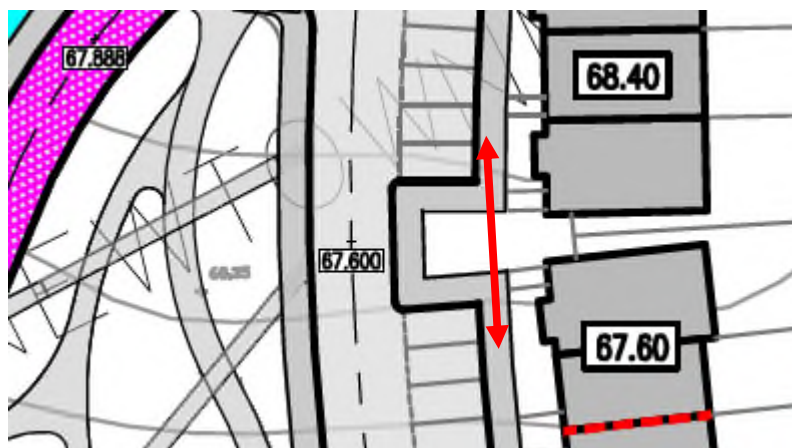
4.13 Problem

There is a footpath along the western side of Road 201 at a buildout between perpendicular car parking spaces that does not represent the desire lines for pedestrians. This will lead pedestrians to travel over the landscaped area instead.

It is recommended that the footpath be provided along the desire line.

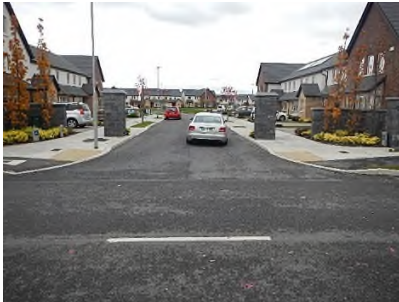
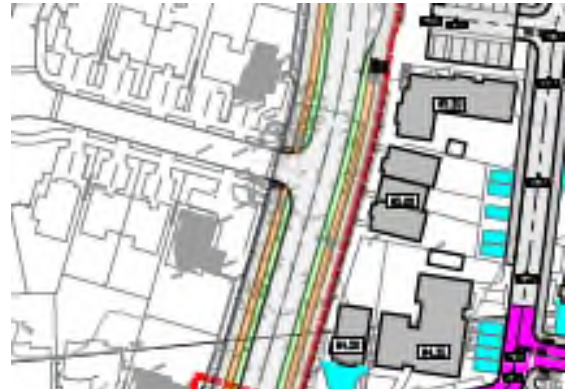
5.1 Observation

Signs and road markings would be reviewed at the detailed design stage. In particular a Stop sign and STOP road marking would be needed at the first junction to the West on the link Road which is currently the access to the occupied units. Drivers exiting this section have priority at present but no longer will once the link road is fully opened.

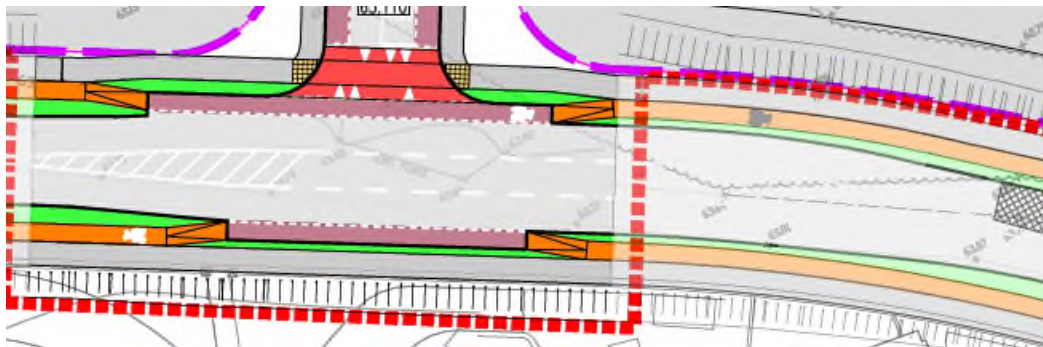
5.2 Observation

The development of the right turning lane on the Link road for the Road 201 junction has not been shown on the drawings. It is assumed that this will be developed at the detailed design stage.
