# Arboricultural Assessment Report

Residential Development,  
Newtownmoyaghy,  
Kilcock, Co. Meath

<b>Project No.</b>	TKIL004	<b>Date</b>	18/11/19
<b>Project Name</b>	Residential Development, Newtownmoyaghy, Kilcock	<b>Revision</b>	D

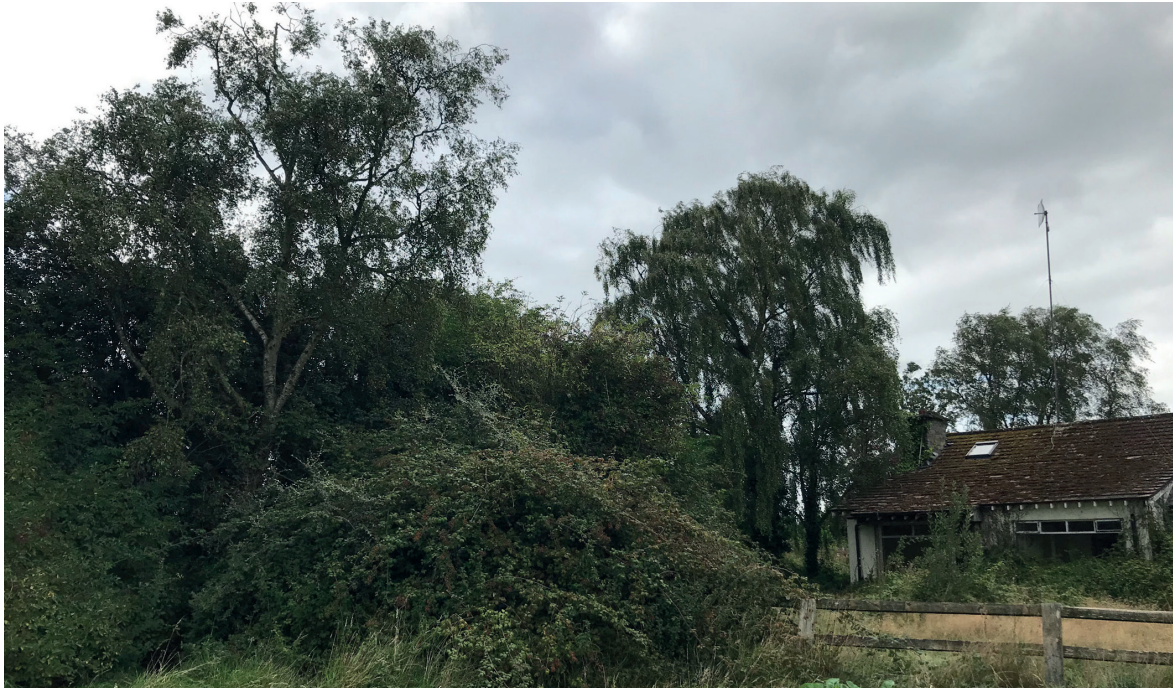
Image 2. The back of property on the R125 showing silver birch (#2811) on left.

2811	<i>Silver birch Betula pendula</i>	Fair	Early Mature	B2	Restricted crown due to subdominant status, otherwise well developed.	No action necessary	15-20	540	8	2s	3;2;3;2
2821	<i>Ash Fraxinus excelsior</i>	Good	Mature	B2	Well formed tree that might suffer drainage issues from being situated in base of ditch.	No action necessary	20-30	600	10	6w	5;5;5;5
2822	<i>Larch Larix decidua</i>	Fair	Early Mature	C2	One of small group of trees. Limited long term potential due to close competition of neighbouring trees.	No action necessary	10-15	380	260	2	1;1;1;1
2823	<i>Douglas fir Pseudotsuga menziesii</i>	Fair	Mature	C2	Dominant specimen of this small grouping of larch. Needles confined to outer tips of branches.	No action necessary	10-15	530	7	0.5n	3;1;3;3
2824	<i>Douglas fir Pseudotsuga menziesii</i>	Dead	Mature	U	One of small group of trees. In a state of advanced decline.	Fell	0	280	4.5	NA	NA
2825	<i>Larch Larix decidua</i>	Poor	Early Mature	C2	One of small group of trees. Canopy suppressed south due to competition.	No action necessary	10	370	7	1n	2;1;1;1.5

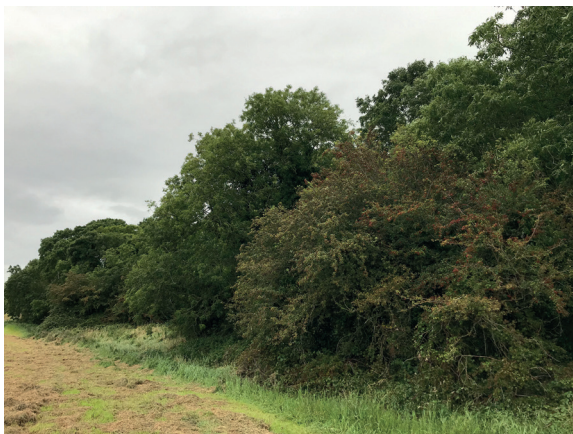
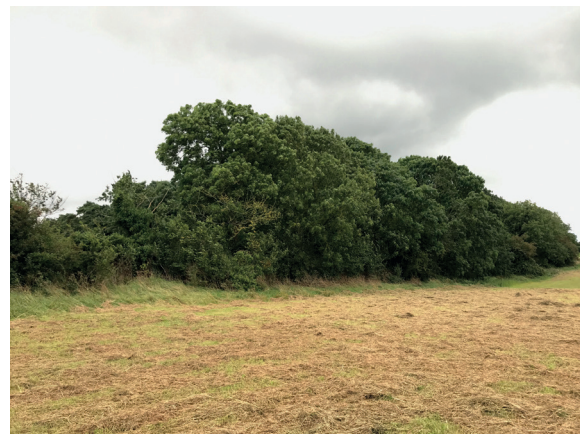
A wooded area located within a neighbouring property to the southwest corner of the site (image 3, page 6) consists a young plantation of ash of less than 30 years. Some of the more established specimens are overhanging site by 1-2m

Images 3 & 4. Wooded area in neighbouring property to southwest corner of site. Young plantation of ash of less than 30 years averaging 16-20 meters in height. Some of the more established specimens are overhanging site by 1-2m.

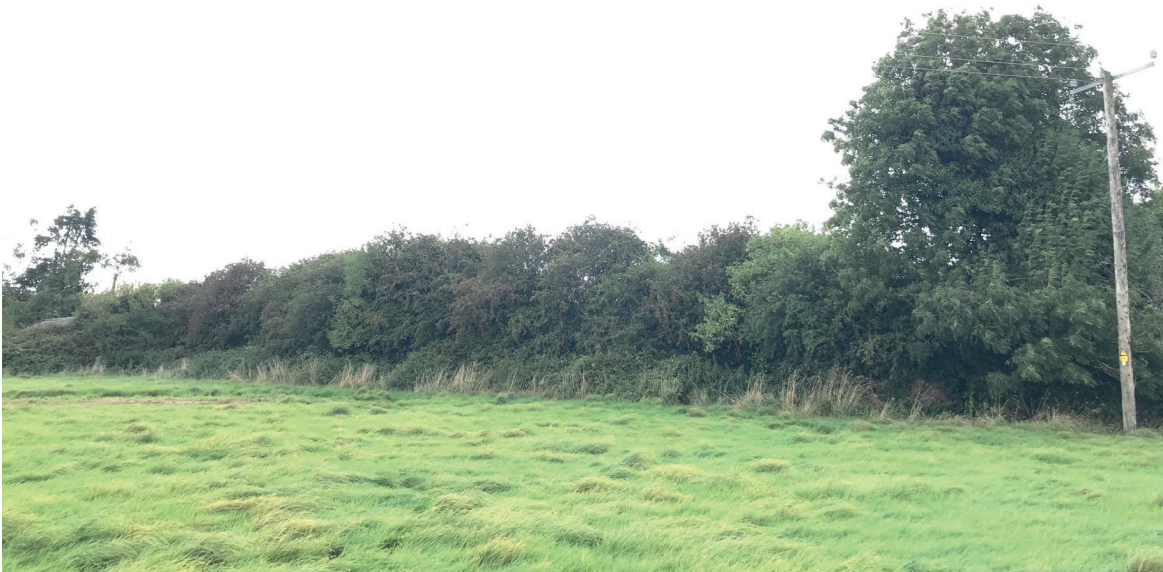
Image 5. Hedgerow A.

**Description:** Agricultural hedgerow in the northeast section of the site. Well developed and mostly complete.

**Species present:** Hawthorn and occasional elder and bramble.

**Average height:** 4 meters **Total length:** 57 meters

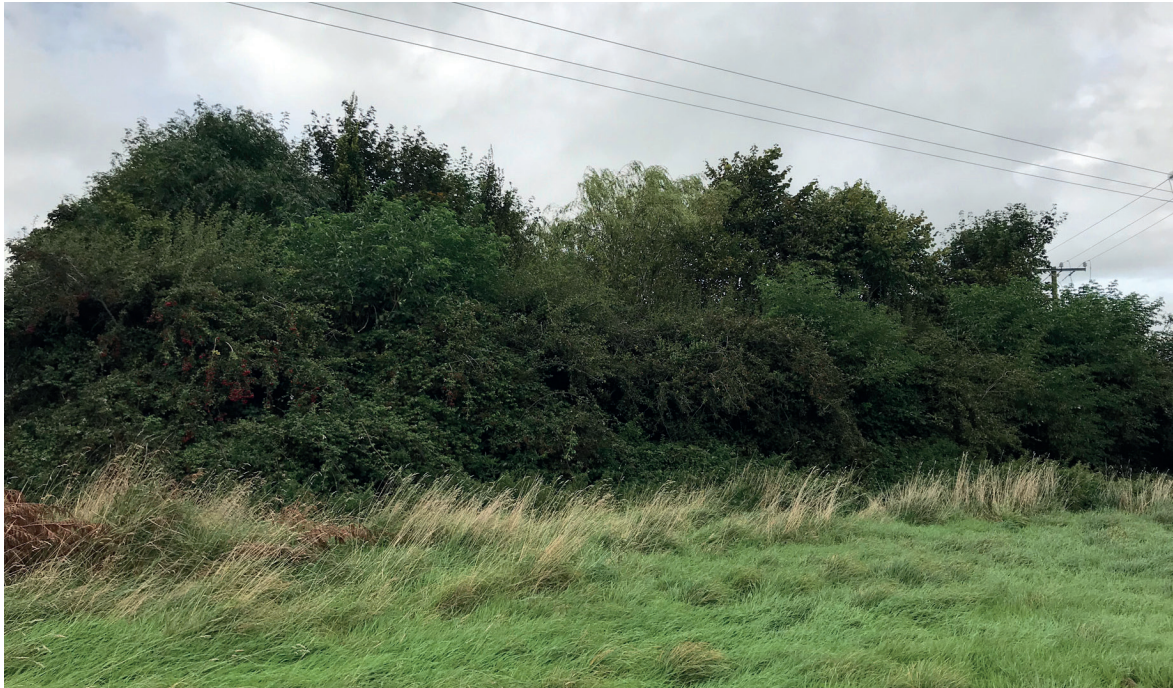
Image 6. Hedgerow B.

**Description:** Hawthorn and elder in a full but unmanaged agricultural field boundary hedgerow. Behind are willow and field maple trees set in a private residential property.

**Species present:** Hawthorn and occasional elder and bramble.

**Average height:** 3 meters **Total length:** 48 meters

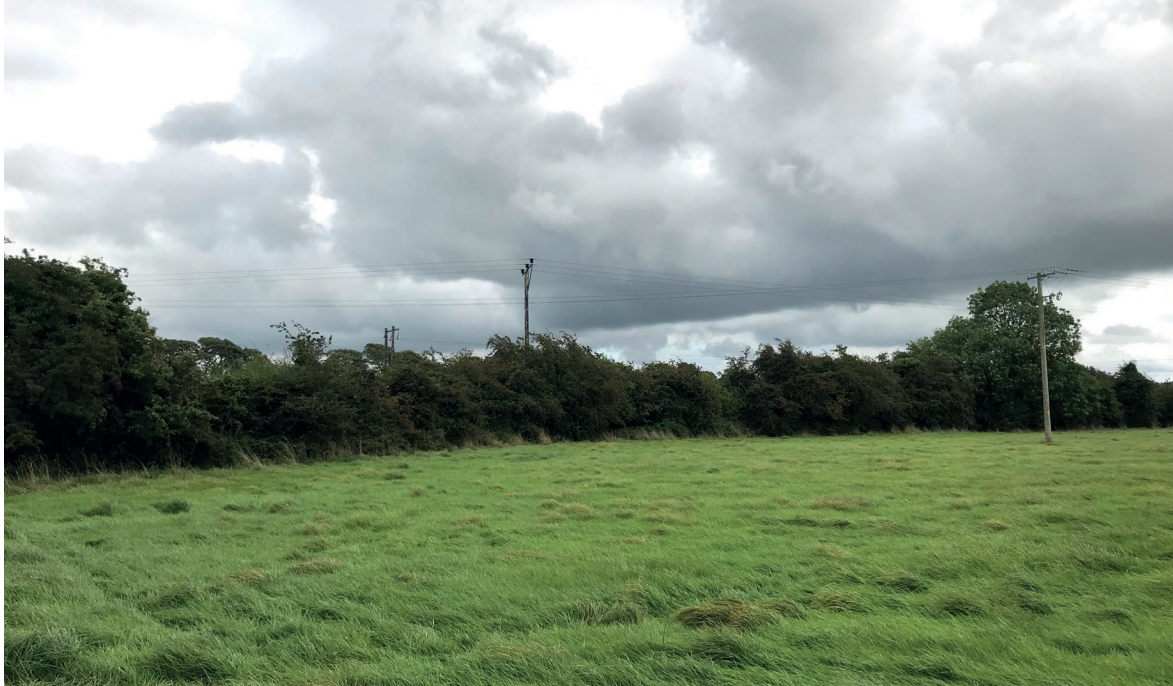
Image 7. Hedgerow C.

**Description:** Agricultural hedgerow mainly composed of hawthorn. Sections of hedgerow incomplete. Occasional elder. Contains two mature ash (#2801 & #2802).

**Species present:** Hawthorn and occasional elder.

**Average height:** 3-5 meters **Total length:** 152 meters

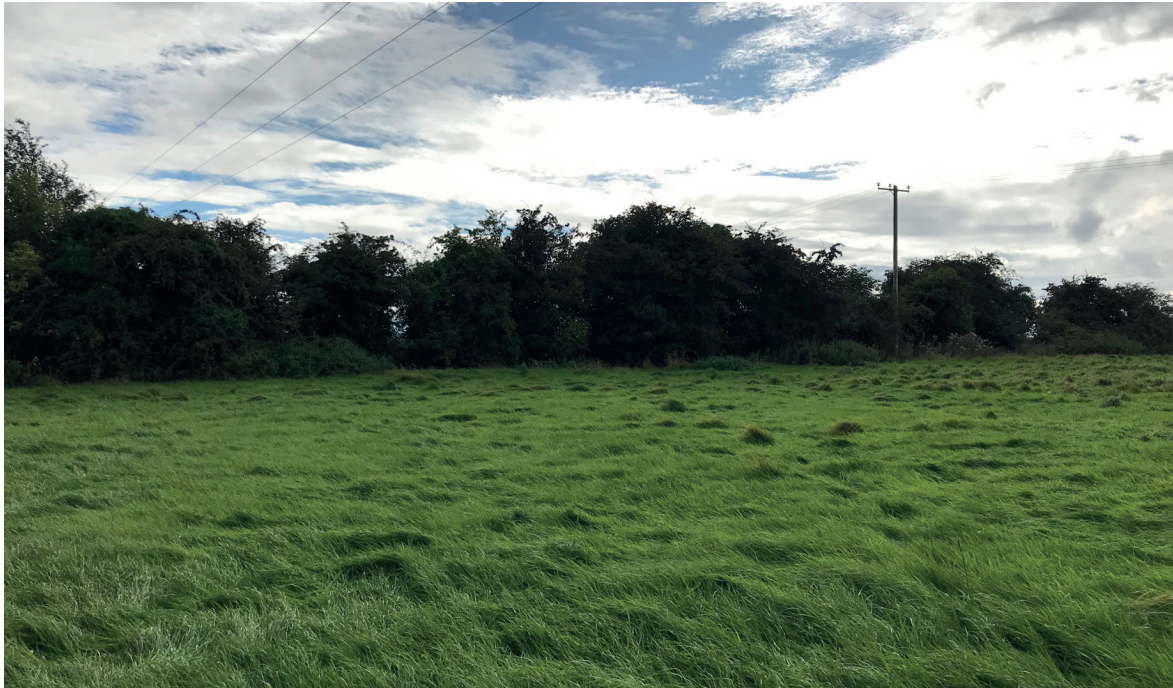
Image 8. Hedgerow D.

**Description:** Agricultural field boundary hedgerow with large hawthorn. Unmanaged and incomplete in places.

**Species present:** Hawthorn and occasional elder and bramble.

**Average height:** 4-6 meters **Total length:** 85 meters

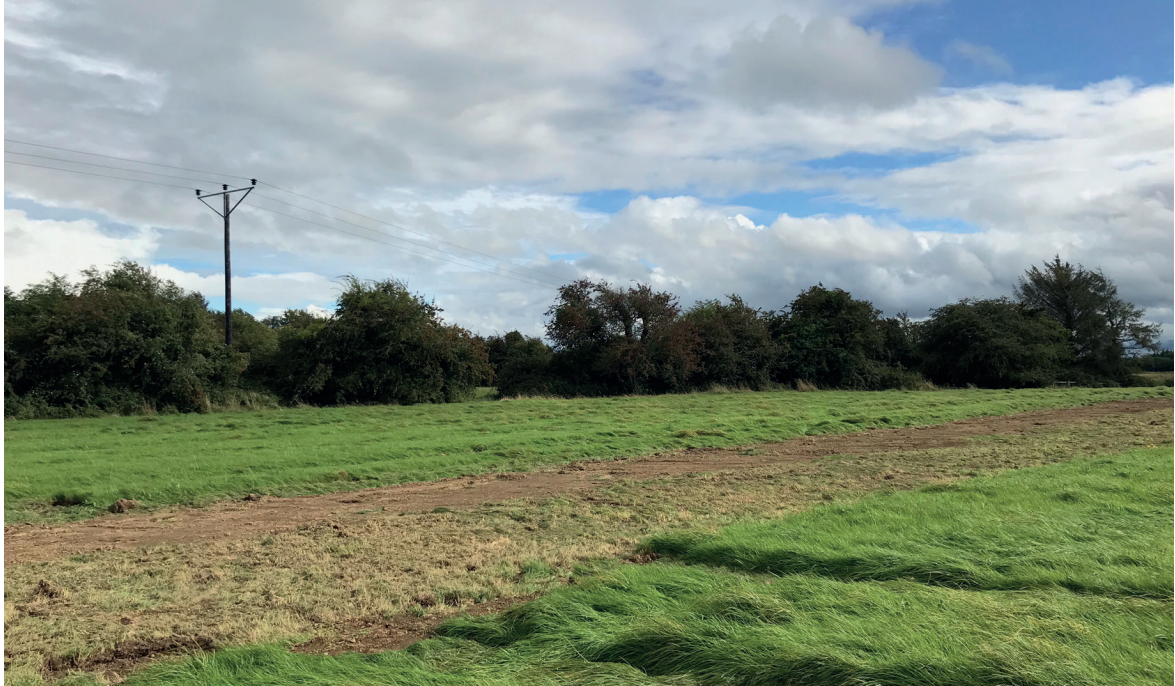
Image 9. Hedgerow E.

**Description:** Agricultural hedgerow on eastern boundary mainly composed of hawthorn with occasional elder and bramble. Incomplete in places. A group of early-mature larch (#2822-2826) of low to moderate value located within a fenced off area to south of hedgerow.

**Species present:** Hawthorn, bramble and elder.

**Average height:** 4 meters **Total length:** 193 meters

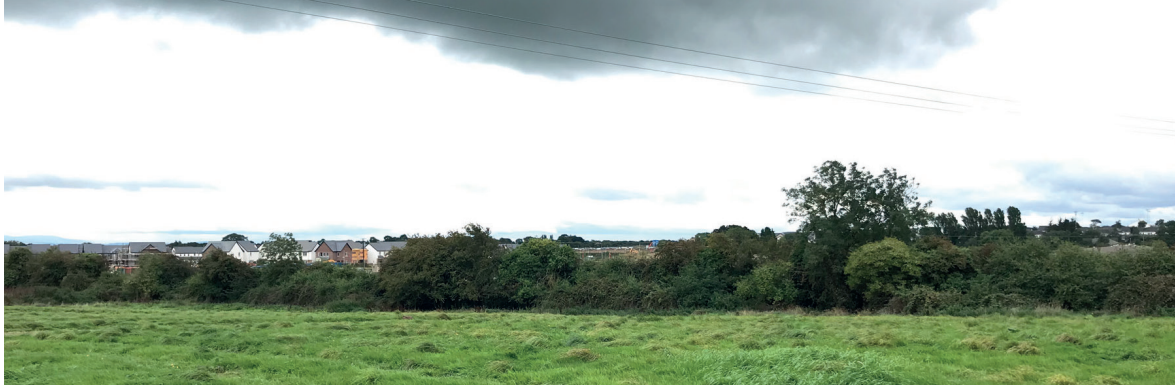
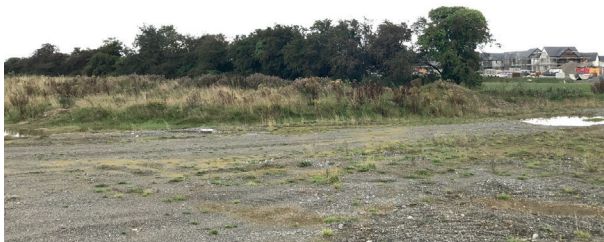
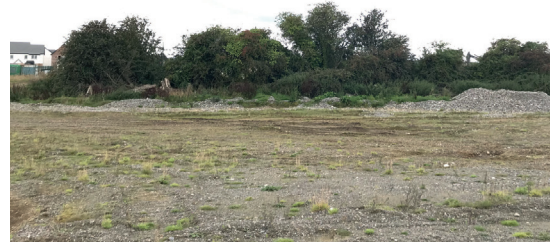
Images 10, 11 and 12. Hedgerow F.

**Description:** Well developed but unmanaged hedgerow on the western boundary of the site with larger specimens of mature hawthorn, alder and occasional ash (#2821 & 2022).

**Species present:** Hawthorn, alder and ash.

**Average height:** 4-7 meters **Total length:** 411 meters

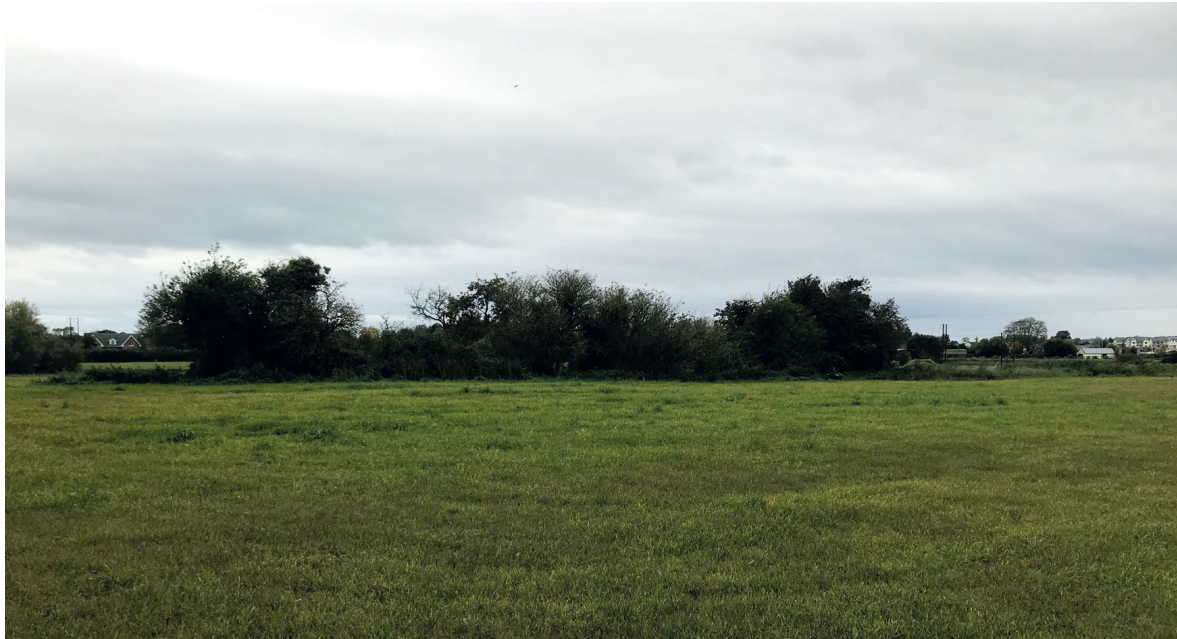
Image 13. Hedgerow G.

**Description:** A degraded agricultural hedgerow located within southern section of the site which has lapsed due to lack of maintenance. Occasional standard hawthorn present. A plantation of young ash within the neighbouring site to the east providing a degree of shelter and screening to subject site.

**Species present:** Hawthorn, elder and bramble.

**Average height:** 4 meters **Total length:** 341 meters
