Stage 1 Road Safety Audit

Residential Development, Rosshill, Galway
On behalf of Kegata Ltd

December 2019

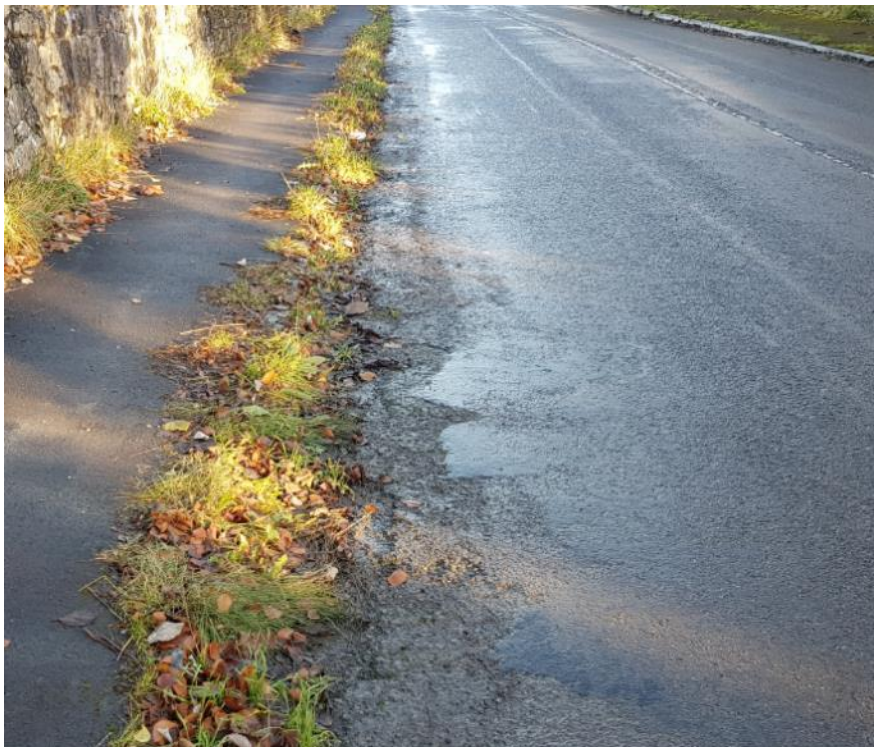
2.2.1 Old Dublin Road – Rosshill Road: Pedestrian Access to the Development

Problem: Neither the Old Dublin Road or the Rosshill Road have suitable pedestrian or cycle facilities. The proposed development is likely to generate substantial pedestrian and cyclist numbers.

We have been informed that the Old Dublin Road in particular gets very busy during the AM and PM peak hours with commuting traffic.

Hazard: Pedestrians may decide to walk in the carriageway due to the poor-quality footpaths. Additionally, motorists may not give sufficient space for cyclists on the road. Impact between users may result.

Recommendation: Provide upgraded facilities for non-motorised users.

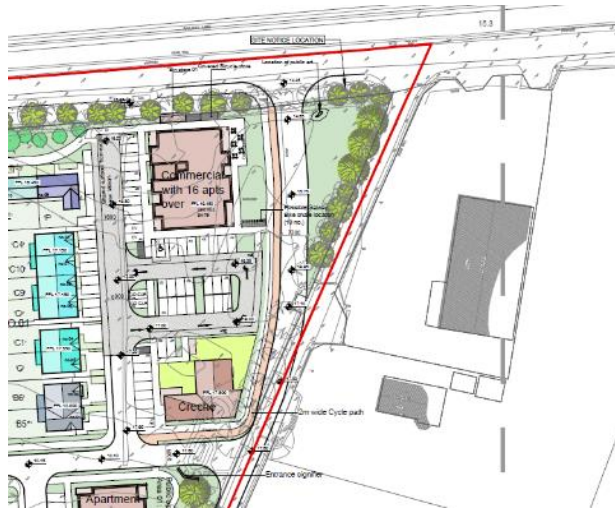
2.2.3 Cyclist Provision

Problem: The proposals indicate a short section of cycle path running adjacent to the revised Rosshill Road. There are no details given to indicate if this is intended to operate as a bi-directional cycle path or details of how the cyclists is meant to join the carriageway at either end.

Hazard: Cyclists may impact with motorised traffic at either end, or pedestrians or other opposing cyclists on route.

Recommendation: Provide facilities for cyclists that are easily understood by the users and caters for access and egress to the development.

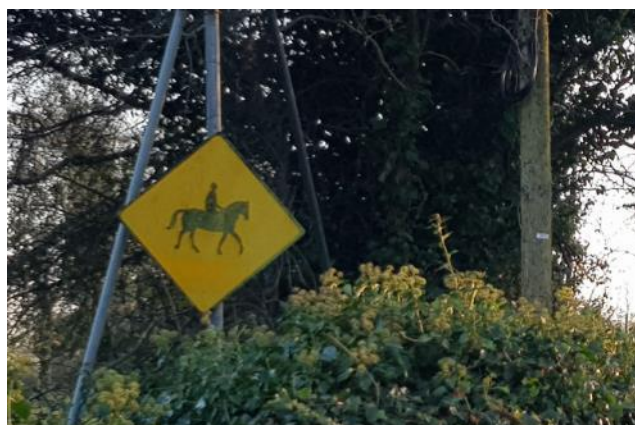
2.2.4 Equestrians

Problem: There are numerous signs on Rosshill Road warning of equestrian use of the road.

Hazard: The increased traffic numbers due to the development increase the risk of vehicle / horse impacts.

Recommendation: The design team should undertake investigations to the use of the Rosshill Road and provide segregated equestrian facilities if deemed necessary.

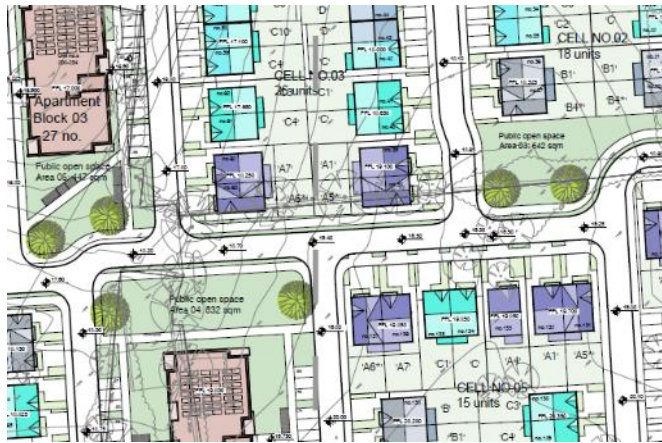
2.2.5 Development Roads: Horizontal Alignment

Problem: The long straight and near straight sections of the internal road network does not promote slow driving.

Hazard: High vehicle speeds generally result in increased injuries when impacts with pedestrians occur.

Recommendation: Ensure long straight lengths of carriageway are removed from the design. DMURS chapter 4.4.7 can be used as a reference document for the design of the internal roads.

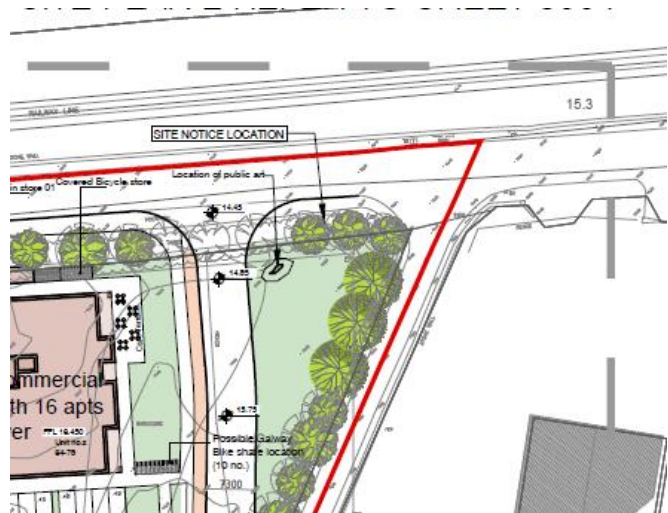
2.3.1 Existing Rosshill Road / Old Dublin Road Junction.

Problem: The proposed new junction is in close proximity to the existing junction.

Hazard: Old Dublin Road traffic arriving from the east may errantly turn into the redundant road junction. These users may be required to reverse back onto the public road. Rear end impacts may result.

Recommendation: Ensure the existing road and junction is removed and suitably landscaped to avoid any confusion that a road exists at this location. Ensure adequate signage is provided to inform drivers of new junction layout.

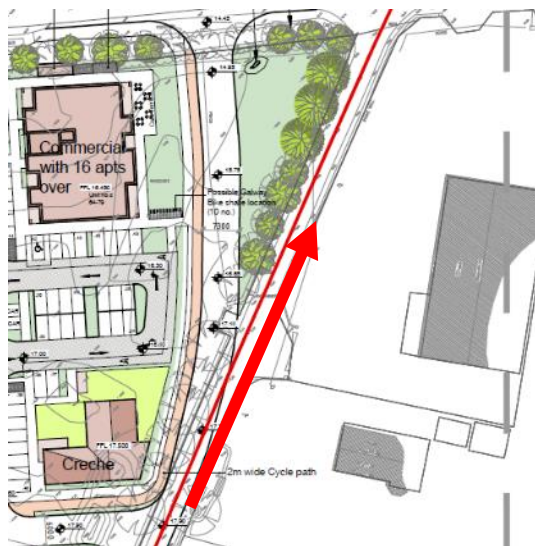
2.3.2 Redundant Section of Rosshill Road

Problem: Northbound Rosshill Road traffic may have see-through to the former section of road (to be closed). Users may errantly drive onto the closed section of road and be required to reverse back onto the revised road alignment.

Hazard: Rear-end shunts may result.

Recommendation: Ensure see-through to the former road is omitted.

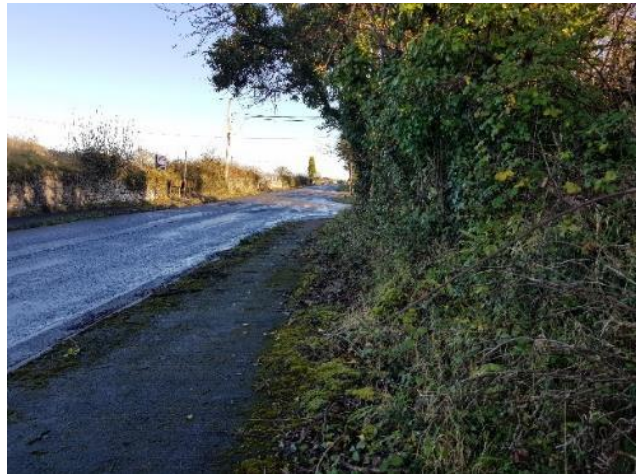
2.3.3 Rosshill Road / Old Dublin Road: Junction Visibility

Problem: Visibility to the right when exiting the development may be restricted due to roadside vegetation. Vehicles approaching the proposed junction from the east do so at high speed.

Hazard: Users may proceed from the new junction into the Old Dublin Road into the path of oncoming vehicles. Impact may result.

Recommendation: Ensure the available junction visibility is suitable for the speed of traffic on the road.

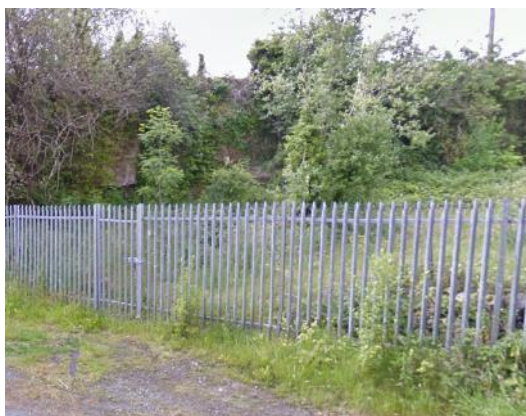
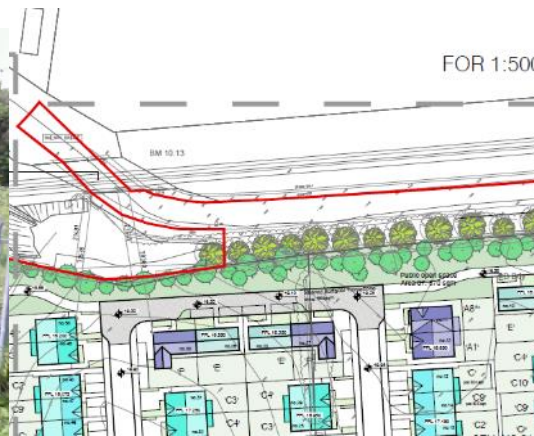
2.3.4 Old Dublin Road: Retaining Wall

Problem: The internal road network is in close proximity to the high retaining wall at the CIÉ entrance to the railway.

Hazard: Errant vehicles may leave the road at the tight bend and fall over the retaining wall.

Recommendation: Provide measures to ensure vehicle access to the top of the wall is not possible.

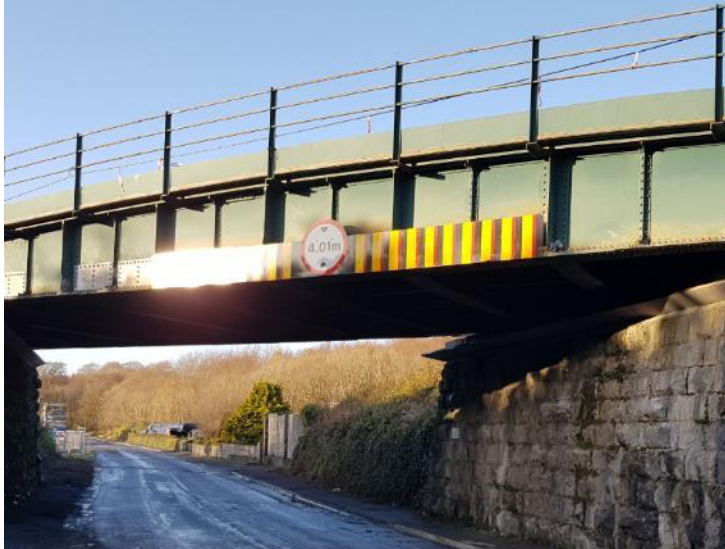
2.3.5 Railway Bridge: Height

Problem: The railway bridge over the Old Dublin Road is signed as 4.0m clearance. Although unlikely to be a problem for the occupants of the development some construction traffic may be higher than this limit.

Hazard: Construction vehicles may strike the bridge and damage the structural integrity of the bridge.

Recommendation: Ensure the Construction Management Plan identifies a suitable access route for high vehicles.

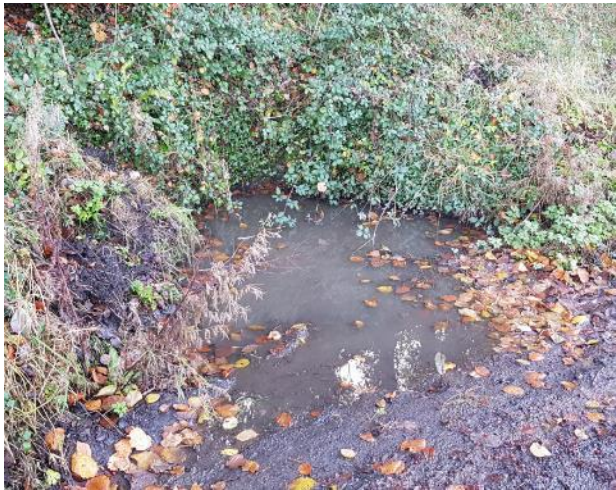
2.3.6 Dublin Road: Drainage

Problem: The existing Old Dublin Road drainage is not working adequately. The development will generate increased traffic movements on this road.

Hazard: During times of extreme rainfall standing water may encroach into the carriageway. Risk of vehicular loss of control will be heightened by the increased use of this road.

Recommendation: Ensure adequate surface water drainage is provided.

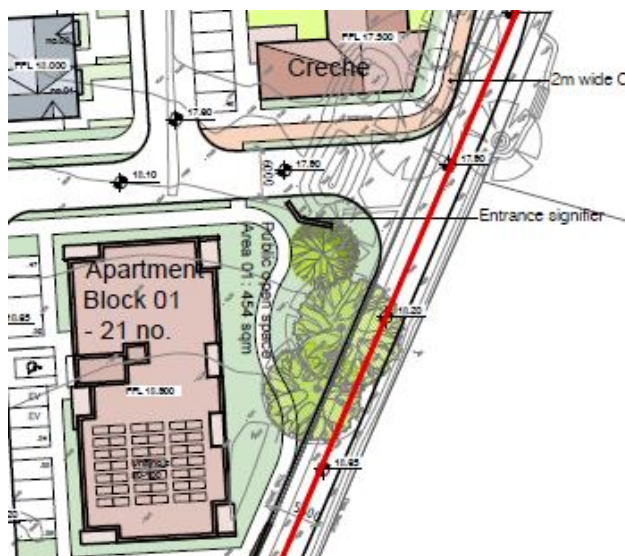
2.3.7 Development Junction with Rosshill Road: Visibility

Problem: Large trees are proposed to the right of the new junction, within the visibility envelope.

Hazard: Users may pull out of the junction into the path of oncoming traffic.

Recommendation: Ensure all high landscaping is kept to the rear of the junction visibility splay.
