Parkgate Street Arboricultural Assessment

Parkgate Street

Project No.	Project name	Date	Revision
TPAR001	Parkgate St.	28/01/19	-

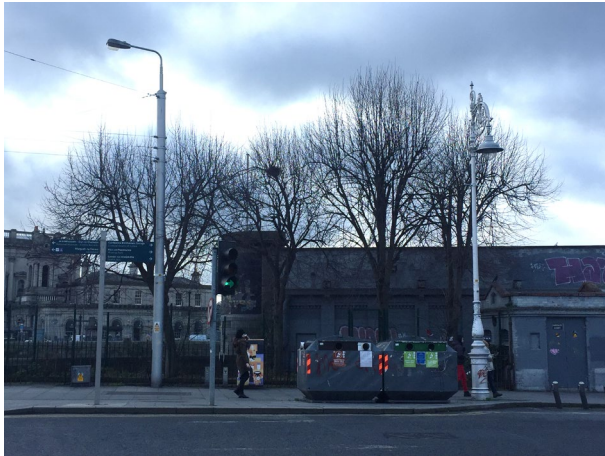
Image 2. View of tree group from north

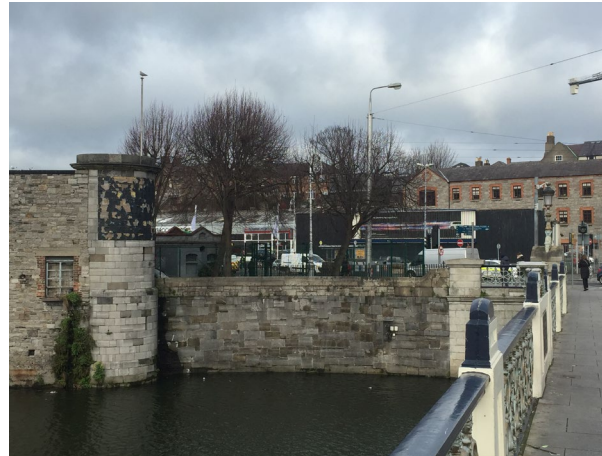
Image 3. View of tree group from south

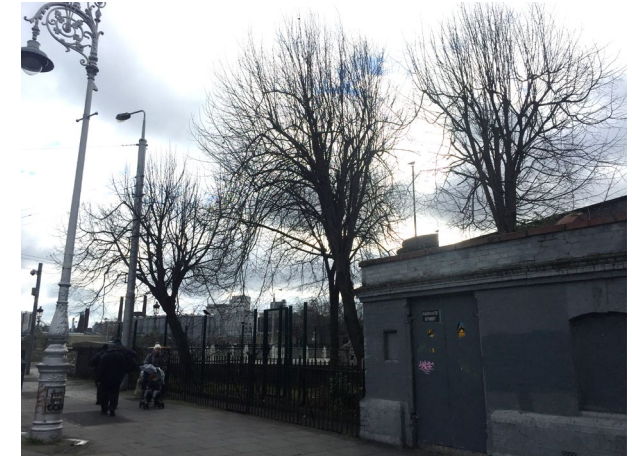
Image 4. Tree #1 to left of image with a lean and tree #4 to right of image with crown topped

Tag No.	Species	Age Category	General Condition	Comments	Preliminary Recommendations	Landscape and Arboricultural Category	Useful Life Expectancy
0001	Lime cultivar Tilia cordata cv	Early-mature	Good	Trunk with a lean toward north-east due to competition from neighbourig tree. Lean not significant with crown vertical in orientation. Upper canopy relatively well dveloped with no visible defects.	No action necessary	B2	30-40
0002	Lime cultivar Tilia cordata cv	Early-mature	Good	Trunk co-dminant from 3m with a wide union between stems. Upper canopy relatively well developed with no visible defects.	No action necessary	B2	30-40
0003	Lime cultivar Tilia cordata cv	Early-mature	Good	Trunk multi-stemmed from 3m with tight unions between stems. However unlikely to be significant at present. Canopy toward west has been reduced in the past but overall crown relatively well developed.	No action necessary	B2	30-40

0004	Lime cultivar Tilia cordata cv	Early-mature	Good	Upper canopy topped to west over neighbouring building reducing the trees visual quality. Remaining crown relatively well developed. Trunk co-dominant from 2m with a tight union and included bark between stems.	No action necessary	B2	30-40
