Date: 30th. May 2019

Project: Title: AIRTON ROAD SHD Stage 3

Report Title: Arboricultural Tree Survey Report

Client(s): GREENLEAF HOMES LIMITED

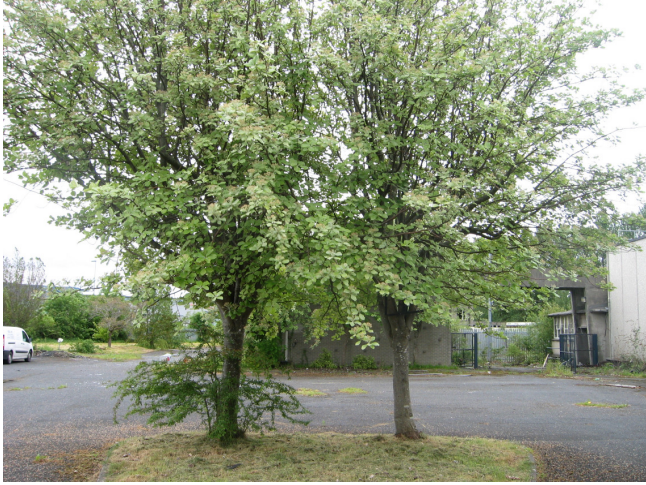
Photo 1: Views of tree no. 861 and 862

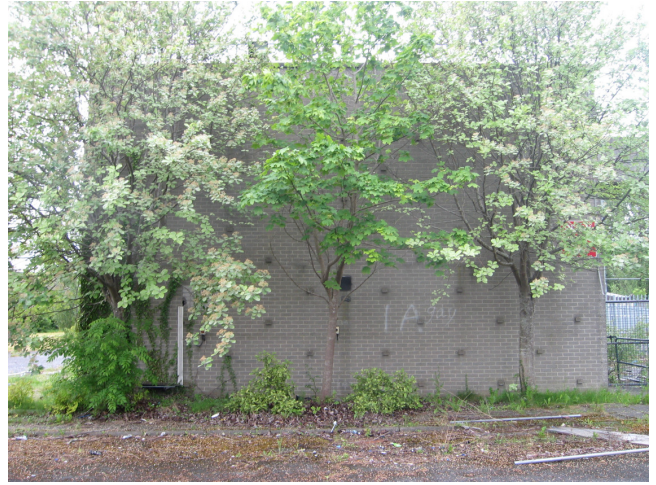
865	Whitebeam	9.0	27	2N 0S 2E 0W	MA	Good.	Growing in shrub bed close to building. Suppressed on southern side. Forked at 1.5m. Unbalanced crown.	Lightly prune back limbs on north side to improve balance and shape. Sever light ivy growth at base.	>40	A
866	Cherry	7.0	14-Avg.	1N 1S 2E 1W	MA	Fair.	Early signs of decline. Forked from .5m. Lacks vigour.	Remove all minor dead stems.	>40	B
867	Cherry	5.0	30	2N 2S 1E 3W	MA	Poor.	Straight stem to 1.5m. Low leaf area. Epicormic shoot growth on east side.	Remove epicormic shoot growth. Prune to invigorate new growth.	>40	C
868	Poplar X 4 stems	9.0	15,13 7,6	1N 1S 1E 1W	M	Fair.	Derived from sucker growth. Close to kerb. Not for long-term retention.	Fell and treat resultants stumps.	>40	U

Photo 2: Views of tree nos. 863-865

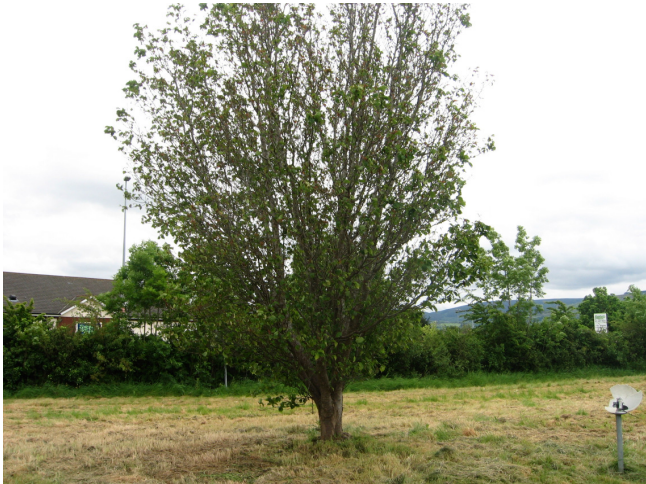
Photo 3: Views of Cherry tree no. 866

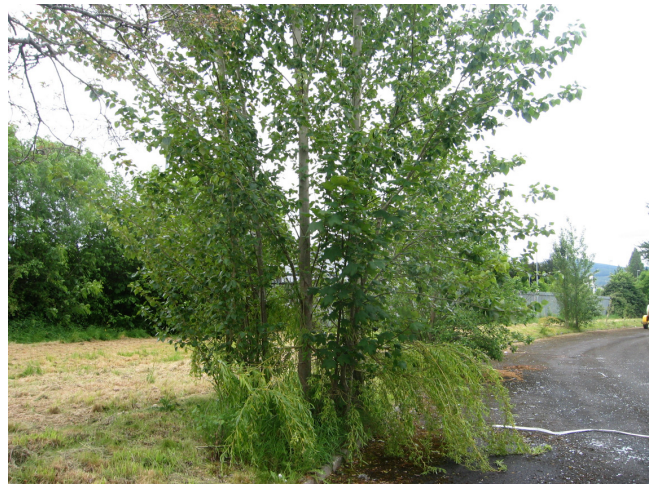
Photo 4: Poplar tree no. 868 derived from root suckering

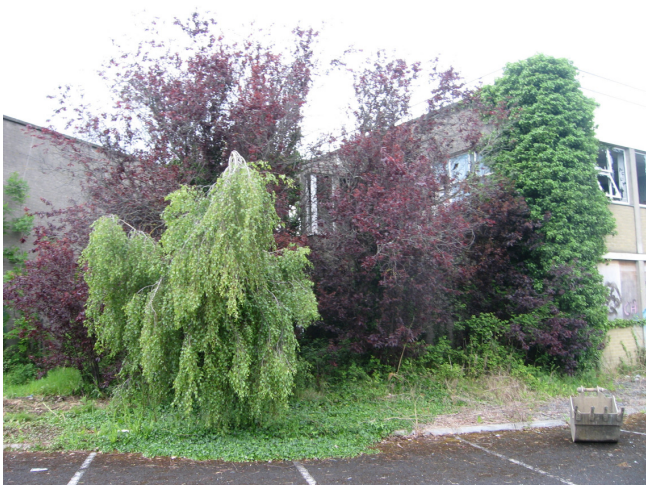
869	Myrobalan Plum	9.0	15,10 9	2N 0S 2E 0W	MA	Fair.	Heavy ivy growth attached. Multiple stems. Early signs of decline.	Sever ivy growth and prune to invigorate new growth. Remove any dead stems.	20-40	B
870	Myrobalan Plum	10.0	38	2N 2S 1E 2W	MA	Fair.	Heavy ivy growth attached. Forked from 1m. Multiple stems. Early signs of decline.	Sever ivy growth and prune to invigorate new growth. Remove any dead stems.	20-40	B
871	Weeping birch	3.0	19	0N 1S 4E 0W	MA	Fair.	Slightly suppressed. Unbalanced crown.	Requires pruning to reshape crown. Retain pendulous habit.	20-40	B
872	Weeping willow	10.0	55	4N 1S 0E 4W	MA	Good.	Leaning to west. Dead stems in crown. Heavy ivy growth to tip.	Remove all dead stems. Sever ivy growth at base. Remove broken stems west side.	>40	A
873	Poplar	10.0	22	.5N .5S .5E .5W	M	Good.	Derived from sucker growth. Close to fence. Not for long-term retention. Vigourous growth habit.	Consider removing tree.	>40	C

Photo 5: Views of tree nos. 869-871

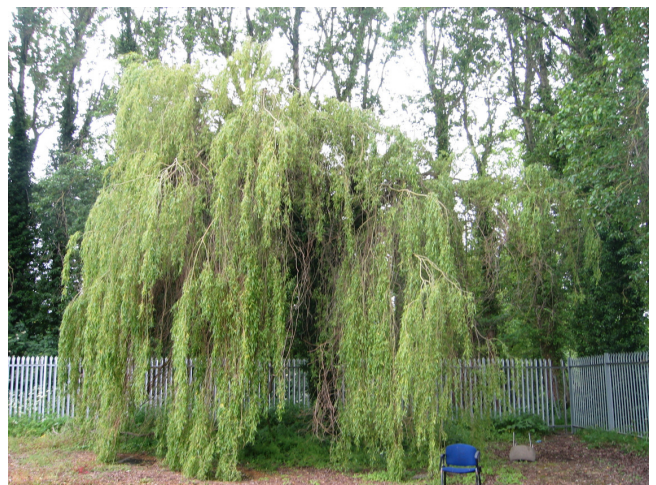
Photo 6: Weeping willow tree no. 872

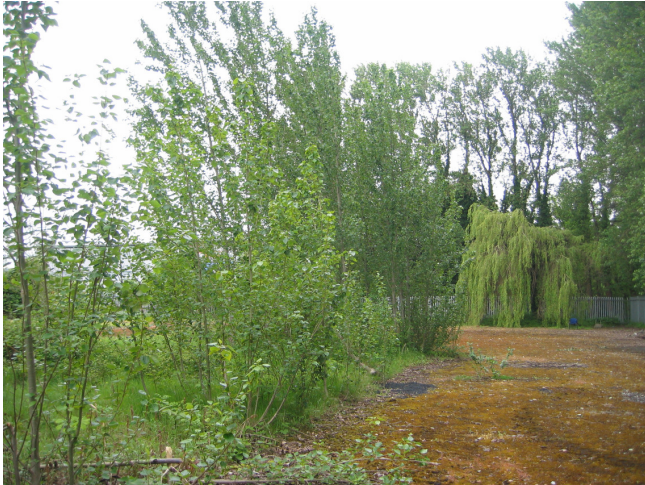
- 4.4 The derelict site is being colonized with pioneer scrub species of Birch, Buddleia and Ash. There are signs of Poplar shoot growth originating from surface roots that have possibly encroached into the site. The Poplar roots and emerging shoots are causing damage to the tarmac surfacing in areas around the site, particularly to the rear of the main building. It is likely that roots are originating from the line of Poplar trees around the southeastern boundary. As Poplar roots are destructive and can cause damage to buildings, roads, and underground services, it will be important as part of any development proposals for the site, that a root control programme be implemented to prevent the encroachment of roots into the site. A tree root control programme may include the installation of a root barrier membrane where required.

Photo 7: Heavy growth mass of Poplar shoots near SW boundary.

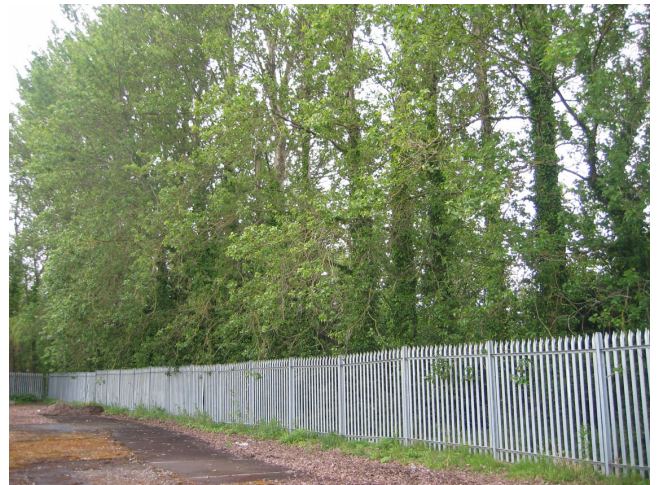
- 4.5 The *Populus spp.* (Poplar) trees in the southwestern corner of the site are generally in fair condition. The trees have a vigorous growth habit and the trees are in excess of twenty-two metres tall. The close planting spacing (1-2m) is causing restricted and suppressed tree crowns as trees compete for light and growing space. Heavy ivy growth is attached to their main stems which restricted and limited our assessments.

Photo 8: Views of row of Poplar trees outside southern boundary.

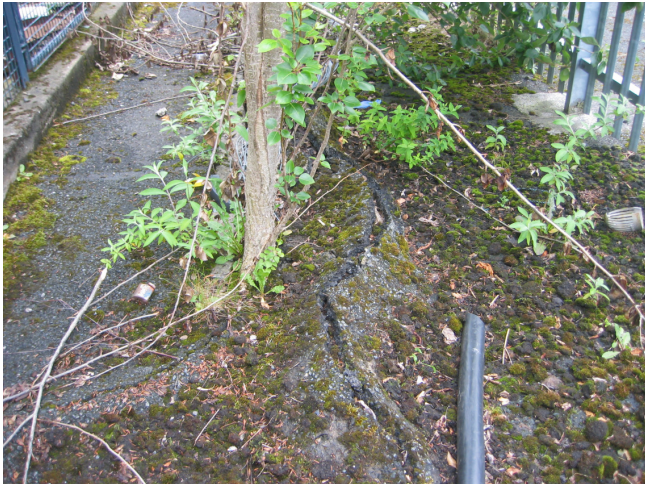
Photo 7: Signs of root damage to paved surface

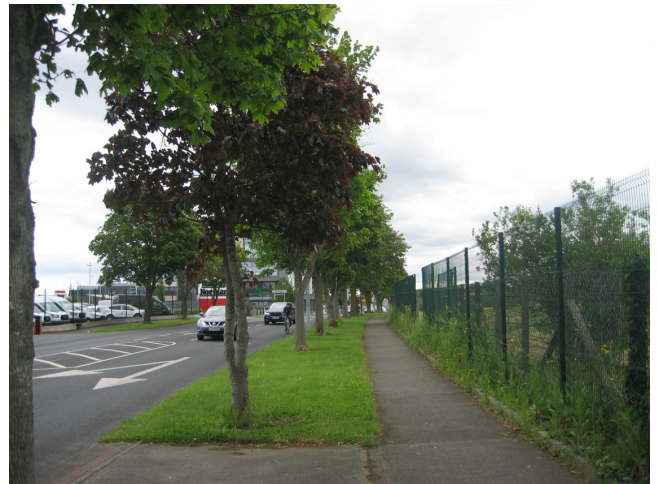
Photo 8: Trees on LA lands northern boundary

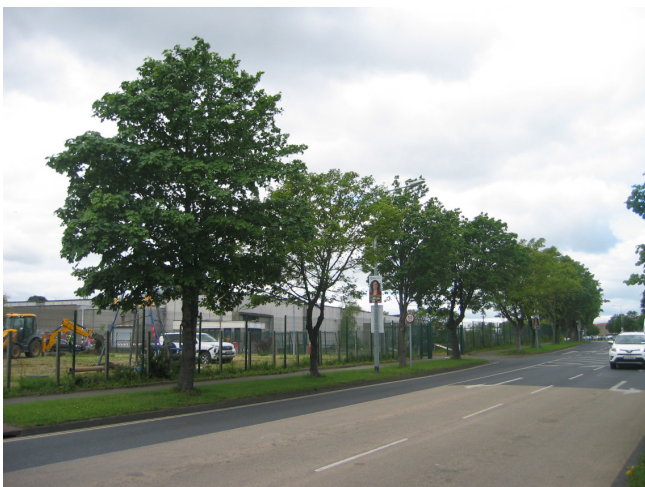
- 4.7 There is an attractive row of middle-aged Maple and Sycamore (Tree ref. A-S) planted on public lands on the narrow grass margin between the footpath and Airton Road. These trees are generally in good condition with the exception of three tree refs. (F, K, M) which are showing symptoms of decline. The roadside trees

Photo 7: Views of trees along Airton Road at entrance to site.

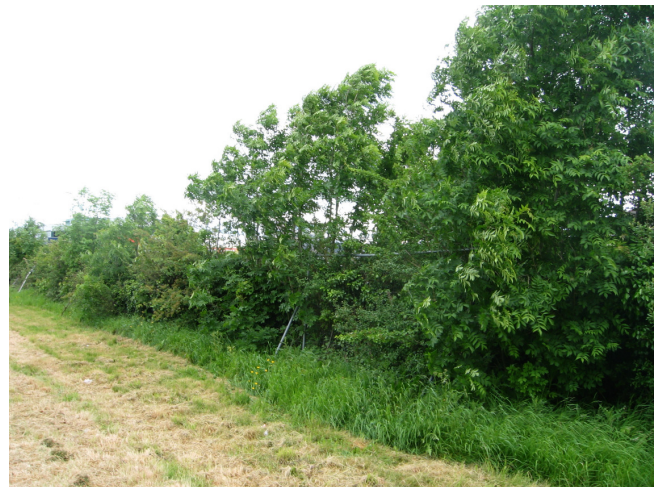
- 4.6 The hedgerow (H1) along the eastern boundary of the site is in good condition and comprises of native hedgerow indigenous species of *Crataegus monogyna* (Whitethorn), *Prunus spinosa* (Blackthorn), *Corylus avellana* (Hazel), *Rosa spp.* (Rosa) and *Fraxinus excelsior* (Ash). The hedgerows will require ongoing trimming to curtail height and lateral spread.

Photo 8: Views of hedgerow (H1) - East boundary.
