ASBESTOS SURVEY REPORT

(Refurbishment / Demolition Survey)

**Location: Former Gallagher Cigarette Factory,
Airton Road Site, Tallaght, Dublin 24**

Report No. PE 19-376

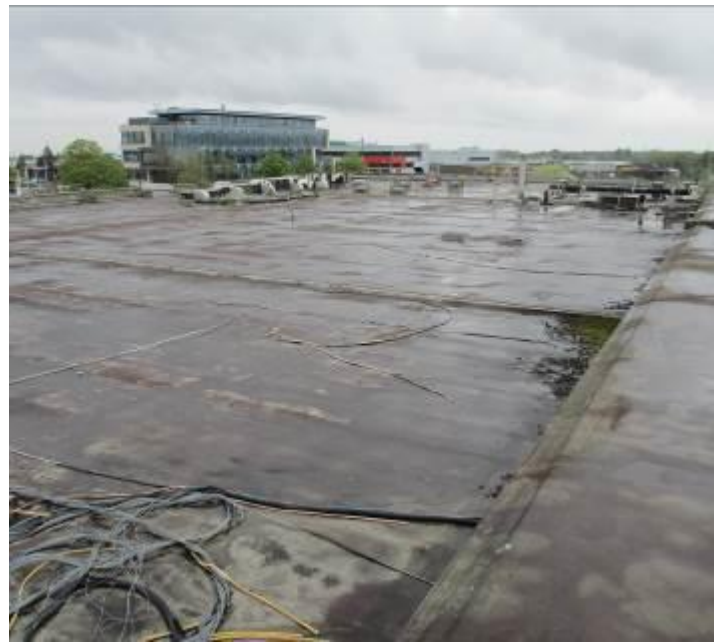
Created By	Andrew Hickey
Date	2 nd May 2019
Site Details	Former Gallagher Cigarette Factory Site, Airton Road Site, Tallaght, Dublin 24
Client Name	Elliott Group
Survey Type	R/D Asbestos Survey
Site Ref	PE 19-376
Building Ref.	Block 1
Location	Main roof
Extent/ Amount	5,250 m ² approx.

MATERIAL ASSESSMENT		PRIORITY ASSESSMENT
Product type	Felt	Normal occupant activity	N/A
Extent of damage	Low	Likelihood of disturbance	N/A
Surface treatment	Well bound material	Human exposure potential	N/A
Asbestos type	Chrysotile	Maintenance activity	N/A
	Material assessment score: N/A	TOTAL SCORE: N/A	Priority assessment score: N/A

All asbestos removal work must be carried out in accordance with S.I. No. 386 of 2006 Safety, Health and Welfare at Work (Exposure to Asbestos) Regulations 2006-2010

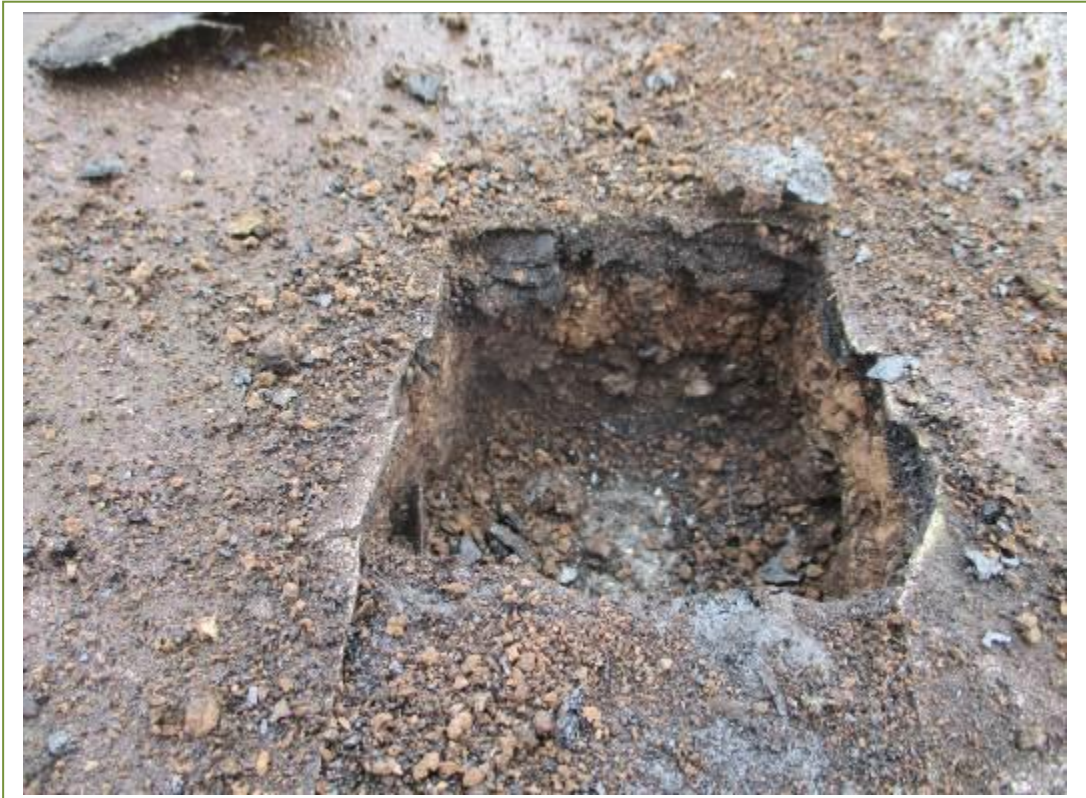
DETAIL OF THE ASBESTOS FELT ON BLOCK 1

Closer view of the asbestos containing felt

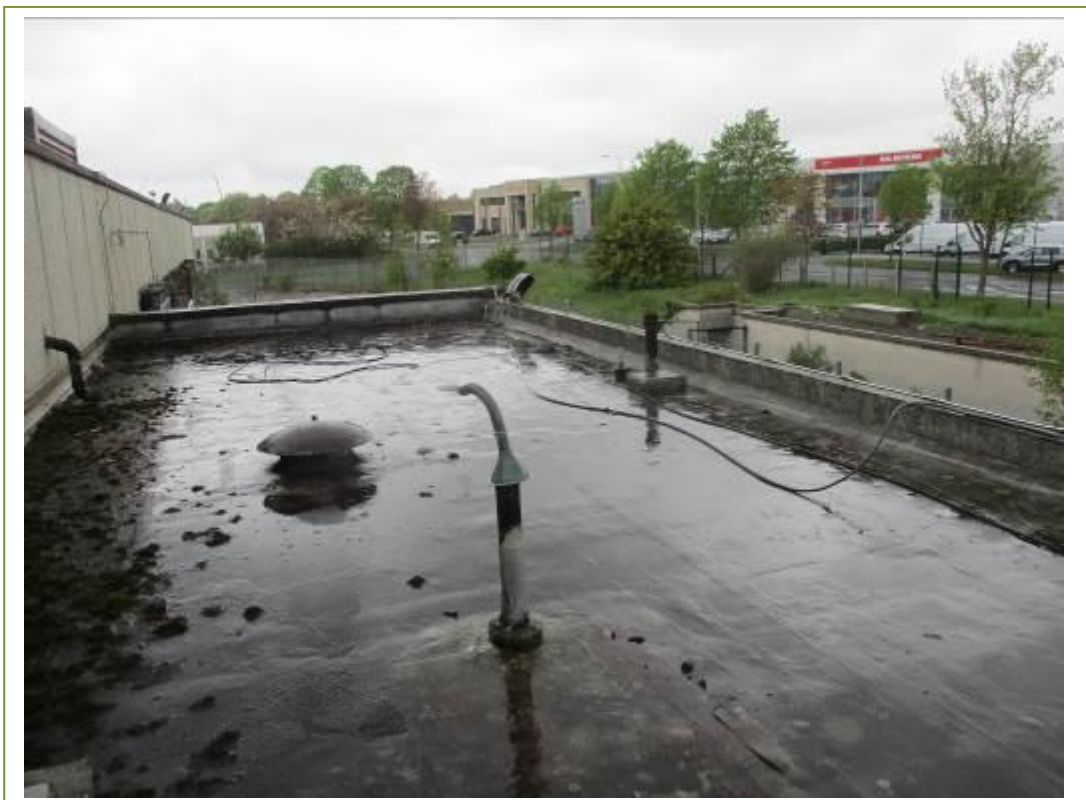
The felt on the lower flat roof to the front had the same felt applied

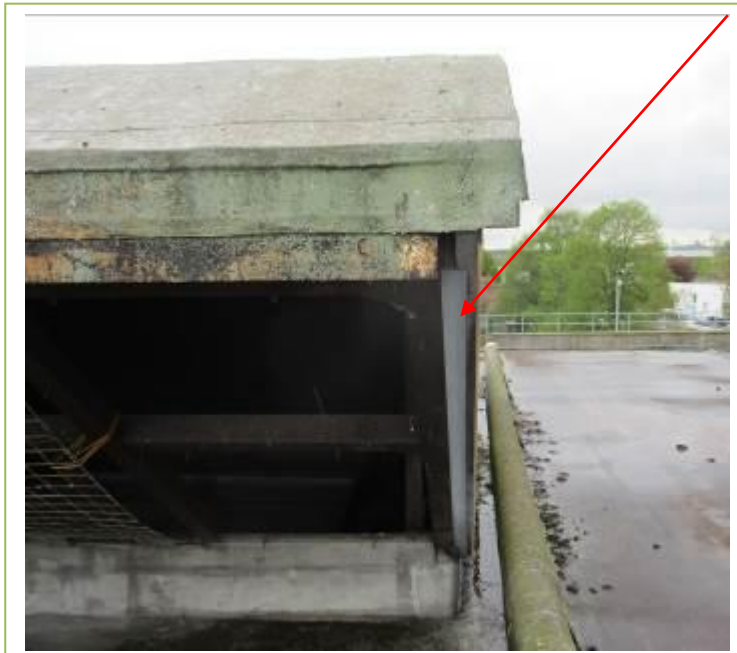
Created By	Andrew Hickey
Date	2 nd May 2019
Site Details	Former Gallagher Cigarette Factory Site, Airton Road Site, Tallaght, Dublin 24
Client Name	Elliott Group
Survey Type	R/D Asbestos Survey
Site Ref	PE 19-376
Building Ref.	Block 1
Location	Main roof area
Extent/ Amount	4 x 2 linear meters approx.

MATERIAL ASSESSMENT		PRIORITY ASSESSMENT
Product type	Galbestos	Normal occupant activity	N/A
Extent of damage	Low	Likelihood of disturbance	N/A
Surface treatment	Well bound material	Human exposure potential	N/A
Asbestos type	Chrysotile	Maintenance activity	N/A
	Material assessment score: N/A	TOTAL SCORE: N/A	Priority assessment score: N/A

All asbestos removal work must be carried out in accordance with S.I. No. 386 of 2006 Safety, Health and Welfare at Work (Exposure to Asbestos) Regulations 2006-2010

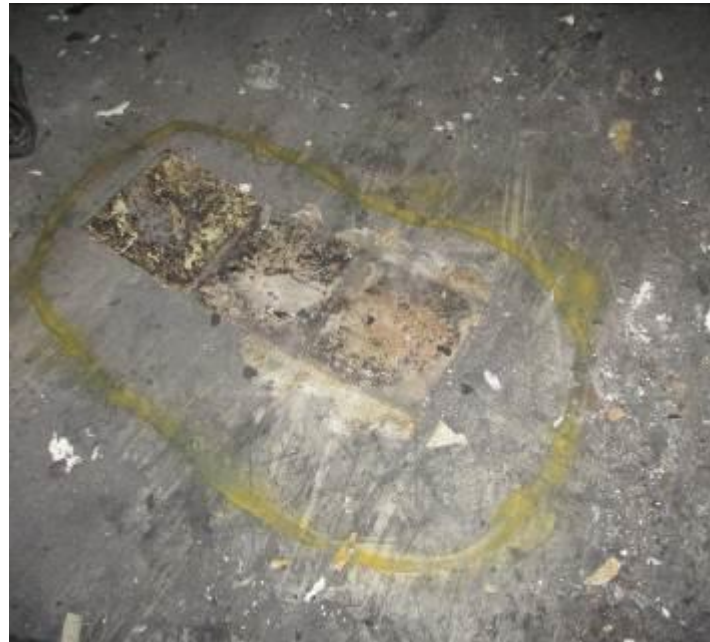
Created By	Andrew Hickey
Date	2 nd May 2019
Site Details	Former Gallagher Cigarette Factory Site, Airton Road Site, Tallaght, Dublin 24
Client Name	Elliott Group
Survey Type	R/D Asbestos Survey
Site Ref	PE 19-376
Building Ref.	Block 1
Location	Warehouse & office areas
Extent/ Amount	1,300 m ² approx.

MATERIAL ASSESSMENT		PRIORITY ASSESSMENT
Product type	Floor tile & bitumen adhesive	Normal occupant activity	N/A
Extent of damage	High	Likelihood of disturbance	N/A
Surface treatment	None	Human exposure potential	N/A
Asbestos type	Chrysotile	Maintenance activity	N/A
	Material assessment score: N/A	TOTAL SCORE: N/A	Priority assessment score: N/A

All asbestos removal work must be carried out in accordance with S.I. No. 386 of 2006 Safety, Health and Welfare at Work (Exposure to Asbestos) Regulations 2006-2010

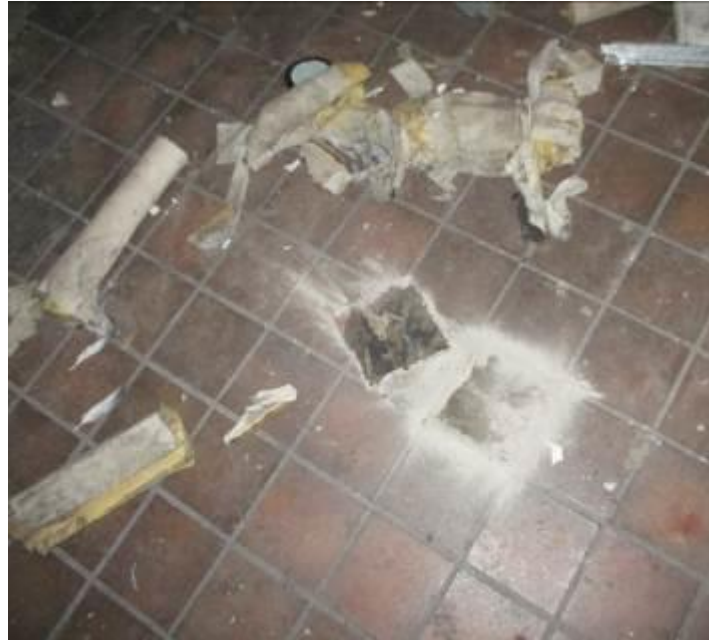
Created By	Andrew Hickey
Date	2 nd May 2019
Site Details	Former Gallagher Cigarette Factory Site, Airton Road Site, Tallaght, Dublin 24
Client Name	Elliott Group
Survey Type	R/D Asbestos Survey
Site Ref	PE 19-376
Building Ref.	Block 1
Location	Toilet block area
Extent/ Amount	90 m ² approx.

MATERIAL ASSESSMENT		PRIORITY ASSESSMENT
Product type	Bitumen adhesive	Normal occupant activity	N/A
Extent of damage	Low	Likelihood of disturbance	N/A
Surface treatment	Covered	Human exposure potential	N/A
Asbestos type	Chrysotile	Maintenance activity	N/A
	Material assessment score: N/A	TOTAL SCORE: N/A	Priority assessment score: N/A

All asbestos removal work must be carried out in accordance with S.I. No. 386 of 2006 Safety, Health and Welfare at Work (Exposure to Asbestos) Regulations 2006-2010

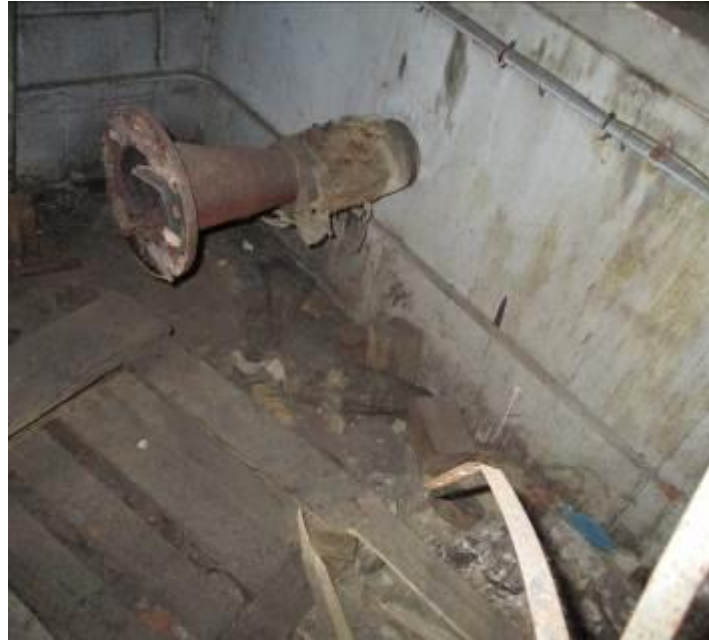
Created By	Andrew Hickey
Date	2 nd May 2019
Site Details	Former Gallagher Cigarette Factory Site, Airton Road Site, Tallaght, Dublin 24
Client Name	Elliott Group
Survey Type	R/D Asbestos Survey
Site Ref	PE 19-376
Building Ref.	Block 1
Location	Throughout
Extent/ Amount	1 per flange & loose

MATERIAL ASSESSMENT		PRIORITY ASSESSMENT
Product type	CAF Gasket	Normal occupant activity	N/A
Extent of damage	High	Likelihood of disturbance	N/A
Surface treatment	None	Human exposure potential	N/A
Asbestos type	Chrysotile	Maintenance activity	N/A
	Material assessment score: N/A	TOTAL SCORE: N/A	Priority assessment score: N/A

The compressed asbestos fibre (CAF) gaskets identified on the pipework flanges and loose on the floor of block 1 contain Chrysotile (white) asbestos. CAF gaskets have an asbestos content approaching 100% asbestos fibres with a small amount of binder

All asbestos removal work must be carried out in accordance with S.I. No. 386 of 2006 Safety, Health and Welfare at Work (Exposure to Asbestos) Regulations 2006-2010

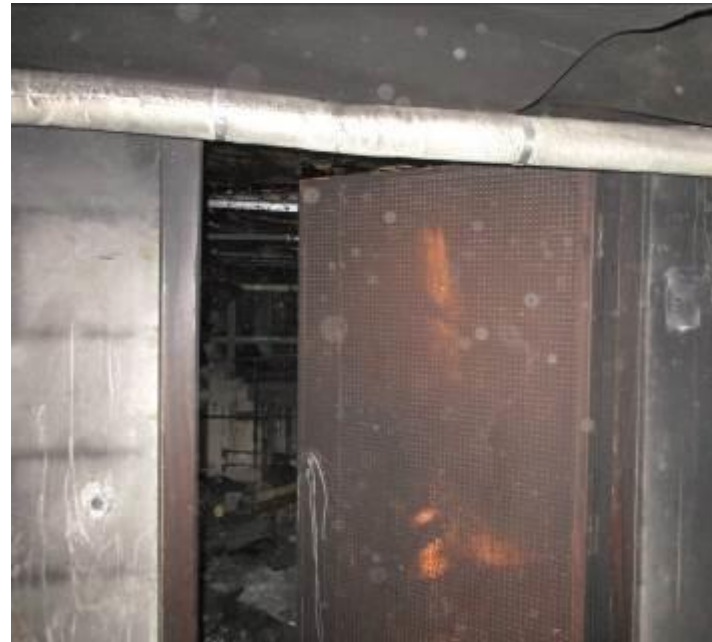
Created By	Andrew Hickey
Date	2 nd May 2019
Site Details	Former Gallagher Cigarette Factory Site, Airton Road Site, Tallaght, Dublin 24
Client Name	Elliott Group
Survey Type	R/D Asbestos Survey
Site Ref	PE 19-376
Building Ref.	Block 1
Location	Warehouse & office areas
Extent/ Amount	5 doors total approx.

MATERIAL ASSESSMENT		PRIORITY ASSESSMENT
Product type	Asbestos insulation board	Normal occupant activity	N/A
Extent of damage	Medium	Likelihood of disturbance	N/A
Surface treatment	None	Human exposure potential	N/A
Asbestos type	Amosite	Maintenance activity	N/A
	Material assessment score: N/A	TOTAL SCORE: N/A	Priority assessment score: N/A

All asbestos removal work must be carried out in accordance with S.I. No. 386 of 2006 Safety, Health and Welfare at Work (Exposure to Asbestos) Regulations 2006-2010

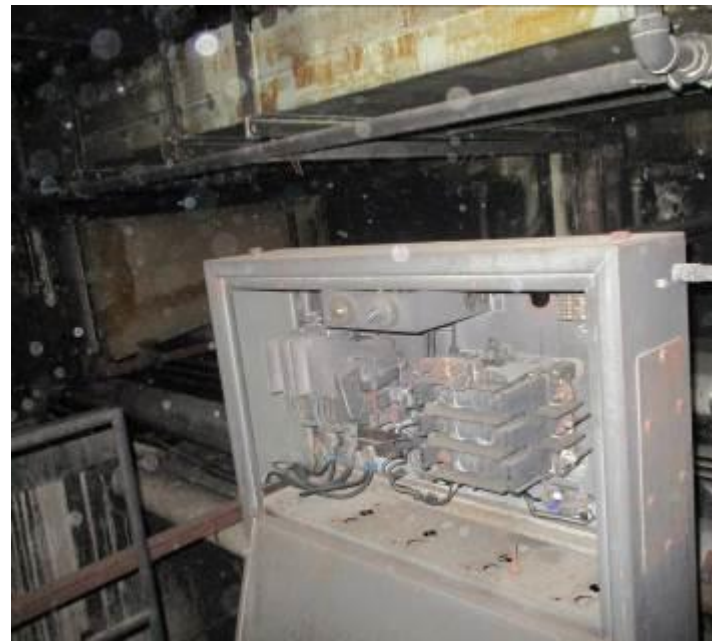
Created By	Andrew Hickey
Date	2nd May 2019
Site Details	Former Gallagher Cigarette Factory Site, Airton Road Site, Tallaght, Dublin 24
Client Name	Elliott Group
Survey Type	R/D Asbestos Survey
Site Ref	PE 19-376
Building Ref.	Block 1
Location	Old electrics
Extent/ Amount	Not quantified

MATERIAL ASSESSMENT		PRIORITY ASSESSMENT
Product type	Asbestos cement	Normal occupant activity	N/A
Extent of damage	Medium	Likelihood of disturbance	N/A
Surface treatment	None	Human exposure potential	N/A
Asbestos type	Chrysotile	Maintenance activity	N/A
	Material assessment score: N/A	TOTAL SCORE: N/A	Priority assessment score: N/A

All asbestos removal work must be carried out in accordance with S.I. No. 386 of 2006 Safety, Health and Welfare at Work (Exposure to Asbestos) Regulations 2006-2010

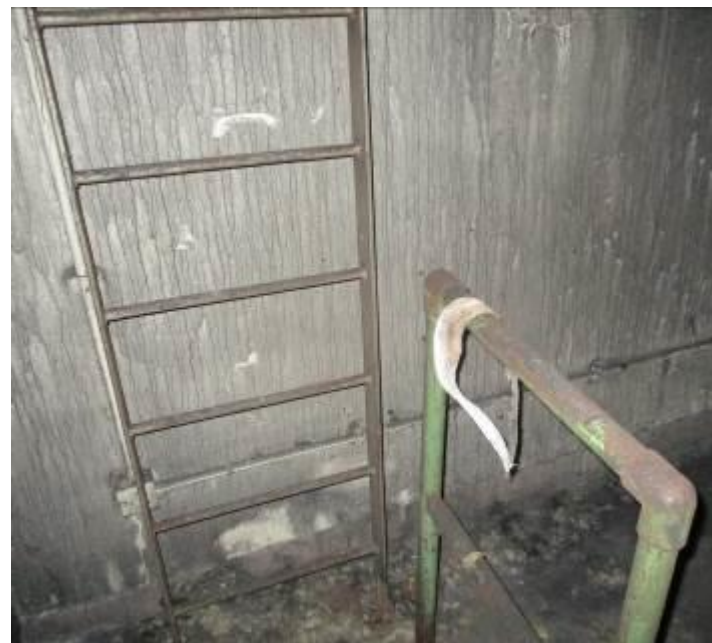
Created By	Andrew Hickey
Date	2 nd May 2019
Site Details	Former Gallagher Cigarette Factory Site, Airton Road Site, Tallaght, Dublin 24
Client Name	Elliott Group
Survey Type	R/D Asbestos Survey
Site Ref	PE 19-376
Building Ref.	Block 1
Location	Mezzanine area
Extent/ Amount	1 roll & debris

MATERIAL ASSESSMENT		PRIORITY ASSESSMENT
Product type	Textile	Normal occupant activity	N/A
Extent of damage	Medium	Likelihood of disturbance	N/A
Surface treatment	None	Human exposure potential	N/A
Asbestos type	Chrysotile	Maintenance activity	N/A
	Material assessment score: N/A	TOTAL SCORE: N/A	Priority assessment score: N/A

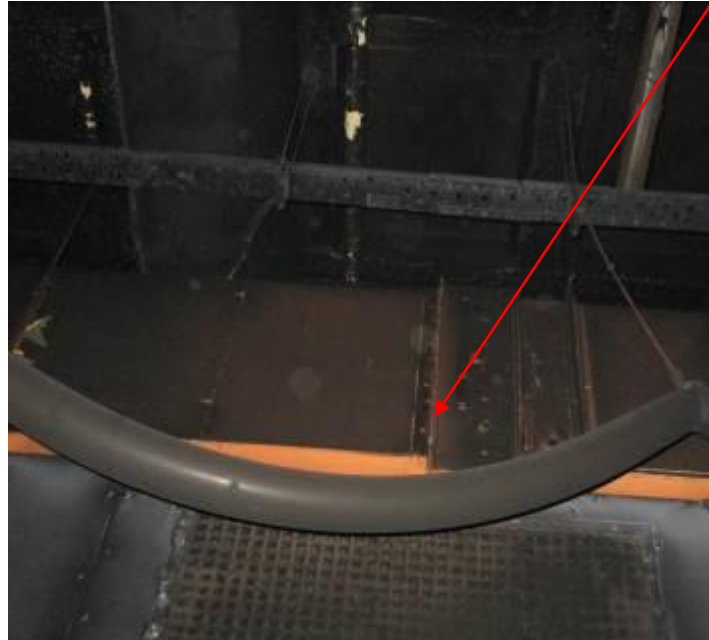
Created By	Andrew Hickey
Date	2 nd May 2019
Site Details	Former Gallagher Cigarette Factory Site, Airton Road Site, Tallaght, Dublin 24
Client Name	Elliott Group
Survey Type	R/D Asbestos Survey
Site Ref	PE 19-376
Building Ref.	Block 1
Location	Ducting
Extent/ Amount	Between joints

MATERIAL ASSESSMENT		PRIORITY ASSESSMENT
Product type	Rope	Normal occupant activity	N/A
Extent of damage	Medium	Likelihood of disturbance	N/A
Surface treatment	None	Human exposure potential	N/A
Asbestos type	Chrysotile	Maintenance activity	N/A
	Material assessment score: N/A	TOTAL SCORE: N/A	Priority assessment score: N/A

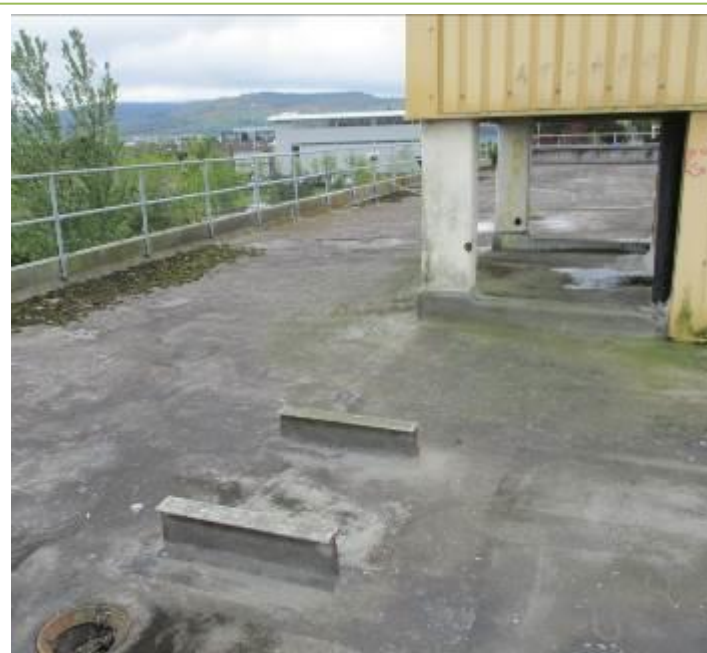
Created By	Andrew Hickey
Date	2 nd May 2019
Site Details	Former Gallagher Cigarette Factory Site, Airton Road Site, Tallaght, Dublin 24
Client Name	Elliott Group
Survey Type	R/D Asbestos Survey
Site Ref	PE 19-376
Building Ref.	Block 2
Location	Main roof
Extent/ Amount	500 m ² approx.

MATERIAL ASSESSMENT		PRIORITY ASSESSMENT
Product type	Felt	Normal occupant activity	N/A
Extent of damage	Low	Likelihood of disturbance	N/A
Surface treatment	Covered with asphalt	Human exposure potential	N/A
Asbestos type	Chrysotile	Maintenance activity	N/A
	Material assessment score: N/A	TOTAL SCORE: N/A	Priority assessment score: N/A

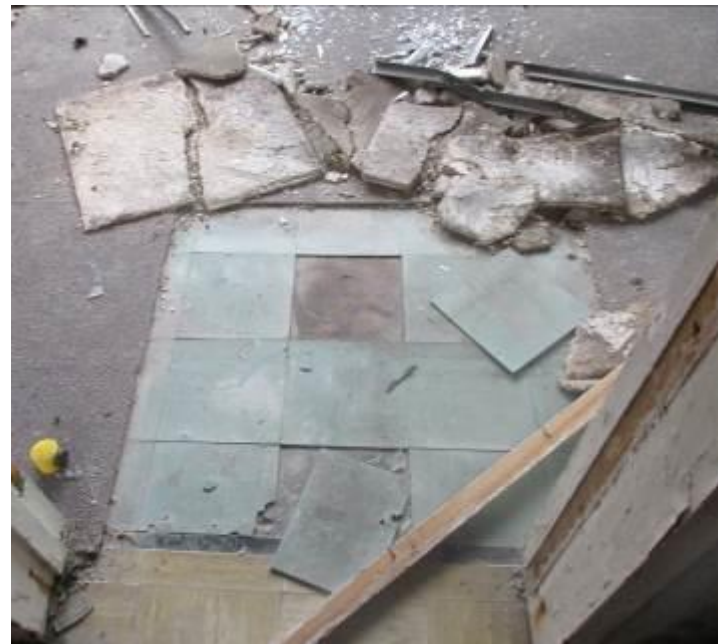
Created By	Andrew Hickey
Date	2 nd May 2019
Site Details	Former Gallagher Cigarette Factory Site, Airton Road Site, Tallaght, Dublin 24
Client Name	Elliott Group
Survey Type	R/D Asbestos Survey
Site Ref	PE 19-376
Building Ref.	Block 2
Location	Office areas
Extent/ Amount	800 m ² approx.

MATERIAL ASSESSMENT		PRIORITY ASSESSMENT
Product type	Floor tile & bitumen adhesive	Normal occupant activity	N/A
Extent of damage	High	Likelihood of disturbance	N/A
Surface treatment	None	Human exposure potential	N/A
Asbestos type	Chrysotile	Maintenance activity	N/A
	Material assessment score: N/A	TOTAL SCORE: N/A	Priority assessment score: N/A

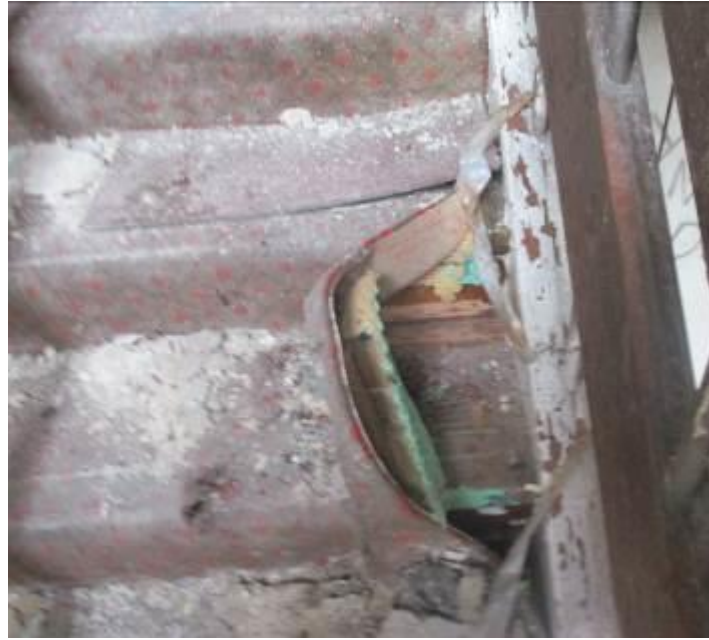
Created By	Andrew Hickey
Date	2 nd May 2019
Site Details	Former Gallagher Cigarette Factory Site, Airton Road Site, Tallaght, Dublin 24
Client Name	Elliott Group
Survey Type	R/D Asbestos Survey
Site Ref	PE 19-376
Building Ref.	Block 2
Location	Office areas
Extent/ Amount	2 per step

MATERIAL ASSESSMENT		PRIORITY ASSESSMENT
Product type	Resin nosings	Normal occupant activity	N/A
Extent of damage	Low	Likelihood of disturbance	N/A
Surface treatment	Reinforced composite	Human exposure potential	N/A
Asbestos type	Chrysotile	Maintenance activity	N/A
	Material assessment score: N/A	TOTAL SCORE: N/A	Priority assessment score: N/A

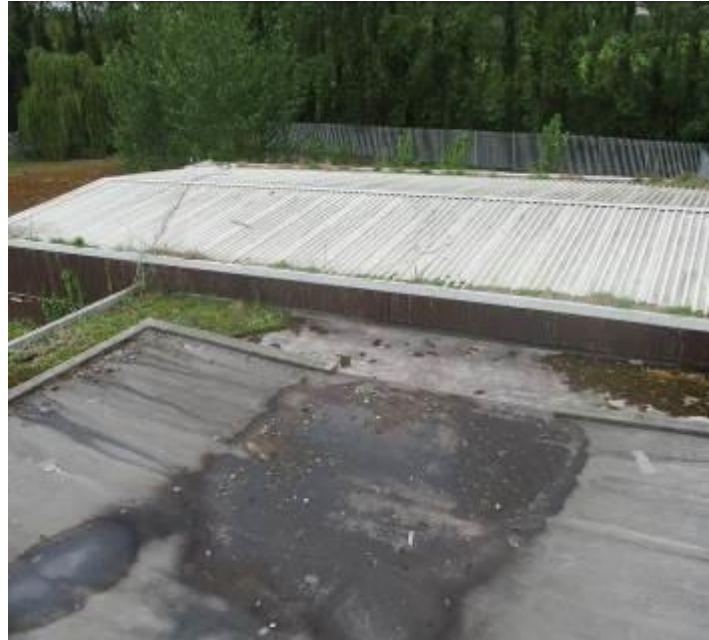
Created By	Andrew Hickey
Date	2 nd May 2019
Site Details	Former Gallagher Cigarette Factory Site, Airton Road Site, Tallaght, Dublin 24
Client Name	Elliott Group
Survey Type	R/D Asbestos Survey
Site Ref	PE 19-376
Building Ref.	Block 3
Location	Canteen roof
Extent/ Amount	180 m ² approx.

MATERIAL ASSESSMENT		PRIORITY ASSESSMENT
Product type	Galbestos	Normal occupant activity	N/A
Extent of damage	Weathered	Likelihood of disturbance	N/A
Surface treatment	Covered with metal cladding	Human exposure potential	N/A
Asbestos type	Chrysotile	Maintenance activity	N/A
	Material assessment score: N/A	TOTAL SCORE: N/A	Priority assessment score: N/A

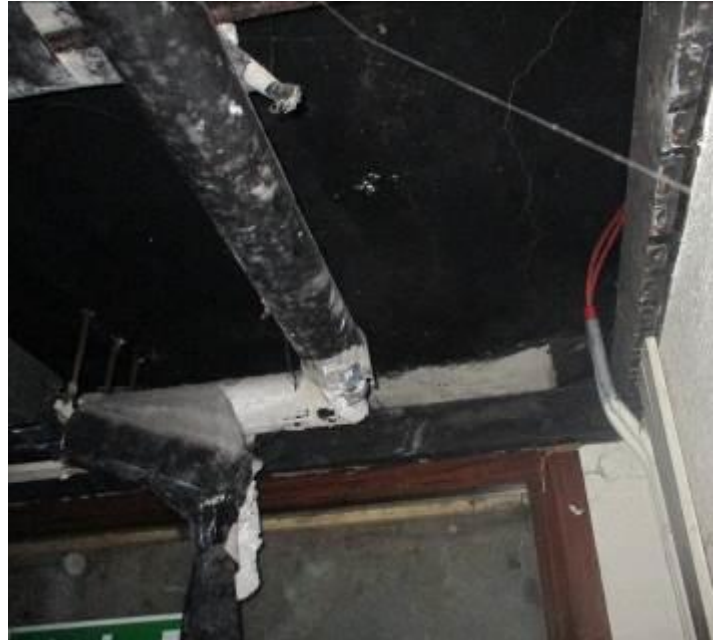
Created By	Andrew Hickey
Date	2 nd May 2019
Site Details	Former Gallagher Cigarette Factory Site, Airton Road Site, Tallaght, Dublin 24
Client Name	Elliott Group
Survey Type	R/D Asbestos Survey
Site Ref	PE 19-376
Building Ref.	Block 3
Location	Entrance at kitchen
Extent/ Amount	10 linear meters approx.

MATERIAL ASSESSMENT		PRIORITY ASSESSMENT
Product type	Thermal insulation	Normal occupant activity	N/A
Extent of damage	High	Likelihood of disturbance	N/A
Surface treatment	None	Human exposure potential	N/A
Asbestos type	Chrysotile	Maintenance activity	N/A
	Material assessment score: N/A	TOTAL SCORE: N/A	Priority assessment score: N/A

The thermal is in extremely poor condition. Access to the ground floor area of block 3 should be restricted due to the large amount of thermal insulation debris on the floor of the kitchen until the area is environmentally cleaned. The removal of asbestos thermal insulation must be carried out under controlled conditions by a specialist asbestos removal contractor and disposed of as asbestos waste.

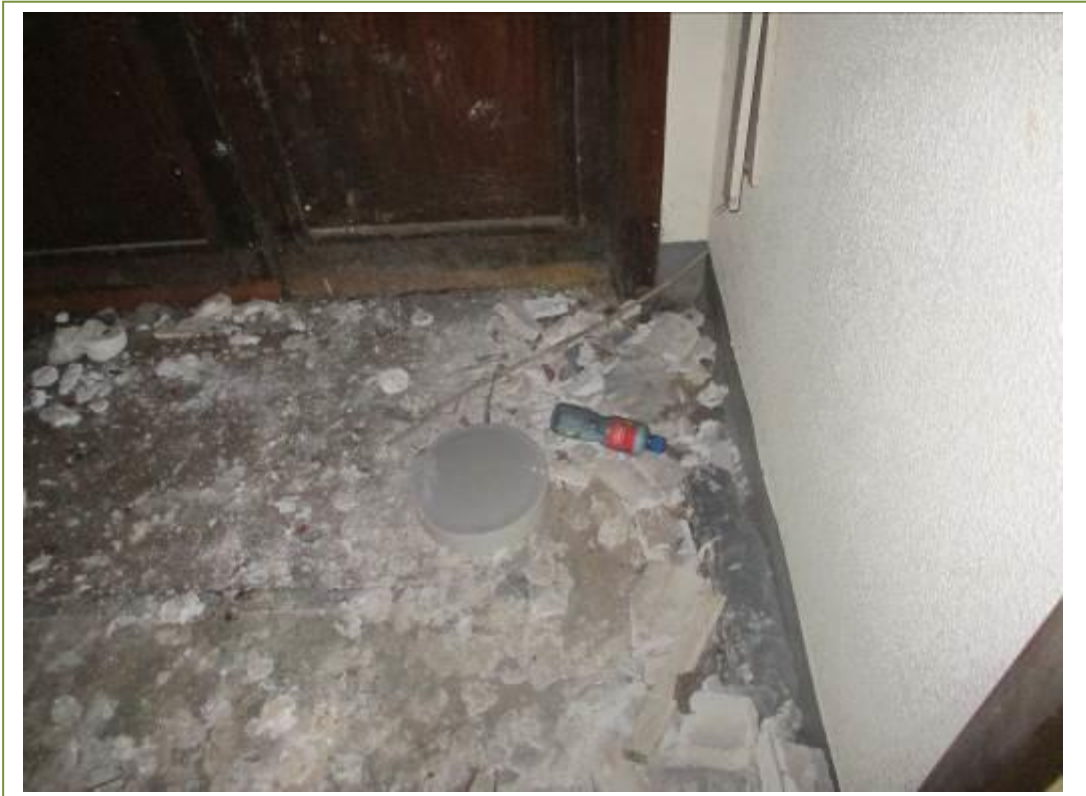
DETAIL OF THE ASBESTOS THERMAL INSULATION DEBRIS

Damaged thermal insulation directly under the pipework

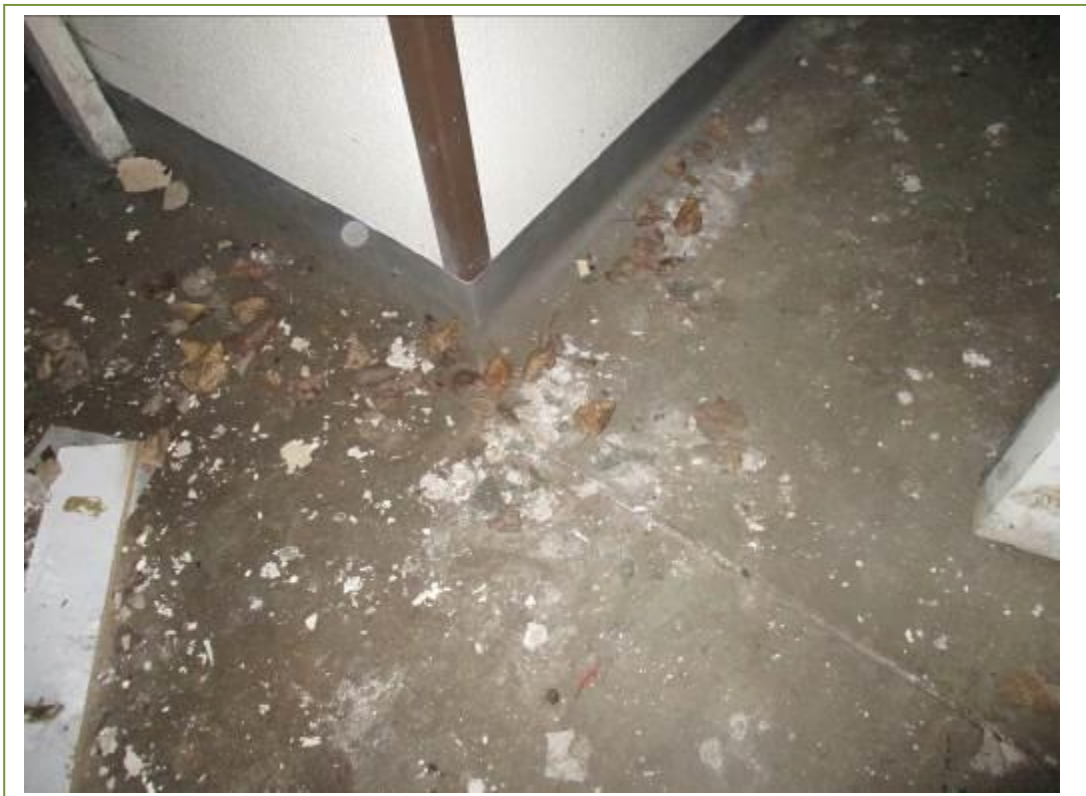
Thermal insulation debris can be seen throughout the floor of the kitchen area

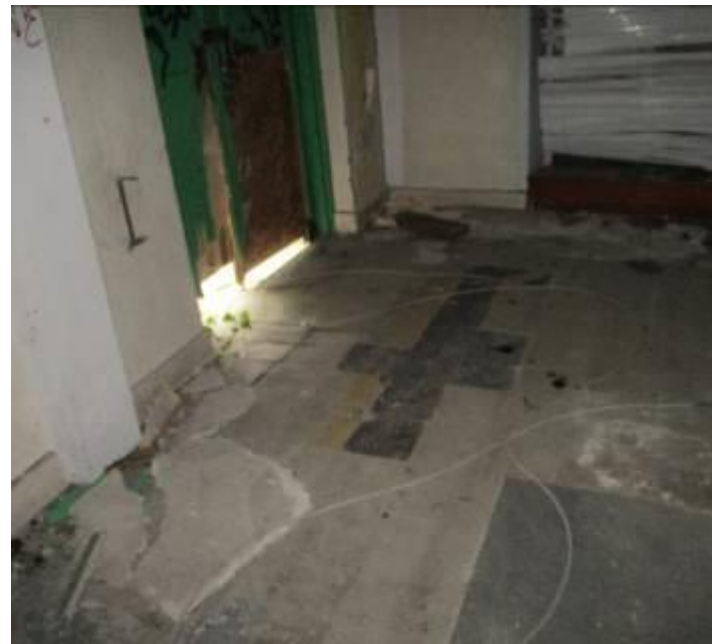
Created By	Andrew Hickey
Date	2 nd May 2019
Site Details	Former Gallagher Cigarette Factory Site, Airton Road Site, Tallaght, Dublin 24
Client Name	Elliott Group
Survey Type	R/D Asbestos Survey
Site Ref	PE 19-376
Building Ref.	Block 3
Location	Throughout
Extent/ Amount	600 m ² approx.

MATERIAL ASSESSMENT		PRIORITY ASSESSMENT
Product type	Floor tile & bitumen adhesive	Normal occupant activity	N/A
Extent of damage	High	Likelihood of disturbance	N/A
Surface treatment	None	Human exposure potential	N/A
Asbestos type	Chrysotile	Maintenance activity	N/A
	Material assessment score: N/A	TOTAL SCORE: N/A	Priority assessment score: N/A

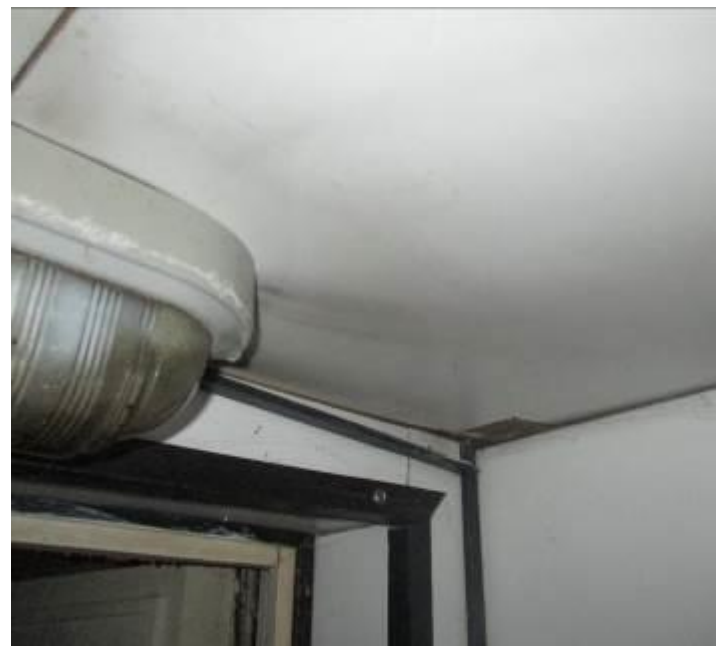
Created By	Andrew Hickey
Date	2 nd May 2019
Site Details	Former Gallagher Cigarette Factory Site, Airton Road Site, Tallaght, Dublin 24
Client Name	Elliott Group
Survey Type	R/D Asbestos Survey
Site Ref	PE 19-376
Building Ref.	Block 3
Location	Kitchen – old fridge
Extent/ Amount	15 m ² approx.

MATERIAL ASSESSMENT		PRIORITY ASSESSMENT
Product type	Asbestos cement	Normal occupant activity	N/A
Extent of damage	Medium	Likelihood of disturbance	N/A
Surface treatment	Painted	Human exposure potential	N/A
Asbestos type	Chrysotile	Maintenance activity	N/A
	Material assessment score: N/A	TOTAL SCORE: N/A	Priority assessment score: N/A

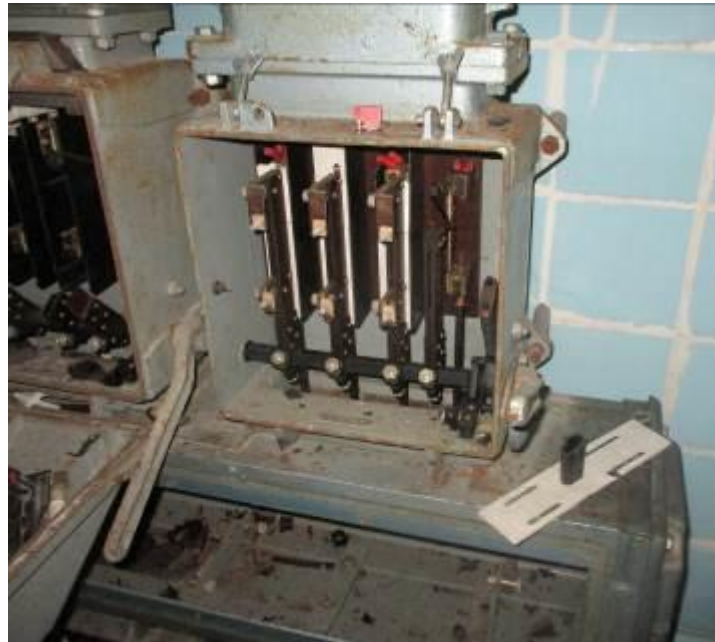
Created By	Andrew Hickey
Date	2 nd May 2019
Site Details	Former Gallagher Cigarette Factory Site, Airton Road Site, Tallaght, Dublin 24
Client Name	Elliott Group
Survey Type	R/D Asbestos Survey
Site Ref	PE 19-376
Building Ref.	Block 3
Location	Old electrics
Extent/ Amount	Not quantified

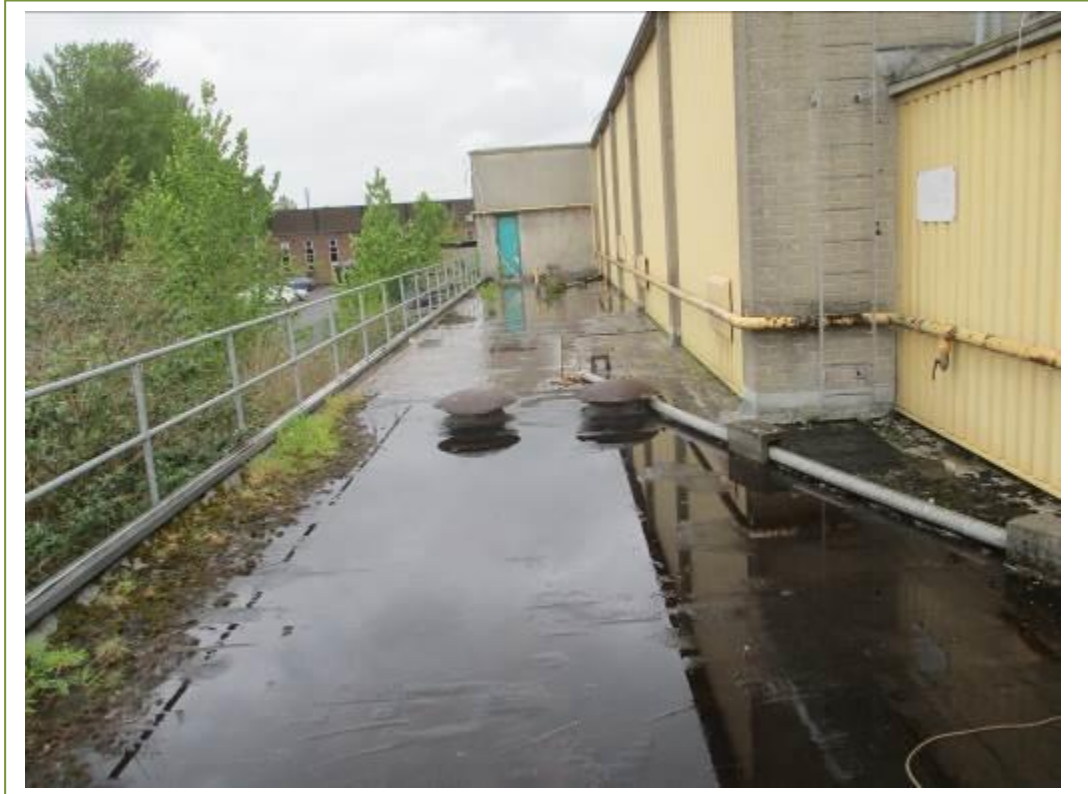
Metal side cladding. No Asbestos Containing Materials (ACM's) detected

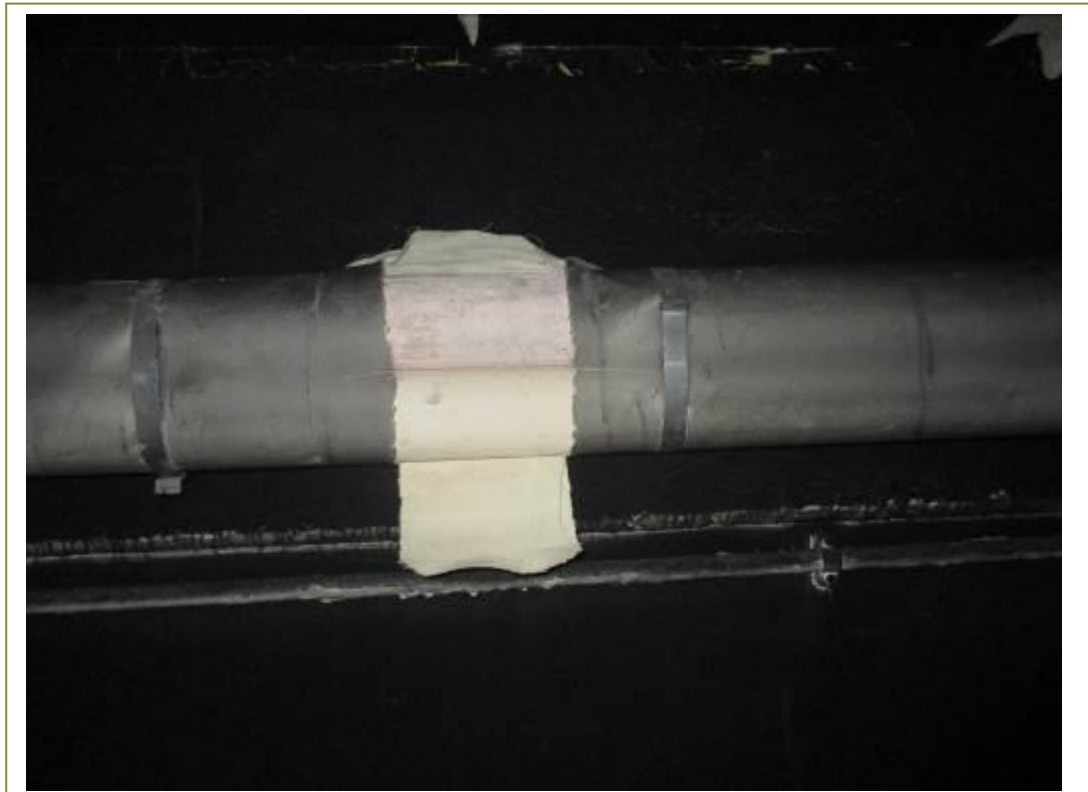
Calcium & magnesium silicate pipework insulation. No ACM's detected

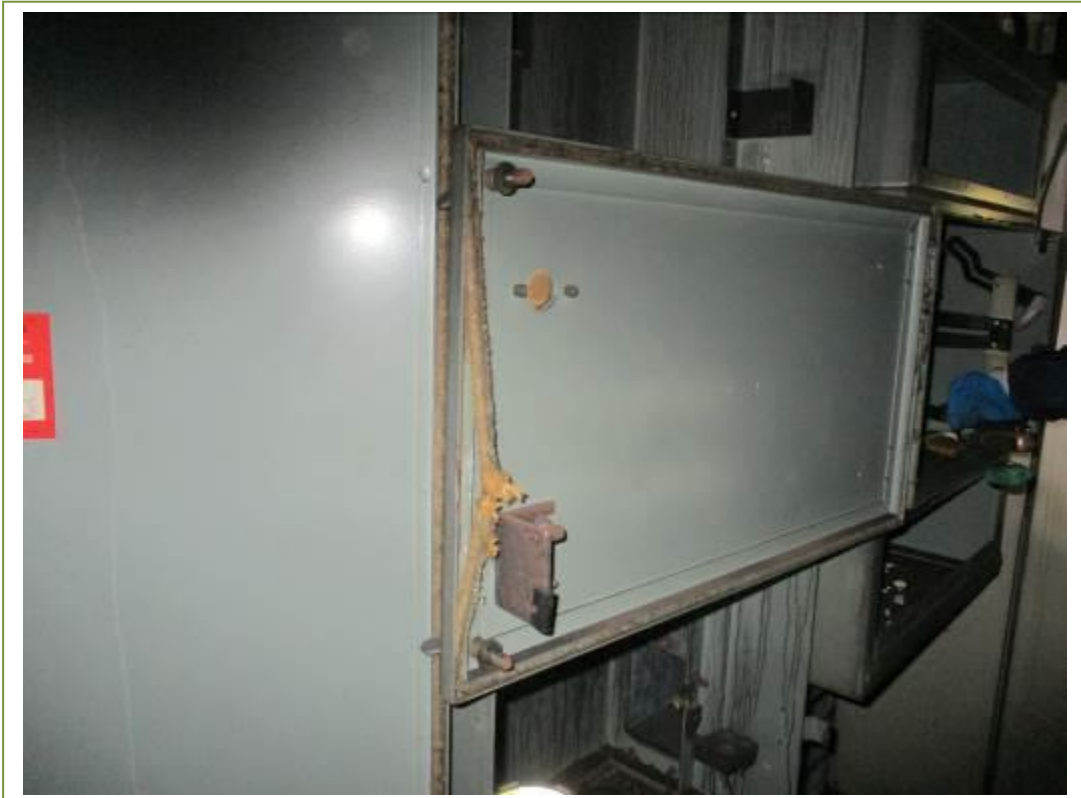
Rope on modern electrical box doors in block 1. No ACM's detected

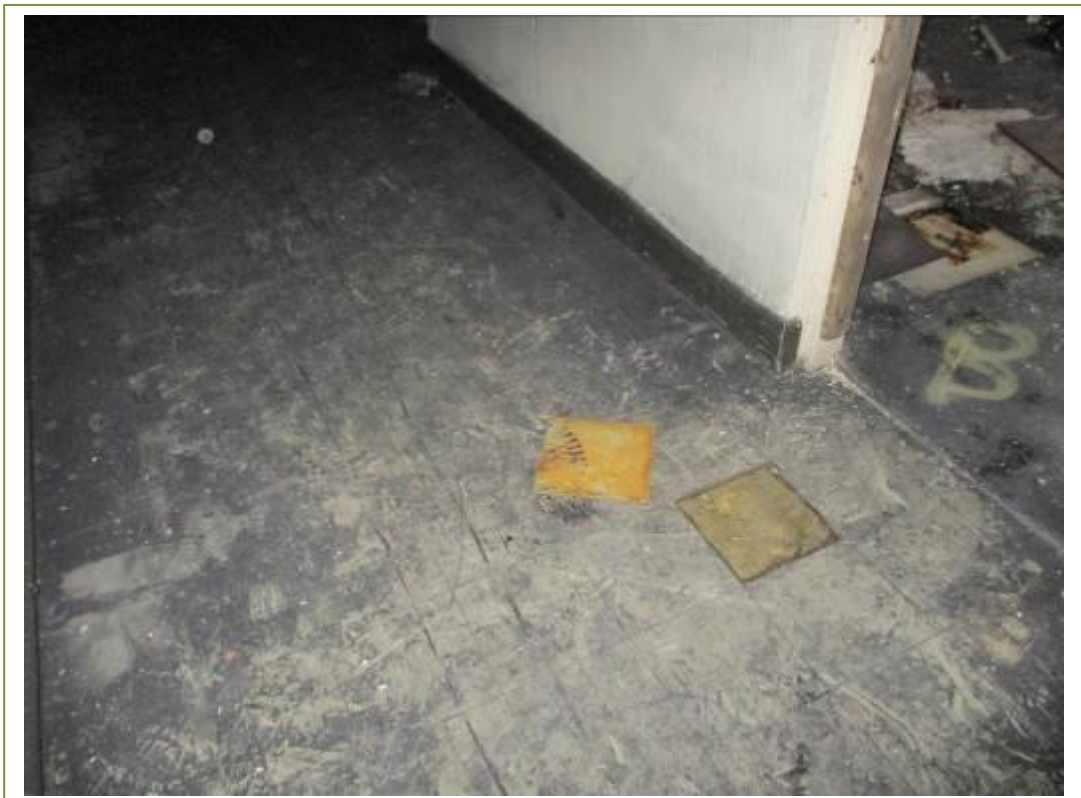
Floor tiles and evostick adhesive. No ACM's detected

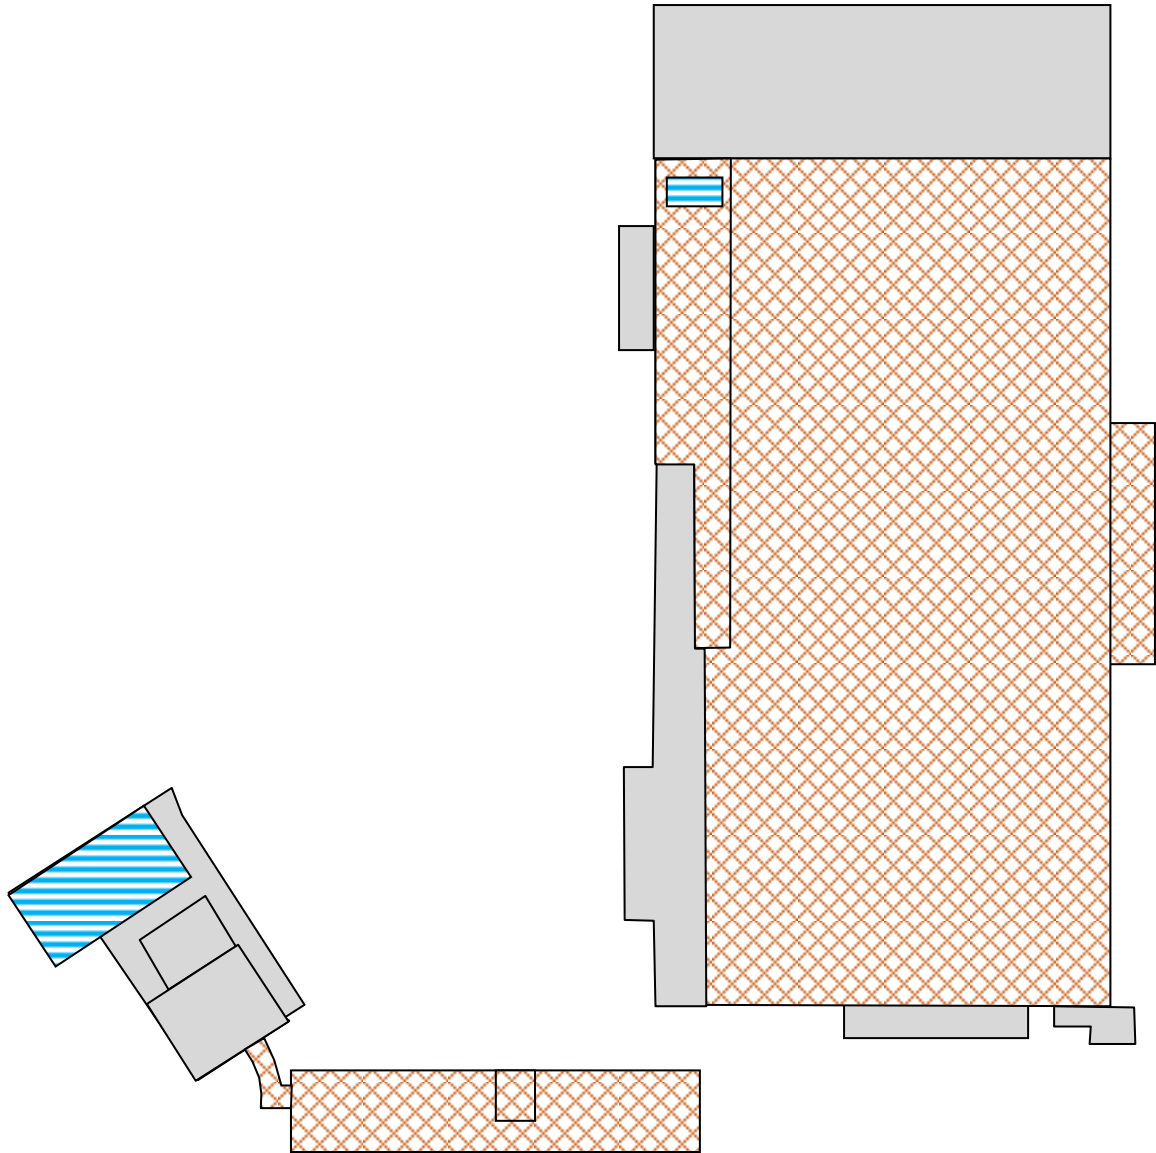
ROOF PLAN

Areas where asbestos containing felt was identified

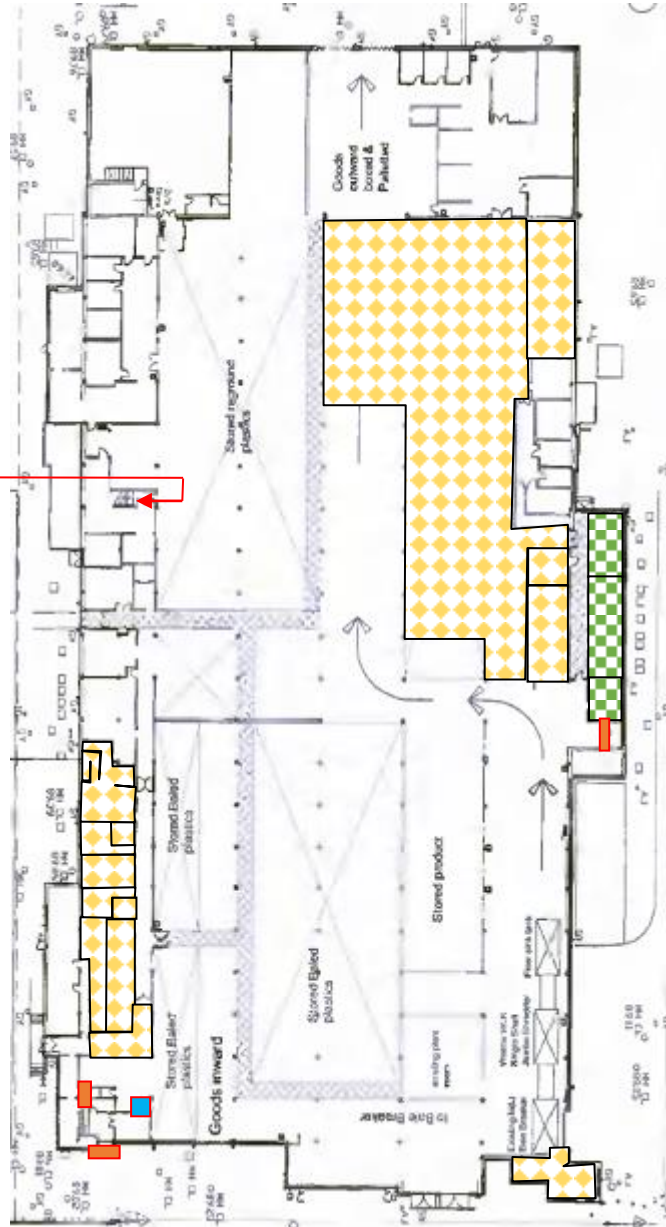
Areas where asbestos containing floor tiles and bitumen adhesive was identified

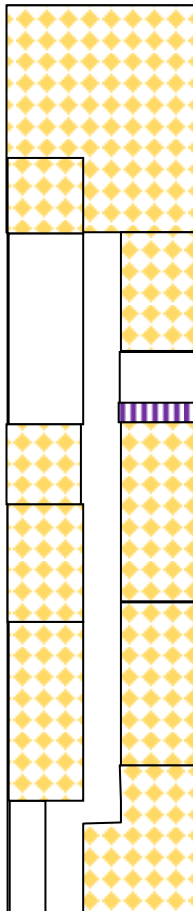
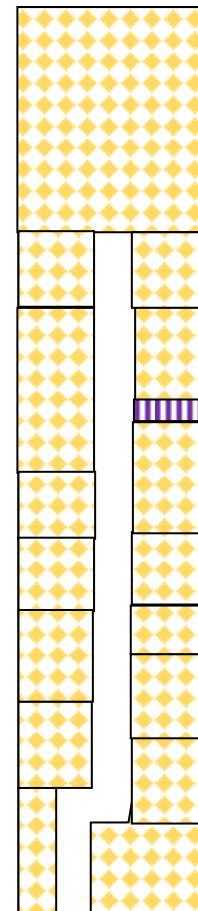
BLOCK 2 FLOOR PLAN

Areas where asbestos containing floor tiles and bitumen adhesive was identified

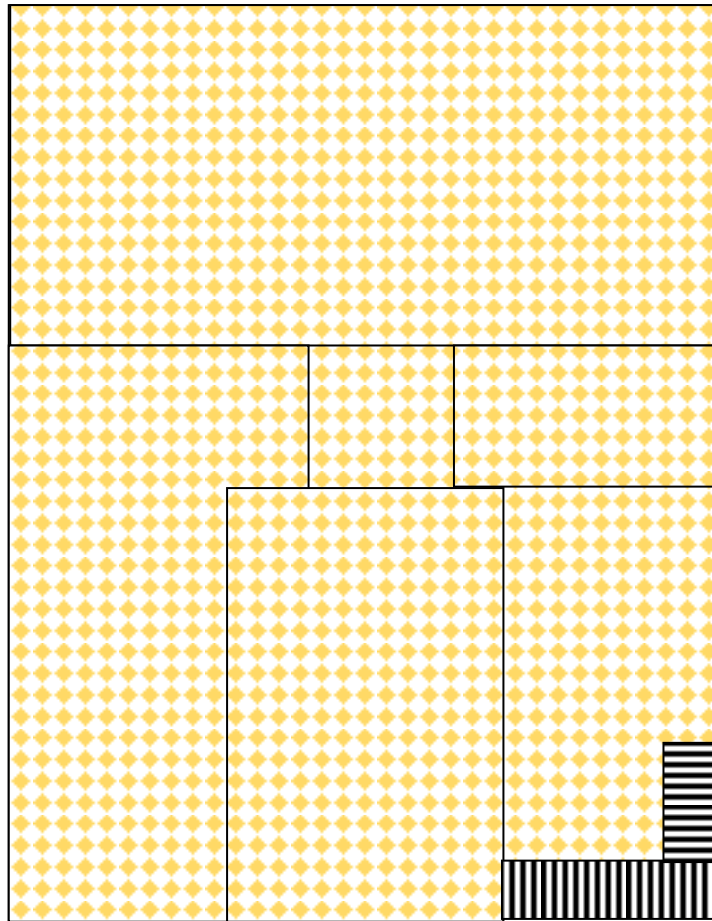
BLOCK 3 – 1ST FLOOR PLAN

Areas where asbestos containing floor tiles and bitumen adhesive was identified

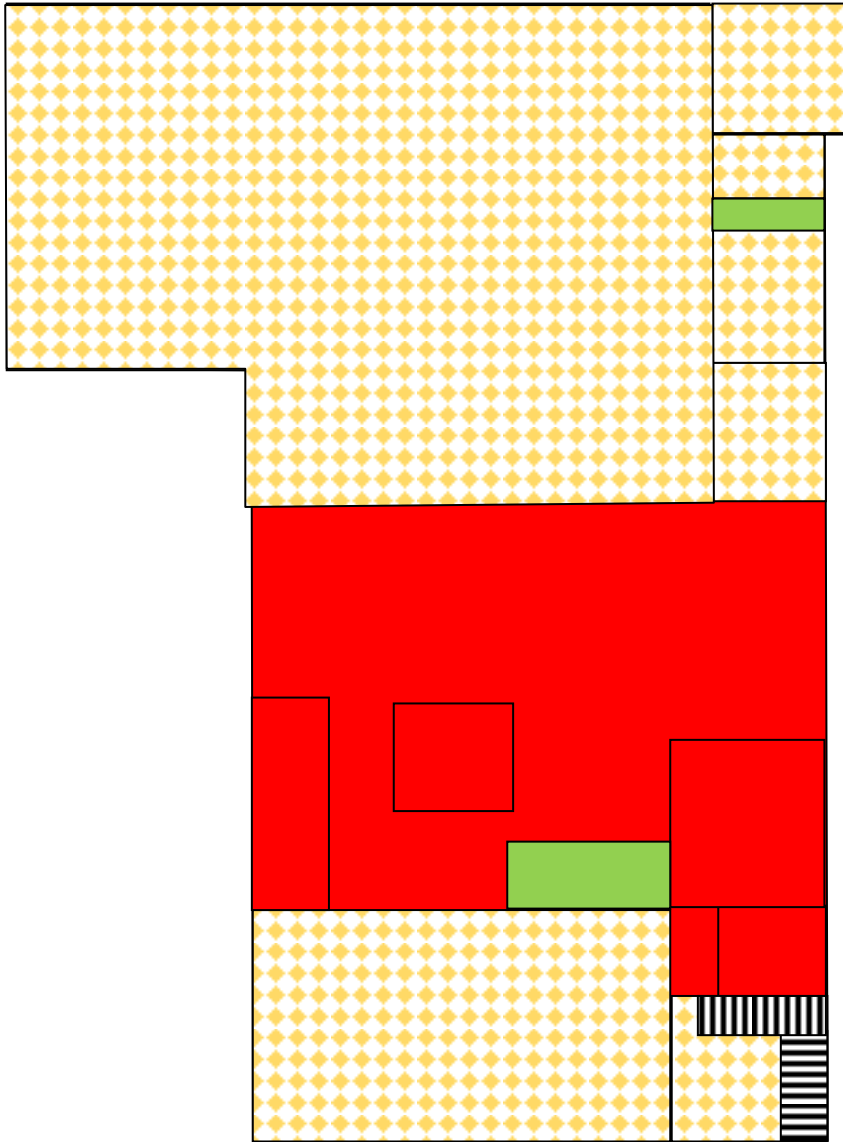
BLOCK 3 - GROUND FLOOR PLAN

Areas where asbestos thermal insulation was identified along with a large area of debris
	Areas where asbestos containing floor tiles and bitumen adhesive was identified
	Areas where asbestos cement boards were identified
