Gort Wind Farms Ltd.

# Remedial Environmental Impact Assessment Report Chapter 10 – Soils, Geology and Land

Document No.: QS-000280-01-R460-001-000

Date: July 2020

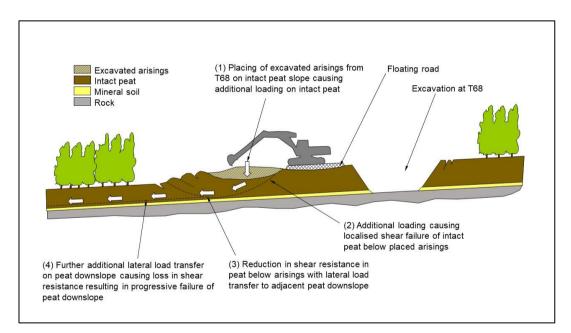
#### Figure 10-1: Schematic of likely failure mechanism of 16<sup>th</sup> October peat slide

AGEC concluded that the construction activity, and particularly the placing of arisings onto the intact peat slopes, most likely triggered the slide. The failure mechanism that they proposed is shown schematically in Figure 10-1. The additional surcharge load on the intact peat slopes could have initially caused a localised shear failure in the underlying intact peat, which would have reduced its shear resistance and resulted in a redistribution or transfer of lateral load to the adjacent peat downslope. Additional transfer of lateral loading as more material was placed on the slopes could have led to a progressive shear failure and reduction in shear resistance along the base of the peat further downslope. Ultimately, this could have led to the large planar or translational peat slide that occurred on the inclined slopes.

The magnitude of the load on the intact peat slopes from the arisings was low relative to the scale of the peat slide. Furthermore, excavated arisings from the turbine foundations had already been sidecast on the intact peat slopes in a number of other locations on the site without causing a failure in the peat. Therefore, on its own it does not fully explain why the slide occurred at Turbine T68.

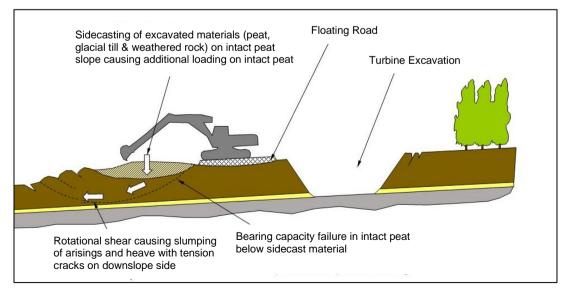
Figure 10-40: Bearing capacity failure below sidecast materials

The bearing capacity failures were characterised by a rotational shear failure in the intact peat under the arisings, which caused slumping of the excavated material and heave with tension cracks in the intact peat downslope, giving the slope an irregular stepped profile, as shown in Figure 10-40. Some trees within the zone of ground movement were tilted over.

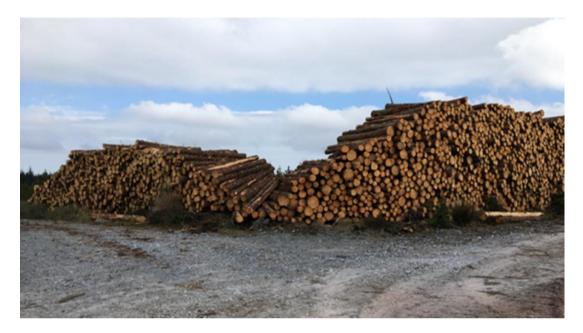
# Plate 10-3: Felled timber from an adjacent plantation stockpiled on the peat within the wind farm site near Turbine T6 in May 2017 (ESBI, 2017)

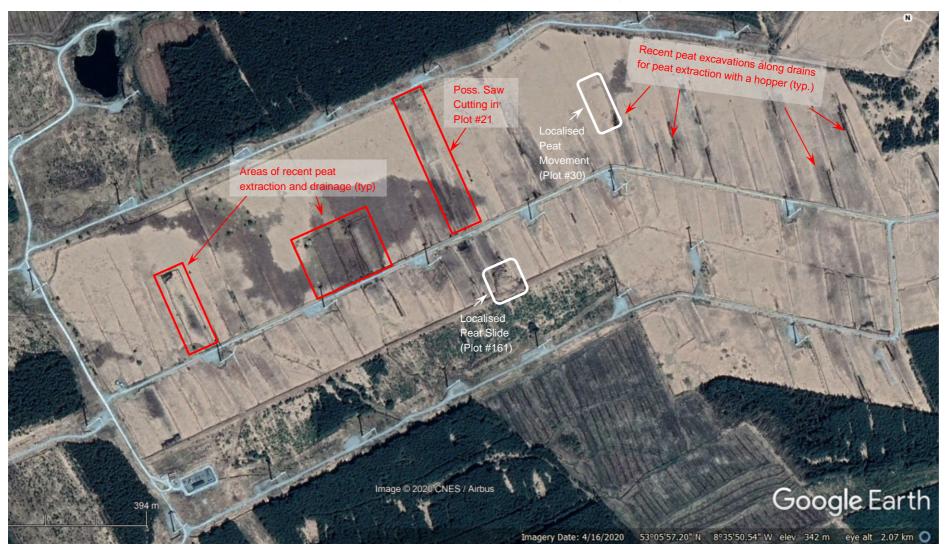
Figure 10-51: 2020 Aerial Photo of turbary plots illustrating recent peat harvesting activity & areas of local peat instability

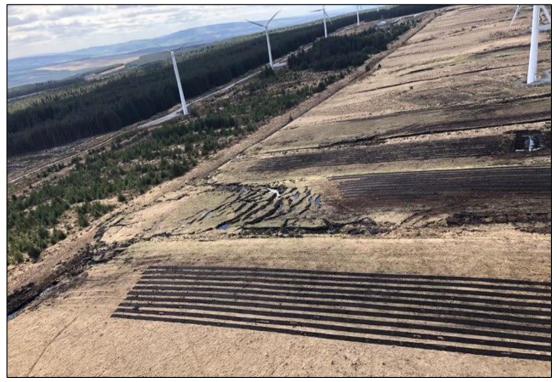
The majority of the vegetated surface layer of the failed peat has remained intact. There are large open water-filled tension cracks at the upslope end of the failed area. At the downslope end the drain has been completely infilled and the displaced peat has "buckled" and spilled over onto the surface of the peat in the firebreak that runs along the downslope side of the open drain, where the slope angle is locally flatter.

Plate 10-8: Peat Failure in Turbary Plot #161 (Site Photo May 2020)

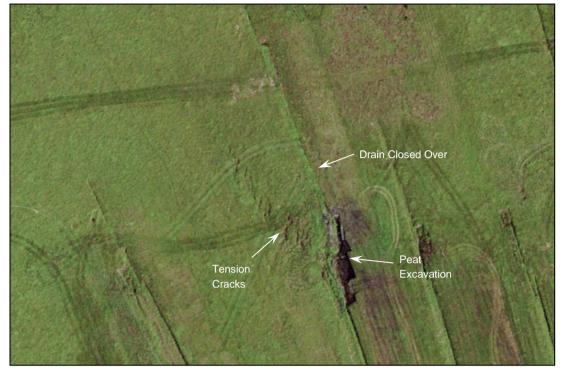
Plate 10-11: Peat Movement in Turbary Plot #30 c2015-2018 (OSI Geohive Portal, 2020)

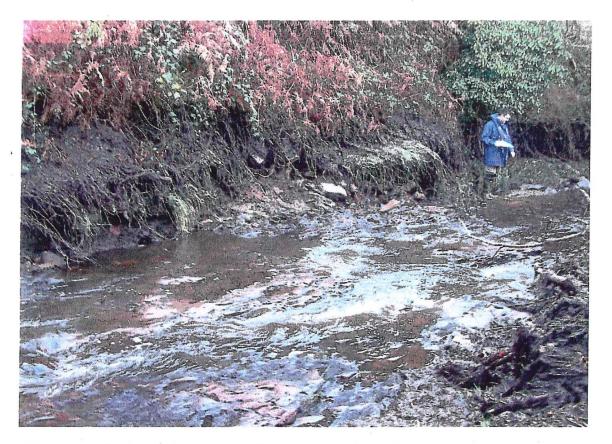
Plate 1 Chainage 196 showing level to which peat slip material reached on this section of river. Bedrock is visible as a result of scouring by transported peat.

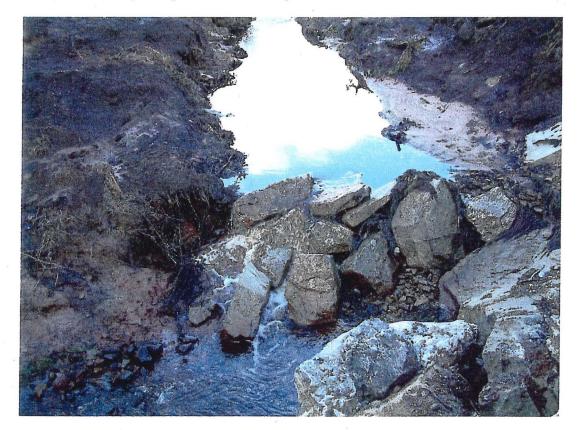
Plate 3 Chainage 199. It is recommended that this blockage be removed. The left bank should be planted in high density formation with shrubs or trees that are ecologically similar to the surrounding flora.

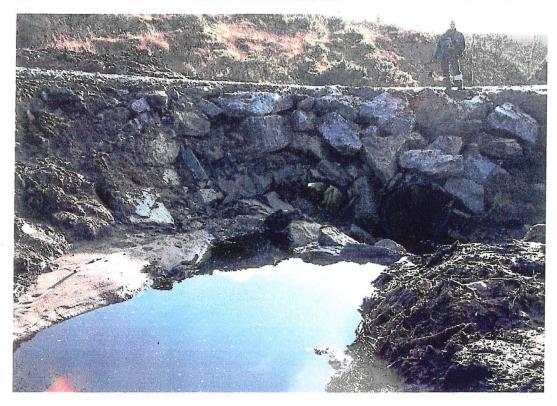
Plate 4 Chainage 198-199 the gauge of the pipes here should be increased to assist flow through.
