L-8221 Local Road Bridge Assessment

Carrownagowan Wind Farm

Assessment of Existing Structures along L-8221 Local Road

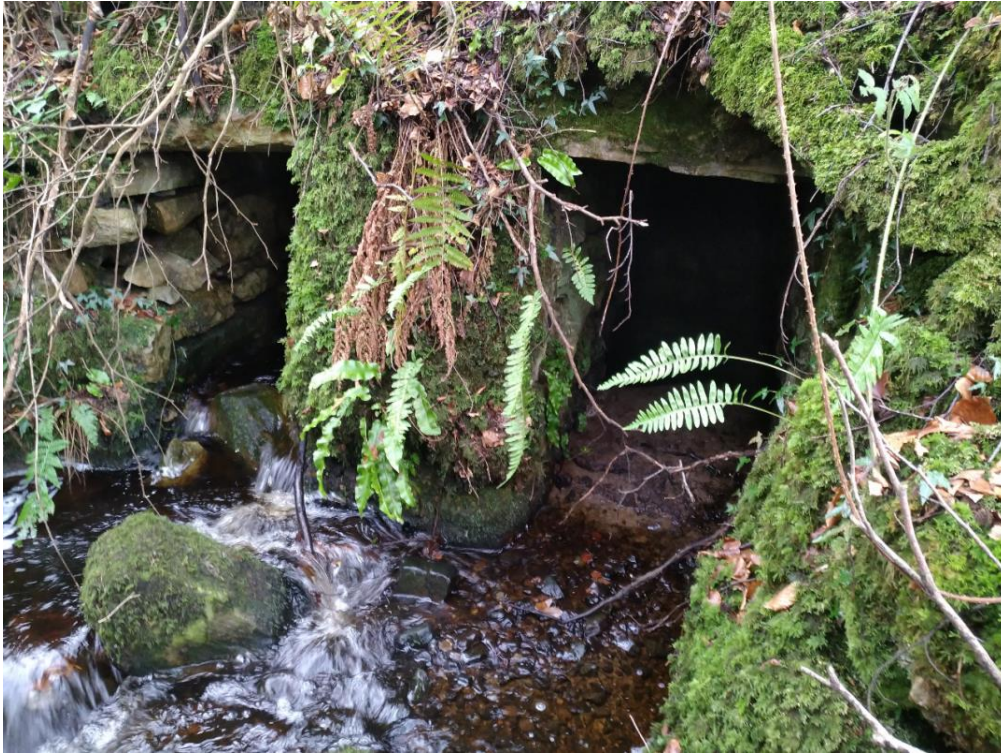
Figure 3 View of Downstream Elevation of Structure No. 1

This structure consists of a double span stone clapper culvert serving a stream crossing. The culvert was generally found to be in good condition with no signs of cracking or deformation present. A tree was found to be growing on the upstream elevation of the structure which is currently blocking the flow of water within span 1 (Figure 4 and Figure 6). Water flow within span 2 remains uninterrupted (Figure 5). The road carriageway above the structure was also found to be in good condition (Figure 7).

To cater for the maximum 12t axle loadings expected from the main crane and turbine deliveries, it is recommended that a reinforced concrete slab should be laid above the existing structure. The installation of a reinforced concrete slab will cater for the delivery of abnormal loads to the wind farm but will also be of long term benefit by protecting the existing fabric of the structure and preventing any failure from other heavy loads.

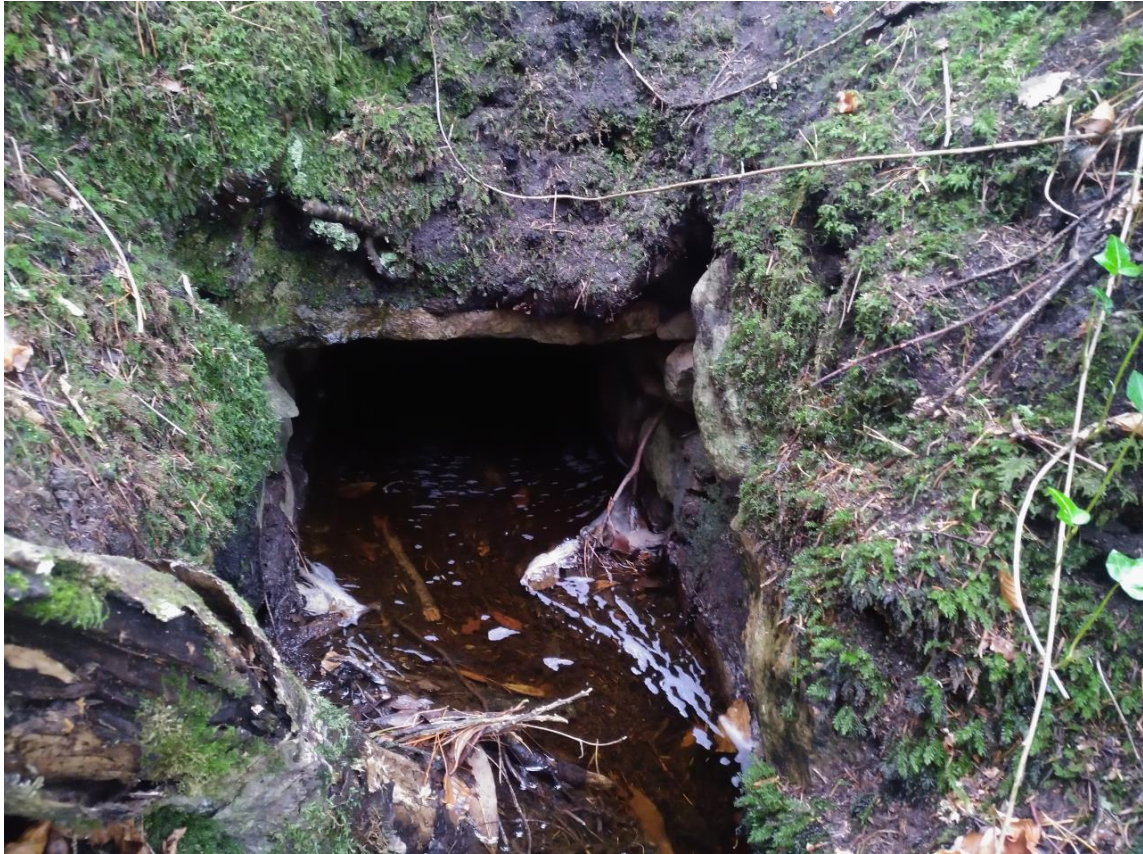
Figure 8 View of Downstream Elevation of Structure No. 2

This structure consists of a single span stone clapper culvert serving a land drain crossing. The culvert was generally found to be in good condition with no signs of cracking or deformation present. Water flow within the channel was found to be uninterrupted (Figure 8). The road carriageway above the structure was also found to be in good condition (Figure 9). Note access could not be obtained to view the upstream elevation of the structure.

To cater for the maximum 12t axle loadings expected from the main crane and turbine deliveries, it is recommended that a reinforced concrete slab should be laid above the existing structure. The installation of a reinforced concrete slab will cater for the delivery of abnormal loads to the wind farm but will also be of long term benefit by protecting the existing fabric of the structure and preventing any failure from other heavy loads.

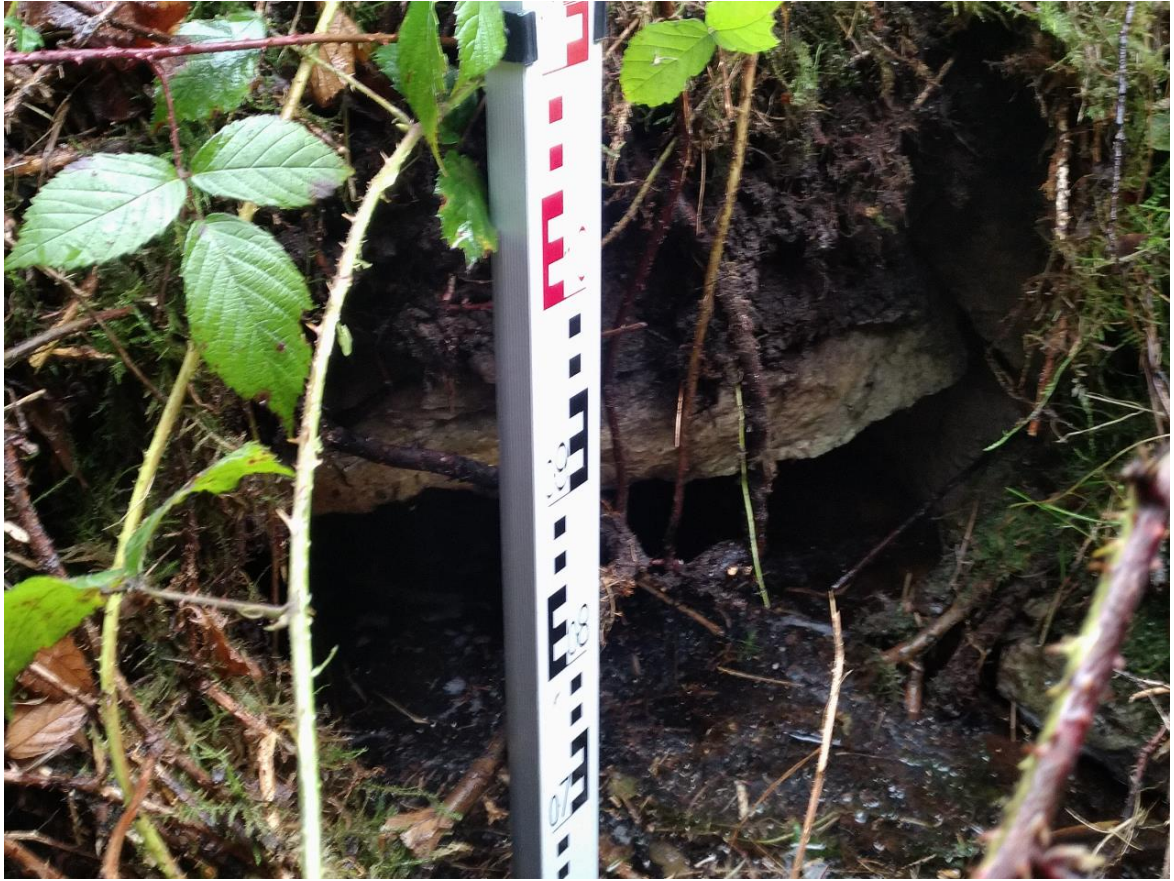
Figure 10 View of Upstream Elevation of Structure No. 3

This structure consists of a single span stone clapper culvert serving a land drain crossing. The culvert was generally found to be in good condition with no signs of cracking or deformation present. Water flow was found to be blocked at the downstream side of the structure but flow was uninterrupted at the upstream side (Figure 10). The road carriageway above the structure was also found to be in good condition (Figure 11).

To cater for the maximum 12t axle loadings expected from the main crane and turbine deliveries, it is recommended that a reinforced concrete slab should be laid above the existing structure. The installation of a reinforced concrete slab will cater for the delivery of abnormal loads to the wind farm but will also be of long term benefit by protecting the existing fabric of the structure and preventing any failure from other heavy loads.

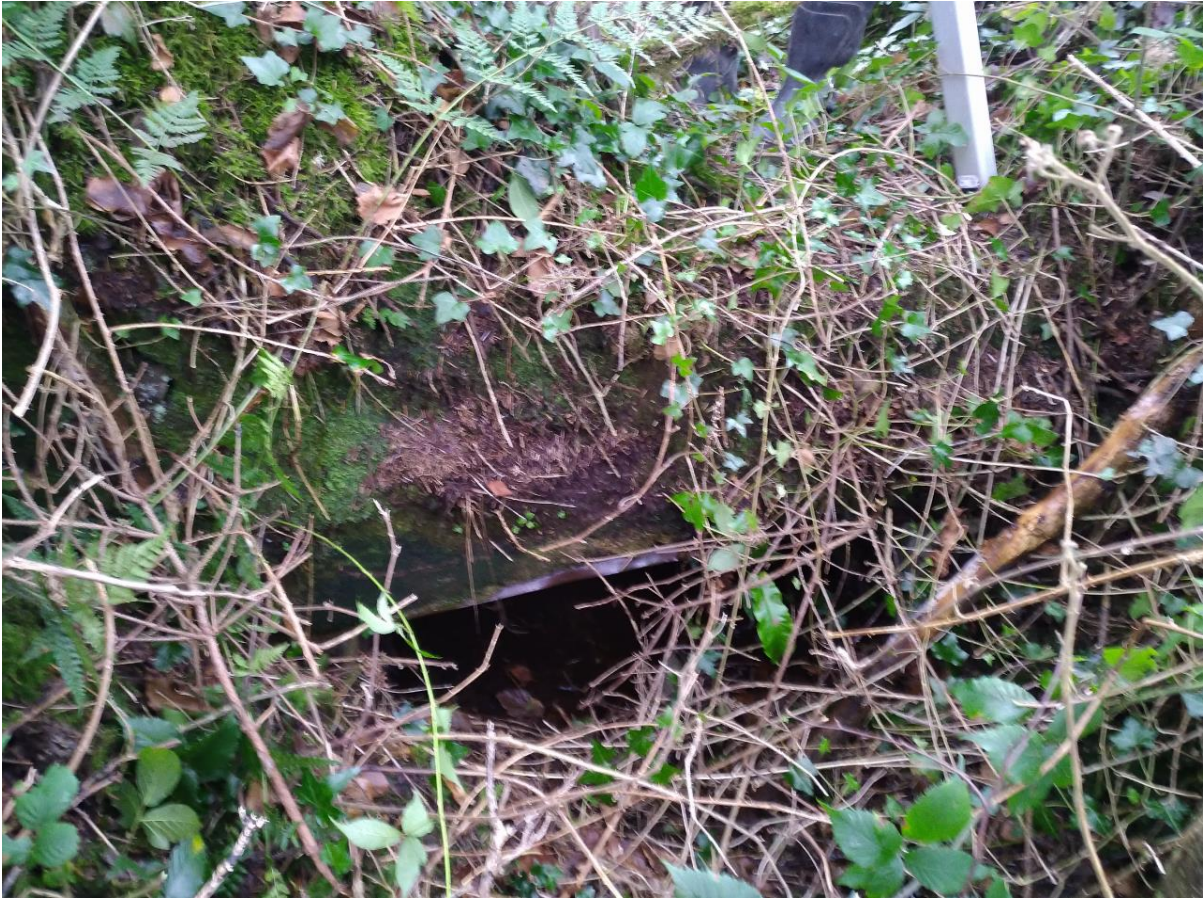
Figure 12 View of Downstream Elevation of Structure No. 4

This structure consists of a single span cast in-situ concrete culvert serving a land drain crossing. The culvert was previously a stone clapper structure but the original flagstones have been replaced with cast in-situ concrete slabs. The structure was generally found to be in good condition with no signs of cracking or deformation present. Water flow within the channel was found to be uninterrupted (Figure 12). The road carriageway above the structure was also found to be in good condition (Figure 13).

To cater for the maximum 12t axle loadings expected from the main crane and turbine deliveries, it is recommended that a reinforced concrete slab should be laid above the existing structure. The installation of a reinforced concrete slab will cater for the delivery of abnormal loads to the wind farm but will also be of long term benefit by protecting the existing fabric of the structure and preventing any failure from other heavy loads.

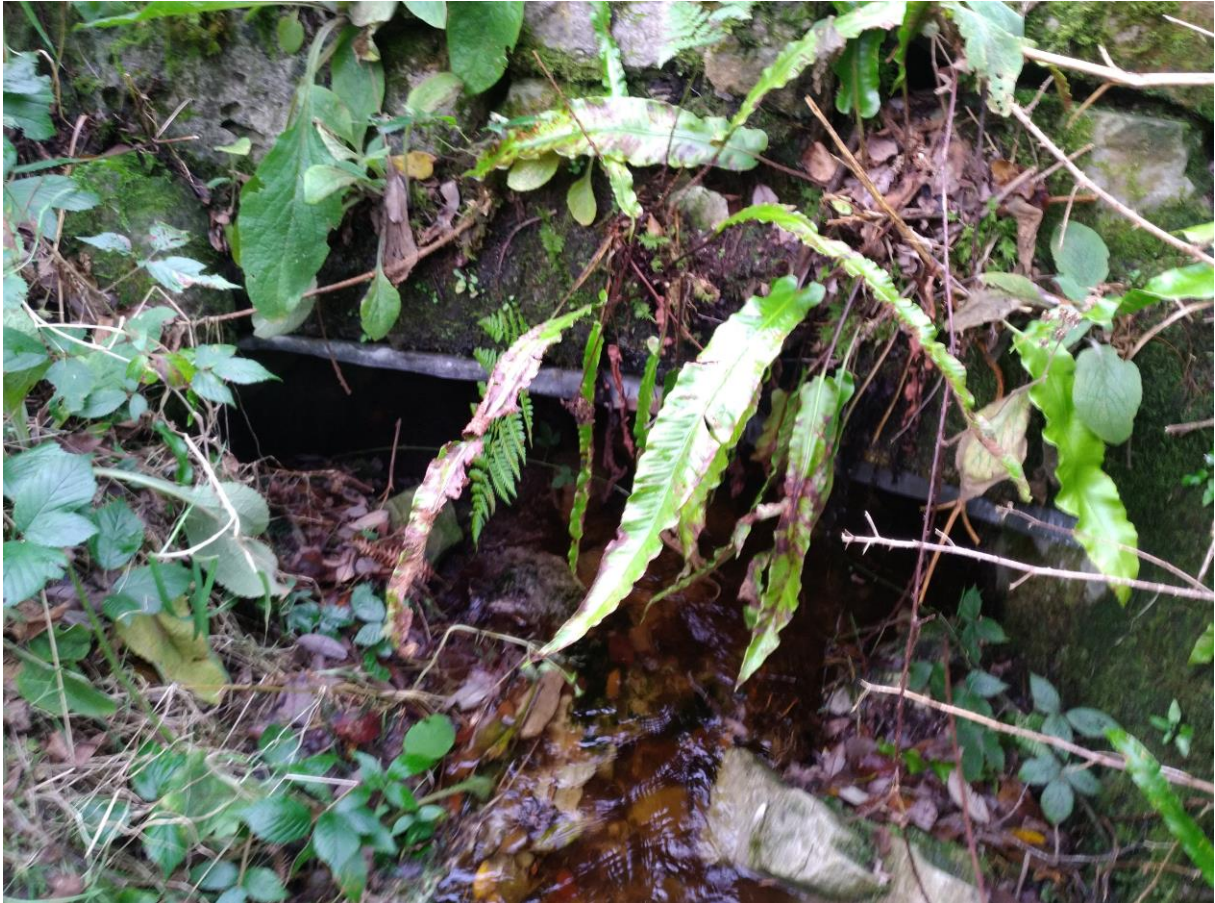
Figure 14 View of Upstream Elevation of Structure No. 5

This structure consists of a single span cast in-situ concrete culvert serving a land drain crossing. The culvert was previously a stone clapper structure but the original flagstones have been replaced with cast in-situ concrete slabs. The structure was generally found to be in good condition with no signs of cracking or deformation present. Water flow within the channel was found to be uninterrupted (Figure 15 and Figure 16). The road carriageway above the structure was also found to be in good condition (Figure 17).

To cater for the maximum 12t axle loadings expected from the main crane and turbine deliveries, it is recommended that a reinforced concrete slab should be laid above the existing structure. The installation of a reinforced concrete slab will cater for the delivery of abnormal loads to the wind farm but will also be of long term benefit by protecting the existing fabric of the structure and preventing any failure from other heavy loads.

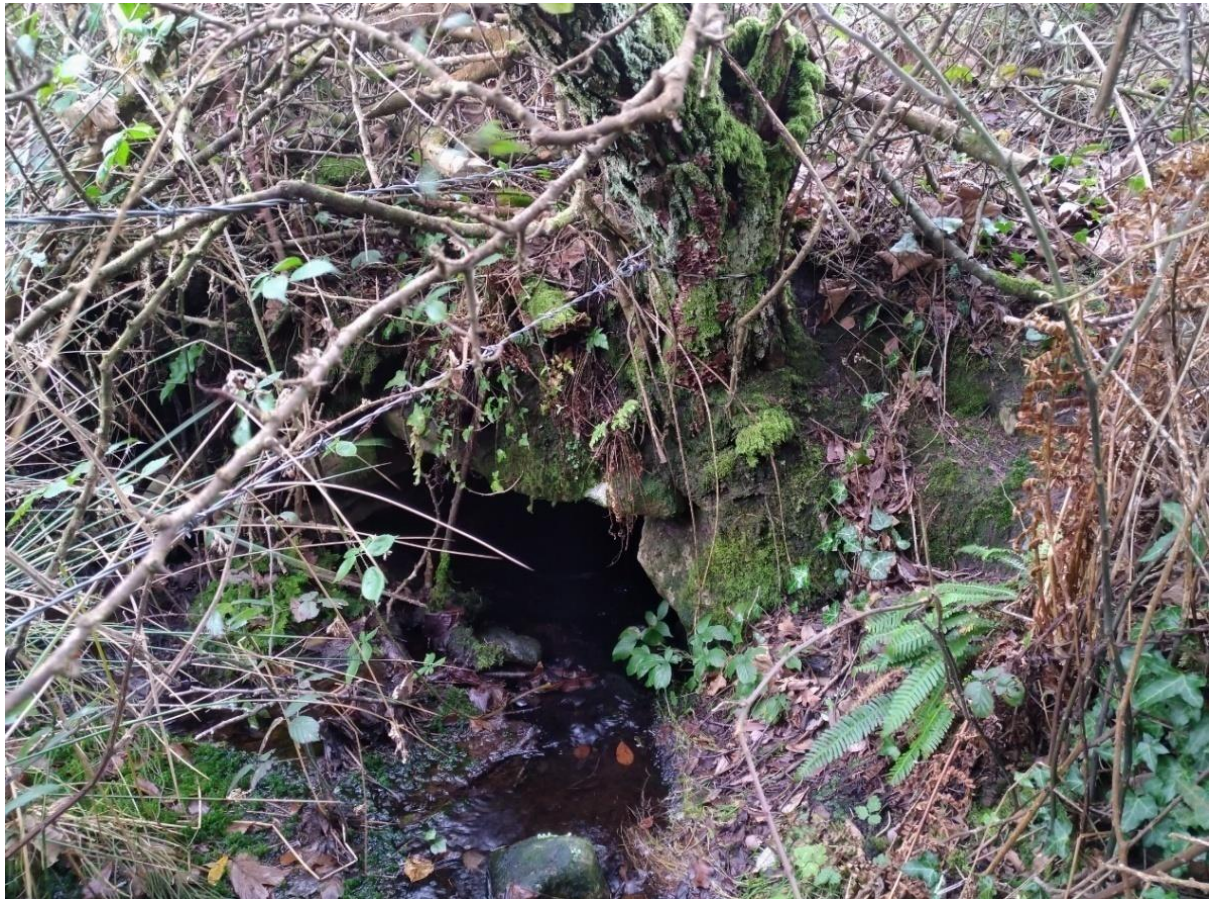
Figure 18 View of Upstream Elevation of Structure No. 6

This structure consists of a single span stone clapper culvert serving a land drain crossing. The culvert was generally found to be in good condition with no signs of cracking or deformation present. Water flow within the channel was found to be uninterrupted (Figure 18). The road carriageway above the structure was also found to be in good condition (Figure 20). Note access could not be obtained to view the downstream elevation of the structure.

To cater for the maximum 12t axle loadings expected from the main crane and turbine deliveries, it is recommended that a reinforced concrete slab should be laid above the existing structure. The installation of a reinforced concrete slab will cater for the delivery of abnormal loads to the wind farm but will also be of long term benefit by protecting the existing fabric of the structure and preventing any failure from other heavy loads.

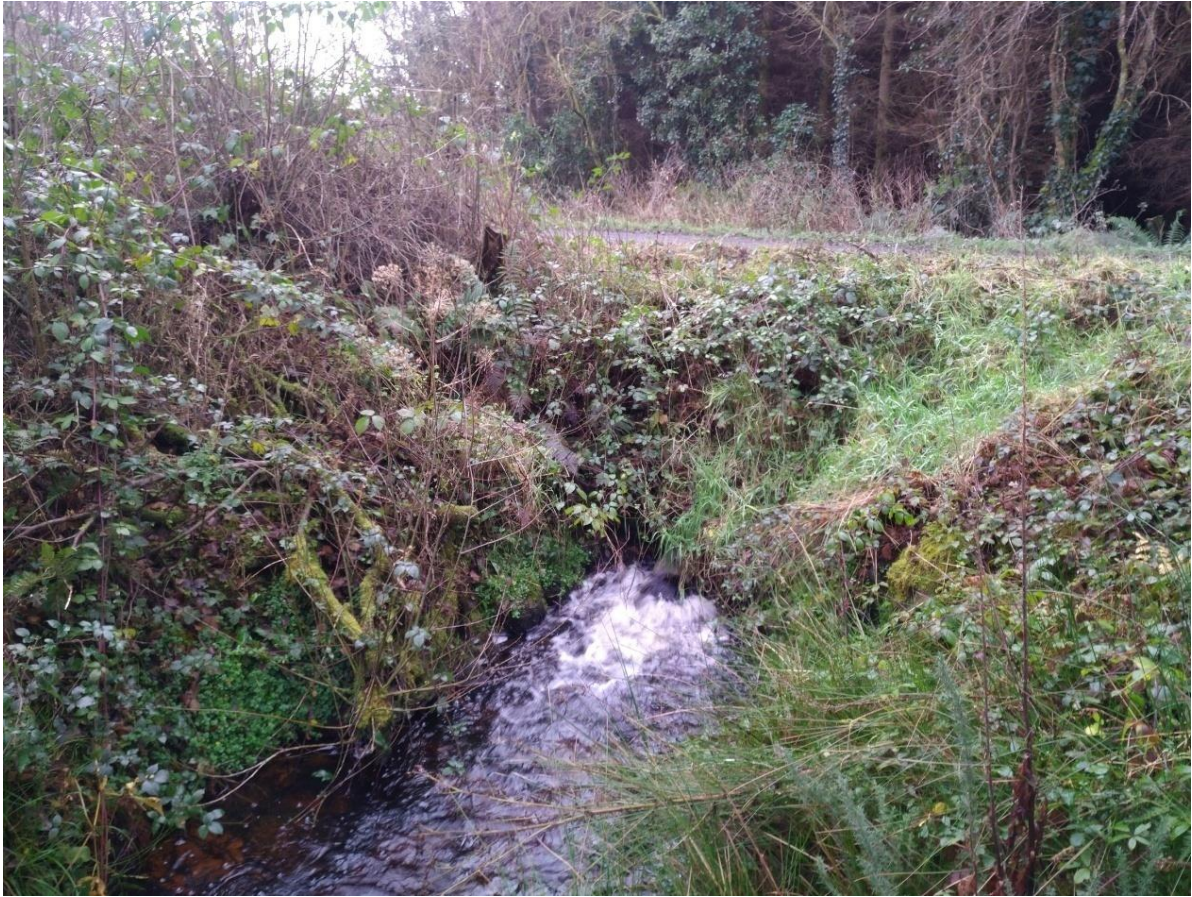
Figure 21 View of Downstream Elevation of Structure No. 7

This structure consists of a single span stone clapper culvert serving a stream crossing. The structure has been modified at the downstream elevation with the installation of a 300mm Ø CorriPipe (Figure 22). There were no signs of cracking or deformation present at the structure. Water flow was found to be blocked at the upstream side of the structure but flow was uninterrupted at the downstream side (Figure 18 and Figure 23). The road carriageway above the structure was found to be in good condition (Figure 24). Note access could not be obtained to view the upstream elevation of the structure.

To cater for the maximum 12t axle loadings expected from the main crane and turbine deliveries, it is recommended that a reinforced concrete slab should be laid above the existing structure. The installation of a reinforced concrete slab will cater for the delivery of abnormal loads to the wind farm but will also be of long term benefit by protecting the existing fabric of the structure and preventing any failure from other heavy loads.

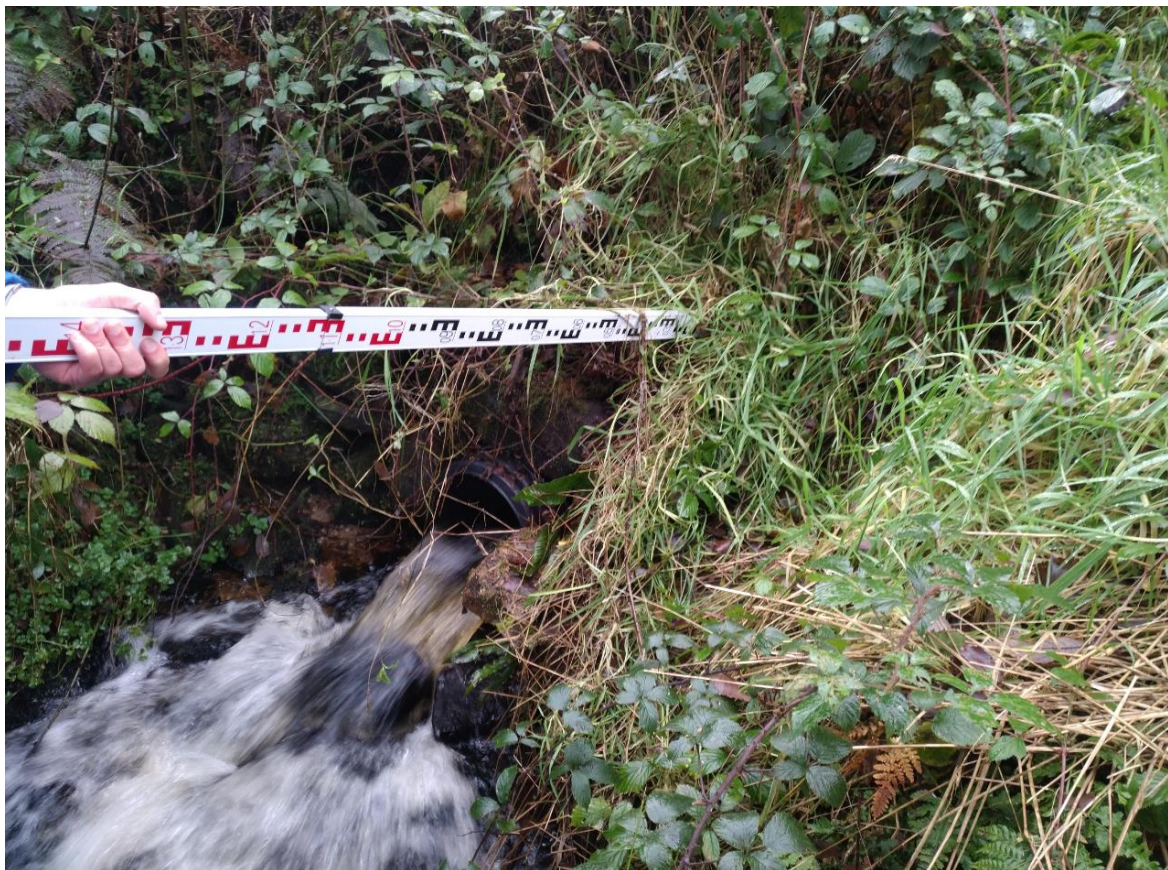
Figure 22 View of 300mm \varnothing CorriPipe within Structure No. 7 at Downstream Elevation

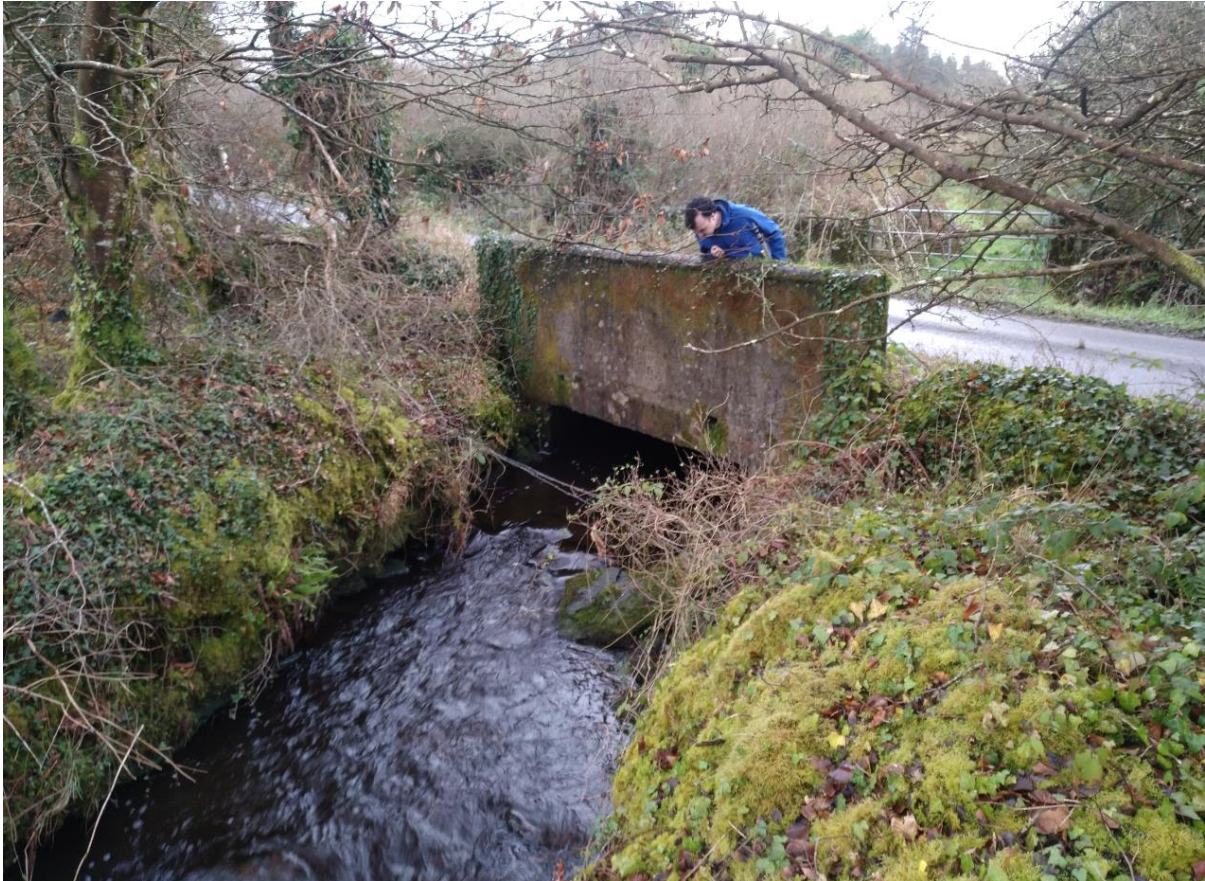
Figure 25 View of Downstream Elevation of Structure No. 8

This structure consists of a single span reinforced concrete bridge serving a stream crossing. The bridge was generally found to be in good condition with no signs of cracking or deformation present. Water flow within the channel was found to be uninterrupted (Figure 26 and Figure 27). The bridge parapets and road carriageway above the structure were both found to be in good condition (Figure 28). Note access could not be obtained to view the upstream elevation of the structure.

To cater for the maximum 12t axle loadings expected from the main crane and turbine deliveries, it is recommended that a reinforced concrete slab should be laid above the existing structure. The installation of a reinforced concrete slab will cater for the delivery of abnormal loads to the wind farm but will also be of long term benefit by protecting the existing fabric of the structure and preventing any failure from other heavy loads.
