Title: QUALITY AUDIT INCLUDING ROAD SAFETY AUDIT STAGE 1 CASTLEFORBES DEVELOPMENT

- Client: DBFL Consulting Engineers
- Date: November 2020

Report reference: 0899R01

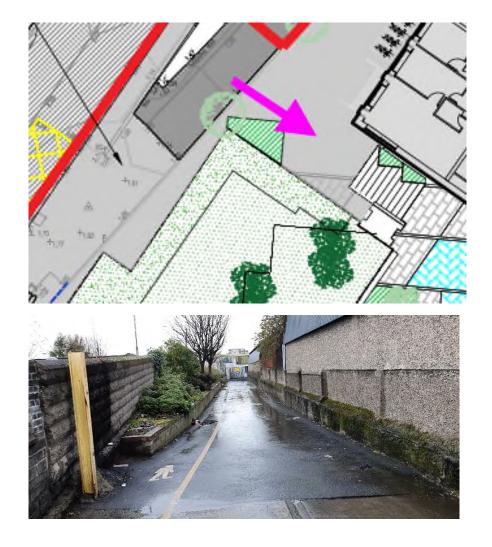
Drawing 180159-2100 P02 Roads Layout, East Road.

The proposed pedestrian access on East Road does not have a clear route for pedestrians from the public footpath. There is a possible pinch point at the hotel site and pedestrians have to share space with vehicles coming up and down the ramp to the commercial units to the North of the development.

It is recommended that a wide and clearly defined route be provided for pedestrians without having to share space with commercial vehicles. Gradients for pedestrians should be no steeper than 5%.

3.1	Yes	No	The existing vehicle access off East Road, to the west of the proposed development, is for access to an existing Irish Water Pumping Station. While we acknowledge that pedestrians will occasionally encounter vehicular traffic from this area, it is anticipated that this will be low given that the only vehicles entering this space will be staff for the Irish Water Pumping Station and that no pedestrian access to the proposed development is being proposed to the north of the access highlighted. As alternative measure, the landscaping proposals will be amended at detailed design to reduce the green landscaped area to facilitate a wider pedestrian entrance to minimise pedestrian/vehicular conflicts	Yes

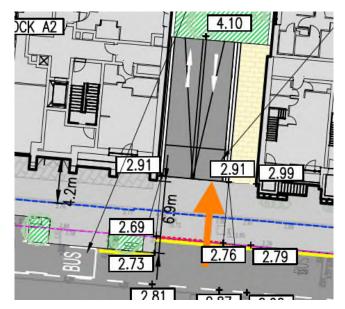
Drawing 180159-2100 P02 Roads Layout, Vehicular Access Sheriff Street Upper.

The bus stops On Sheriff Street Upper are in close proximity to the vehicular entrance to the basement car park. There is a risk that parked buses will obscure visibility for drivers exiting the car park leading to cars being stopped on the footpath blocking the path of pedestrians.

The Buildout for the eastbound bus lane is within the swept path for drivers turning left into the car park and could lead to reversing movements to complete the manoeuvre.

It is recommended that the bus stops be located where they do not obstruct movements or visibility from the development accesses.

3.2	Yes	No	We acknowledge that this concern may arise given the proximity of the bus stop to the basement entrance/exit. The location of the bus stop could be relocated away from the basement entrance/exit; however, the area is outside the control/ownership of the applicant and in the charge of DCC. We agree to approach DCC to relocate this bus	Yes

stop. Should DCC allow the applicant to relocate the bus stop, and grant	
			the necessary licenses, then same will be facilitated.	
3.3	Yes	Yes		
3.4	Yes	Yes

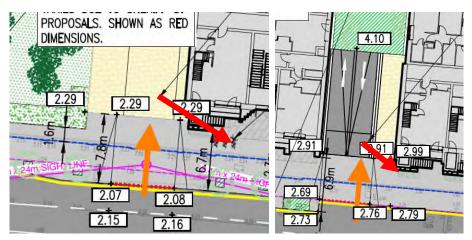
Drawing 180159-2100 P02 Roads Layout, Vehicular Accesses Sheriff Street Upper.

It is unclear if there will be sufficient visibility for drivers exiting the basement car parks to pedestrians or cyclists on the footpaths on Sheriff Street Upper. Without adequate visibility collisions could occur.

It is recommended that the visibility envelopes for pedestrians at the interface between the accesses and the footpath be kept clear of obstacles and building elements.

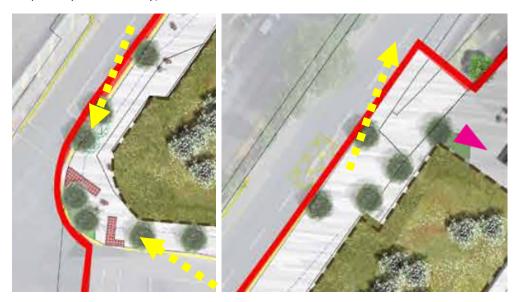
Drawing 6608_0300 Rev – Proposed Site Landscape Layout.

There is a risk that the proposed trees along the edge of the carriageway will block visibility to signal heads (either primary or secondary) which could result in collisions.

It is recommended that trees be removed from in front of traffic signals and from within visibility splays.

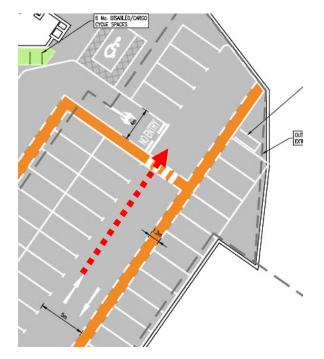
Drawing 180159-2101 Rev P02, Western Basement layout.

The basement circulatory layout road markings suggest that there can be two-way traffic on the second aisle however there is no exit for northeast bound traffic and no turning area if all the spaces are occupied. This could lead to wrong way driving and head-on collisions.

It is recommended that the layout be revised.

3.5	Yes	Yes	We acknowledge that this concern may arise, however the parking spaces will be assigned to residents of the development and it is unlikely that a vehicle will access the area without the intention of parking. To accommodate the unlikely event of this occurring, the motorcycle space will be relocated during detailed design to allow for turning space of vehicles. In addition to the relocation of the motorcycle space and the 6.2m wide aisle, this will create enough space for a 3-point turn.	Yes
