Proposed Strategic Housing Development on the
Former Player Wills Site and Undeveloped Land
Owned by Dublin City Council at South Circular
Road, Dublin 8.

Structural Assessment Report for Planning

DOCUMENT NO: 19.117 – PWFR – 01

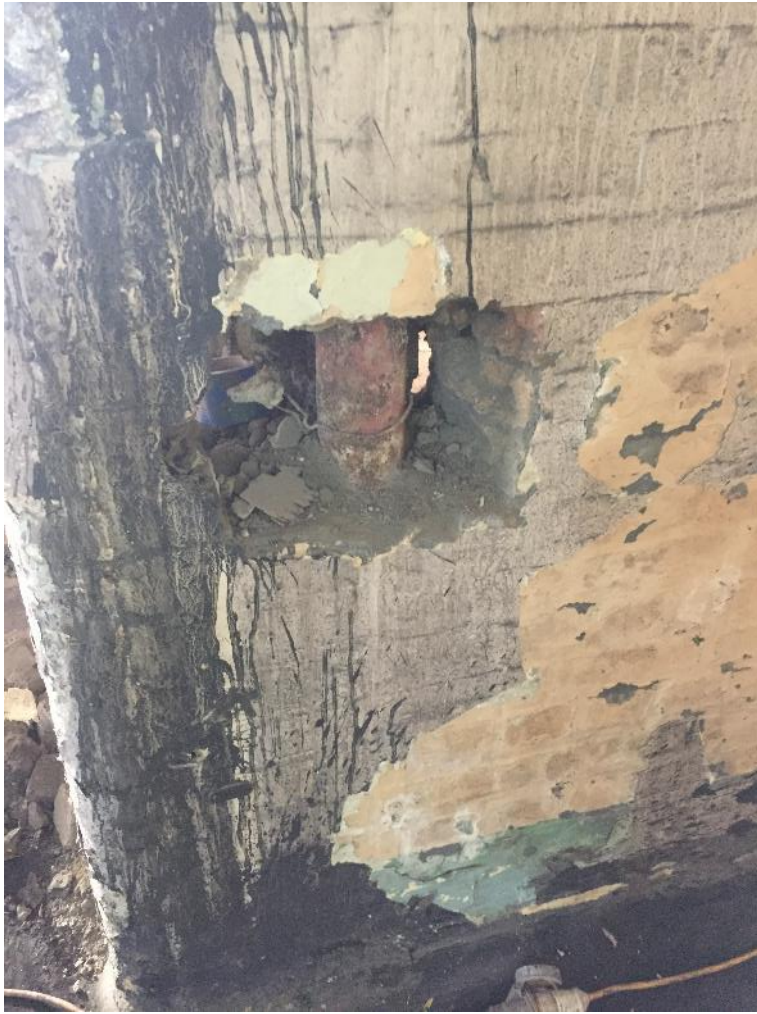
Photo 16: Embedded Steel

During the investigations, it was discovered that the external brick façade piers encase structural steel columns, and that the concrete lintels are an encasement to structural steel beams (refer to Photos 16-20 in Appendix A). Corrosion of the steelwork was noted in the initial opening up works and the results of this initial opening up can be seen in Appendix E. As a result, specialist cathodic protection testing has been commissioned so as to investigate its effectiveness of protecting the steel within the facade. This is to establish if this method of corrosion protection will be successful in preventing further corrosion of the structural steelwork, which would affect its loadbearing capacity, and also result in expansive corrosion having deleterious effects on the encasing brick façade. This cathodic protection testing has commenced and a report outlining the findings and long term corrosion protection for the encased steel elements will be produced upon completion of the testing.

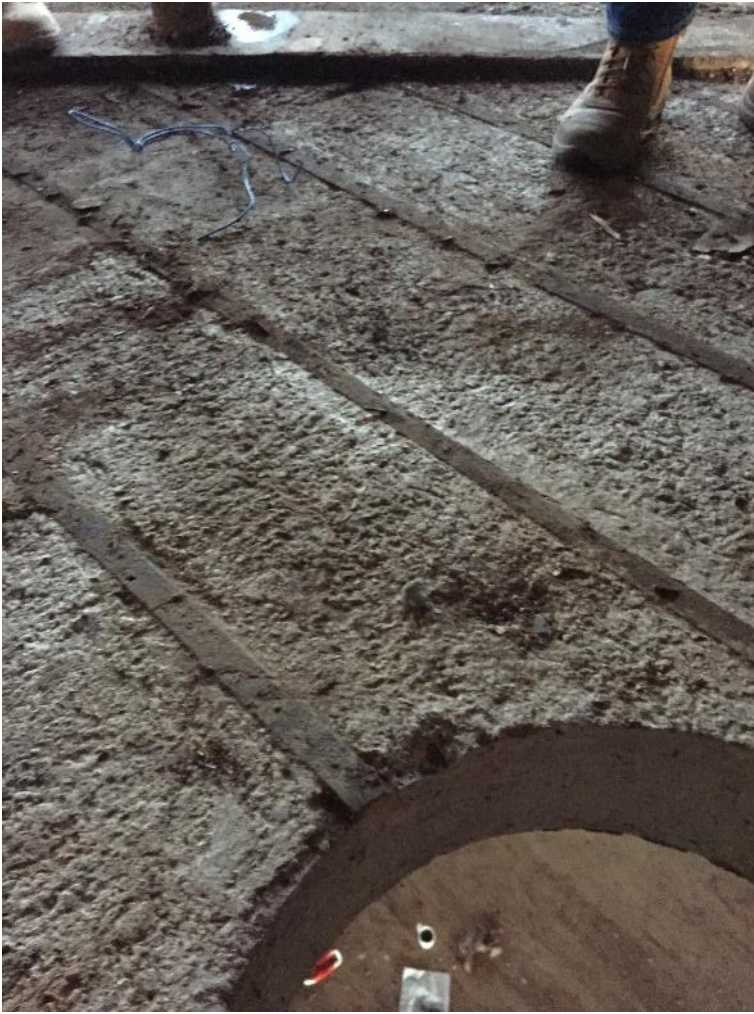
Non-structural screed containing timber batons at regular spacings have been cast above the structural slabs on levels 1 and 2. Given that the building was exposed to years of wet and damp conditions, these timber batons have rotted. To ensure the new construction is not subject to the potential effects of leaving these screeds in place, the screeds shall be removed and replaced with new non-structural floor screeds.

Photo 23: Core sample, with non-structural screed with timber batons

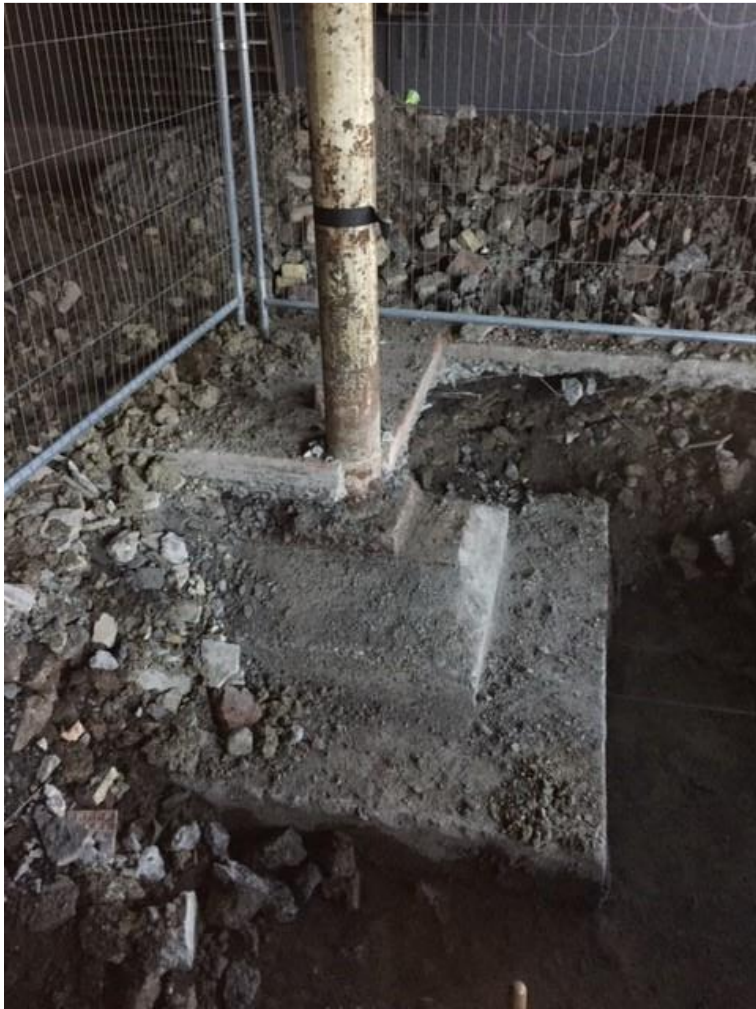
Photo 28: Tiered spread footing

A number of footing exposures were carried out, typically two each at internal atrium columns location, internal columns and at external façade piers (refer to Photos 28-31 in Appendix A). These exposures comprised of locally removing the ground floor slab around each element to establish the footing type, size, depth and founding material. As expected, all foundations were found to be conventional concrete spread footings, with tiered bases which were common at the time of construction. The concrete was found to be in good condition. Compressive tests on core samples were also carried out, giving results of 59.1 and 61.3 N/mm². The footings are founded on a soft to firm brown boulder clay with relatively low bearing capacity of 80kN/m².

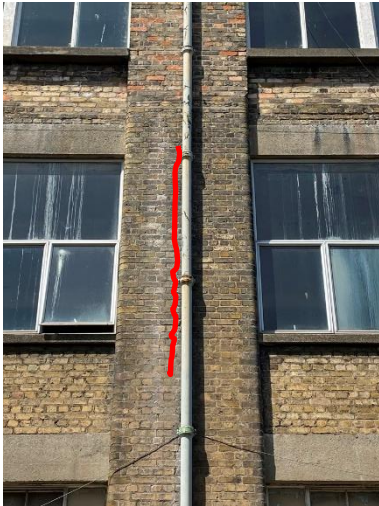
Plate 1

- Numerous instances of cracking were observed on the brickwork encasement at column locations. The severity of cracking ranged from hairline cracking to heavy cracking. The orientation of the observed cracking tended to be vertical, following the alignment of the embedded steel column (Plates 1 to 3). In the most severe of cases, 2no. parallel vertical cracks, coinciding with alignment of the column flanges, were present over the full height (storey height) of the affected columns (Plates 4 to 6).

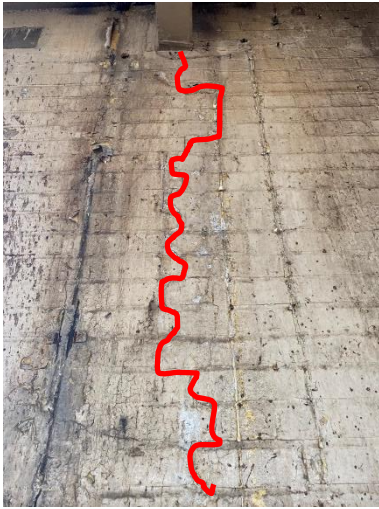
Plate 7

- Bulging and displacement of the brickwork encasement was identified at 1no. location (Plate 7).

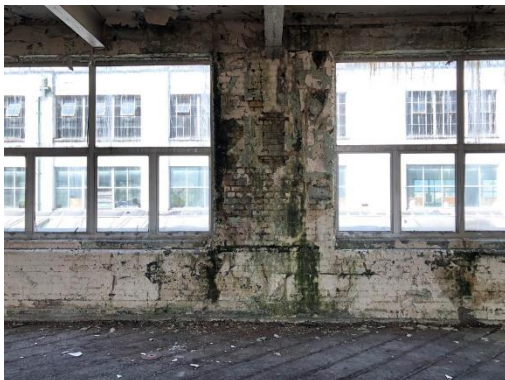
Plate 8

- Evidence of saturation was identified at a number of encased column and lintel locations (Plates 8 and 9). Saturation was particularly prevalent across the south elevation internally (Plates 10 and 11). Whilst the areas where saturation was evident often also exhibited cracking, there were instances where saturation was not accompanied by observable defects. Nonetheless, there is an increased likelihood of corrosion occurring at these locations given the availability of moisture to support the corrosion process.

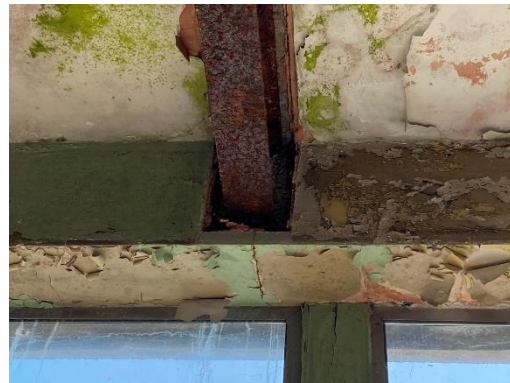
**Plate 17**

- Numerous instances of cracking were observed on concrete encased lintels. The cracking was predominantly vertical in orientation, likely coinciding with the position of supplementary stirrups (Plates 12 and 13) – this type of bar reinforcement was observed surrounding the steel lintel sections at locations where opening up works had been undertaken (by others). At a limited number of locations, horizontal cracking was also observed, likely coinciding with the bottom flange of the encased lintel (Plates 14 to 16). Localised cracking of the concrete encasement was also observed at the point of connection between encased lintels and secondary beams (Plate 17).

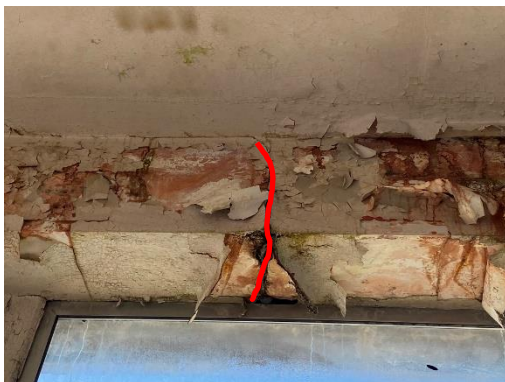
**Plate 18**

- Numerous instances of cracking were also observed on reinforced concrete lintels, likely coinciding with the position of shear links (Plate 18). At a selection of reinforced concrete lintels, spalled concrete and exposed corroded reinforcement was identified (Plate 19). Reinforced concrete lintels are believed only to be present over a selection of second floor window locations.

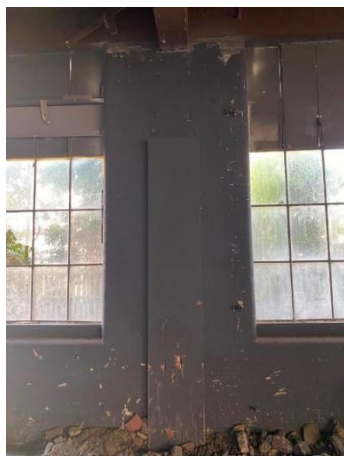
**Plate 20**

- Within the interior of the building, surface finishes (paint coatings, tiling, plasterwork, panelling etc.) may have inhibited the identification of defects (plate 20). Additionally, along the southern building elevation (gridline N) the existence of inbuilt chimney flues, thickened brick piers and exterior stone cladding may have concealed defects (Plates 21 to 23).

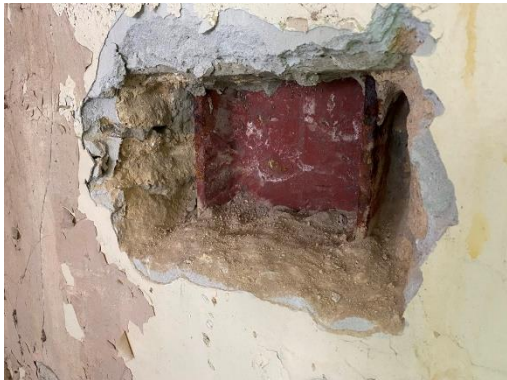
Plate 24

- Localised areas of brick/concrete encasement have been removed (by others) to expose the embedded steel sections or steel reinforcement. The condition of the steel present at these locations varied, from exhibiting little or no corrosion (Plates 24 and 25) to exhibiting moderate surface corrosion (Plates 26 and 27). From the limited number of elements exposed, it appears that the embedded columns located along the eastern elevation are worst affected.

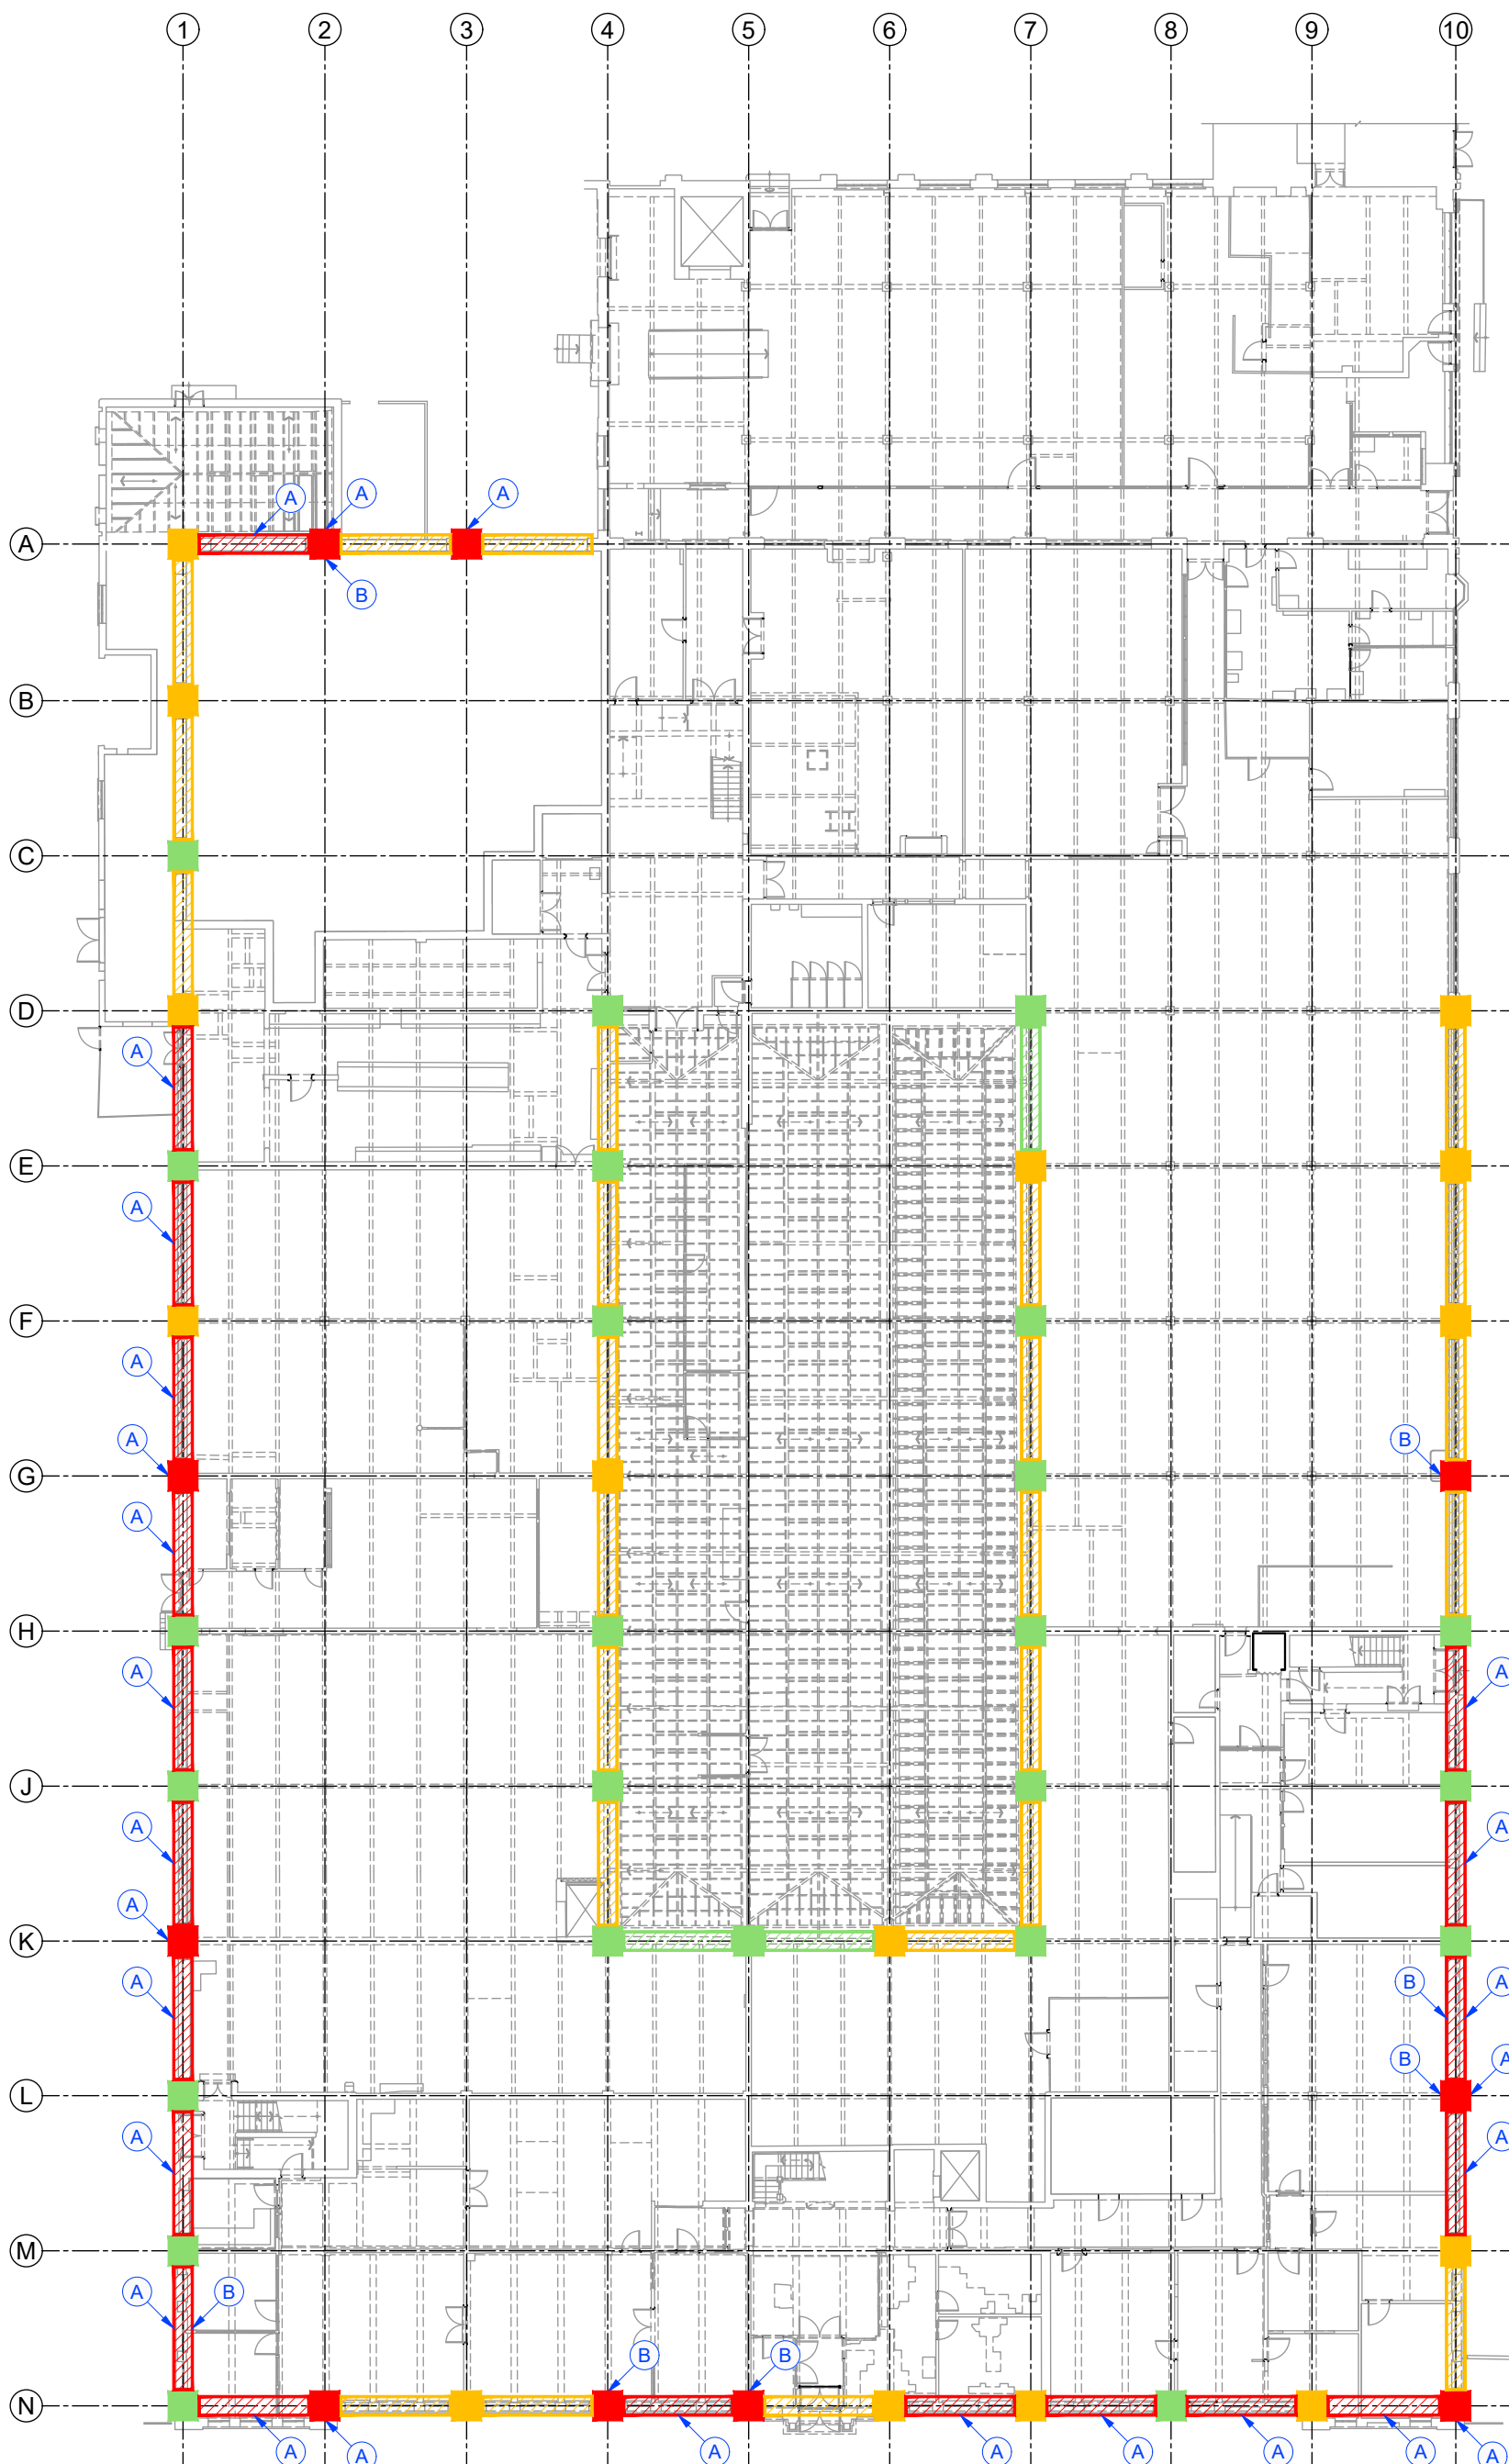
Ground Floor

Cracking of the encasement surrounding columns and lintels was observed at numerous locations throughout the building, both on external and internal faces. The survey also indicates a significant concentration of defects to the eastern aspect of the building on the first floor. In addition to the observed cracking, spalled and delaminated concrete was also identified on a selection of reinforced concrete lintels located on the second floor.

Nonetheless, it is recommended that further investigations are undertaken to determine whether the embedded steel is likely to be actively corroding, and the extent over which this may be occurring. It is also recommended that investigations are undertaken to determine the presence of deleterious contaminants or the action of deterioration processes which may be contributing to the corrosion of the embedded steel.
