Player Wills

Stage 1 Road Safety Audit

September 2020

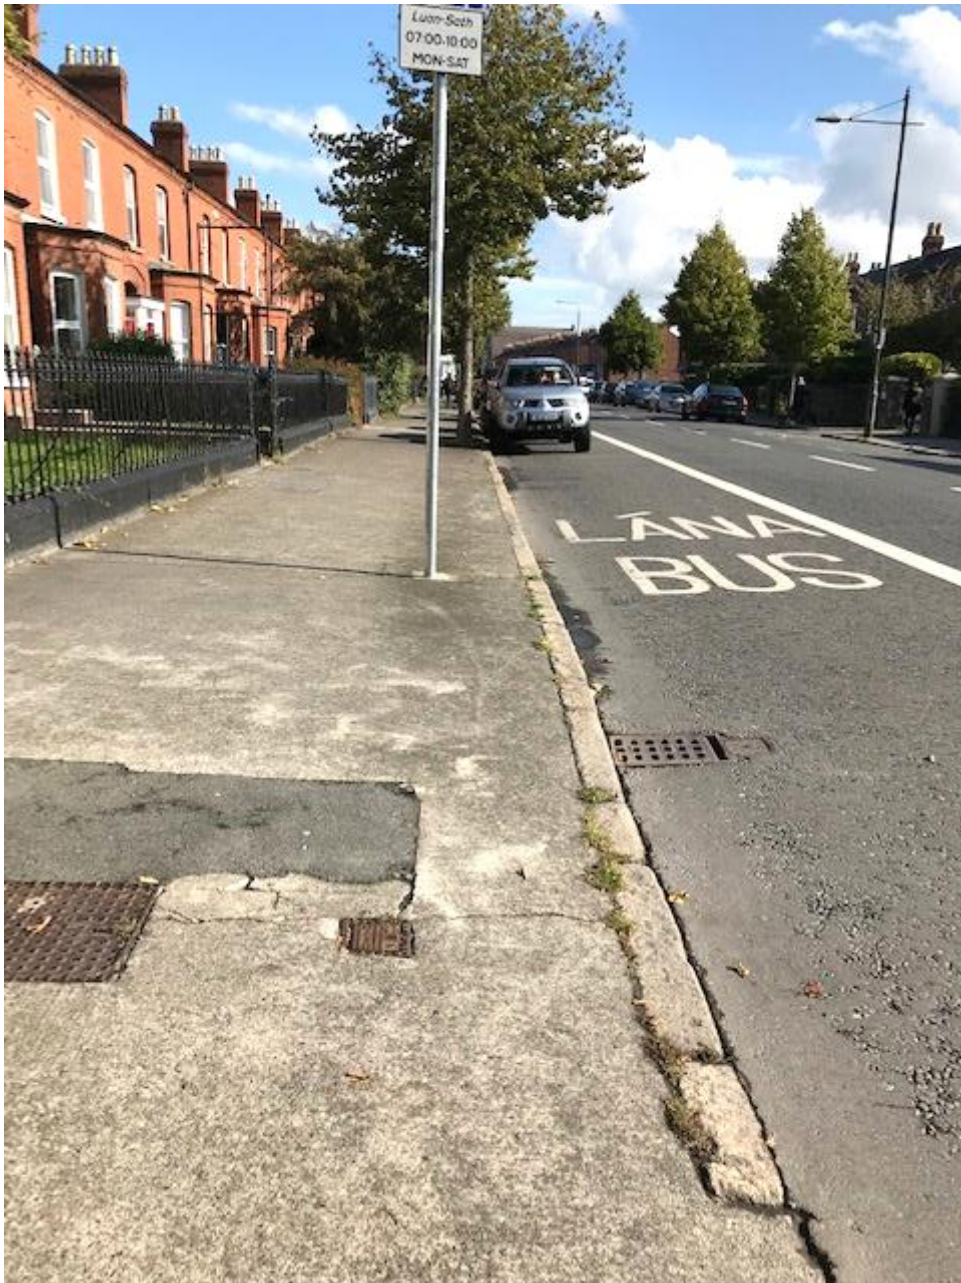
2.1 Problem: Parking in Bus Lane on South Circular Road

It was noted on the site visit that cars were parked in the bus lane on South Circular Road. Parking is prohibited in the bus lane only between 7am and 10am. Cars parked in the bus lane will impede visibility to the left and to the right for drivers exiting the proposed development and could lead to collisions as vehicles emerge.

Figure 2.1: Vehicles parked in bus lane (east)

Provide the required visibility splays by prohibiting on-street parking on both sides of the access onto South Circular Road.

2.1	Yes	Yes	Proposal to prohibit on-street parking on both sides of the access to be part of the Detailed Design Stage.	n/a
2.2	Yes	Yes	The existing street lighting on Donore Avenue at the proposed access to the development will be reviewed as part of the Detailed Design Stage.	n/a

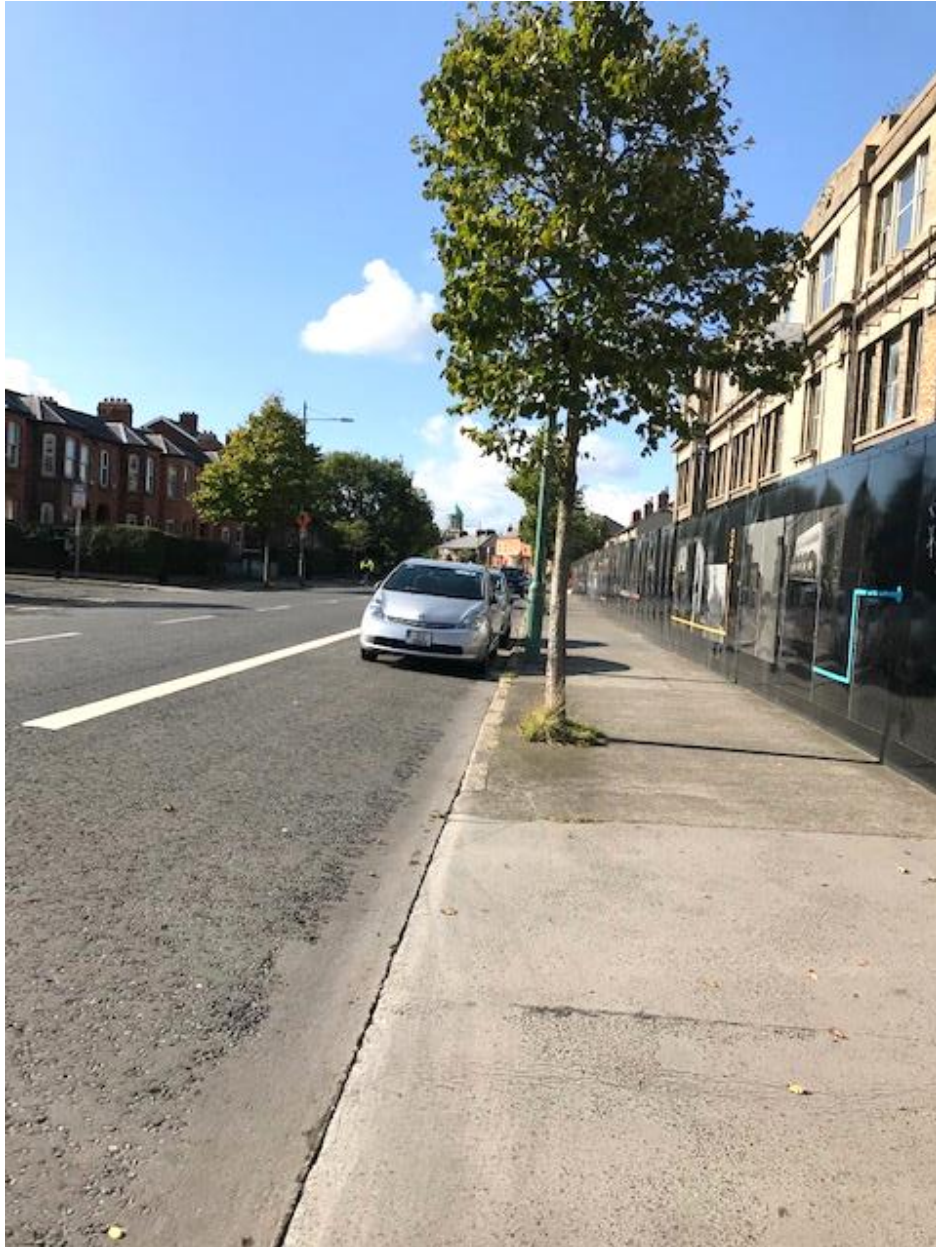
Figure 2.2: Vehicles parked in bus lane (west)

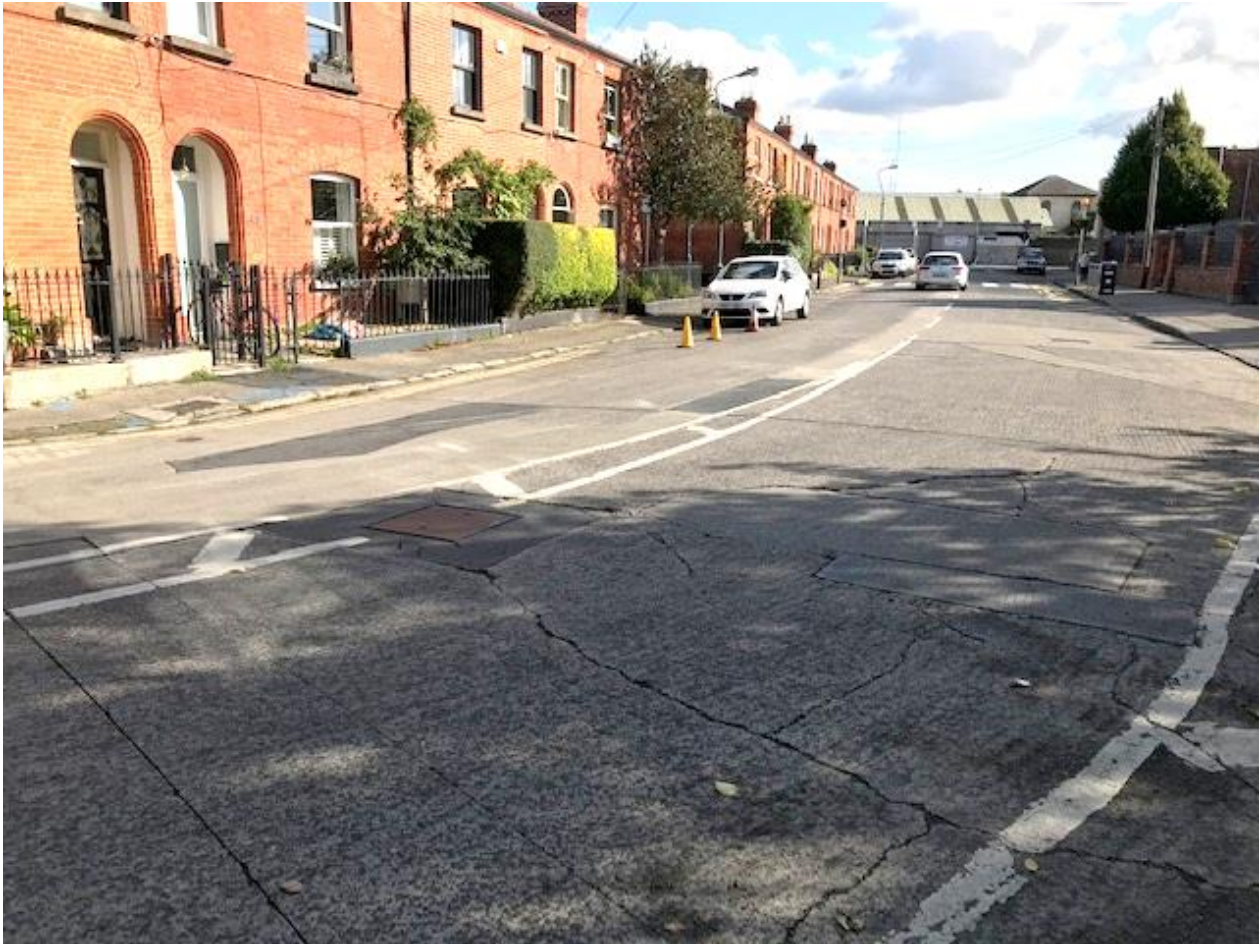
2.3 Problem: Condition of existing road surface

The existing concrete road surface is in poor condition in places at the proposed access onto Donore Avenue. The condition of the surfacing also has the potential to deteriorate further once the proposed access is installed due to increased traffic movements, especially after use by construction-related traffic. This may give rise to pedestrians tripping as they cross the road.

Figure 2.3: Condition of road surface

Undertake an assessment of the condition of the existing road surface and carry out improvement works where necessary.

2.3	Yes	Yes	The existing conditions review of the road surface will be undertaken as part of the Detailed Design Stage.	n/a
2.4	Yes	Yes	Cul-de-sac sign to be provided as part of the Detailed Design Stage	n/a

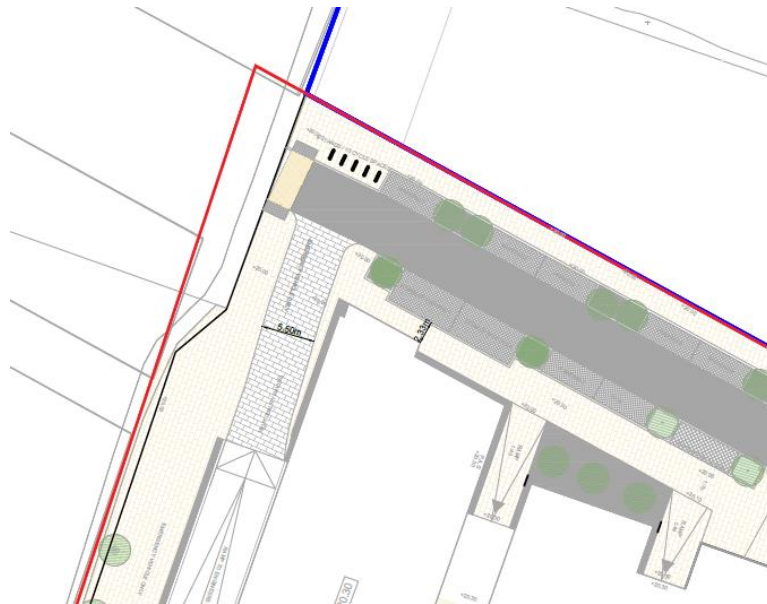
Figure 2.4: Cul-de-sac at link to Bailey Gibson

2.5 Problem: Cul-de-sac at link to Bailey Gibson

There is a cul-de-sac arrangement at the link to Bailey Gibson. It is assumed that this will provide future development connection. However, in the interim there is no turning head provision at this location, which may lead to drivers reversing back if they are unable to turn, potentially causing them to come into conflict with other road users.

Provide a cul-de-sac sign to minimise the risk of drivers inadvertently driving to the end of the cul-de-sac. Refer also to Problem 2.9.

2.5	Yes	Yes	Cul-de-sac sign to be provided as part of the Detailed Design Stage	n/a
2.6	Yes	Yes	This issue has been resolved as shown in the Planning Drawings	n/a

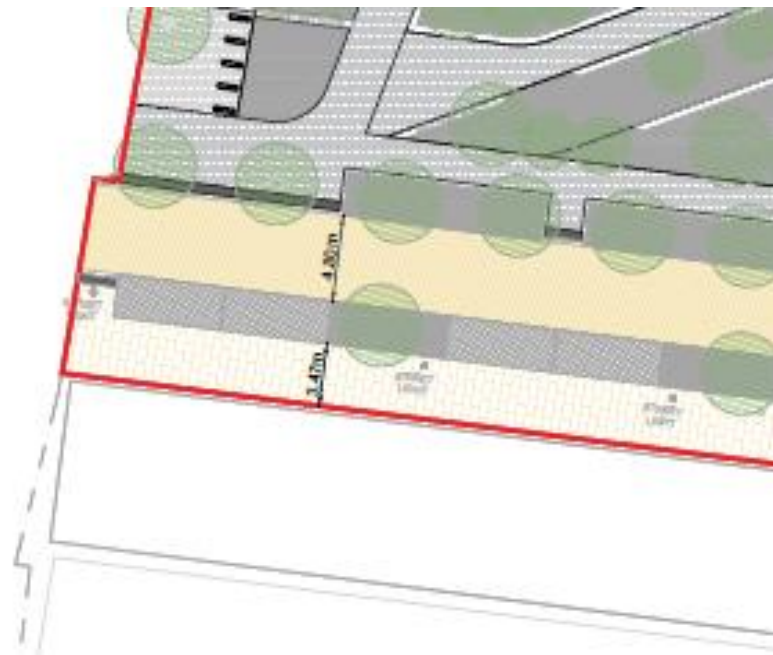
2.4 Problem: Cul-de-sac at car park ramp entrance

There is a cul-de-sac arrangement at the car park ramp entrance. There is no turning head provision at this location, which may lead to some drivers reversing back along the road if they are unable to turn, potentially causing them coming into conflict with other road users.

Figure 2.5: Cul-de-sac at car park entrance

Provide cul-de-sac sign to minimise the risk of drivers inadvertently driving to the end of the cul-de-sac. Refer also to Problem 2.9.

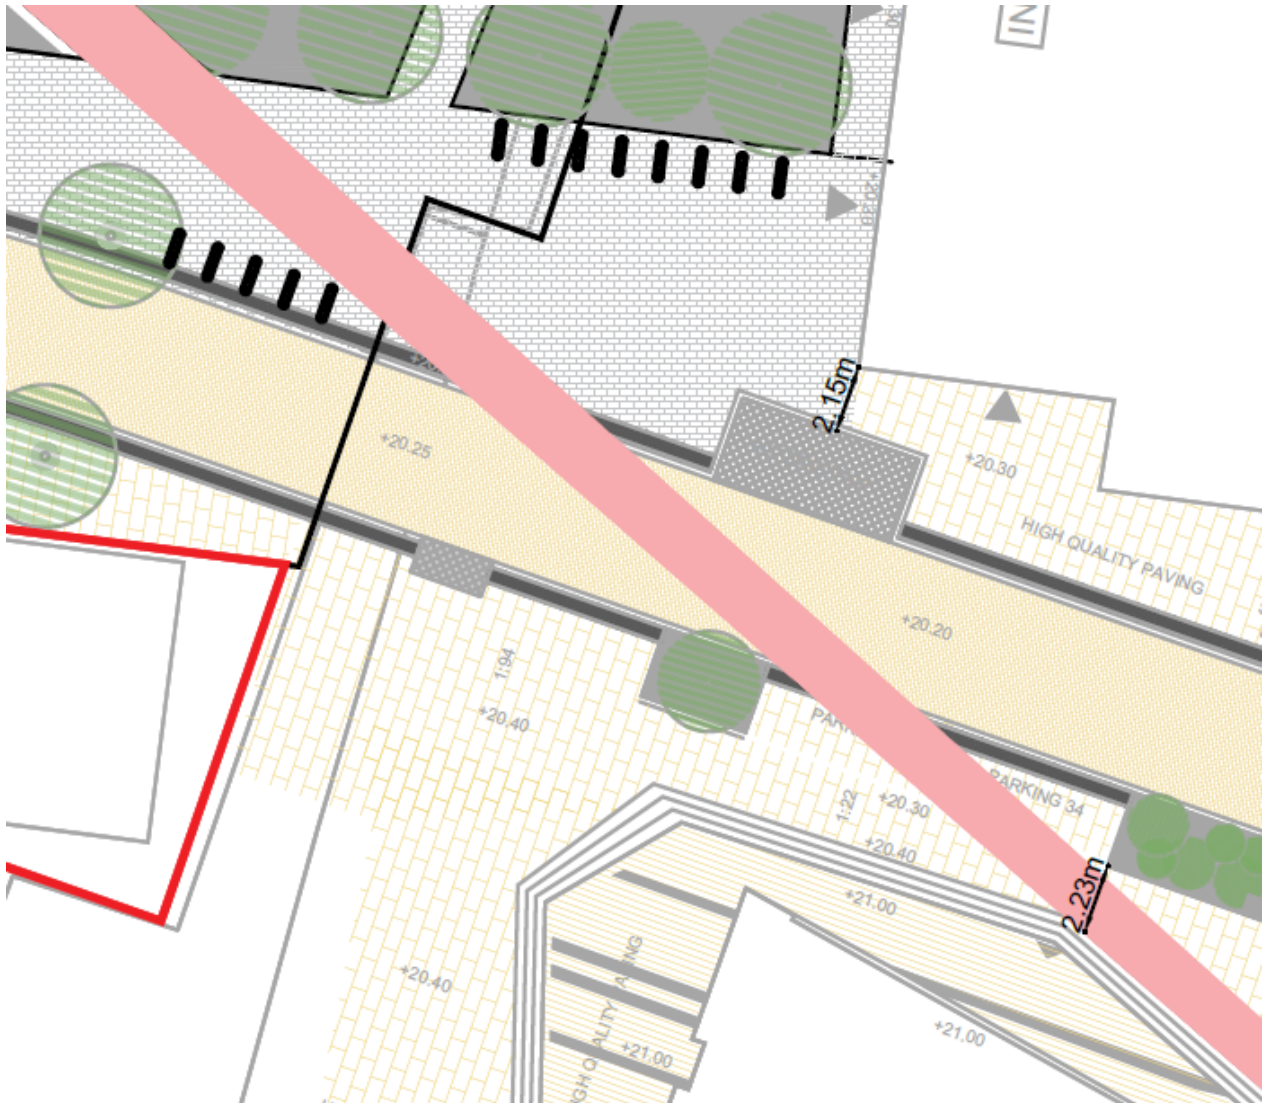
2.6 Problem: Angled pedestrian crossing point

The red paved route through the site crosses the shared space roadway at a diagonal angle. This may result in pedestrians, especially visually impaired pedestrians, making unsafe crossings, with potential for them to come into conflict with road traffic.

Figure 2.6: Angled pedestrian crossing point

Amend the arrangement so that the pedestrian crossing is perpendicular to the shared space roadway, ensuring the shortest crossing route for pedestrians and limiting their exposure to conflict with traffic.

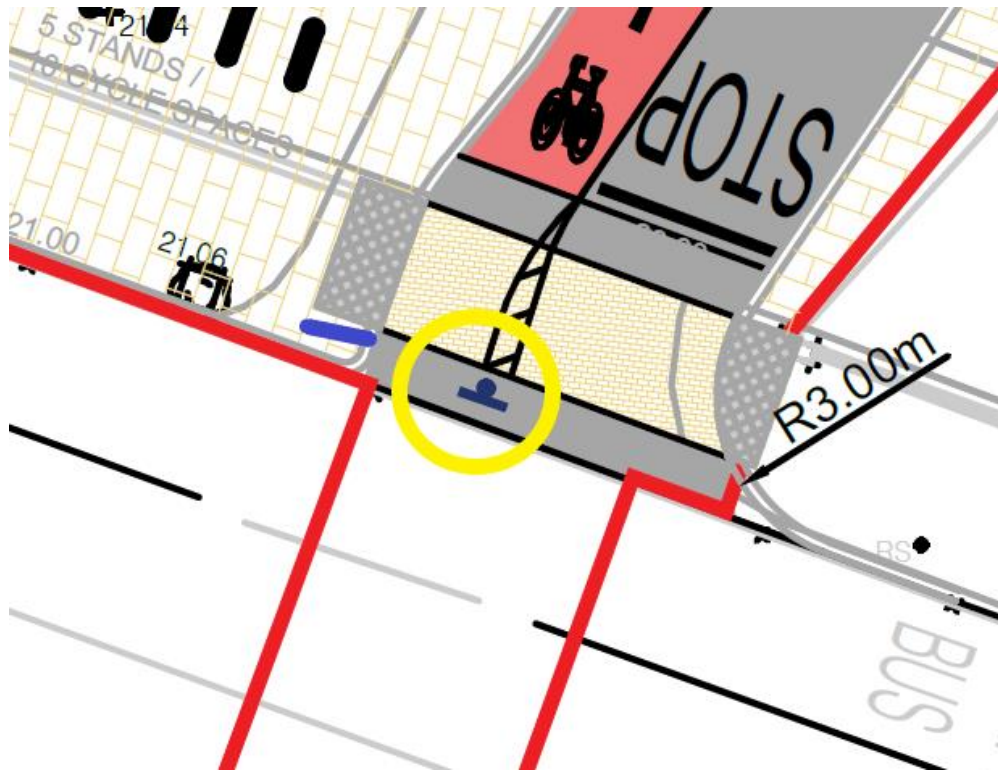
2.7 Problem: Sign placement

There is a proposed sign positioned between the cycleway and the vehicular exit onto South Circular Road. This sign poses a hazard to vehicles and cyclists using this access/exit.

Figure 2.7: Sign placement

Reposition the sign to the footpath to minimise the potential for vehicles or cyclists coming into conflict with it (indicated with the blue line on the image below).

2.7	Yes	Yes	This issue has been resolved as shown in the Planning Drawings	n/a
2.8	Yes	Yes	It is proposed to review the road markings arrangement along the cycle lane as part of the Detailed Design Stage	n/a

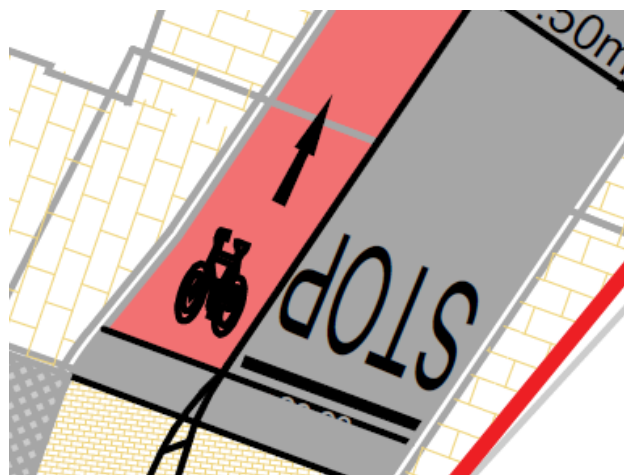
2.8 Problem: Cycle road markings

The cycle directional arrows are considered unnecessary and pose a risk of cyclists slipping on a wet road surface due to reduced grip. The cycle symbols give a sufficiently clear indication of the intended direction of travel.

Figure 2.8: Cycle arrows

Remove the directional arrows.

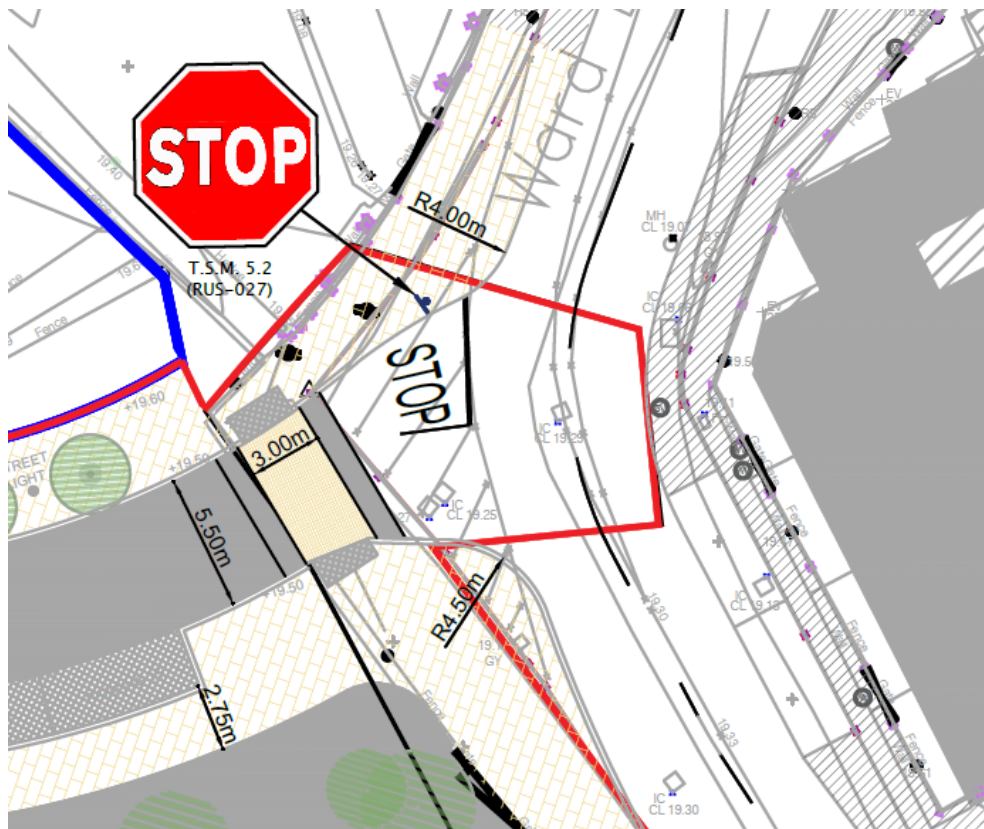
2.10 Comment

Figure 2.9: Orientation of stop line centreline

Review orientation of the stop line centreline to ensure it follows the centreline of the proposed access.

2.9	Yes	Yes	Wayfinding to be provided as part of the Detailed Design Stage	n/a
2.10	Yes	Yes	This issue has been resolved as shown in the Planning Drawings	n/a
2.11	Yes	No	Due to the low speed and volumes on this road, we are proposing that cyclists will share the road space as throughout the site when travelling southbound, therefore there is no need to provide a 2-way cycleway (2.5m wide). The potential narrowing of the traffic lane to 3m wide will be investigated at the Detailed Design Stage	Yes
2.12	Yes	Yes	Signage arrangement at the entrance of the development to be provided as part of the Detailed Design Stage	n/a

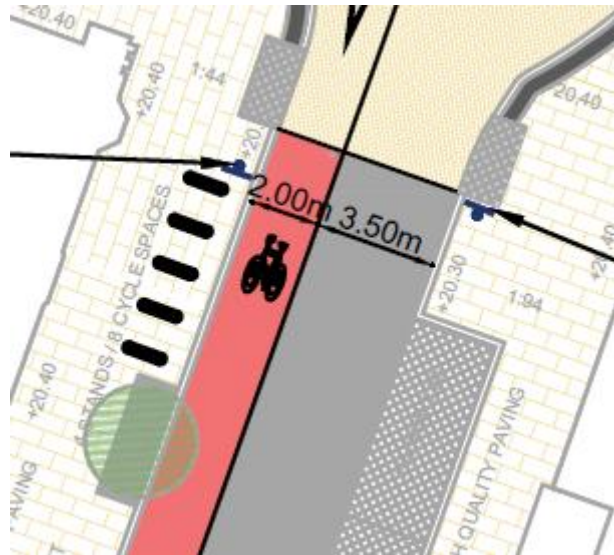
2.11 Comment

The one-way vehicular route exiting onto South Circular Road is shown as 3.5m alongside a 2m one-way cycleway. 3m would be sufficient for the one-way vehicular route. Reducing this to 3m would allow for increasing the cycleway to 2.5m, which would permit a two-way cycle track.

Figure 2.10: Lane widths
