Title: **QUALITY AUDIT
INCLUDING ROAD SAFETY AUDIT STAGE 1
Proposed Residential Development at Glenamuck Road**

Client: **DBFL Consulting Engineers**

Date: **November 2020**

Report reference: **0878R01**

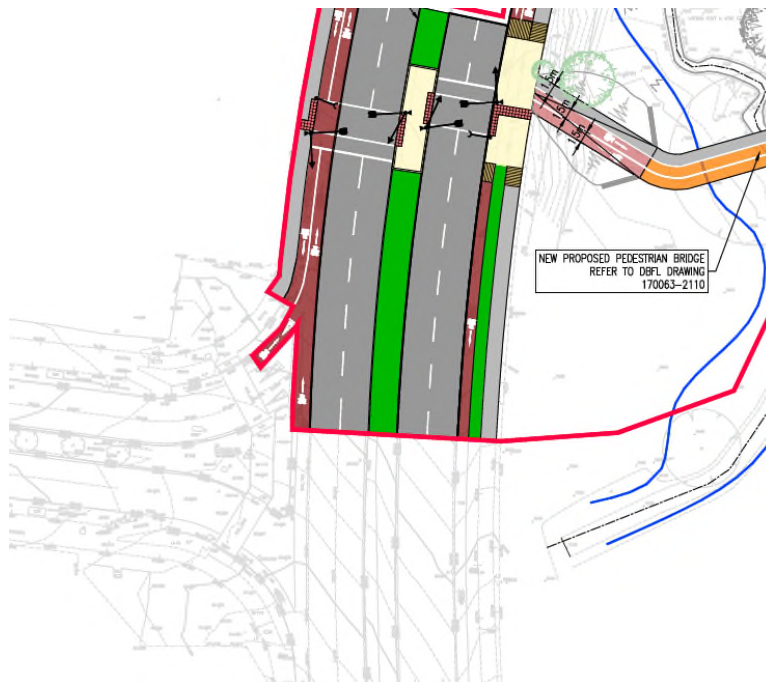
Drawing 170063-2100 Rev P02, Toucan Crossing Glenamuck Road.

The audit team have concerns regarding the location of the toucan crossing on the western side of Glenamuck Road. As there is a good level of visibility to the right for vehicle drivers travelling along the Carrickmines Park Shopping centre's egress lanes (in advance of the immediate approach to the junction), vehicle drivers can clearly see (in advance of the junction) if there are oncoming vehicles on Glenamuck Road. If there are no vehicles approaching in both (or the nearside) lanes on Glenamuck Road, vehicle drivers were observed to exit The Carrickmines Park Shopping centre without stopping/yielding at the junction. Due to these rapid exit practices being undertaken, vehicle drivers may fail to acknowledge the toucan crossing signals located immediately to the left of the junction in sufficient time to stop. This could result in conflict with pedestrians/cyclists crossing the carriageway.

3.1	Yes	Yes	We acknowledge the auditor’s concern and agree with the recommended measure, however the area is outside the control/ownership of the applicant and in the ownership of a DLRCC. We agree to notify DLRCC of the problem for their attention. Should DLRCC condition the applicant for its relocation and grant the necessary licenses then same will be facilitated.	Yes

It is recommended that the toucan crossing be moved further away from the junction or that the junction of The Carrickmines Park Shopping Centre is altered to ensure that vehicles exiting onto Glenamuck road are travelling at a very low speed.

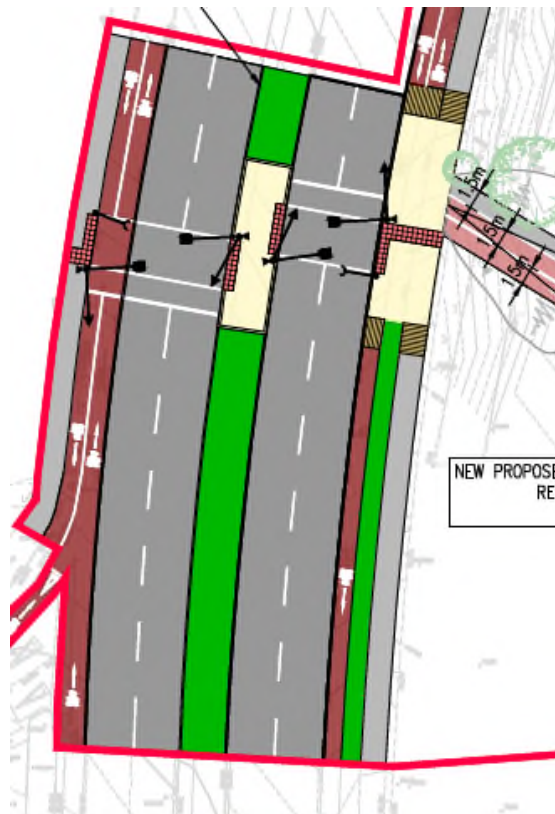
Drawing 170063-2100 Rev P02, Toucan Crossing Glenamuck Road.

There is an existing median hedge on Glenamuck Road dual carriageway. It is unclear if the hedge is to be cleared and if so to what extent. Without sufficient clearance of the median hedge inter-visibility between crossing cyclists and pedestrians with oncoming drivers may be limited leading to collisions.

3.2	Yes	Yes	We acknowledge the auditor’s concern and agree with the recommended measure, however the area is outside the control/ownership of the applicant and in the ownership of DLRCC. We agree to notify DLRCC of the problem for their attention. Should DLRCC condition the applicant for the recommendation and grant the necessary licenses then same will be facilitated.	Yes

It is recommended that the median hedge be cleared for sufficient distance in both directions to ensure adequate visibility to crossing vulnerable road users.

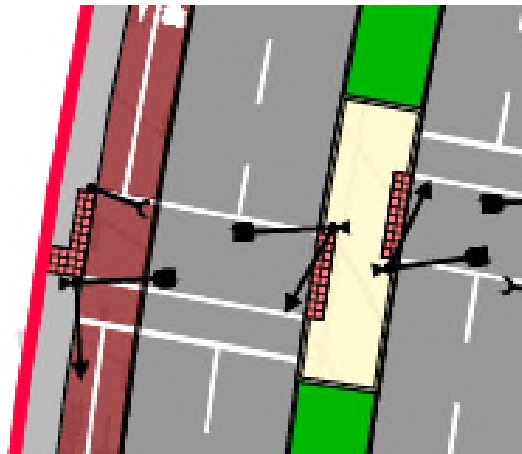
Drawing 170063-2100 Rev P02, Toucan Crossing Glenamuck Road.

Cyclists on the western side of Glenamuck Road may collide with crossing pedestrians if they do not expect them to cross at the proposed toucan crossing.

3.4	Yes	Yes	We acknowledge the auditor's concern and agree with the recommended measure, however the area is outside the control/ownership of the applicant and in the ownership of DLRCC. We agree to notify DLRCC of the problem for their attention. Should DLRCC condition the applicant for the recommendation and grant the necessary licenses then same will be facilitated.	Yes

It is recommended that the toucan signals be provided at the carriageway edge rather than at the back of the cycle track and that a shared area be provided for pedestrians and cyclists to share.

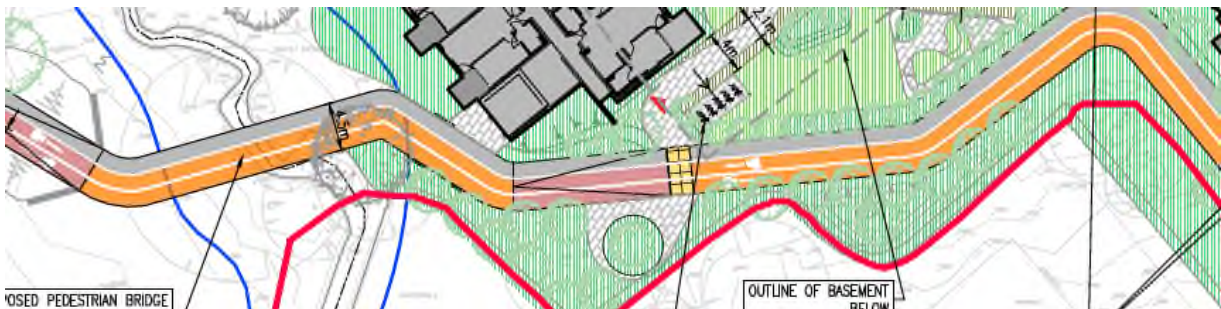
Drawing 170063-2100 Rev P02, Internal cycle track.

There are a number of sharp horizontal bends on the internal cycle track linking Golf Lane with Glenamuck Road. This may lead to cyclists travelling across their lane into oncoming cyclists or pedestrians resulting in injury.

3.5	Yes	Yes	We acknowledge the auditor's concern regarding the horizontal bends on the internal cycle track, however it is intended to keep speeds low along the internal cycle track, especially approaching the proposed bridge. Where horizontal bends are tight, localised widening shall be provided during detailed designs as per the auditor's recommendations.	Yes

It is recommended that that the sharp bends be smoothed or that localised widening of the track be provided.

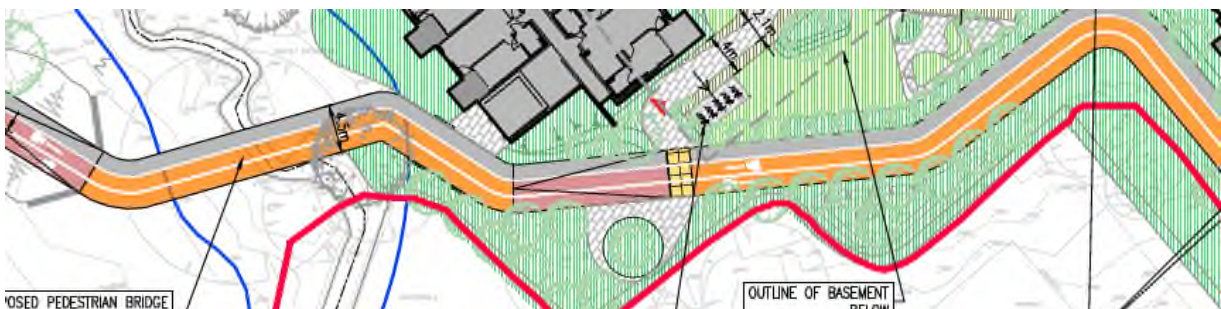
Drawing 170063-2100 Rev P02, Internal footpath

The internal footpath linking Golf lane with Glenamuck Road is only 1.5m wide. This would result in pedestrians having to enter the cycle track if they meet, particularly the mobility impaired and buggy pushers.

It is recommended that the footpath be widened to cater for the volume of expected users and the need for pedestrians to pass without having to step into the cycle track.

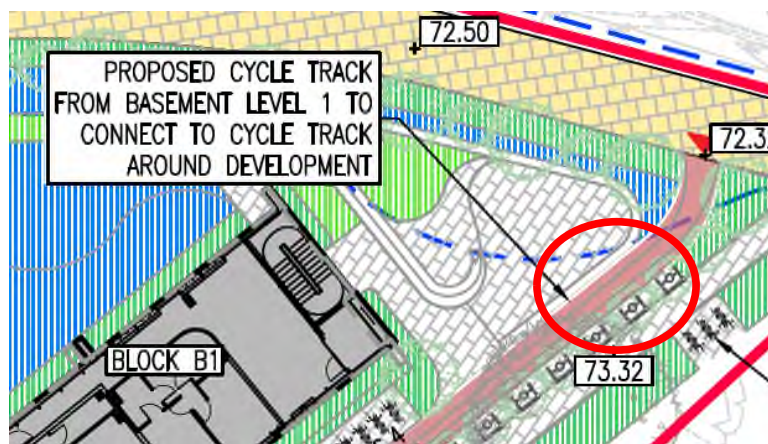
Drawing 170063-2100 Rev P02, cycle track to basement.

It is unclear what width the two-way cycle ramp to the basement is. If it is too narrow, there is a risk of collision between passing cyclists. The speed differential could be high given the high gradients which could lead to higher severity injuries.

It is recommended that the two-way cycle lane to and from the basement is of suitable width to accommodate fast moving cyclists.

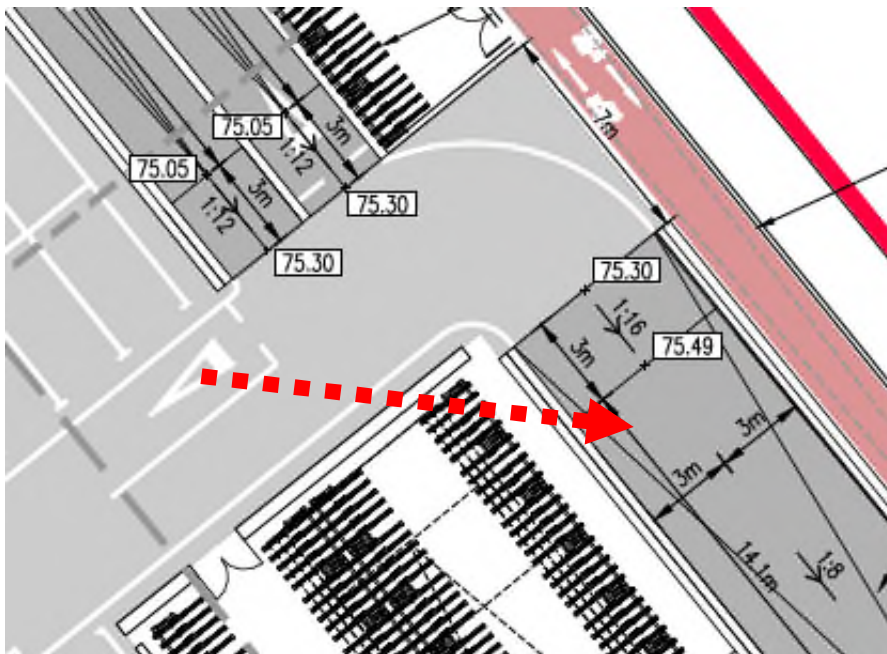
Drawing 170063-2101-P02, Basement level 1 Layout.

Vehicles exiting the basement have to yield to vehicles entering the basement due to the tight horizontal bend. It is unclear if there will be sufficient visibility for drivers to see if a vehicle is coming down the ramp when at the yield line. Without adequate visibility this could result in head-on collisions or reversing leading to material damage.

It is recommended that a swept path analysis be carried out so that two vehicles can meet or that sufficient visibility is provided at the Yield line.

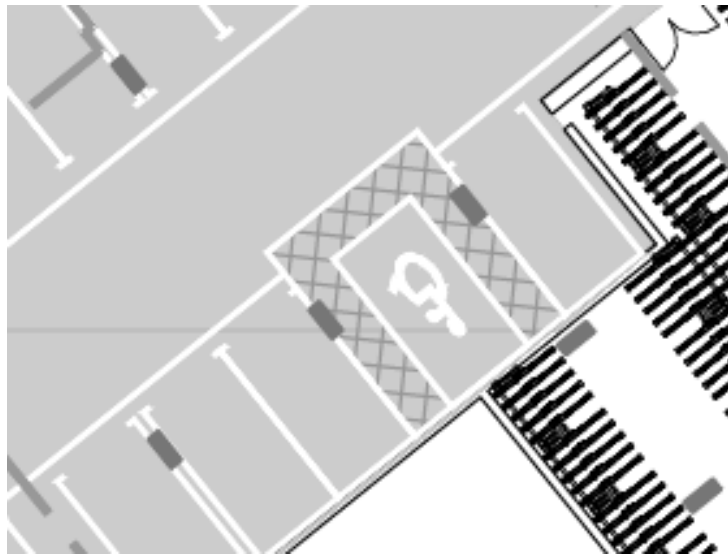
Drawing 170063-2101-P02, Basement level 1 Layout.

The structural columns appear to be located in the buffer zone around the single disabled parking bay in the south eastern aisle. This could lead to accessibility issues for wheelchair users.

It is recommended that the buffer zone for disabled parking bays be kept free from obstacles.

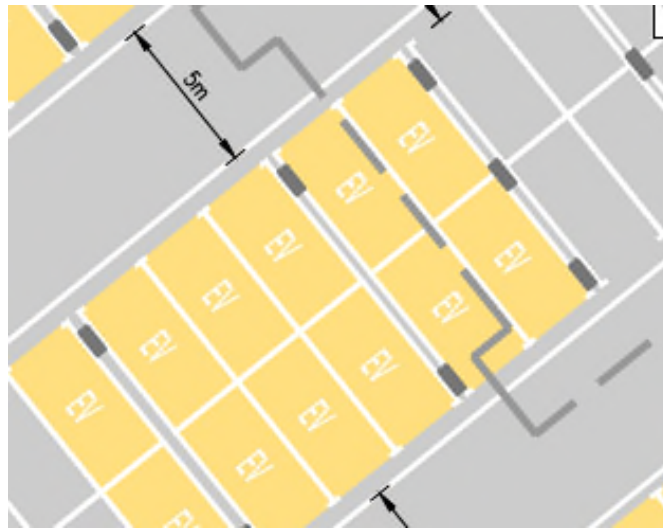
Drawing 170063-2101-P02, Basement level 1 Layout.

The electric vehicle charging spaces do not appear to be any larger than the standard parking spaces. This could lead to accessibility issues for users especially for side-entry charging. There is also a possibility of trips and falls due to the lack of space for cables between vehicles.

It is recommended that buffer zones be provided around electric changing spaces as per the guidance in the Traffic Signs Manual.

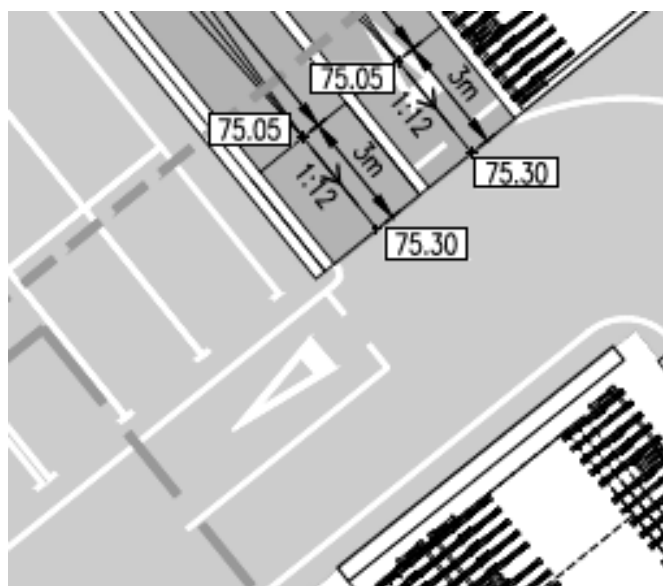
Drawing 170063-2101-P02, Basement level 1 Layout.

It is unclear if drivers will be able to turn left to enter the ramp to Basement Level 2 without colliding with the median of the ramp or the wall of the ramp shaft due to the tight turn required.

It is recommended that a swept path analysis be carried out for the left turn into Basement level 2 and if it cannot be easily carried out in a single manoeuvre for a long car then the layout should be modified.

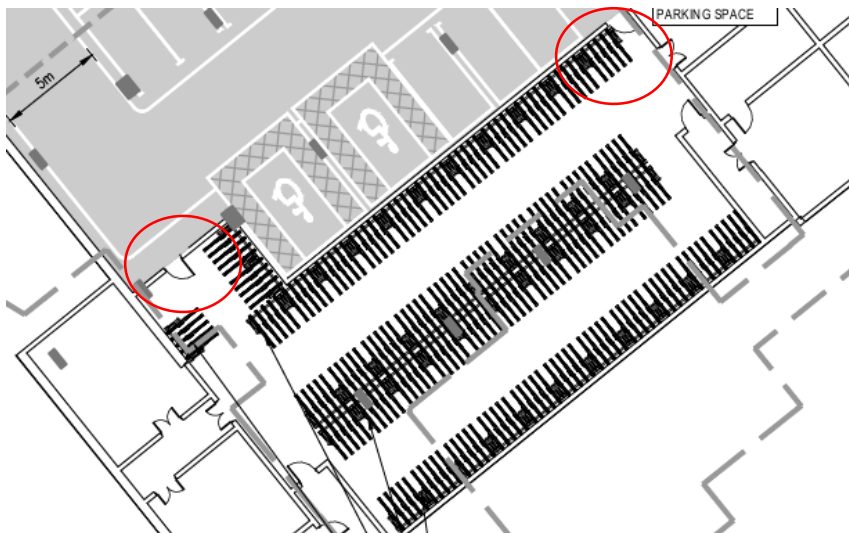
Drawing 170063-2101-P02, Basement level 1 Layout, bicycle park.

There are two single doors for the large (450no.) bicycle parking area in basement No. 1. The lack of space at the doorways for a busy area could lead to damage of the door/frames and possible cyclist injury and discomfort/frustration.

It is recommended that double doors be used instead of single doors.

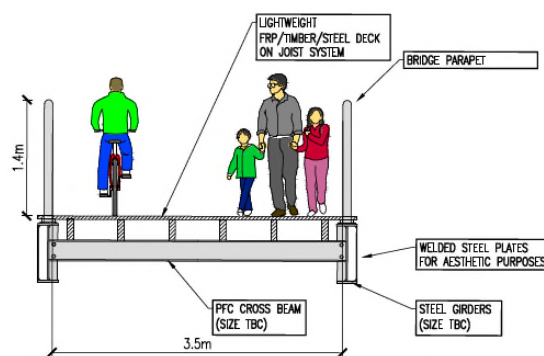
TYPICAL BRIDGE CROSS SECTION
SCALE 1:50

The pedestrian bridge cross sections show a cross sectional width of 3.5m. The cycle track and footpath have an overall cross section of 4.5m & 4.0m. A restriction in width could lead to collisions between cyclists and pedestrians.

It is assumed that the bridge parapet height will be 1.4m as indicated on the cross section and not 1.2m as indicated on the elevation to cater for the containment of cyclists.

It is recommended that the effective width of the bridge be the same as the general facility taking into account the reduction caused by the parapet upstands.

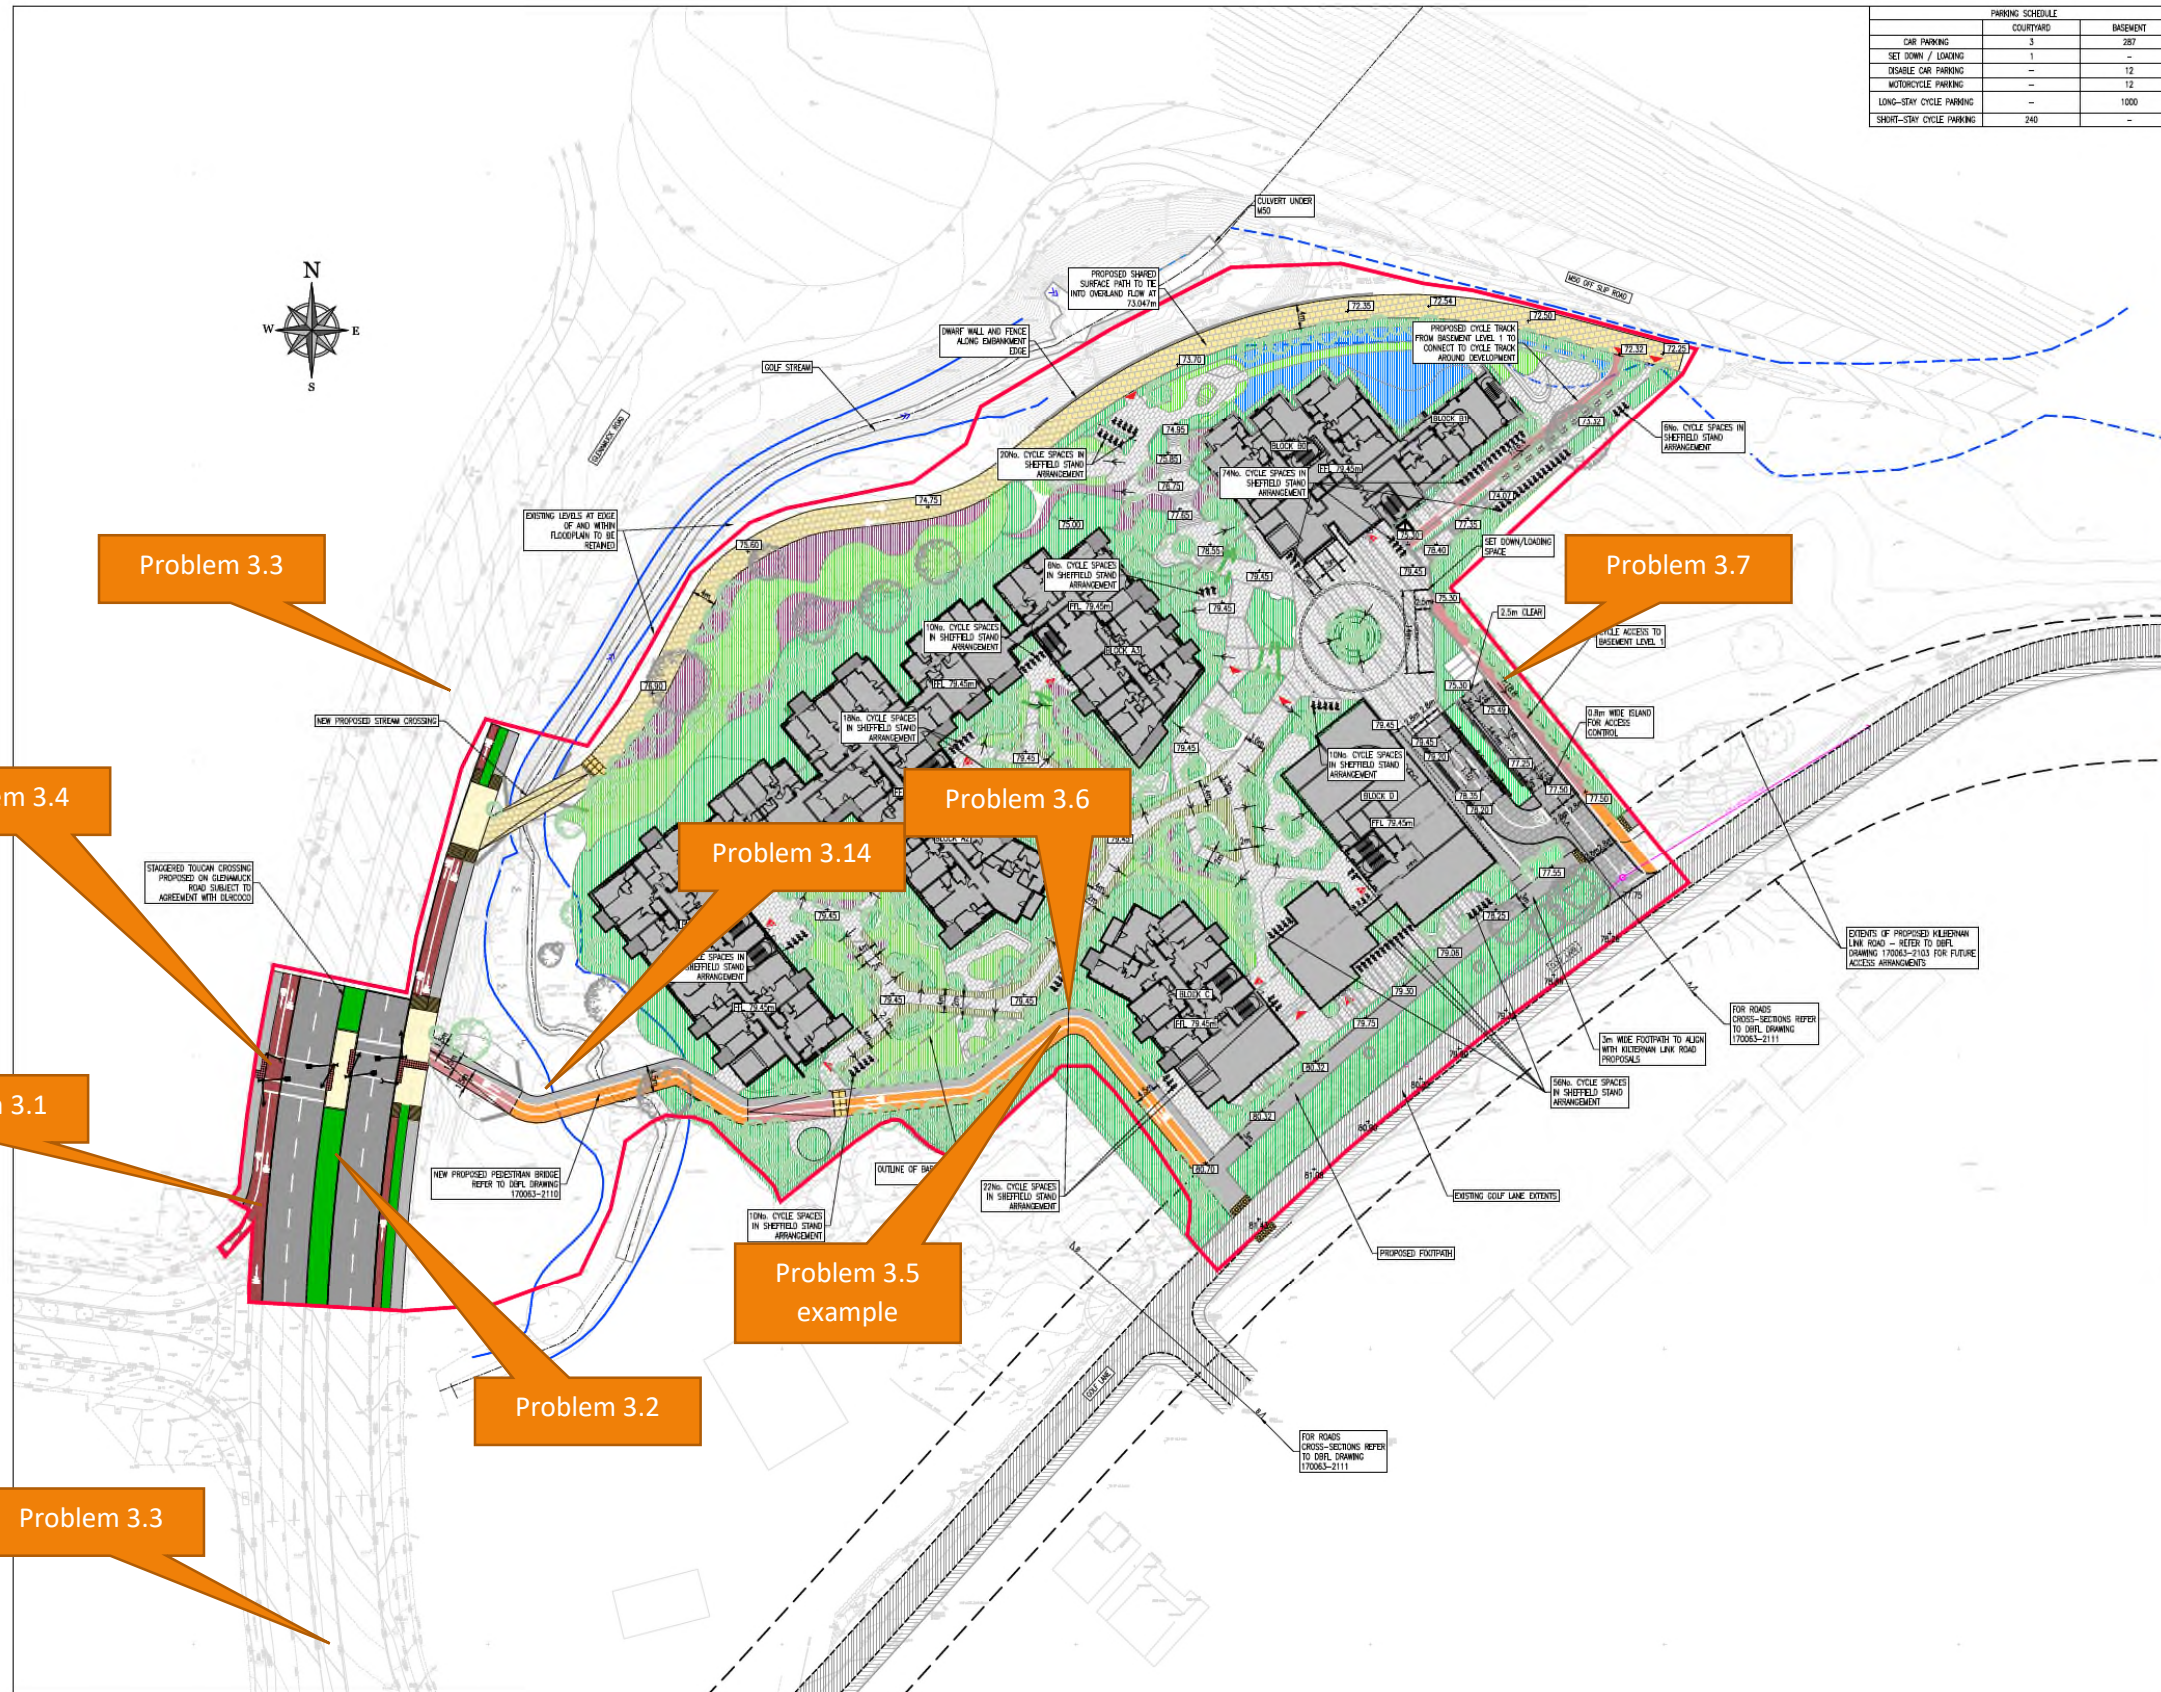
Problem Location Plan.

Problem 3.3

Problem 3.7

Problem 3.4

Problem 3.6

Problem 3.1

Problem 3.14

Problem 3.5 example

Problem 3.2
