20120-01-001

Proposed Wind Farm at Castlebanny, Co. Kilkenny

ROAD SAFETY AUDIT STAGE 1/2

December 2020

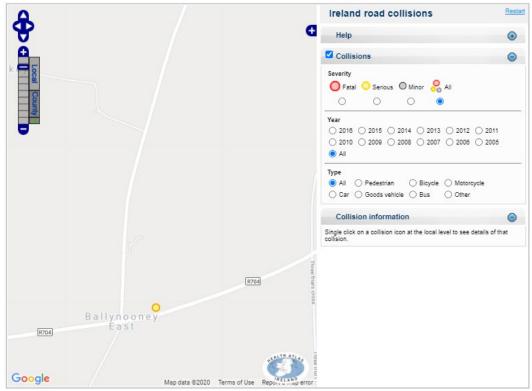
Figure 1: Road Collisions

- 1.4 An examination of the RSA collision database shows that there have been one serious collision within close proximity to the location of the proposed access to the wind farm from the R704 in the period of 2005 to 2016 inclusive. The collision is recorded as a single vehicle collision. The location of the collision is shown in Figure 1 below:

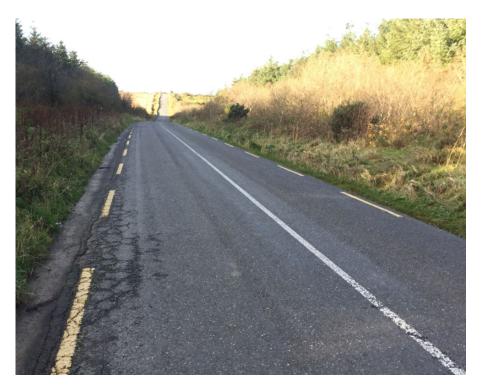
2.1 Problem.

There is an existing dip in the vertical alignment located on the western side of the R704 carriageway. Visibility splays at the proposed access to the wind farm may be restricted by the vertical alignment of the R704 regional road. A lack of adequate visibility at the proposed access may contribute to a side impact collision at the access.

Ensure adequate horizontal and vertical visibility splays are provided at the proposed access onto the R704 regional road.

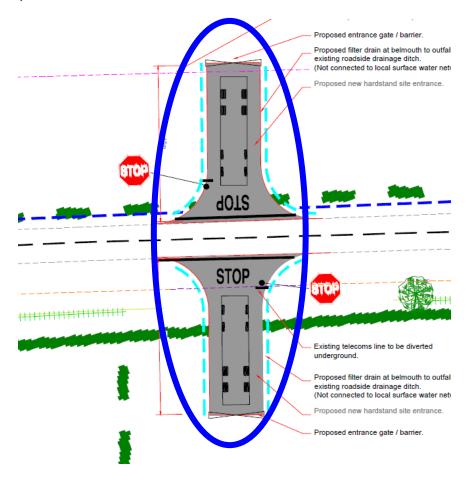
2.3 Problem.

At the proposed crossing point located on the local road the proposed internal access road is approximately 5m wide. The proposed width may not adequately cater for opposing HGV's passing one another at the

access points. A delay in a HGV entering the access points may lead to a side impact collision with a vehicle on the mainline.

Ensure adequate width is provided at the access points to cater for opposing HGV's to pass one another.
