Castlebanny Wind Farm

342068

Thursday, 23 January 2020

Prepared For Coiltte

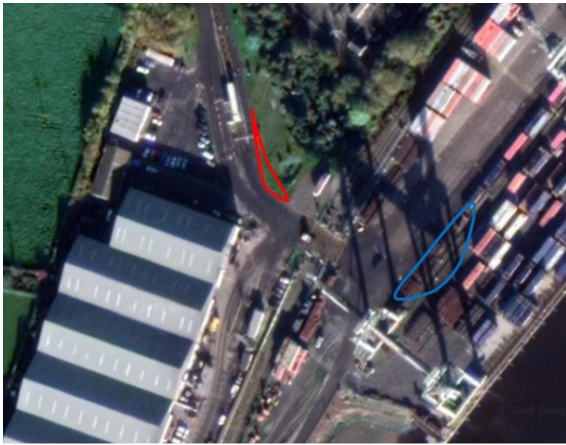
Location 1 - Exit Port Of Waterford

Visual inspection indicates that loaded blades will require to contra flow the security building and oversail land on offside.

Road widening will be required as per the red hatching shown on grass verge.

Blade tips will require to oversail area shown on Ariel mapping as indicated by blue hatching.

It is recommended that the new fencing within the port near blue hatching is made removable to assist navigation.

A topographical survey and swept path analysis is recommended at this location to confirm exact modifications required.

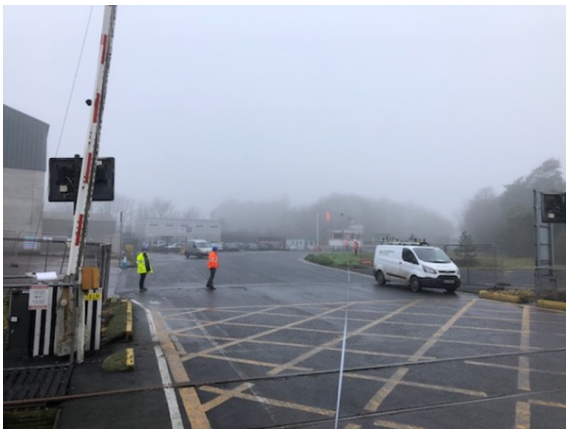
Location 1 Continued - Exit Port Of Waterford

Road widening will be required as per the red hatching shown on grass verge.

A topographical survey and swept path analysis is recommended at this location to confirm exact modifications required.

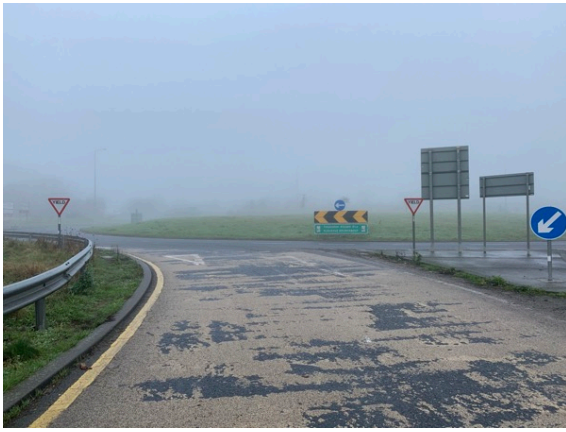
Location 2 - N29 / R711 Roundabout

Visual inspection indicates that road widening on the central island and the removal of several road signs will be required to accommodate loaded blade vehicles.

A topographical survey and swept path analysis is recommended at this location to confirm exact modifications required.

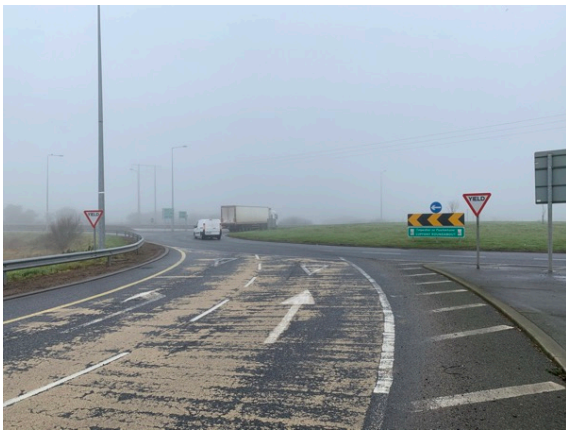
Location 3 - N29 / N25 Roundabout

Visual inspection indicates that road widening on the central island and the removal of several road signs will be required to accommodate loaded blade vehicles.

A topographical survey and swept path analysis is recommended at this location to confirm exact modifications required.

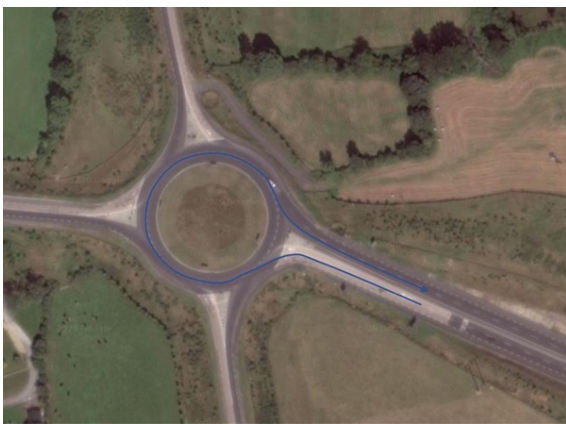
Location 4 - N25 Roundabout

Visual inspection indicates that road widening on the central island and the removal of several road signs will be required to accommodate loaded blade vehicles. Several lamp posts may also be affected by the blade vehicle and should be confirmed using Swept path analysis.

A topographical survey and swept path analysis is recommended at this location to confirm exact modifications required.

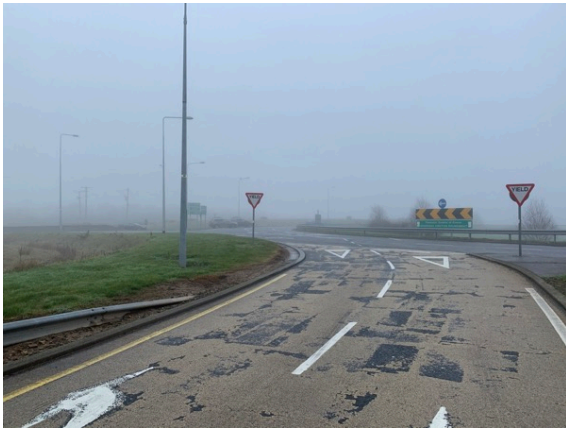
Location 5 - N25 / N24 Roundabout

Visual inspection indicates that loaded blade vehicle will require three lamp posts and one road sign to be removed from the nearside verge.

A topographical survey and swept path analysis is recommended at this location to confirm exact modifications required.

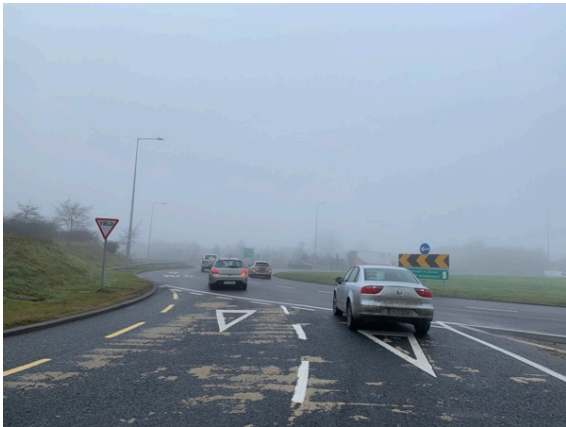
Location 6 - N24 / M9 Roundabout

Visual inspection indicates that road widening on the central island and the removal of several road signs will be required to accommodate loaded blade vehicles.

A topographical survey and swept path analysis is recommended at this location to confirm exact modifications required.

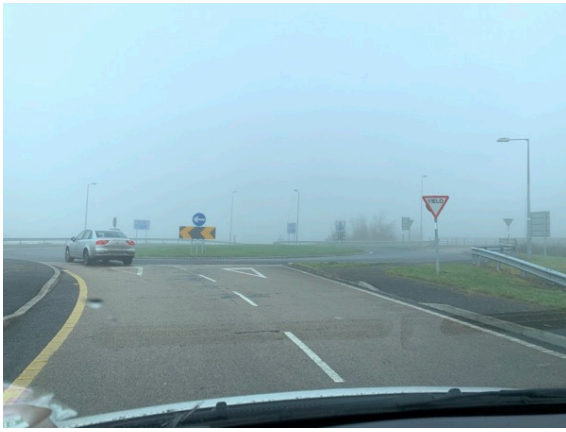
Location 7 - Exit M9 At Junction 11

Visual inspection indicates that loaded blade vehicles will contra flow the roundabout to minimise modifications required.

Road widening across central island and the offside pavement/verge will be required.

The safety barrier on the offside will require to be removed / realigned.

One lamp post on the nearside entry to roundabout will require removal.

Several road signs on both sides of the road and central / splitter islands will require removal.

A topographical survey and swept path analysis is recommended at this location to confirm exact modifications required.

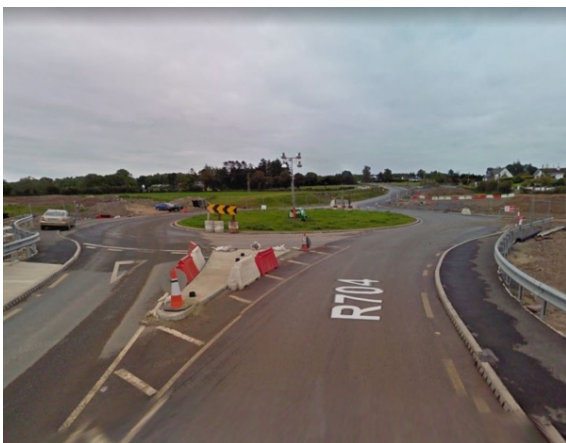
Location 8 - 2nd Roundabout Onto R704

Visual inspection indicates that loaded blade vehicles will contra flow the roundabout to minimise modifications required.

Road widening on the central island and the removal of a road sign will be required to accommodate loaded blade vehicles.

A topographical survey and swept path analysis is recommended at this location to confirm exact modifications required.

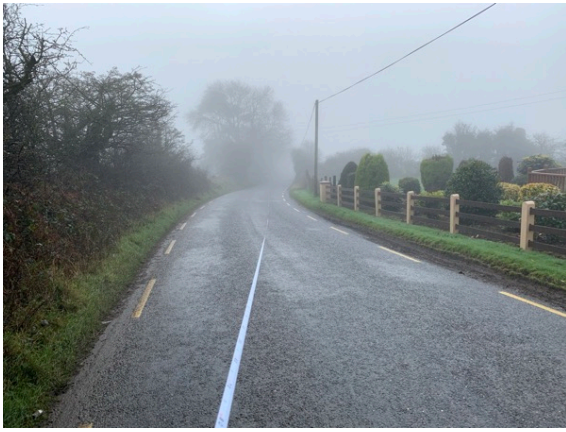
Location 9 - R704 Left Hand Bend

Visual inspection indicates that tree pruning on the offside will be required to avoid damage to the blade tips.

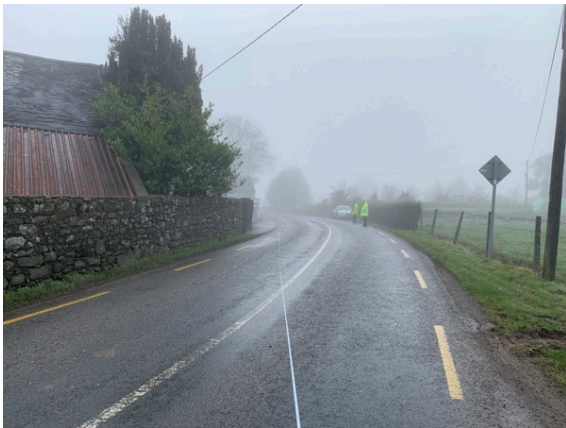
Location 10 - R701 First Right Hand Bend

Visual inspection indicates that loaded blade vehicle will require third party land.

Road widening (Load bearing) will be required across the nearside highways verge and within third party land.

The telegraph pole and road sign will require removal / relocation.

A topographical survey and swept path analysis is recommended at this location to confirm exact modifications.

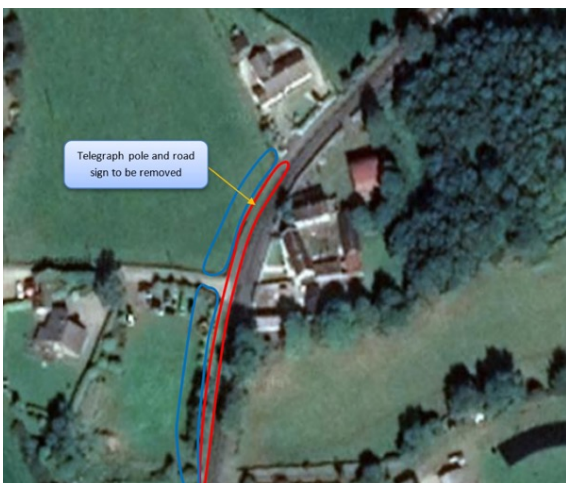
Location 10 Continued - R704 First Right Hand Bend

Road widening (Load bearing) is required as indicated by the red outline.

Blade will oversail as indicated by blue outline.

Telegraph pole and road sign on nearside required to be removed.

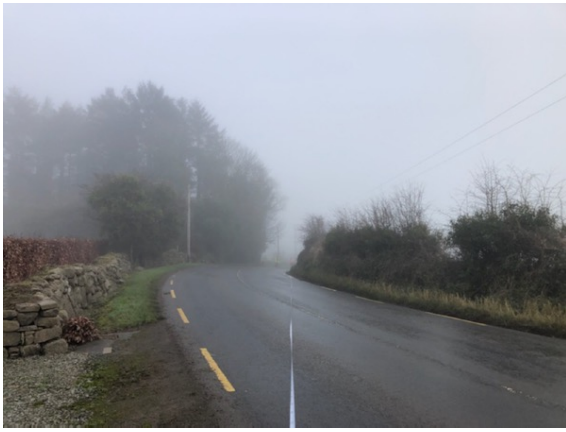
Location 11 - Second Right Hand Bend On R704

Visual inspection indicates that loaded blade vehicle will require third party land.

Road widening (Load bearing) will be required across the offside highways verge and within third party land.

A topographical survey and swept path analysis is recommended at this location to confirm exact modifications.

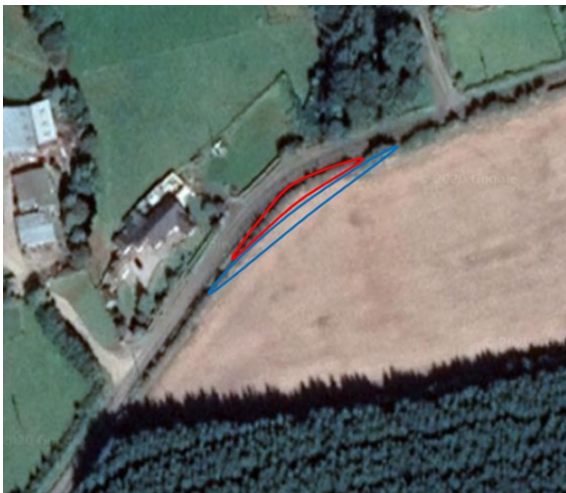
Location 11 Continued - Second Right Hand Bend On R704

Road widening (Load bearing) is required as indicated by the red outline.

Blade will oversail as indicated by blue outline.

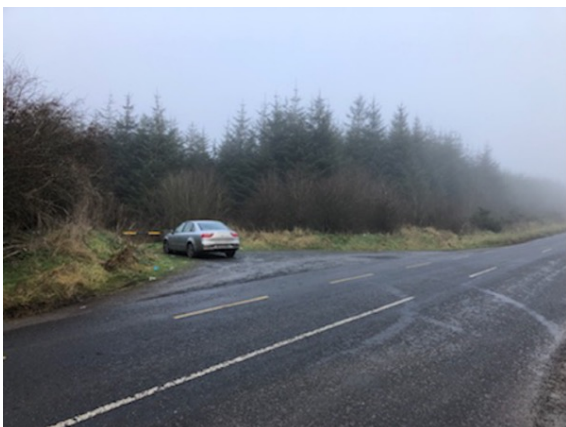
Location 12 - Site Entrance

Visual inspection indicates that a suitable site entrance will require to to be constructed to accommodate all loaded vehicles.

A topographical survey and swept path analysis is recommended at this location to confirm exact modifications required.
