Report on Current Condition, proposed repair  
and advice on conservation based alterations for re-use to

## The Walled Garden Walls and corner Bastions at Auburn House, Streamstown, Malahide, Co Dublin

**5<sup>h</sup> March 2021**

**Project 21549**

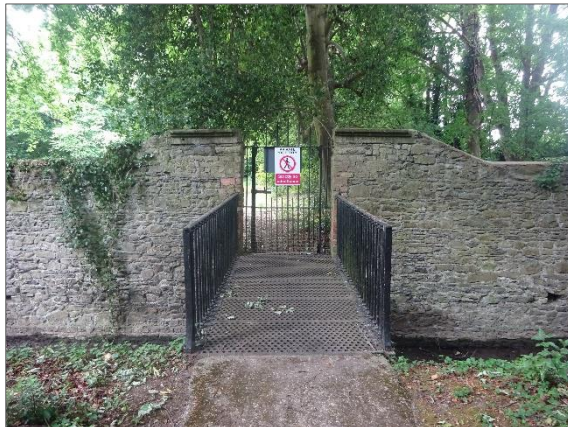
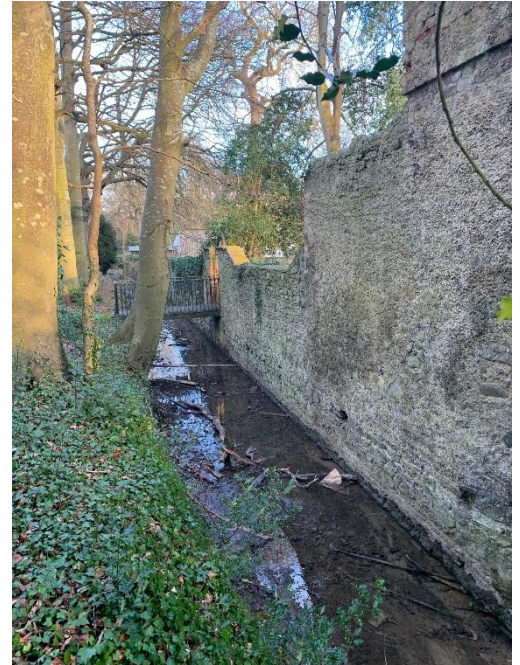
*Entrance form north over moat  
Photographs courtesy of Sheehan Barry Architects*

The north wall is interrupted by scooped ends framing the metal gate at the end of the bridge. The gate piers are formed of both random rubble and brick.

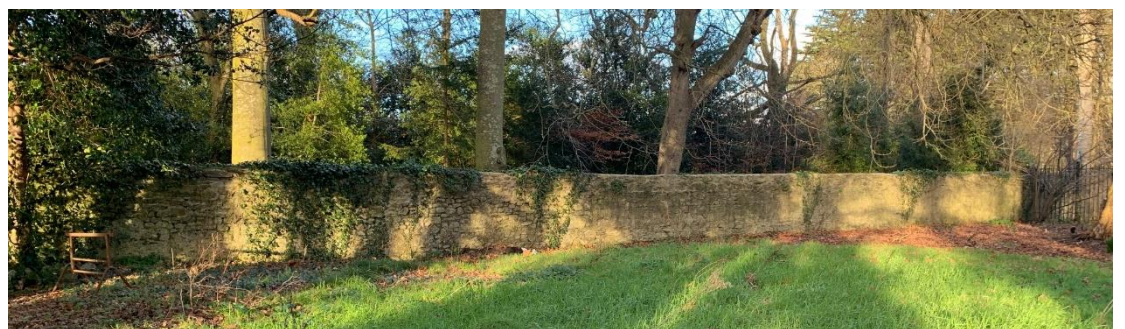
Within the garden because of the change in levels between the moat and the garden the height of the wall is more modest.

*View of north wall from within the Walled garden. Photograph courtesy of Sheehan Barry Architects*

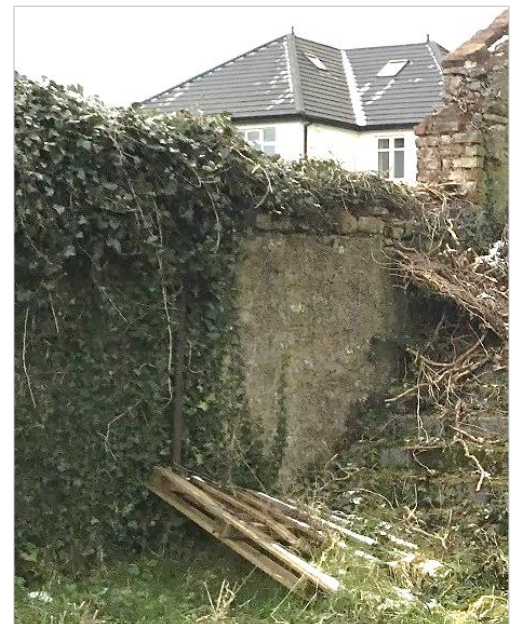
The south wall appears to be of random rubble with a dash to the vertical face and a rusticated random rubble top.

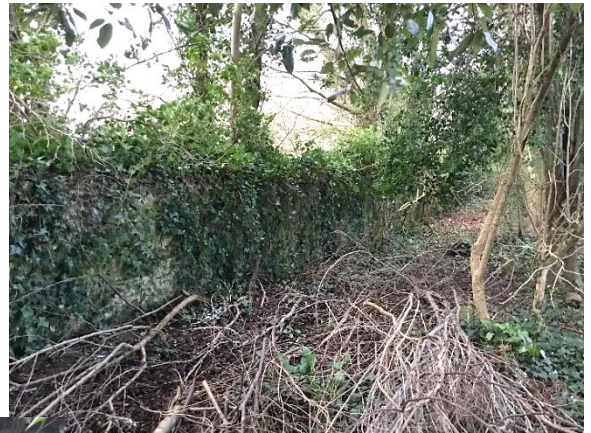
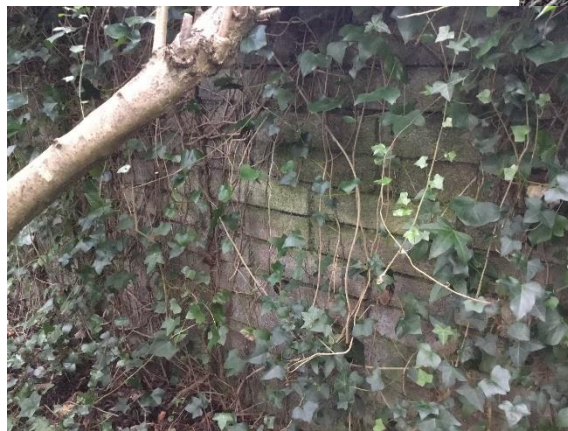
The wall is covered in Ivy and hard to discern, let alone establish its condition.

It was noted in two locations that there were more recent blockwork repairs. There may be more interventions

Significant lean to the wall both inwards and outwards was also noted.

To properly assess the walls vegetation control needs to take place in the form of a hard haircut of all plant growth on the walls. There are more ecologically friendly times to carry this out such as between 1<sup>st</sup> Sept and 28<sup>th</sup> February. Refer to vegetation control specification in the Appendix.

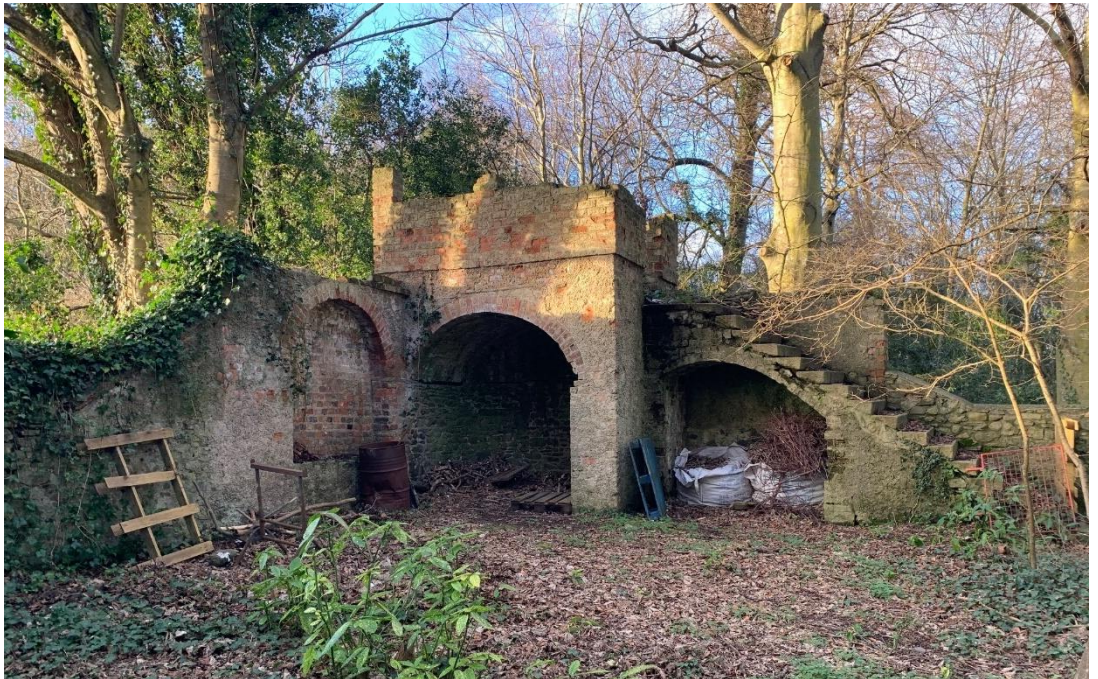
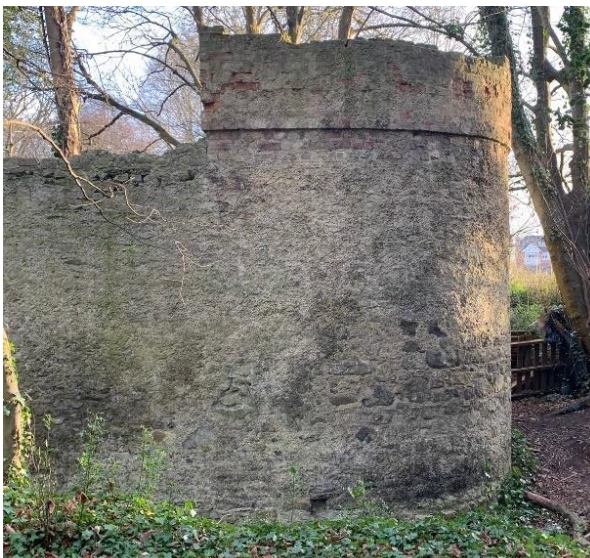
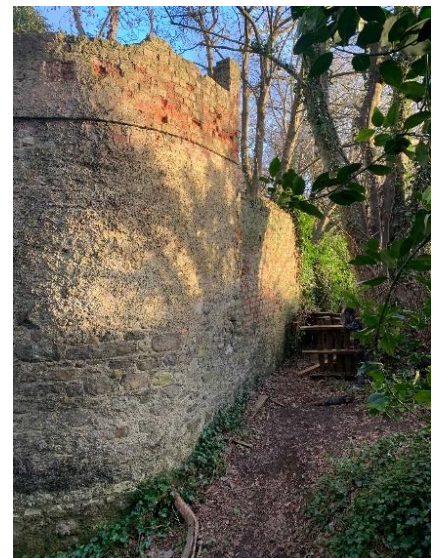
To the northwest corner there is a brick arched masonry 2 storey bastion nestled into the curve of the walled garden northwest corner, accompanied by a blind arch to the west wall.

*Northwest Bastion and outer northwest corner of walled garden.  
Photos courtesy of Sheehan Barry Architects*

- Careful control and removal of vegetation
- Back propping as deemed necessary to arches for safety and to allow repair of arches
- Temporary removal of granite steps if deemed necessary to facilitate repair of arches under
- Repair of brick arch vaults using bricks to match set in new lime mortar as specification.
- Reseating of granite steps, including re-bedding / pointing to ensure falls down the steps and limit water penetration into brick vaults.
- Re-establishment of parapet detail to Architects drawings using materials to match existing, set in lime mortars.
- Security fencing / guarding to prevent unauthorised access to platforms.

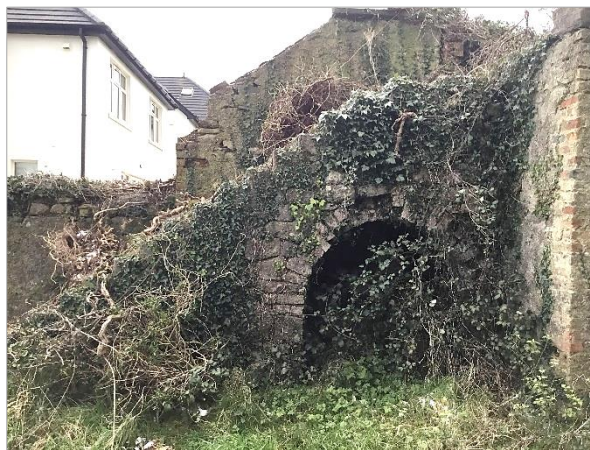
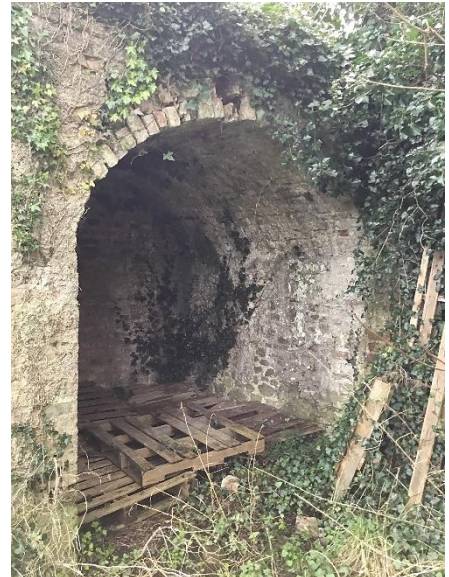
Both bastions have brick masonry vaults supporting the stairs and first floor platforms, solid granite steps laid onto the vault, and brick parapet walls.

The brickwork has suffered degradation from plant growth and general neglect, the parapet walls are missing in places.

The granite steps are uneven and in places slipped and tilted backwards towards the structure.
