ARKLOW BANK WIND PARK  
PHASE 2

**ONSHORE GRID  
INFRASTRUCTURE**

**Appendix 9.2** Site Walkover Summary

# Arklow Bank Cable Route Arup Site Walkover

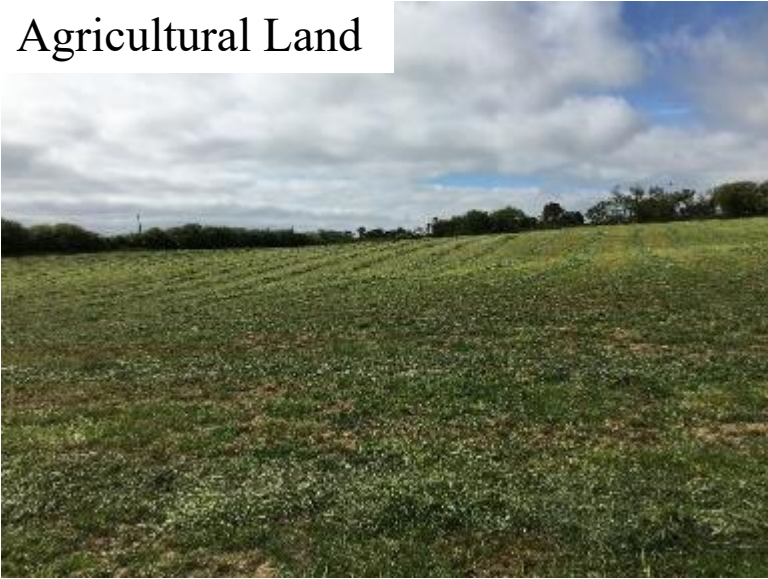
Agricultural Land

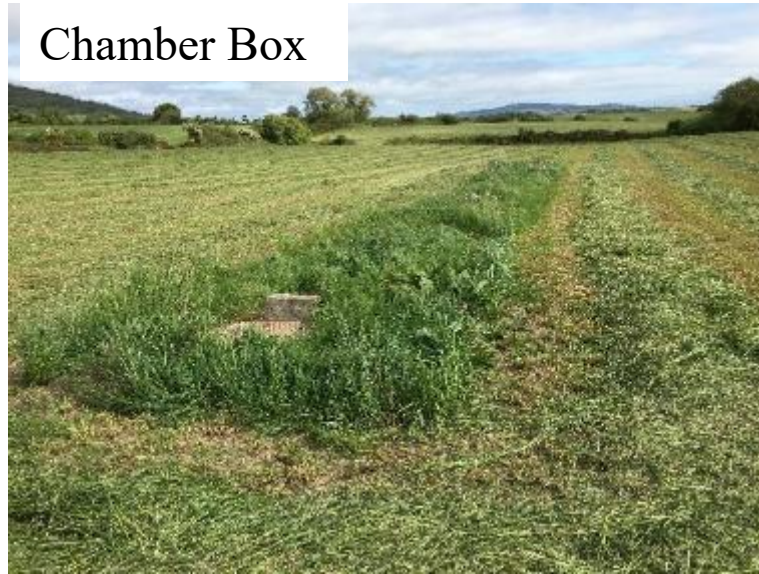
Chamber Box

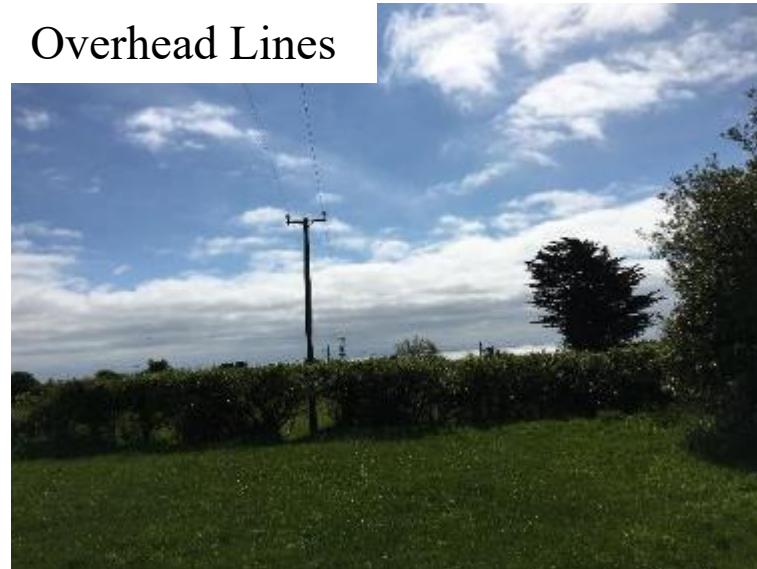
Overhead Lines

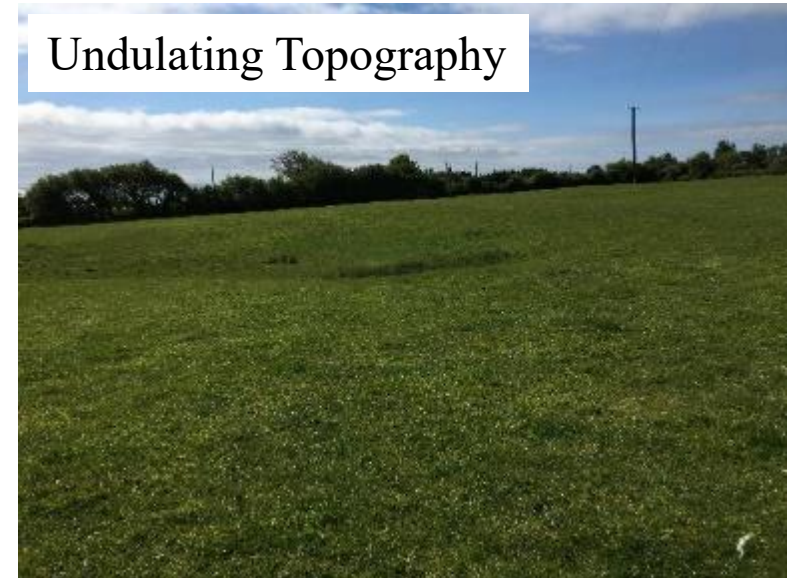
Undulating Topography

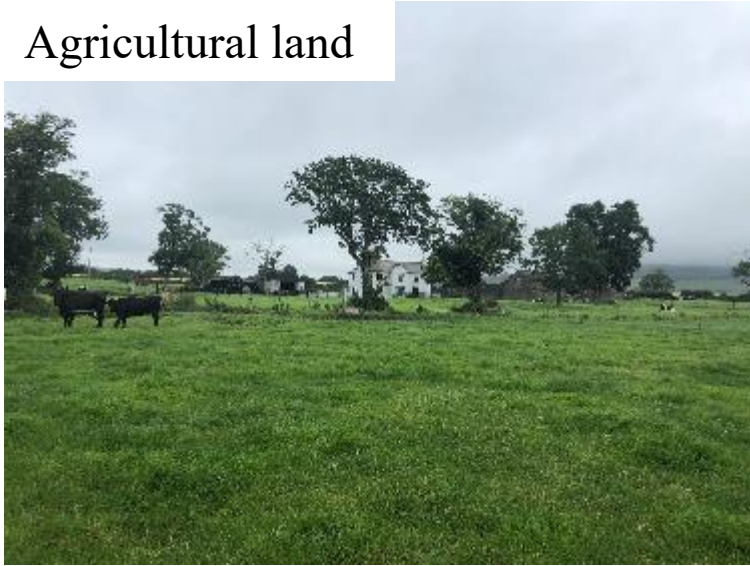
Agricultural land

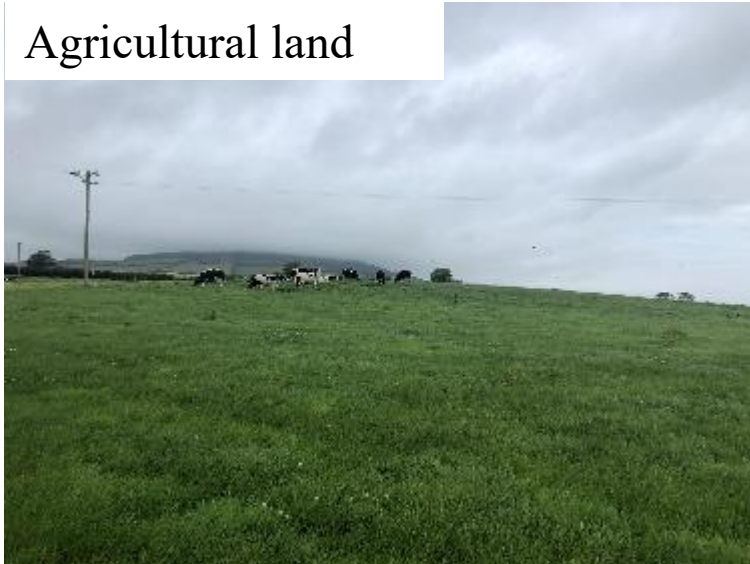
Agricultural land

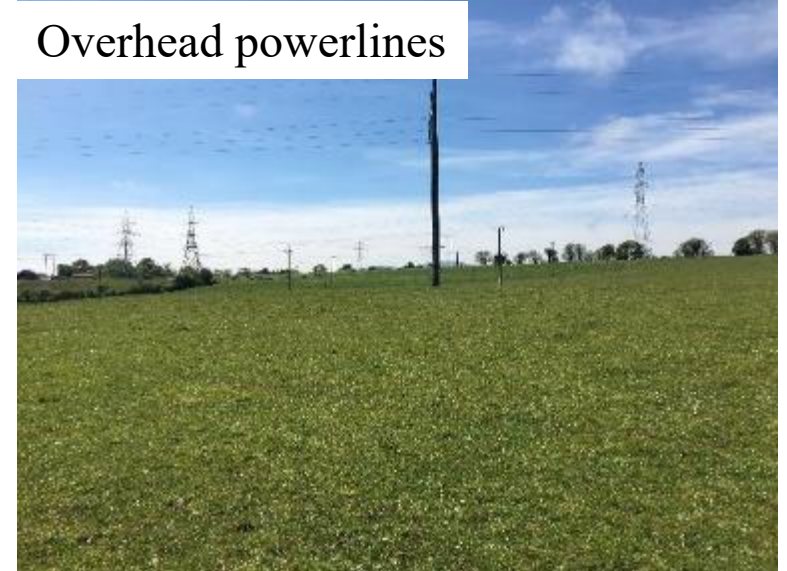
Overhead powerlines

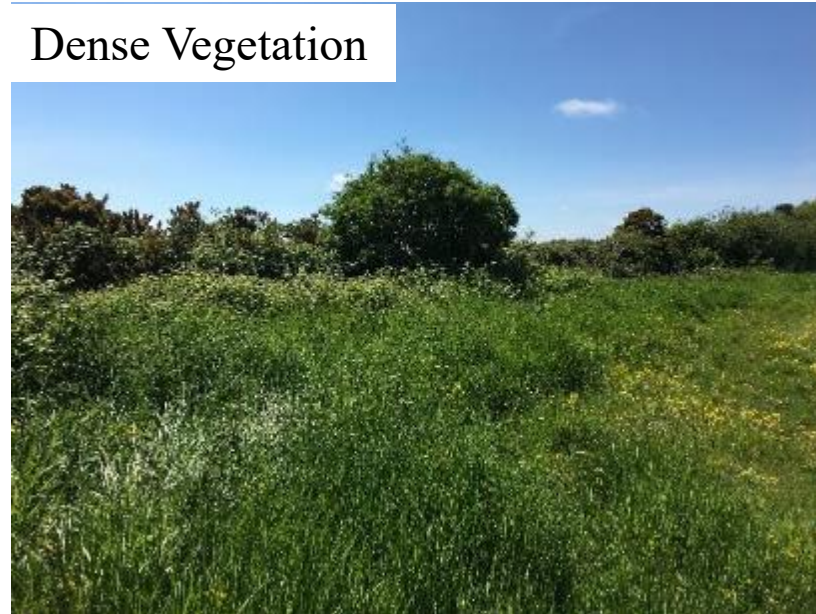
Dense Vegetation

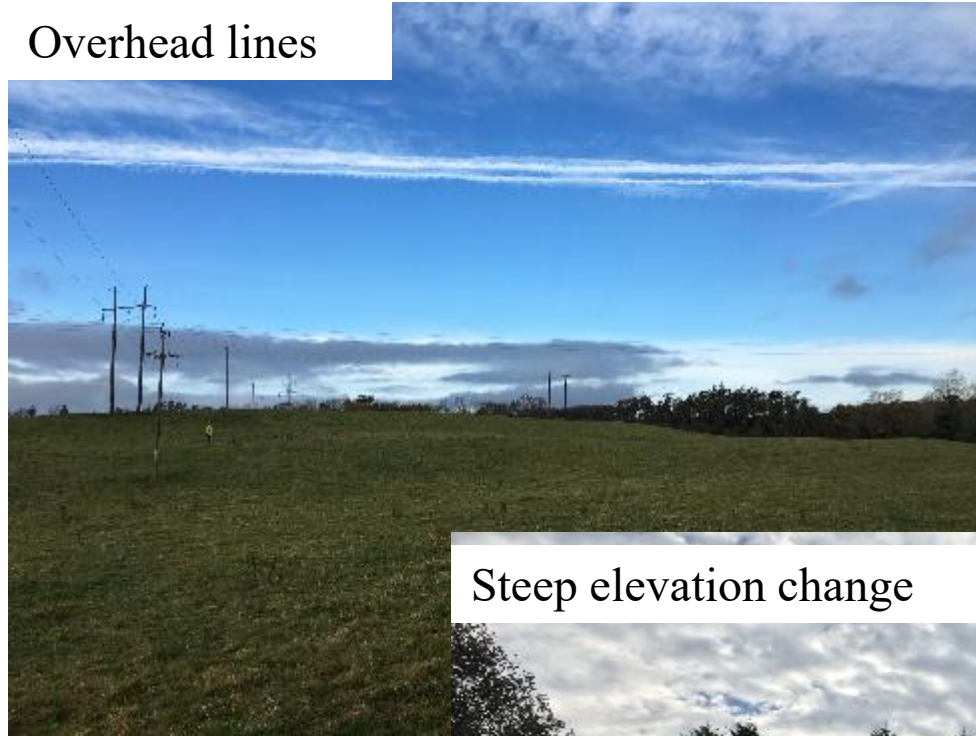
Overhead lines

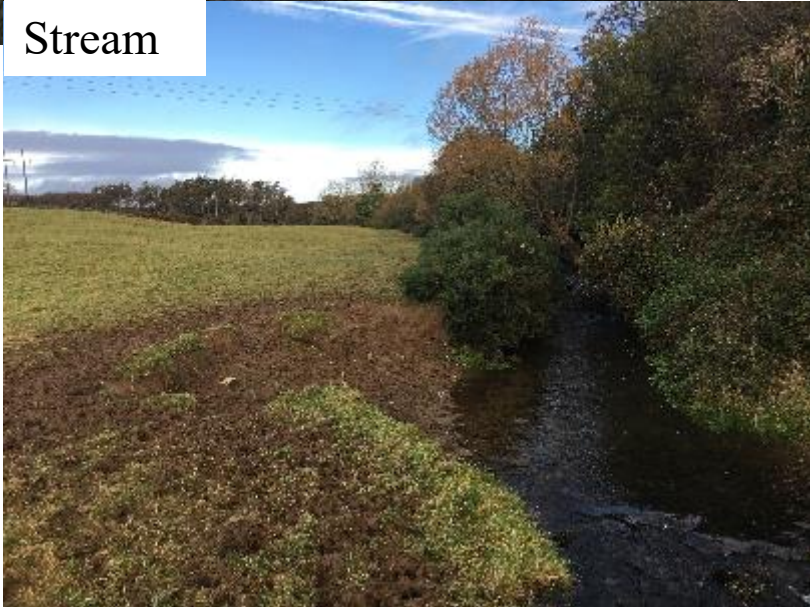
Stream

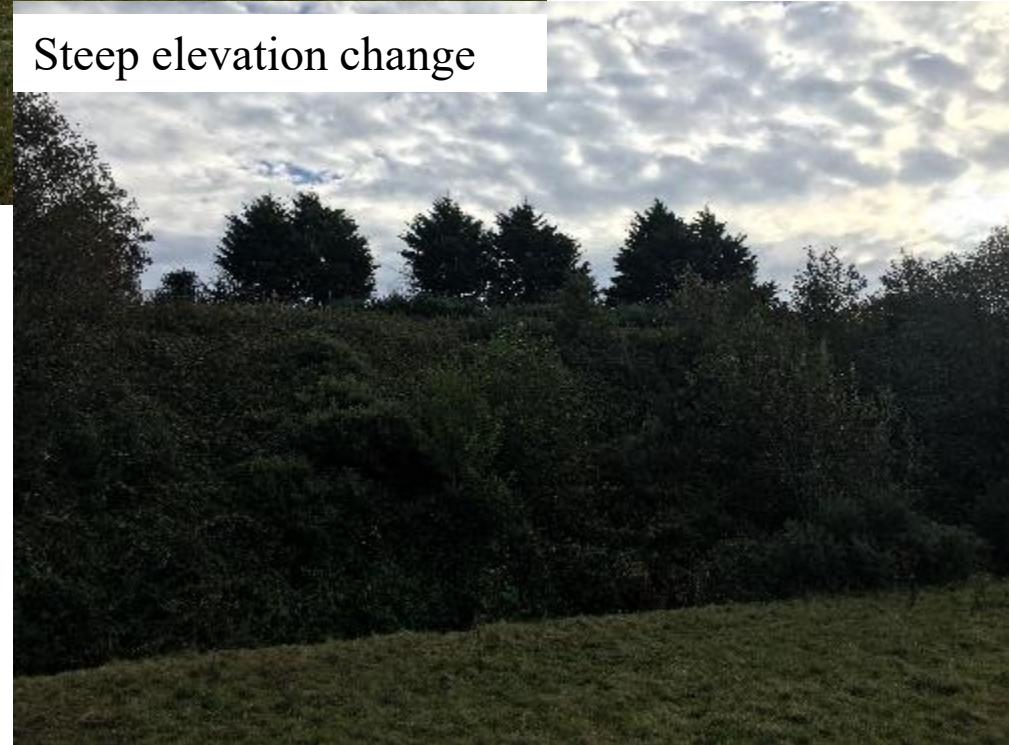
Steep elevation change

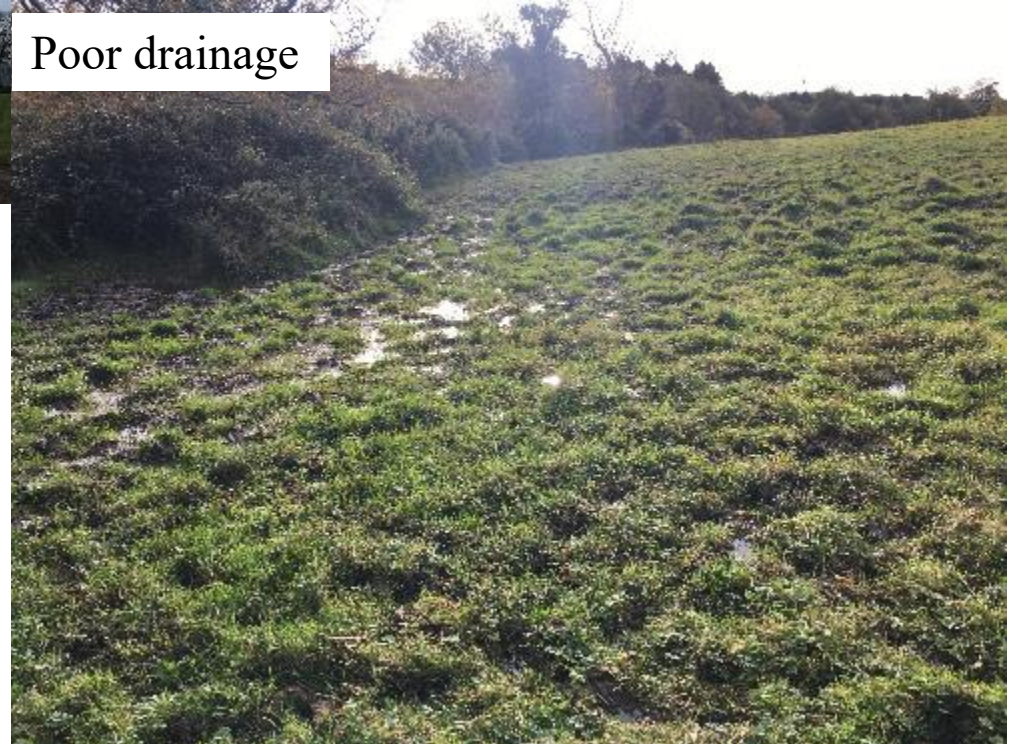
Poor drainage noted around stream crossing

Poor drainage

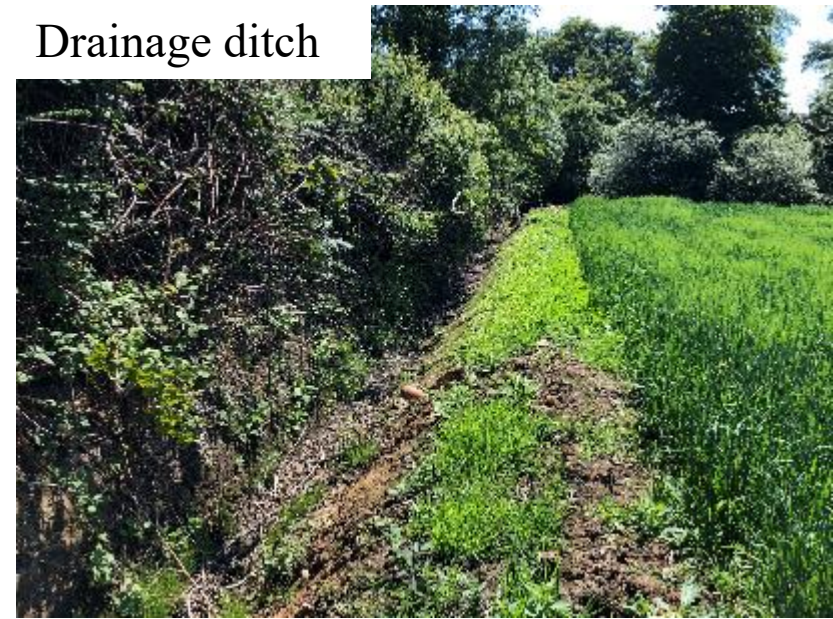
Drainage ditch

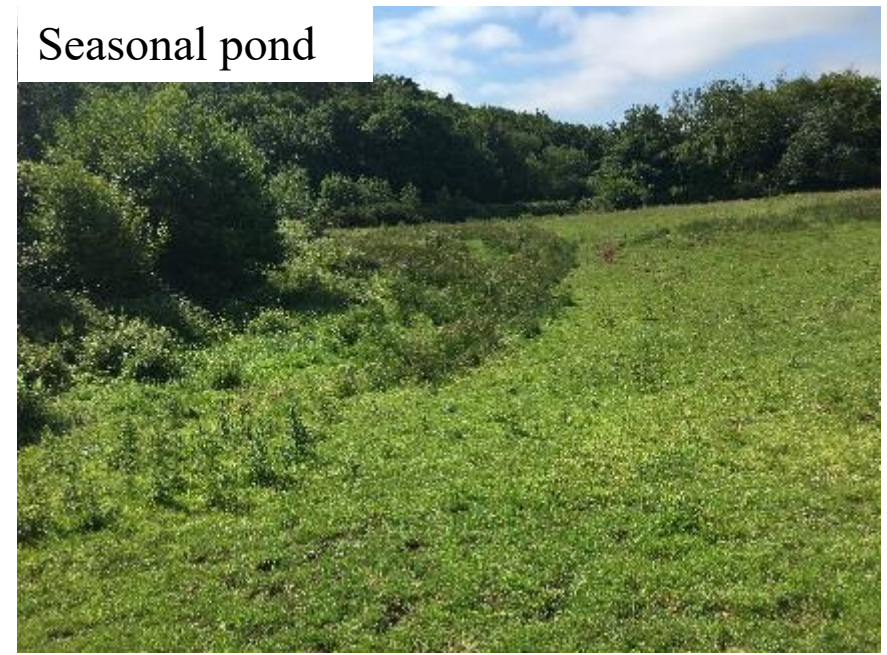
Seasonal pond

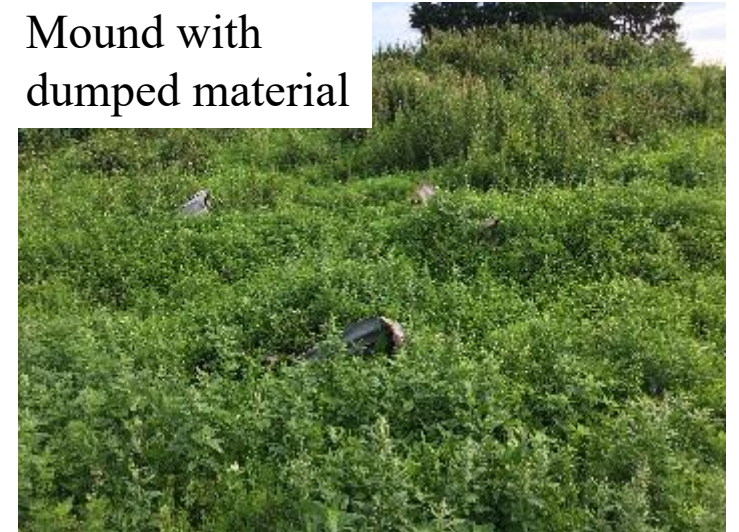
Mound with dumped material

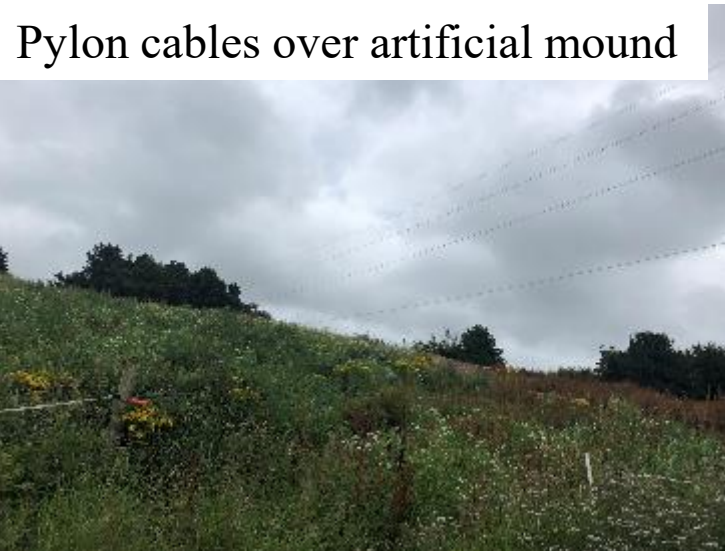
Pylon cables over artificial mound

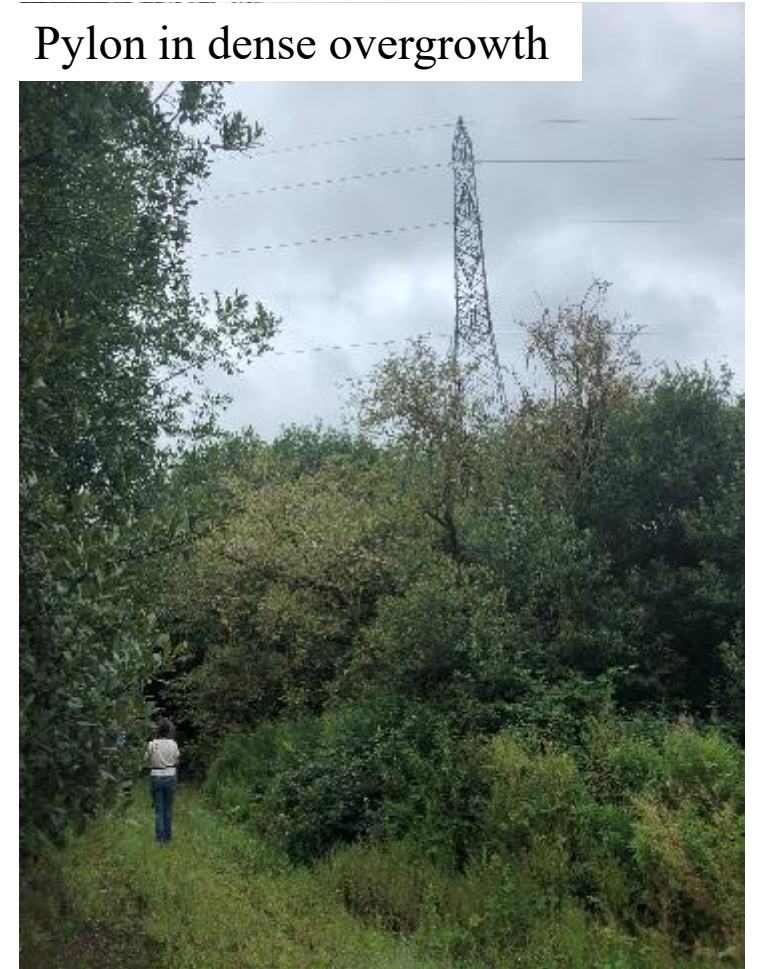
Pylon in dense overgrowth

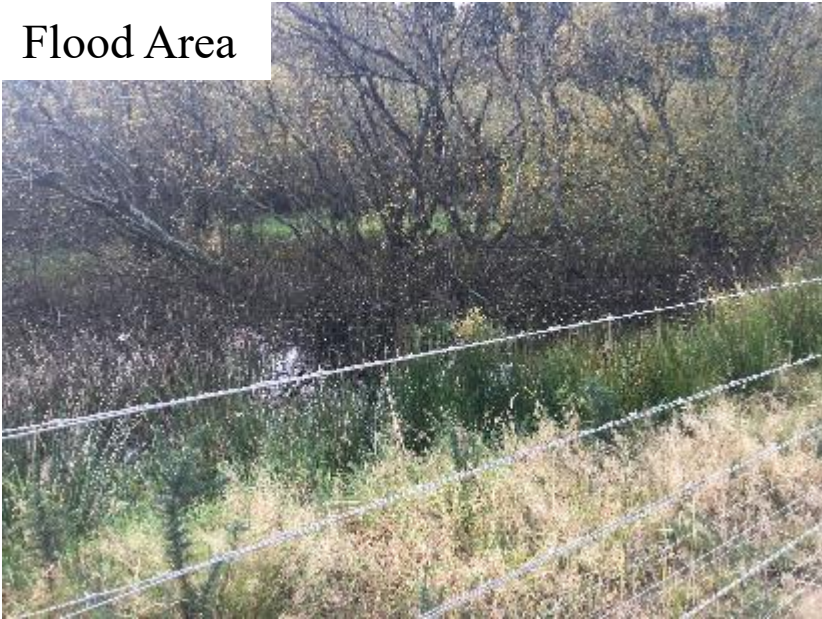
Flood Area
