## Cork Line Level Crossings Road Safety Audit Stage 1

Iarnród Éireann

Rev. P02

February 2020

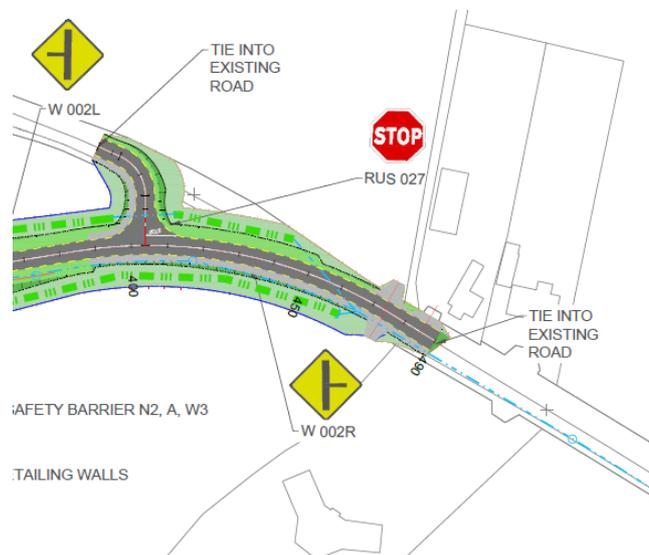
Figure 2-1 Proposed Footpath

Where the new road alignment ties in with the existing road to the eastern extent of the scheme, there is a proposed footpath. This ties in with the existing footpath on southern side of the carriageway, which is currently street lit.

The proposed footpath terminates on southern side of the carriageway and continues a short distance down a new side road to the northern side of the carriageway. Pedestrians could find themselves crossing on a bend, which could result in them being in conflict with vehicles if there is insufficient forward visibility.

The design team need to ensure there is adequate visibility to safely allow pedestrians cross the road. The design team should ensure that public lighting is provided along the footpath.

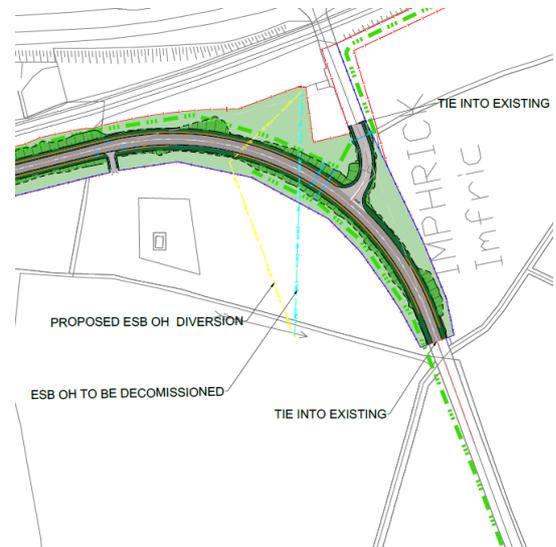
Figure 2-2 New Road Alignment

Where the existing road (L1320) ties in with the new road the road deviates to the left, with a junction to the right for a field access. Drivers unfamiliar with the new layout may become confused and take the right turn to gain access onto the N20.

Install advanced direction signs / chevrons on both approaches on the main road to highlight the direction of travel.

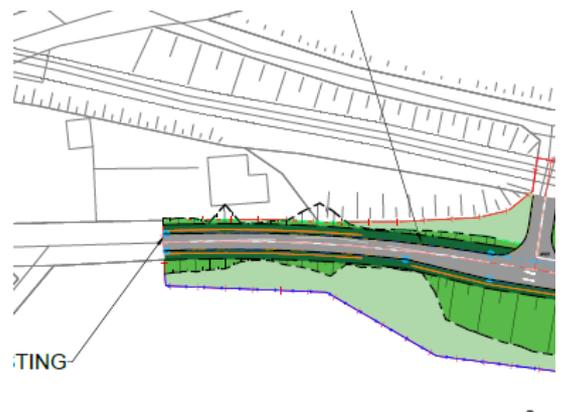
Figure 2-3 Tie in between existing and new road alignment

There is an existing public house with parking bays that front the highway as well as a car park, the Audit Team are concerned that with the removal of the on-street parking and introduction of the verge that drivers will still park on the road, reducing the width of the carriageway, this could result in side swipe or head on collisions.

The Design Team shall ensure that the proposed alignment ties in with existing and that the access to the car park is retained and consider the introduction of parking restrictions.

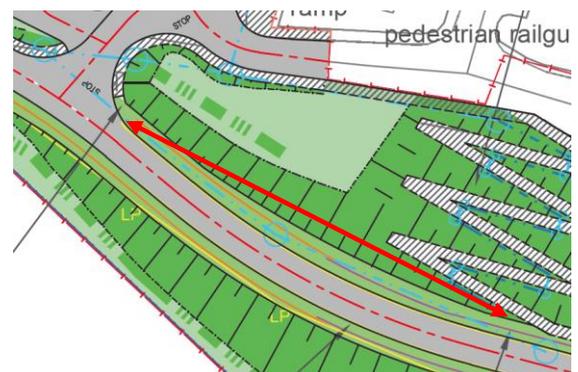
Figure 2-4 Potential Desire Line

The Audit Team are concerned that a desire line may exist along the realigned road that may result in pedestrians walking along the northern verge to reach the footpath at the bellmouth on Beechwood Drive. This may result in an increased risk of trips and falls.

The design team should consider if there is a demand for a footpath/ shared surface along this section.

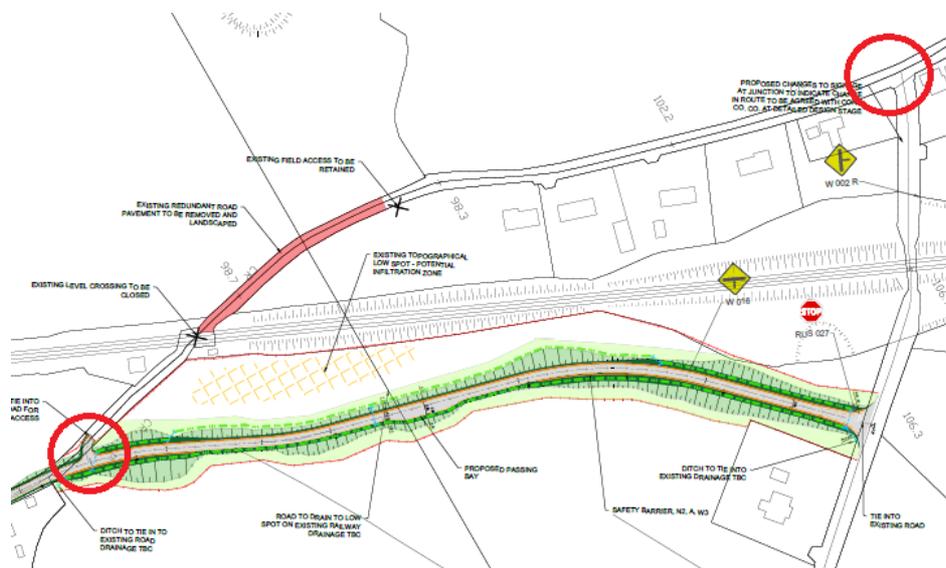
Figure 2-5 Cul De Sac Warning Signs

The Audit Team is concerned that motorists unfamiliar with the new layout, will be unaware of the closure of the level crossing with no turning head provided to allow vehicles to turn and exit. The lack of a turning head may result in vehicles having to reverse over a long distance leading to a loss of control type collisions.

The design team shall provide a turning head at the end of these proposed cul de sacs. A F 350: Cul-de-sac sign shall be provided in accordance with the Traffic signs Manual at the entrance to each local road.

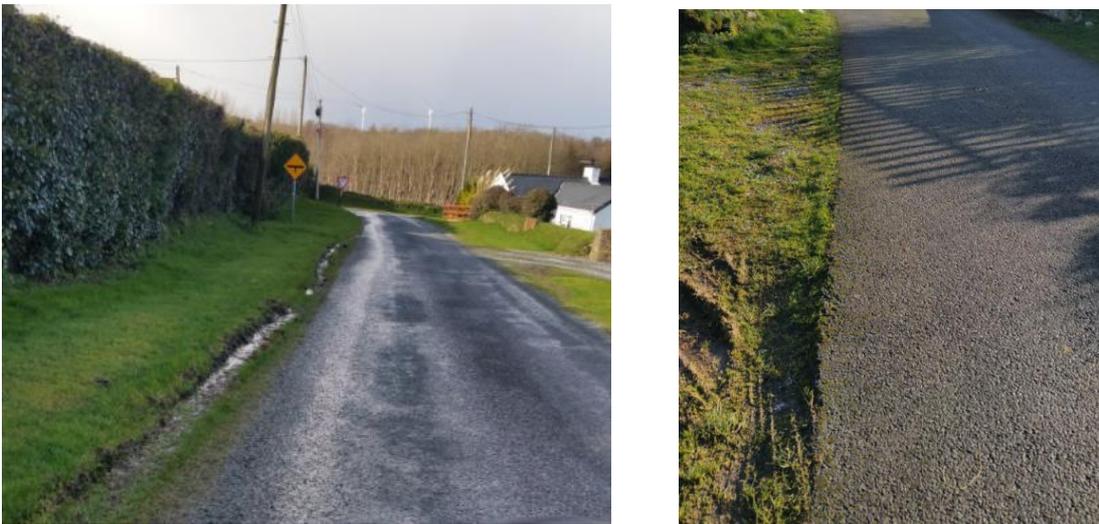
Figure 2-6 Rutting of Road Verge

The Audit Team note that the existing L5535-0 is narrow in width and on-site observation indicate rutting of the existing verge. It is assumed this is to facilitate vehicles passing one another. The proposed realignment will generate an increase in traffic along the L5535-0 exacerbating this situation and lead to detritus on the carriageway resulting an increased risk of loss of control type collisions.

The Design Team should consider the provision of a formal hardstanding area on either side of the overbridge to allow vehicles to pull in off the L5535-0 and allow other vehicles to pass.

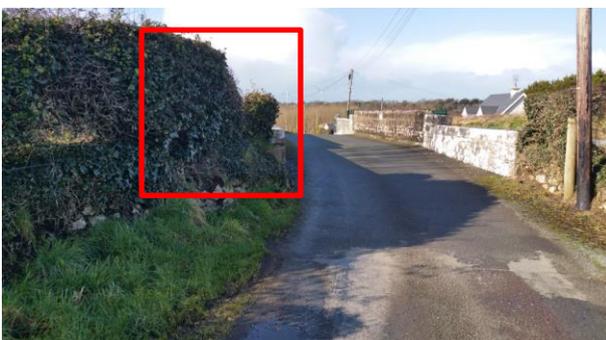
Figure 2-7 Existing vegetation impinging on forward visibility

The proposed realignment will result in increased traffic on the L5535-0 and utilisation of the existing narrow rail overbridge. The Audit Team are concerned that the existing forward visibility approaching the existing rail overbridge is compromised by existing vegetation, leading to an increased risk of head on type collisions.

The existing vegetation is removed to improve forward visibility of the overbridge.

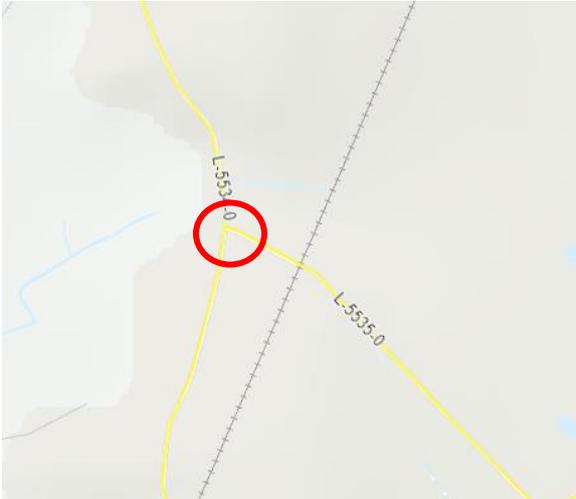
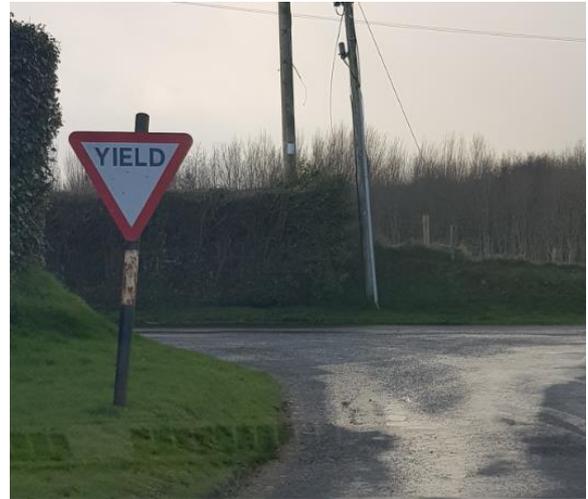
Figure 2-8 Bell mouth in poor condition

The Audit Team note that at the junction of the L5534-0 and L5535-0, the road surface is poor and road markings are faded. In addition, a Yield sign is located at the junction resulting in an increased risk of motorists overshooting the junction.

The design team shall highlight the issue to Cork County Council for resolution. It is recommended that the “Yield” sign is replaced with a “STOP” warning sign.

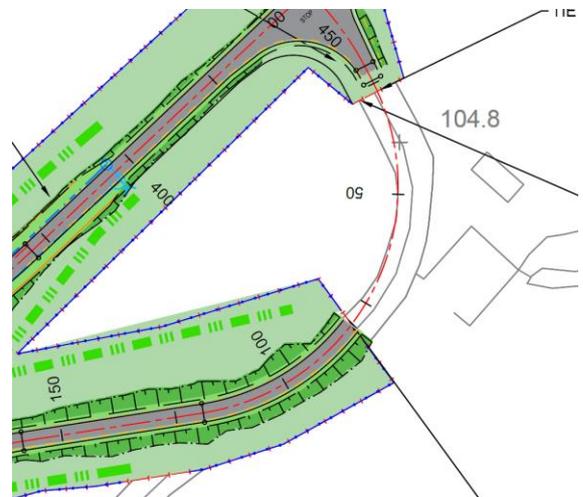
Figure 2-9 Tie in between existing and new road alignment

The Audit Team are concerned that the proposed tie in of the Connector South road may not tie in with the existing alignment leading to an increased risk of loss of control type collisions

The Design Team shall insure that the proposed alignment ties in with existing.

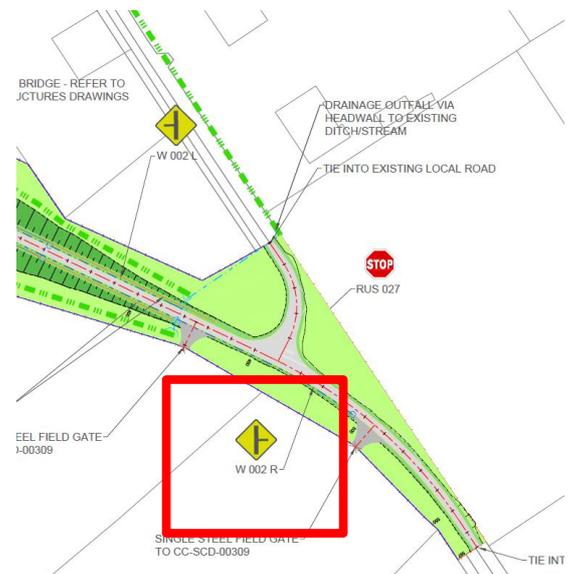
Figure 2-10 Location of Warning Sign

The Audit Team are concerned that the junction ahead warning sign is in close proximity to the junction itself which will lead to an increased risk of late braking and rear shunt type collisions or loss of control type collisions

The warning sign should be located in advance of the junction in accordance with the Traffic Signs Manual.
