### Tree Survey Report

Arklow  
Co. Wicklow

Project No. 5909

**DOCUMENT:**  
**5909 – Tree Survey Report**

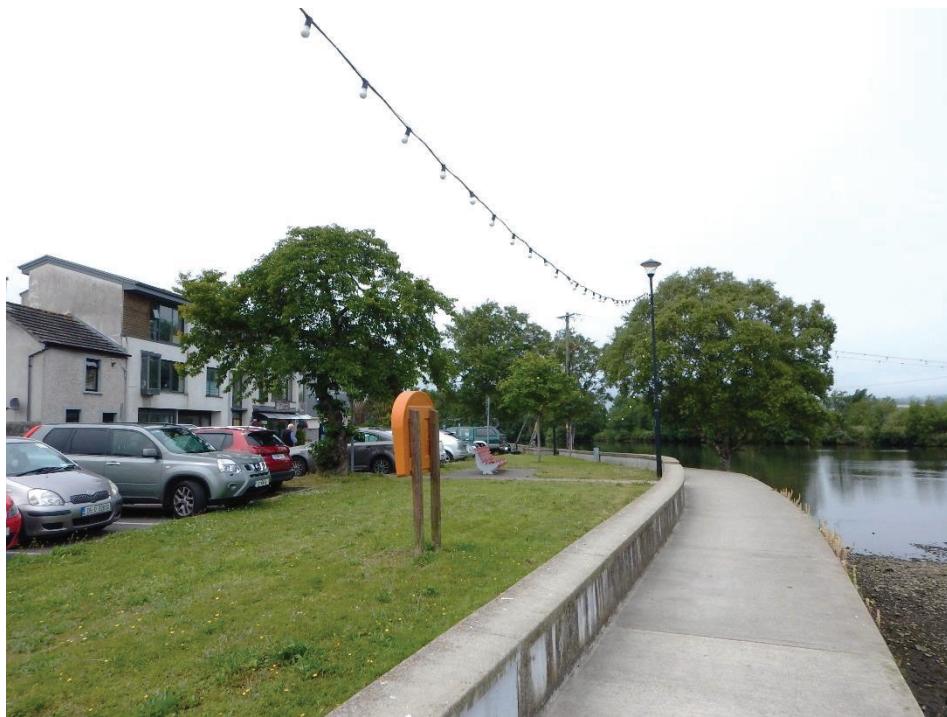
The area to the west of the bridge on the southern bank included trees numbered T1-T30; these trees are mostly growing in linear green open space along the footpath and riverbank and provide moderate to good amenity and landscape value. Most of the trees are not of especially high arboricultural value as individuals; although there are several trees graded as category B, most notably the Weeping Willows (T25, T26 and T29) at the far western end of the survey area and Ash tree T22.

*Photo 1. Trees established along the southern river bank; to the west of the road bridge*

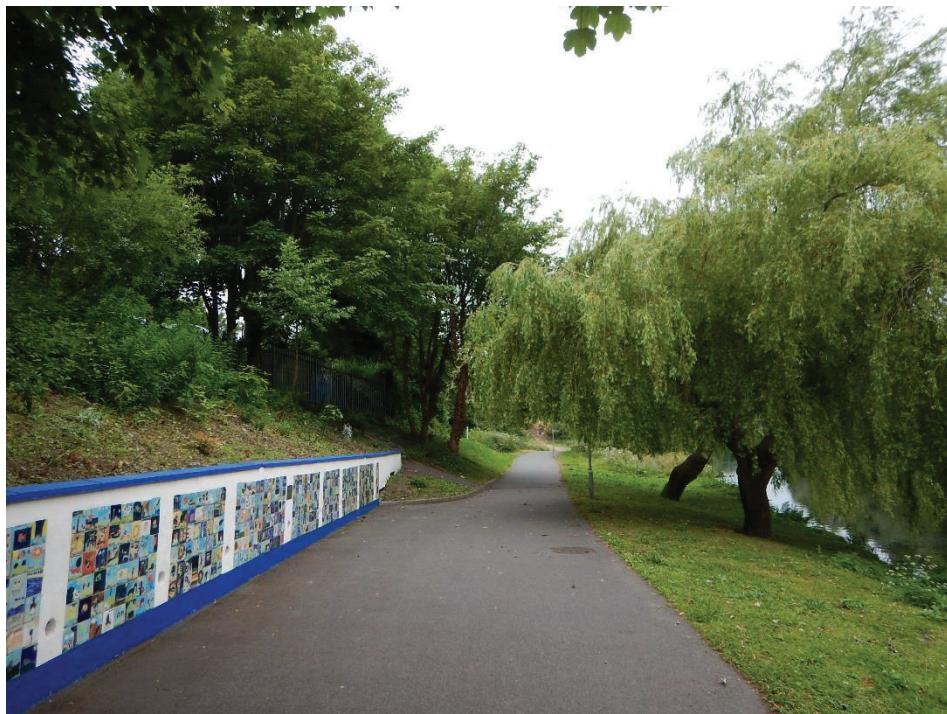
*Photo 2. Willow trees on the southern bank of the river towards the western end of survey area*

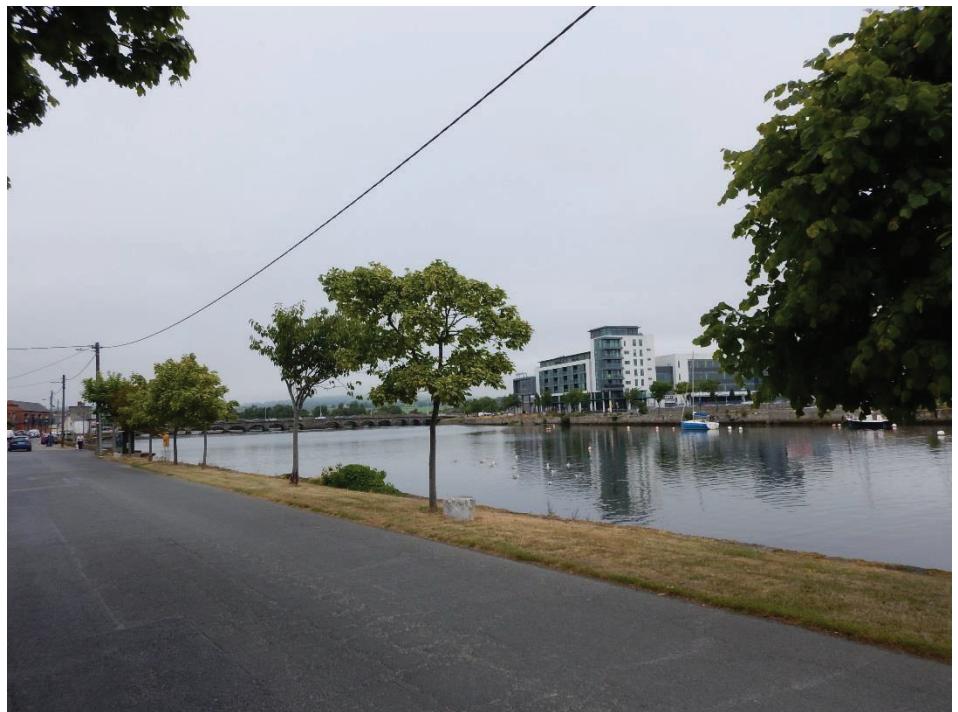
The trees included in the schedule to the south-east of the bridge are all smaller, young trees of fairly low quality and value. The trees do provide some amenity value, however the poor growing environment and species selection is likely to mean that this contribution will remain limited into the future.

*Photo 3. Young trees established in the grass verge along the southern bank of the river, south-east of the bridge*

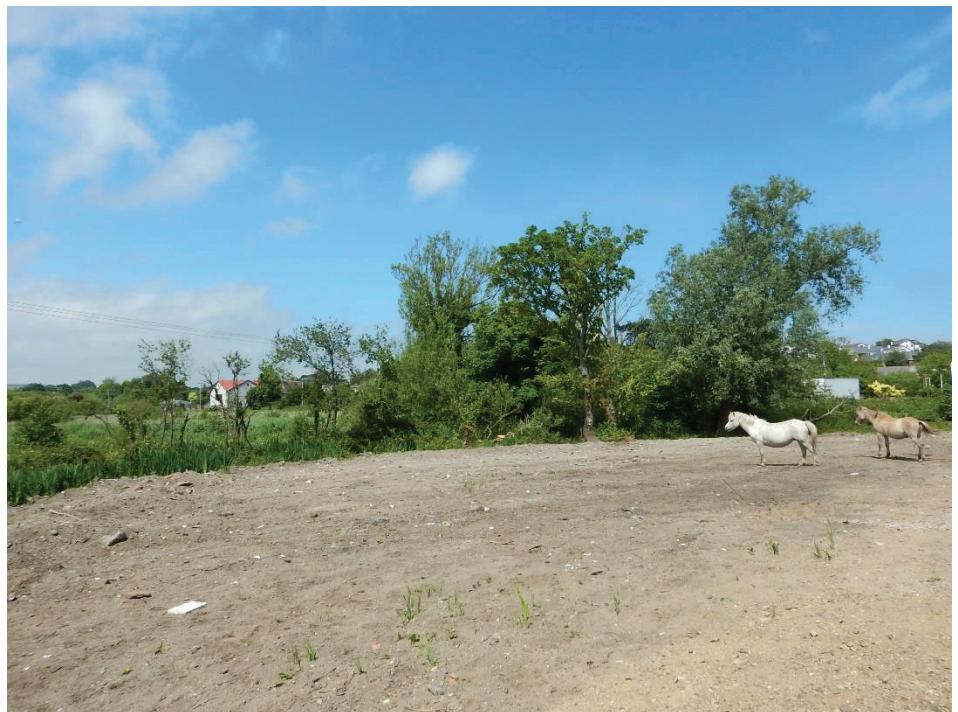
*Photo 4. Mixed willow scrub (G3 in the survey schedule and survey drawing) and trees 105-107 at the northern end of the survey area*

T107	Acer pseudoplatanus (Sycamore)	EM	10	350	1	2	3	5	4	3	<10	Poor	Fair/Poor. Low vitality. Recent significant root damage likely. Dieback in crown, leaf size small for species and foliage pale in colour/chlorotic.	Monitor tree condition. Consider coppicing to allow regeneration of fresh growth.	4.2	55	U
T108	Pinus sylvestris (Scots Pine)	M	15	750	1	3	4.5	5	5	5	20+	Good	Fair. Well structured mature Pine in reasonably good condition. Some broken branches in crown.	Target prune broken/damaged branches.	9	255	B2
T109	Acer pseudoplatanus (Sycamore)	EM	10	583	3	0	4	5	5	4	20+	Good	Fair. Self-sown multi-stem coppice stool.	No urgent works needed.	7	154	C2
T110	Acer pseudoplatanus (Sycamore)	M	15	693	3	2	6	6	6	6	20+	Good	Fair. Mature tree located in private garden; not fully accessed or inspected. Tree appears to be in good health based on the observations made.	No urgent works needed.	8.32	218	B2
T111	Tilia X europaea (Common Lime)	M	16	750	1	0	8	8	8	8	20+	Good	Fair. Mature tree located in private garden; not fully accessed or inspected. Tree appears to be in good health based on the observations made.	No urgent works needed.	9	255	B2

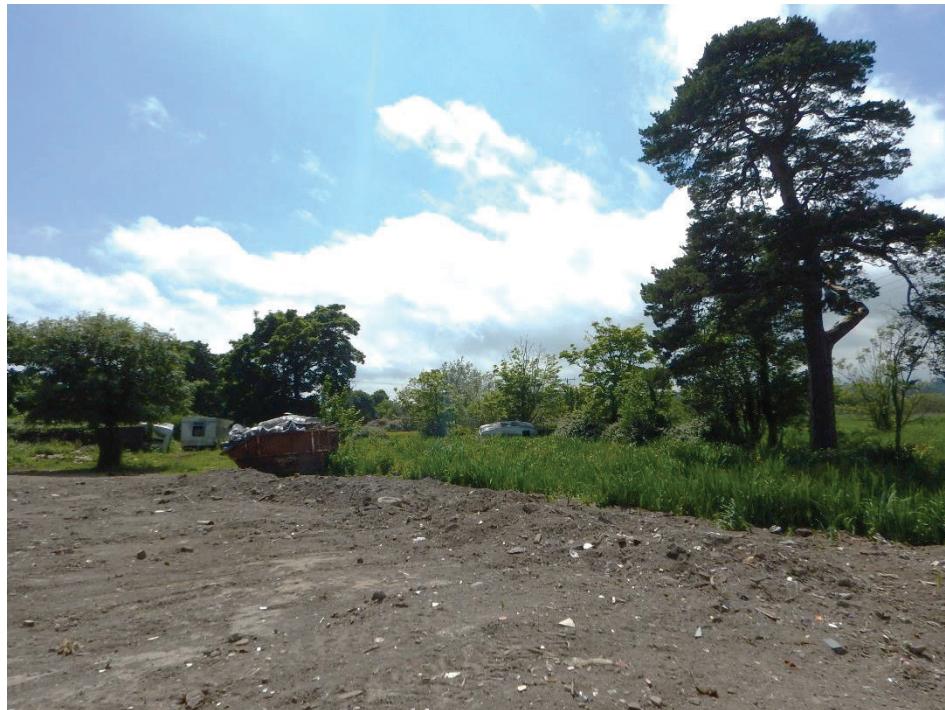
The land in the survey area to the west of the properties along the west side of the R772 (Ferrybank) includes significant areas of wetland and dense scrub that was not accessible by foot. The part of the area that was accessible had been left derelict for some time, but has recently been worked over by machinery. Many of the trees are in poor condition, however one Pine tree (T108) remains in fairly good health.

Photo 5. Scots Pine tree 108 along with some poor quality Willow bushes at the edge of the wetland

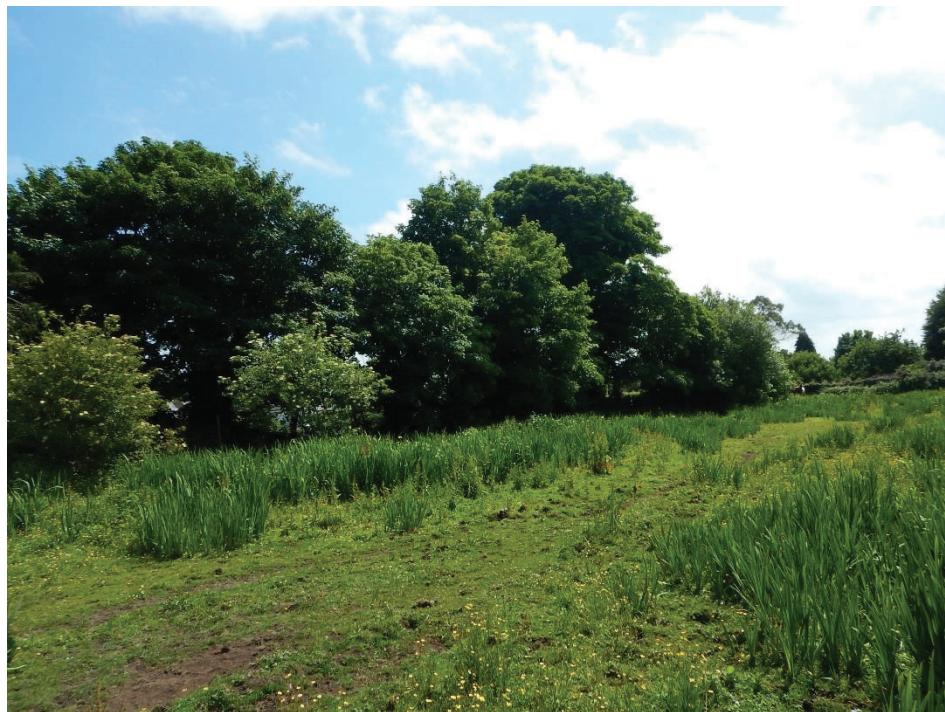
The linear tree group G4 (including trees T110-T112) extends just outside the eastern edge of the survey area; these trees are the largest and most significant individuals included in the schedule. The trees were not accessed directly and their dimensions were estimated, however their appearance indicates that they are good physiological condition and some would probably be classed as category A trees if no structural defects were seen during a more thorough inspection. There is likely to be significant root-spread out into the survey area from these trees; as indicated on the survey drawing.

Photo 6. Linear tree group G4 including some good quality Sycamore and Lime trees

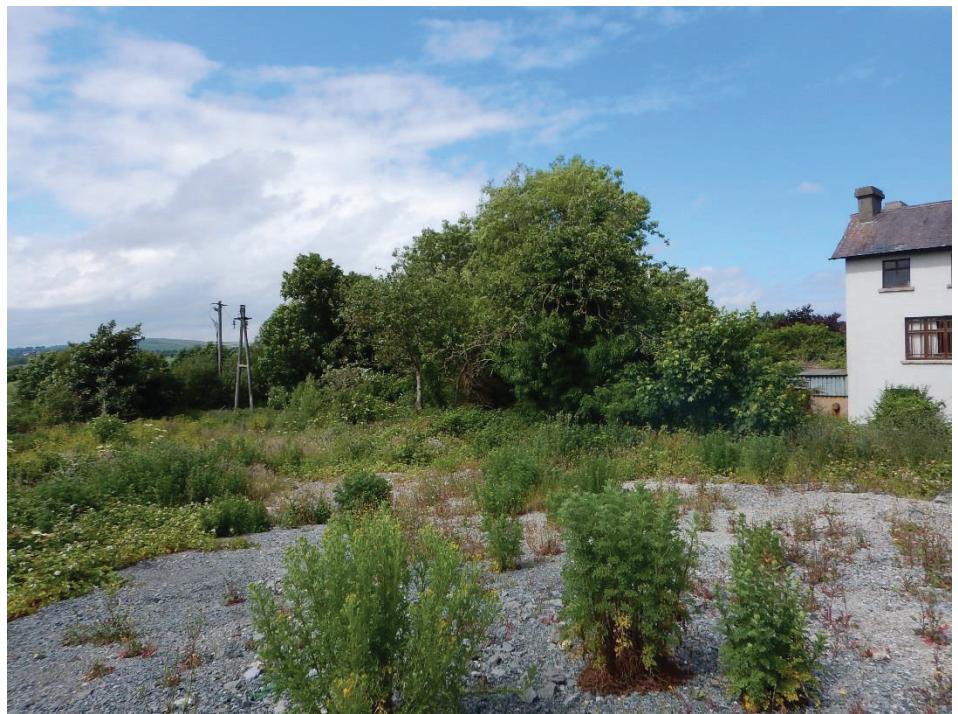
*Photo 7. Cluster of trees (G6) immediately north of the bridge – on site of demolished building*

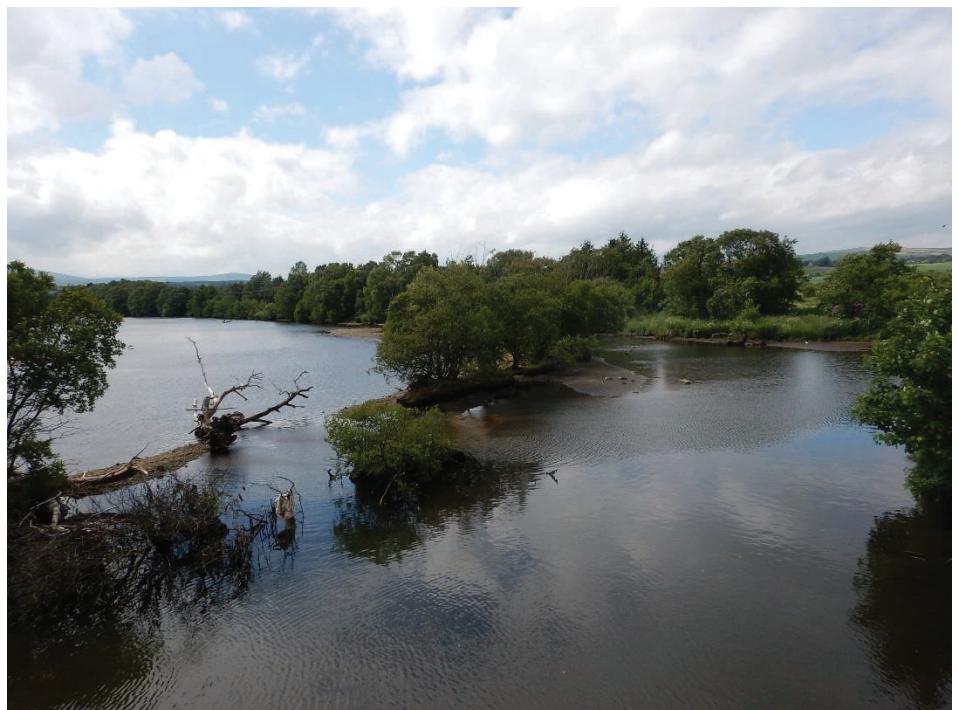
The north bank of the Avoca River and several small islands are covered by mixed trees and bushes; mostly Willow species but also including Alder, Ash, Birch and Sycamore of moderate to low value. There are some coniferous trees (including Pine and Cypress) close to the western edge of the survey area, just north of the riverbank, however these trees were not accessed or inspected in any detail.

*Photo 8. Willow bushes on small islands in the river and riparian tree-line along the northern river bank just north-west of the bridge*

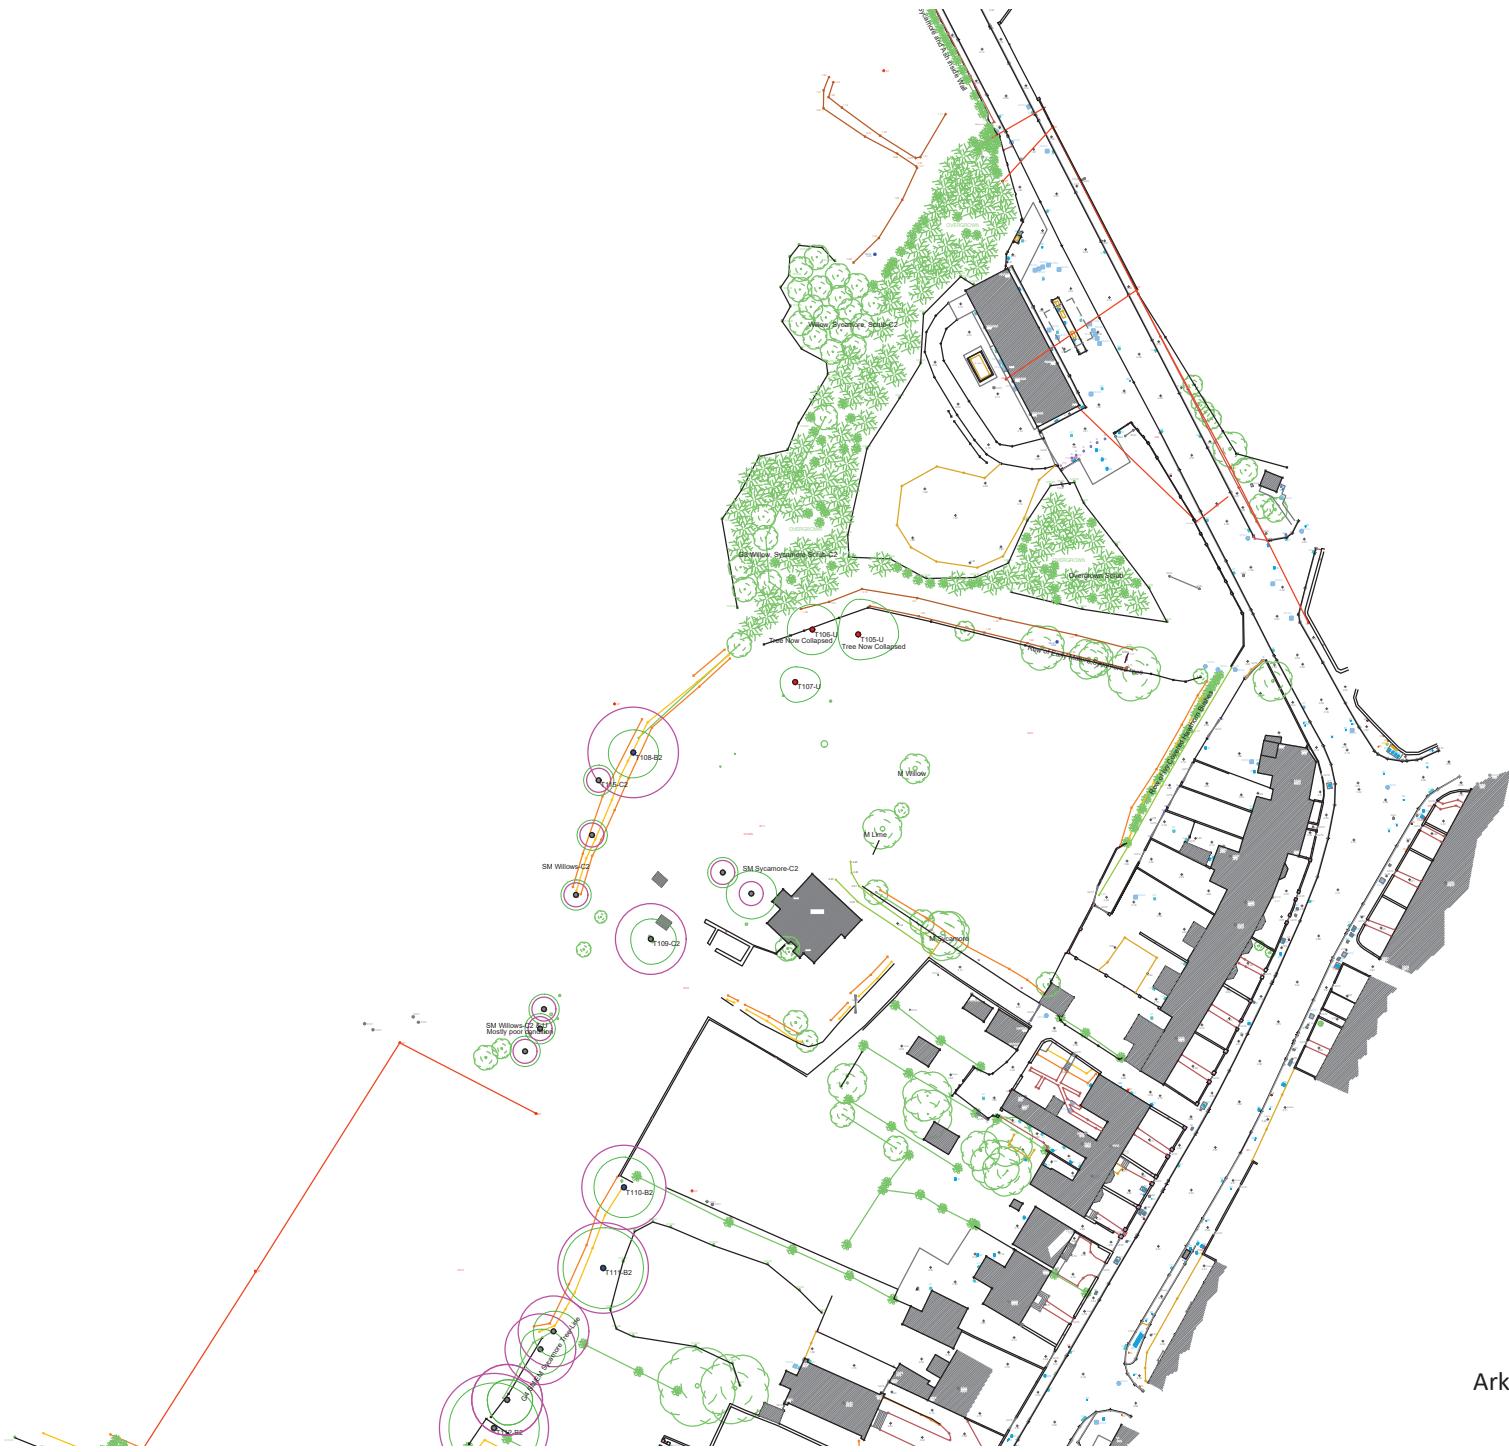
Arklow Flood Relief Scheme  
5909-100-Sheet 01

Riparian Tree-Line of Willow, Alder, Birch-B2

Willow Bushes-C2 & U  
Some in poor condition
