Proposed Residential
Development at Howth Road,
Dublin 3

Stage 1 Road Safety Audit

Document Ref: P21-018-RSA-PD-RP-001

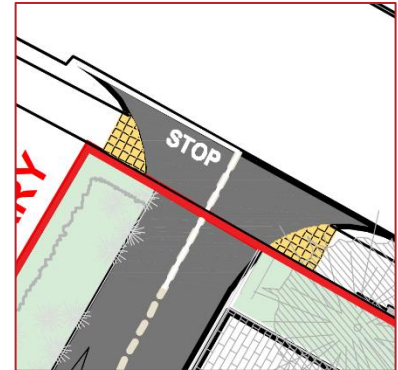
Location: Drawing HOW-BMD-00-ZZ-DR-C1000 (Rev. P4)

Summary: The tactile paving indicated at the uncontrolled crossing of the development access is not of the required depth across the full width of the crossing.

Tactile paving has been indicated on both sides of the access to the proposed development. The depth of the tactile paving, however, is not sufficient across the full width of the crossing for an inline crossing.

This could lead to a visually impaired pedestrian stepping over the tactile paving, where it is of insufficient depth, and inadvertently entering the carriageway without due care and attention where they are at an increased risk of being struck by a vehicle.

Ensure the tactile paving is a minimum of 1.2m deep across the full width of the crossing.

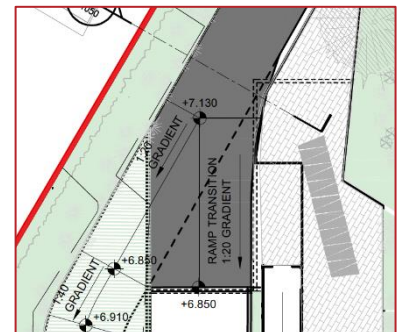
Location: Drawing HOW-BMD-00-ZZ-DR-C1001 (Rev. P4)

Summary: Sudden change in the horizontal alignment of the access and the narrowing of the carriageway at the top of the ramp may lead to poor lane discipline and kerb strikes.

The access road within the proposed development leading to the access ramp to the basement carpark includes sudden changes of direction in the horizontal alignment and appears to widen at the top of the ramp, which coincides with the location of these changes in direction.

A combination of the narrowing cross section and sudden changes in direction may lead to drivers being unable to sufficiently discern the edge of carriageway and thus the narrowing, particularly during the hours of darkness resulting in the potential for kerb strikes and material damage collisions.

Ensure the wider carriageway gradually tapers at the narrowing and that the edge of carriageway is sufficiently visible on the approach to, and departure from, the basement carpark access ramp.

Also, as the design progresses, ensure the access road is sufficiently lit.

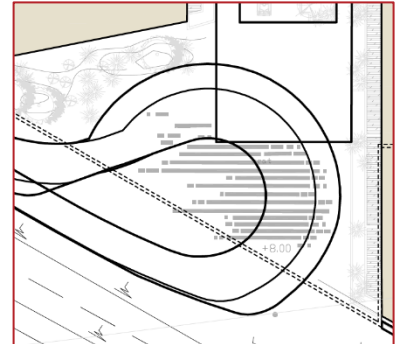
Location: Drawing HOW-BMD-00-ZZ-DR-C1042 (Rev. P4)

Summary: Fire tenders may experience difficulty when travelling in the grassed verge and may reduce the structural integrity of the paved areas within the development.

The swept path for a fire tender within the proposed development is indicated as using the grass verge and pedestrian area when travelling through, and turning within, the development.

It is unclear if the paved vulnerable road user areas will have sufficient structural properties to withstand a fire tender as it undertakes a U-turn manoeuvre. If the pavement is not strong enough to support such loads there is a risk of cracking and structural failure resulting in trip hazards for VRUs.

The 'Grass Pave' area adjacent the top of the basement carpark access ramp should be extended to the rear of the apartment blocks throughout the length of the emergency access route.

Also, ensure the paved VRU areas can sufficiently support the load of a turning fire tender.

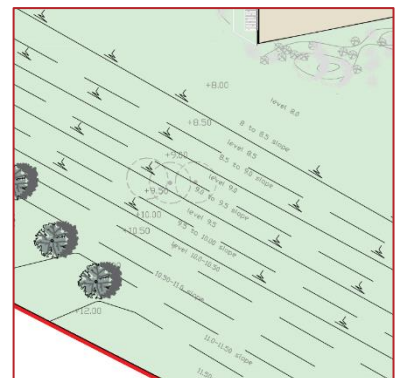
Location: Drawing HOW-BMD-00-ZZ-DR-C1000 (Rev. P4)

Summary: Pedestrians, particularly young children, may climb the embankment to the rear of the development where there is a risk of falls from a height and serious injuries.

An embankment is indicated to the rear of the apartment blocks within the proposed development which is indicated as rising in increments of 0.5m, with level surfaces between each rise, with a total rise of 4m. The Audit Team are concerned that pedestrians, particularly young children, may climb on the embankment where there is a subsequent risk of falls from height and the potential for serious injury.

Measures (i.e. vegetation, landscaping, fencing etc) should be provided at the base of the embankment to deter climbing.

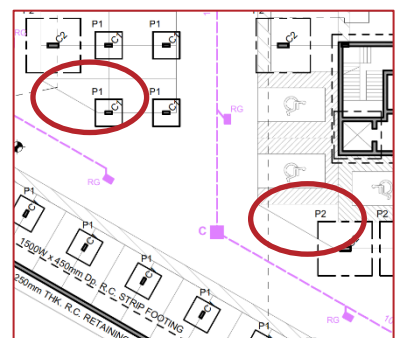
Location: Drawing HOW-BMD-00-ZZ-DR-C1002 (Rev. P4)

Summary: Drivers may park in areas not designated for parking resulting in them encroaching into the traffic lanes.

Triangular areas have been indicated at the end of parking aisles within the basement carpark. The Audit Team is concerned that, should all the spaces in the carpark be occupied, drivers may park their vehicles at these locations where there is insufficient space for a vehicle to park safely outside the carpark carriageway. Should drivers park in these locations, there is a risk of vehicles encroaching into the traffic lane resulting in an increased risk of low speed material damage collisions.

If these areas are for smaller vehicles (i.e. motorcycles), ensure they are sufficiently marked as such. Otherwise, these areas should be hatched

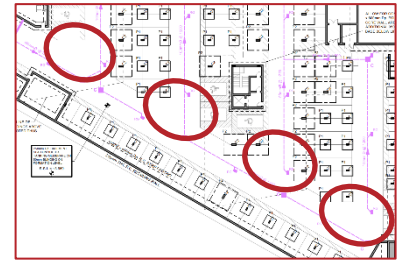
Location: Drawing HOW-BMD-00-ZZ-DR-C1002 (Rev. P4)

Summary: Junction control and priority has not been indicated within the basement carpark.

Junction control and priority has not been indicated at locations where the aisles within the carpark intersect. This could result in driver confusion and hesitation leading to collisions should drivers assume that they have priority over vehicles in adjacent carpark aisles, leading to low speed collisions and material damage.

Junction control and priority should be clearly provided via roadmarkings at locations where aisles intersect within the carpark.

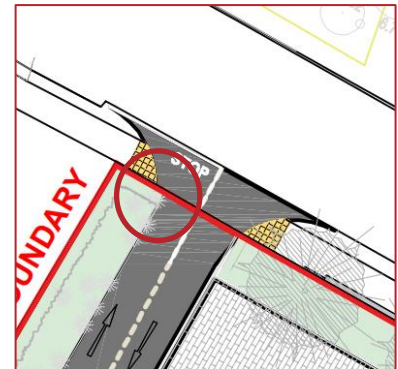
4.1 The junction corner radius on the western side of the development access does not align with the edge of the access road carriageway/verge. While the Audit Team assume that this is a drafting error the drawing should be amended to correctly display the junction radius and verge.

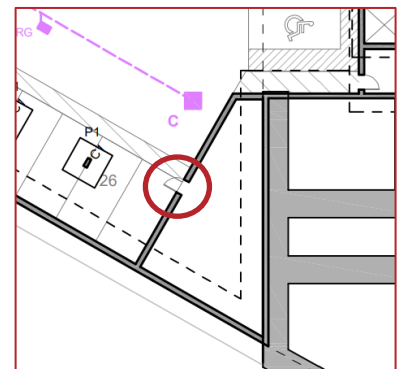
4.3 A room has been indicated in the south-eastern corner of the basement carpark accessed from a door adjacent a parking space. When this space is occupied this door will be blocked restricting access to this room. The door should be relocated, or the parking space removed, to ensure access to this room is possible at all times.

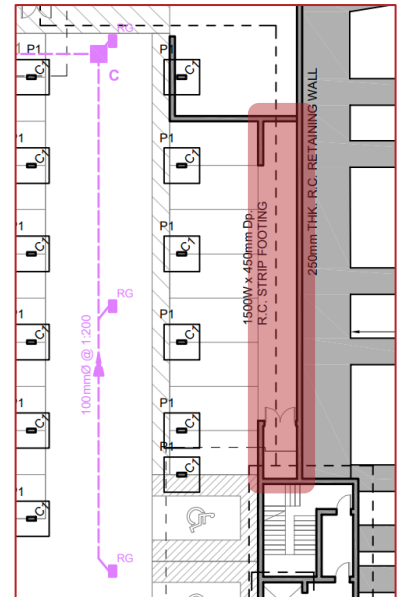
4.4 An access route has been indicated to the rear of the easterly most aisle of parking spaces within the basement carpark. It is unclear where this route leads to as a door has been indicated at one end, and a wall at the other. When the adjacent spaces are occupied access to/from this 'corridor' will be restricted which could lead to pedestrians who enter the carpark at this location being unable to leave this 'corridor.' An exit should be provided to allow safe access/egress at all times.

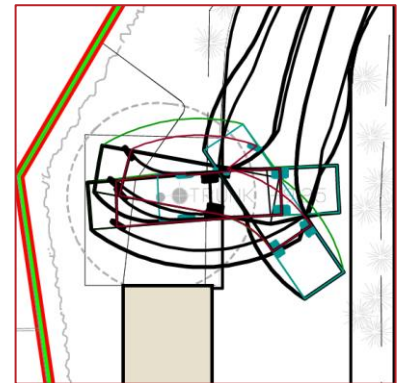
4.5 The swept path for an ESB Van turning within the proposed development is indicated as using the grass verge adjacent the top of the basement carpark access ramp. There is a risk that the wheels of a van may sink within the grass verge when turning which may lead to rutting in the verge and difficulty when exiting. The 'Grass Pave' area adjacent the top of the basement carpark access ramp should be extended to the turning circle used by ESB/delivery vans.
