Ruirside Development Limited
42A Parkgate Street
Preliminary Site Assessment

265381-00

Issue | 16 May 2019

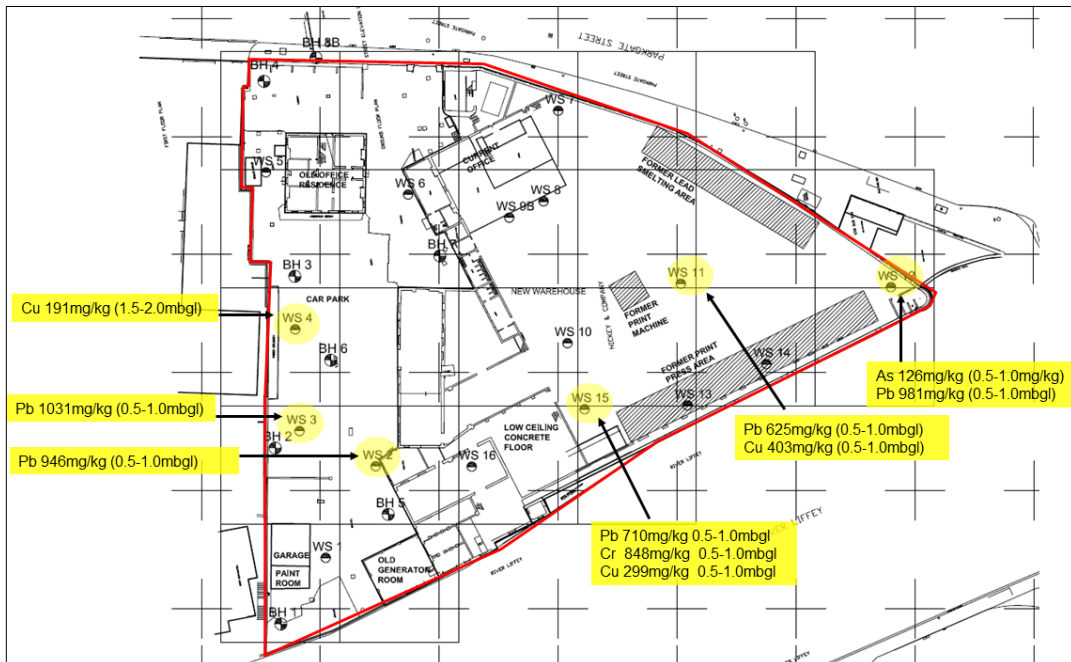
Figure 22: Metal concentrations from the GI (IGSL, 2002)

A review of the environmental soil testing results showed lead cadmium, arsenic and copper in soil samples across the southern half of the site that exceeded the DIV, as discussed in **Section 5.1.3**. Refer to **Figure 22** below.

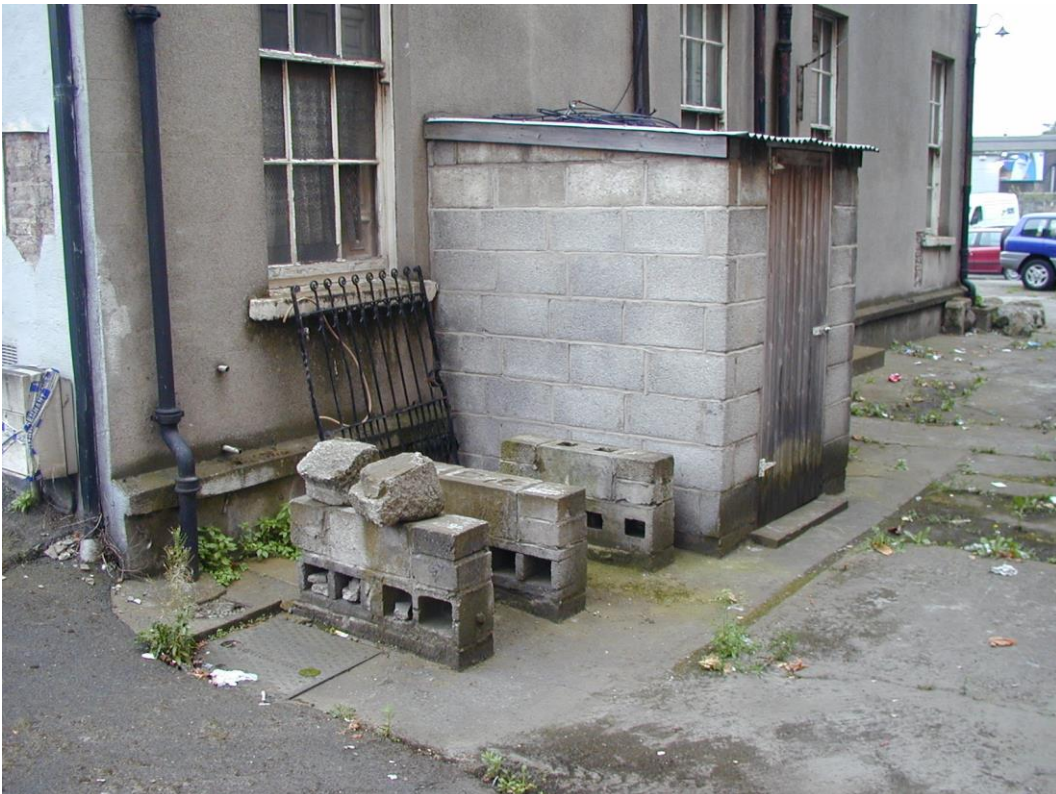
The report noted four AST on site. Three were used for the storage of heating oil and the fourth tank was noted to be out of use. There was evidence of a fifth tank (likely AST No. 3, refer to Figure 7) with the concrete pedestals still in place. This assessment also highlighted the likely presence of asbestos sheeting in the roof tiles of the garage building.

Photograph 7: Former location of former location of an above ground storage tank (No. 3) adjacent to the former office/residence. Photo taken by Arup in August 2002. Area no longer accessible

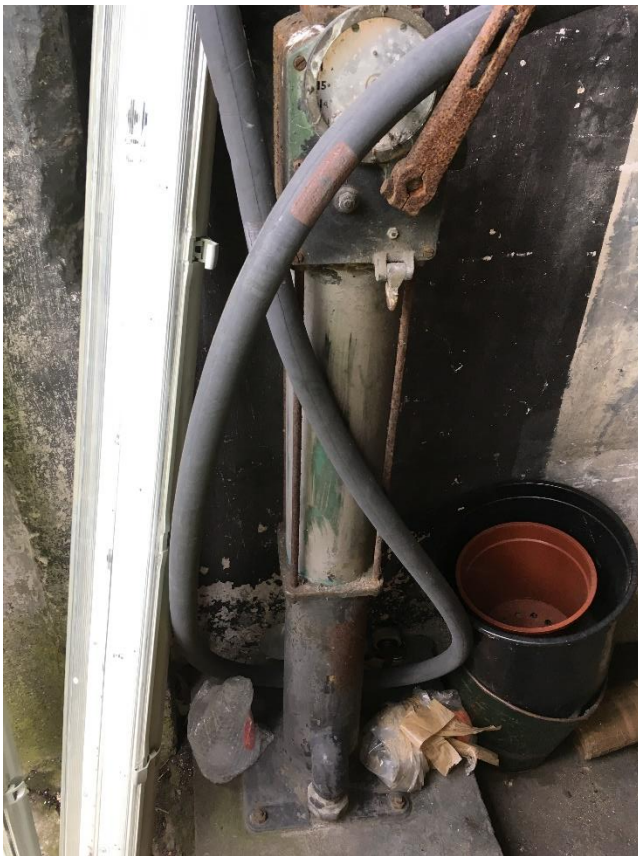
Photograph 9: Disused pump at the garage/paint room

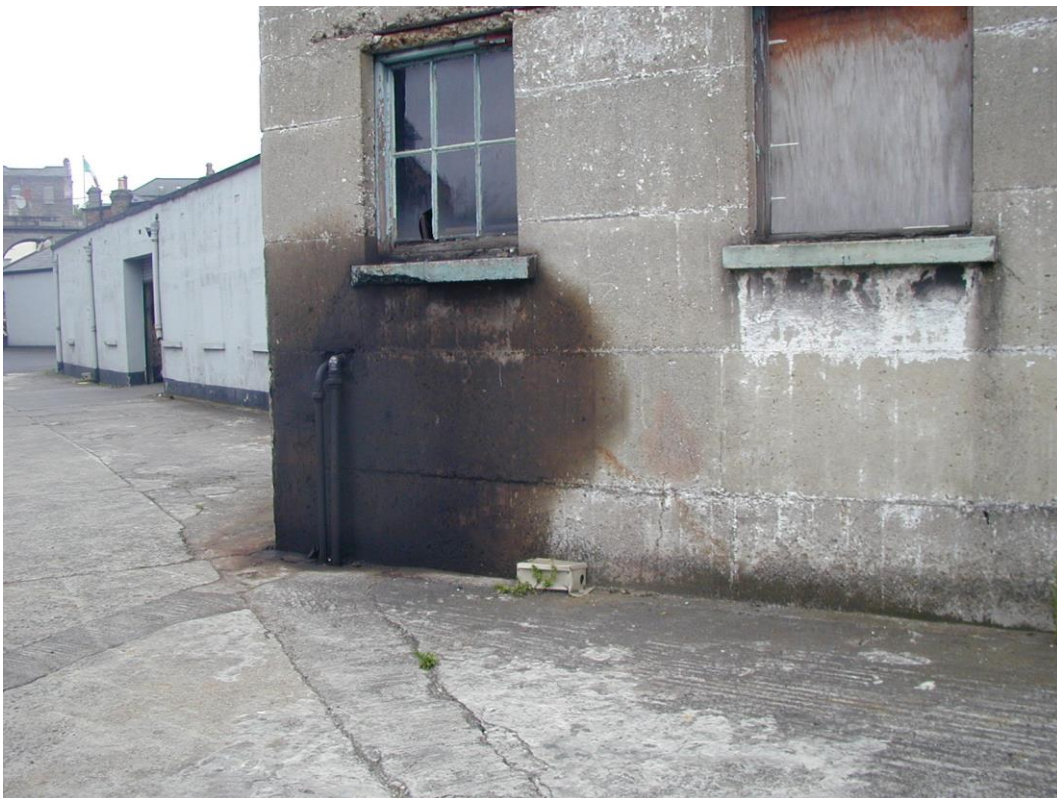
Photograph 11: Boiler house No. 2 (Photography taken in 2002)

There are two boiler houses located on site; one adjacent to the former office/residence (No. 1) and the second is adjacent to the main warehouse (No. 2), refer to **Photograph 11** and **Photograph 12** in **Appendix C** and **Figure 5** in **Appendix E**. A photograph of the boiler house (No. 2), west and adjacent to the warehouse, taken in 2002, shows staining on the walls of the building, (**Photograph 11**).

The two boiler houses were also inspected. One was noted to contain an AST 1.5m above the floor level of the building (boiler house No.2 and AST No.4, refer to **Figure 7**). This AST was used for the temporary storage of oil for the generators. Evidence of spills and hydrocarbon contamination was noted with staining observed on some of the walls. Refer to **Photograph 11** in **Appendix C**.

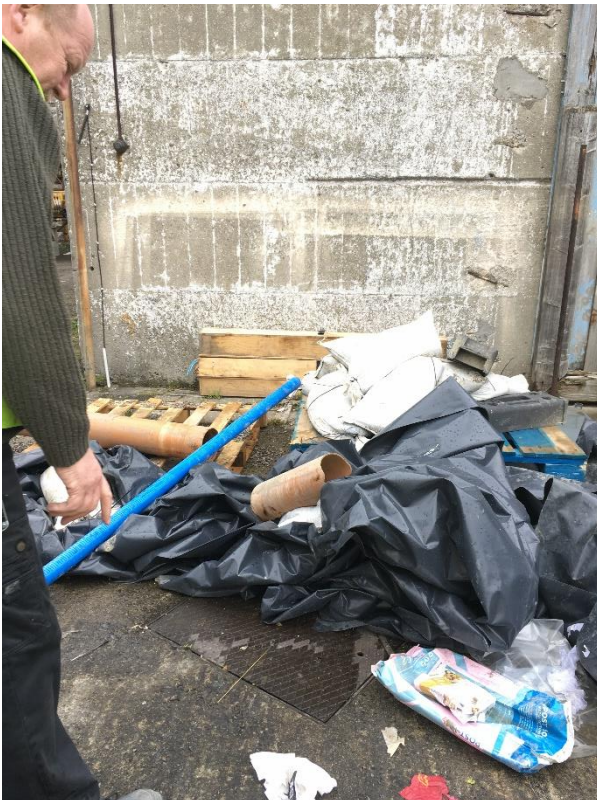
Photograph 13: Access point for underground storage tank adjacent to the old generator room

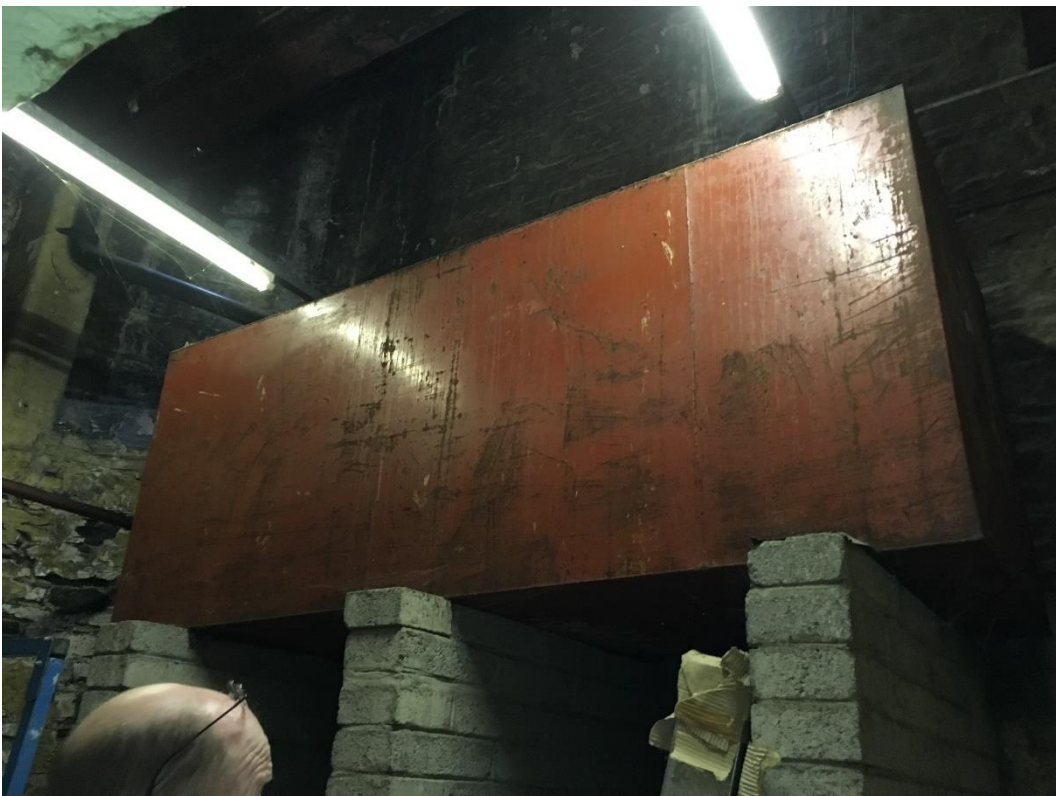
Photograph 15: Above ground storage tank (No. 5) located in the south-eastern tip of the new warehouse

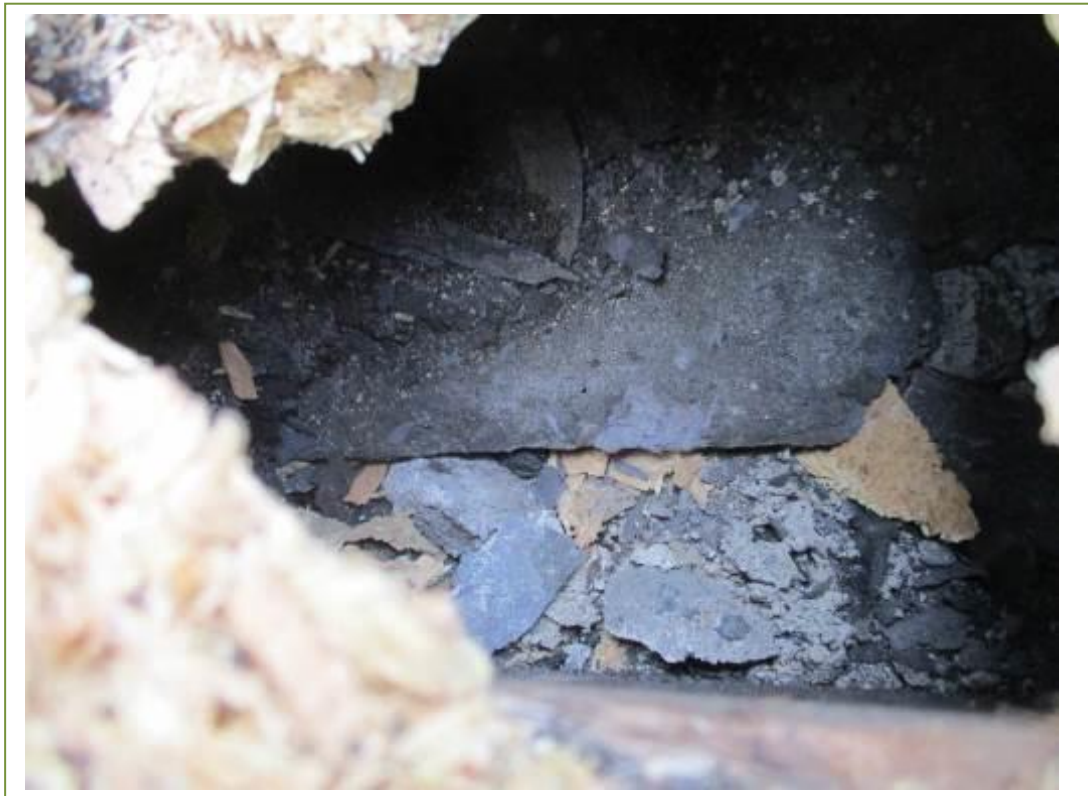
DETAIL OF THE ASBESTOS CEMENT REPLACEMENT SLATES & DEBRIS

Natural slates present in the void between the felted roof and the lining boards beneath

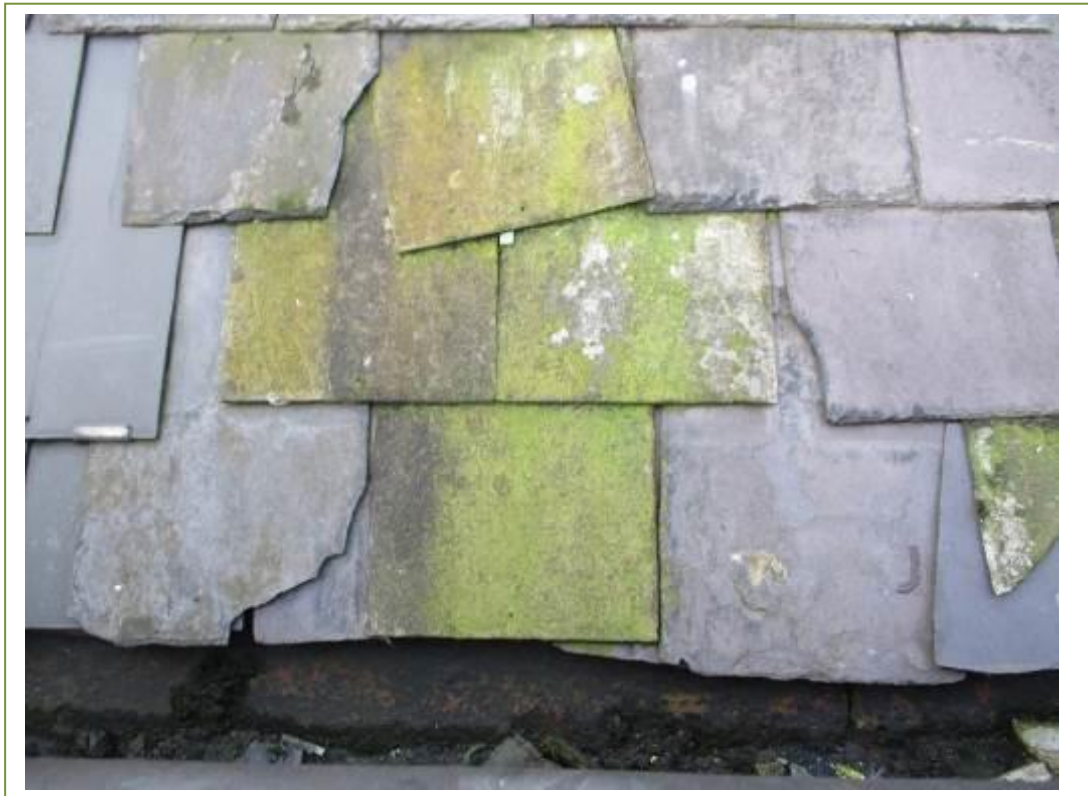
DETAIL OF THE ASBESTOS CEMENT REPLACEMENT SLATES & DEBRIS

Cement replacement slates identified on the rear roof beside the main pitched roof

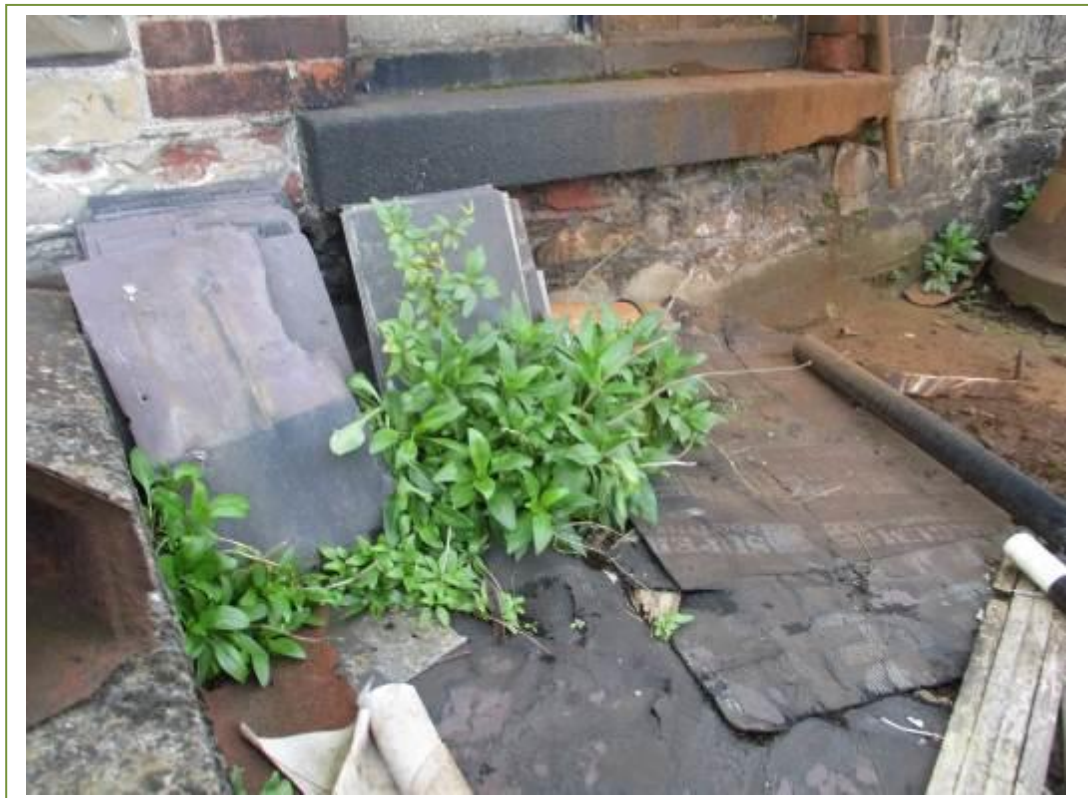
Cement slates identified on the flat roof area

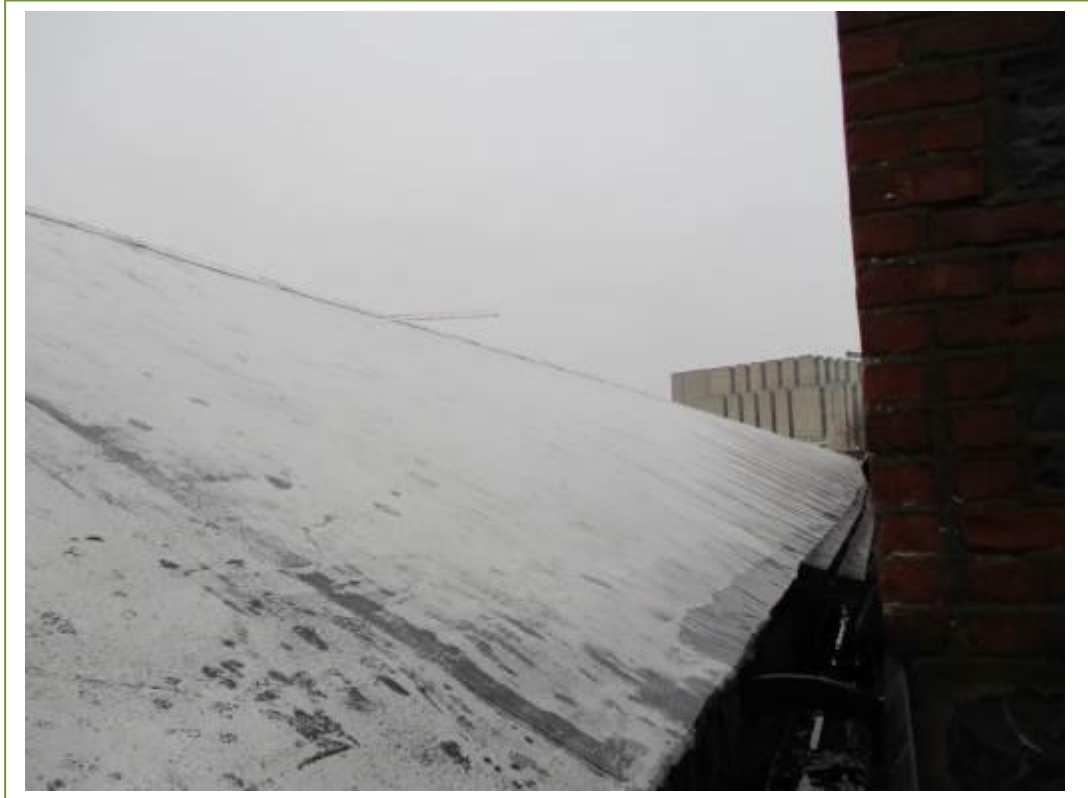
Felt on main pitched roof. No Asbestos Containing Materials (ACM's) detected

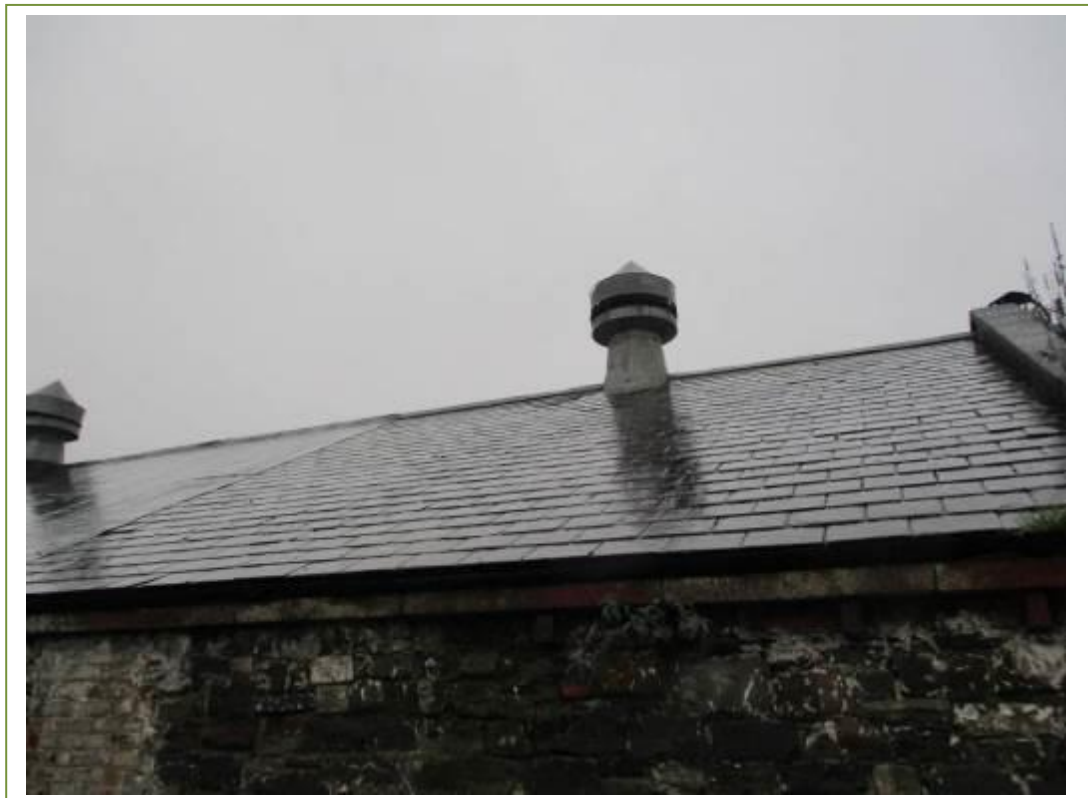
Natural slates on some rear roofs. No ACM's detected

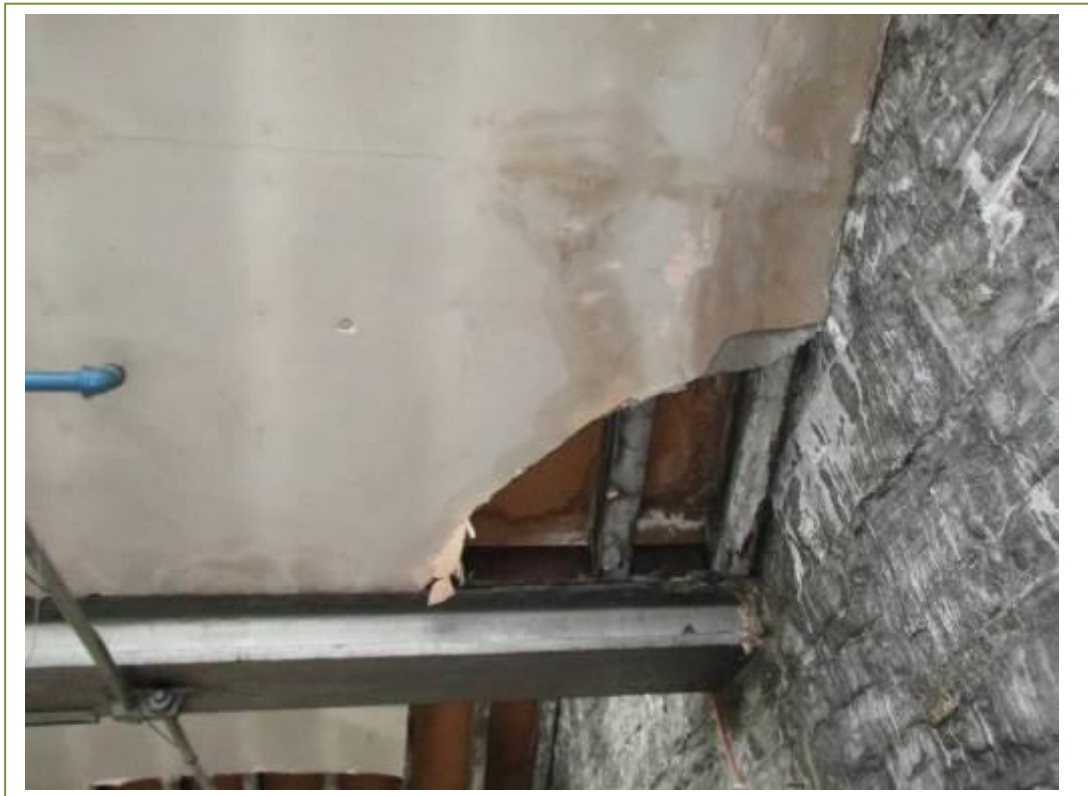
Plasterboard ceiling boards under main pitched roof. No ACM's detected

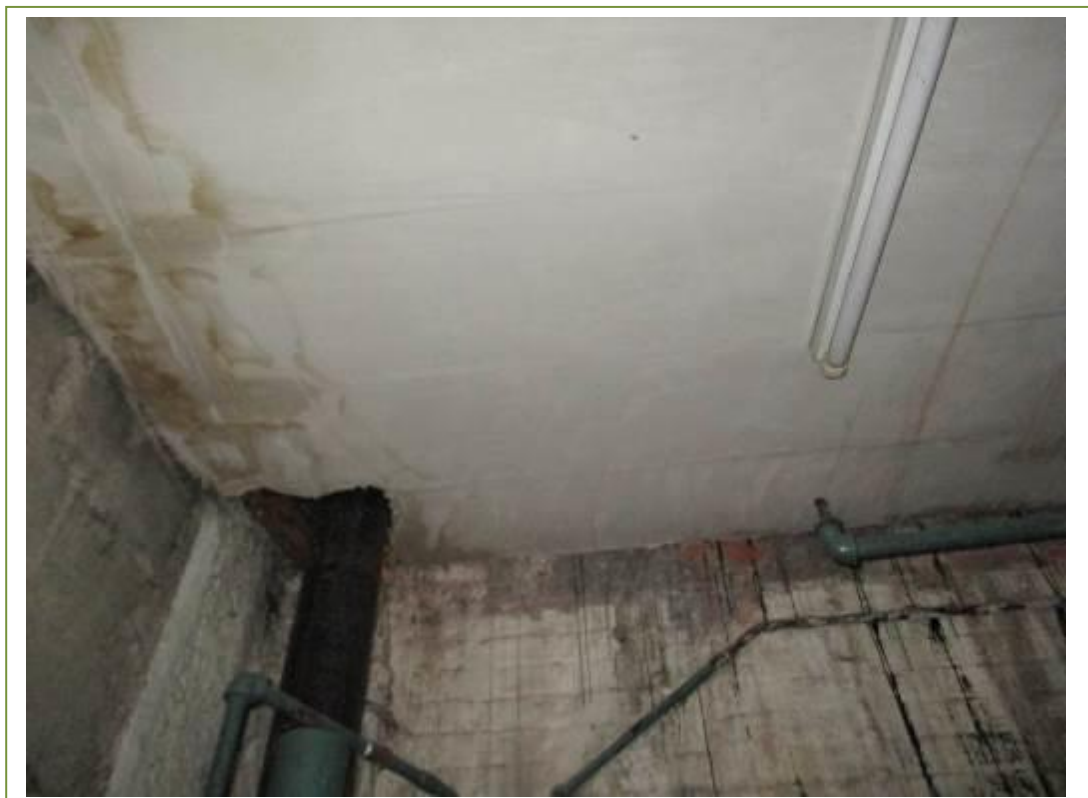
Plasterboard ceilings in sprinkler room. No ACM's detected
