# Parkgate Street Arboricultural Assessment and Tree Protection Report

## Parkgate Street Dublin 8

<b>Project No.</b>	<b>Project name</b>	<b>Date</b>	<b>Revision</b>
TPAR002	Parkgate Street	14/04/21	-

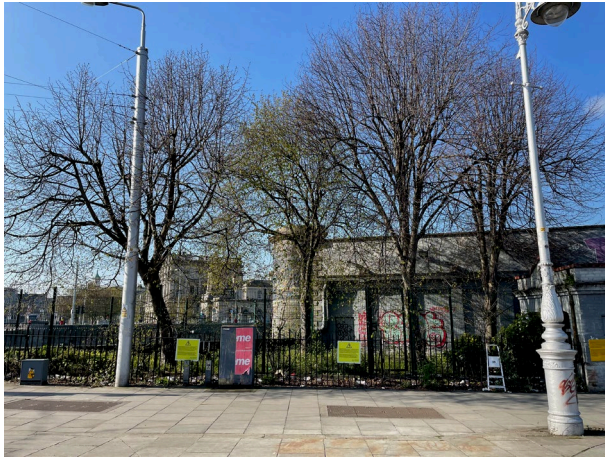
**Image 2.** View of tree group from north

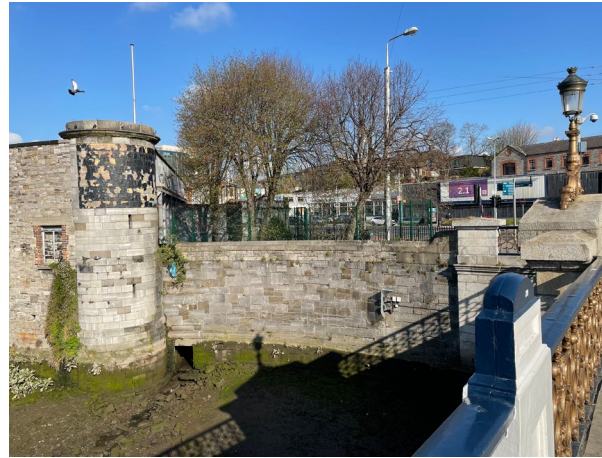
**Image 3.** View of tree group from south

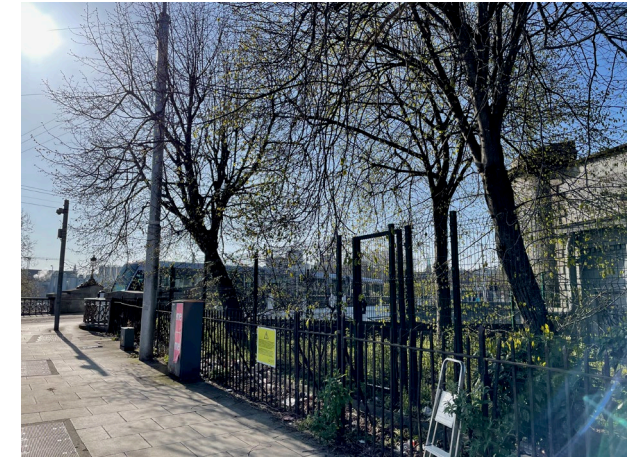
**Image 4.** Tree #1 to left of image with a lean

Tag No.	Species	Age Category	General Condition	Comments	Preliminary Recommendations	Landscape and Arboricultural Category	Useful Life Expectancy
0001	Lime cultivar Tilia cordata cv	Early-mature	Good	Trunk with a lean toward north-east due to competition from neighbourig tree. Lean not significant with crown vertical in orientation. Upper canopy relatively well dveloped with no visible defects.	No action necessary	B2	30-40
0002	Lime cultivar Tilia cordata cv	Early-mature	Good	Trunk co-dminant from 3m with a wide union between stems. Upper canopy relatively well developed with no visible defects.	No action necessary	B2	30-40
0003	Lime cultivar Tilia cordata cv	Early-mature	Good	Upper canopy topped to east over neighbouring building reducing the trees visual quality. Remaining crown relatively well developed. Trunk co-dominant from 2m with a tight union and included bark between stems which may reduce long term potential.	No action necessary	B2	30-40
