Stage 1 Road Safety Audit

**Phase 1 of Residential Development,
Rosshill, Galway**

On behalf of **Alber Developments Ltd**

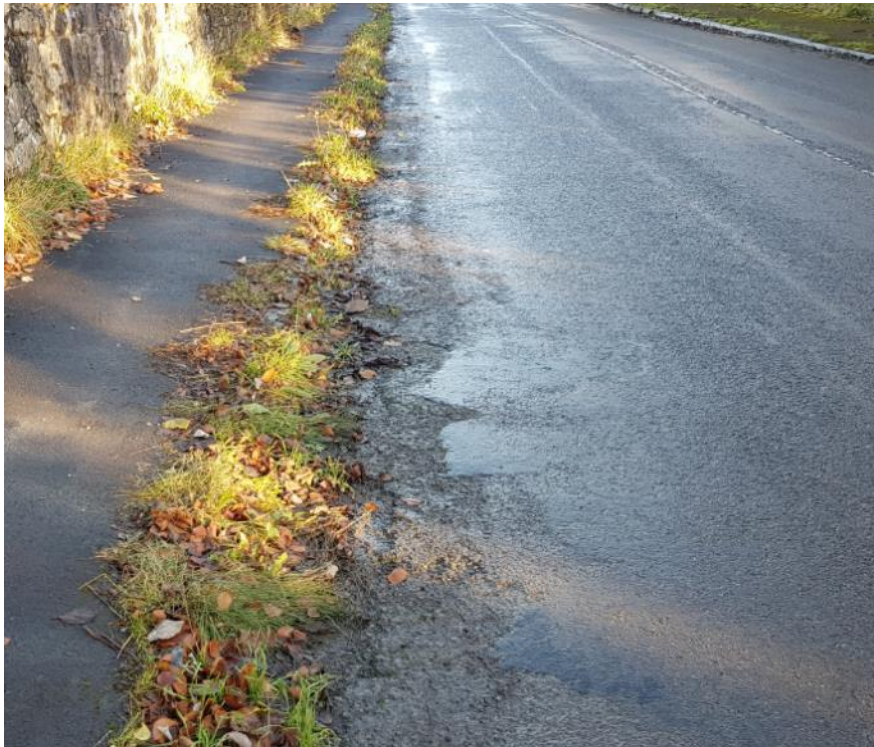
2.2.1 Rosshill Road : Pedestrian Access to the Development

Problem: Rosshill Road does not have suitable pedestrian or cycle facilities. The proposed development is likely to generate substantial pedestrian and cyclist numbers.

Rosshill Road gets very busy during the AM and PM peak hours with commuting traffic.

Hazard: Pedestrians may decide to walk in the carriageway due to the poor-quality footpaths. Additionally, motorists may not give sufficient space for cyclists on the road. Impact between users may result.

Recommendation: Provide upgraded facilities for non-motorised users.

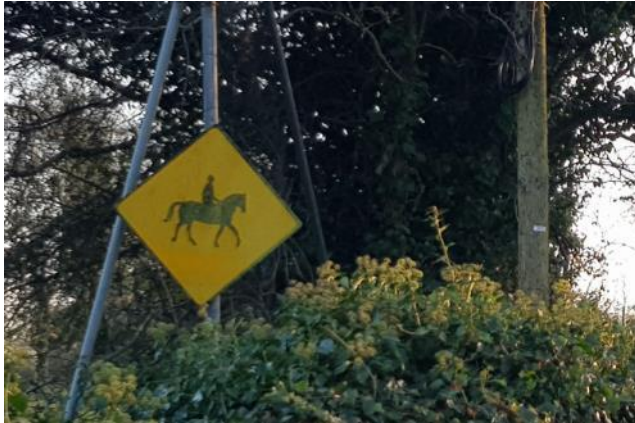
2.2.3 Equestrians

Problem: There are numerous signs on Rosshill Road warning of equestrian use of the road.

Hazard: The increased traffic numbers due to the development increase the risk of vehicle / horse impacts.

Recommendation: The design team should undertake investigations to the use of the Rosshill Road and provide segregated equestrian facilities if deemed necessary.

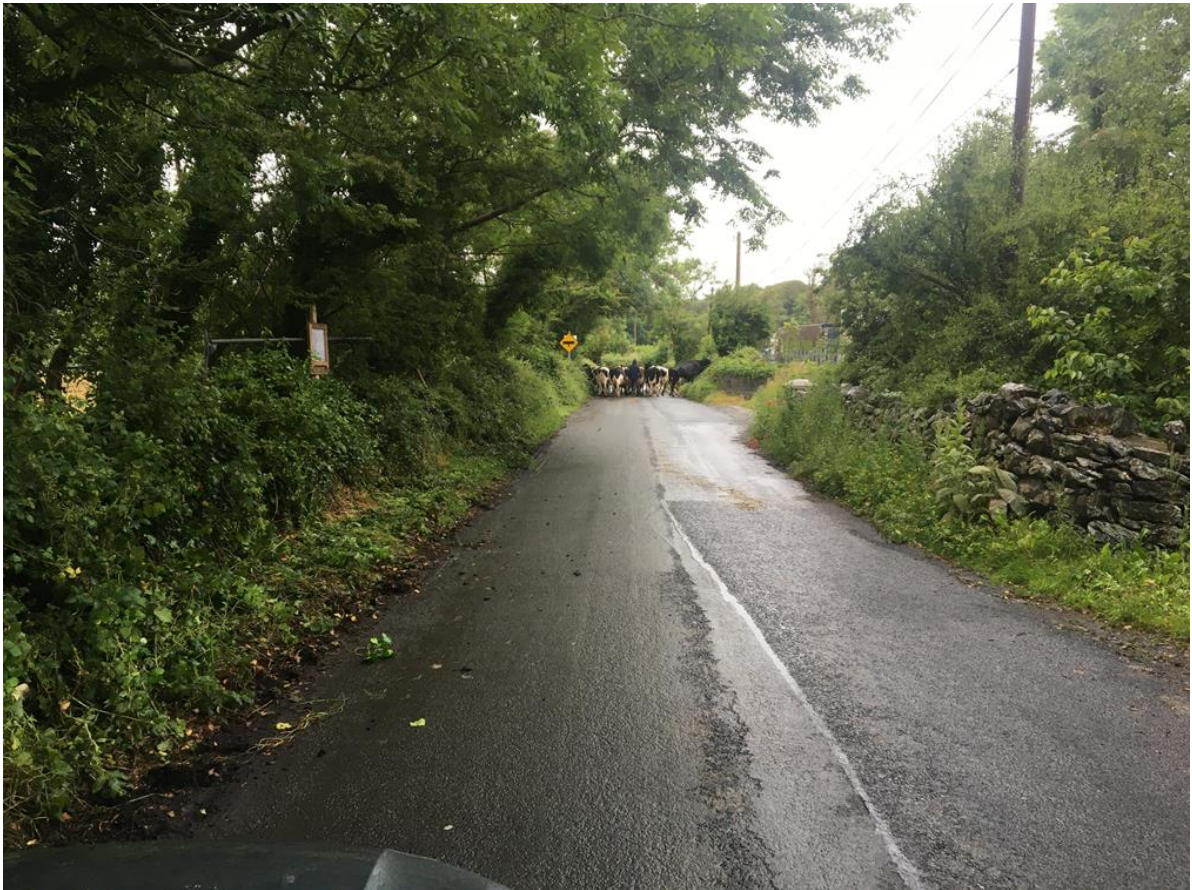
2.3.1 Cattle on Rosshill Road

Problem: Milking cows were observed being driven on Rosshill Studfarm Road, along Rosshill Road and to a pen near opposite Rosshill Studfarm Road. The proposed new junction for Rosshill Road will mean the cattle require to be driven a longer distance on Rosshill Road.

Hazard: Rosshill Road can be busy with faster moving traffic and there is an increased risk of vehicle/animal impact. Also, the development will mean an increase in traffic on Rosshill Studfarm Road.

Recommendation: Maintain an element of the existing road for use by the cattle. Ensure adequate signage is provided to inform drivers of the presence of cattle.

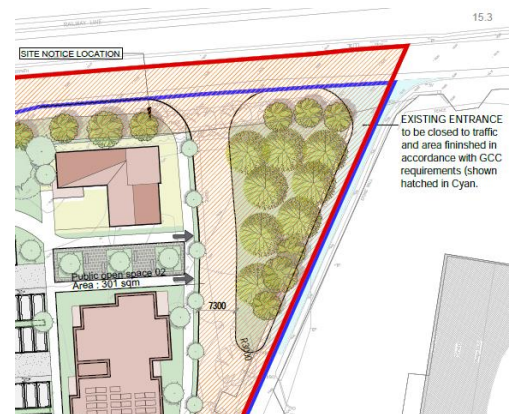
2.3.2 Existing Rosshill Road / Rosshill Studfarm Road Junction.

Problem: The proposed new junction is in close proximity to the existing junction.

Hazard: Rosshill Road traffic arriving from the east may errantly turn into the redundant road junction. These users may be required to reverse back onto the public road. Rear-end impacts may result.

Recommendation: Ensure the existing road and junction is removed and suitably landscaped to avoid any confusion that a road exists at this location. However, refer to 2.3.1 above. Ensure adequate signage is provided to inform drivers of new junction layout.

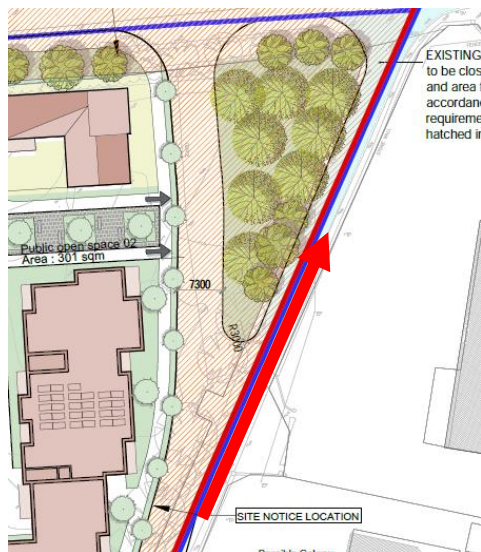
2.3.3 Redundant Section of Rosshill Studfarm Road

Problem: Northbound Rosshill Studfarm Road traffic may have see-through to the former section of road (to be closed). Users may errantly drive onto the closed section of road and be required to reverse back onto the revised road alignment.

Hazard: Rear-end shunts may result.

Recommendation: Ensure see-through to the former road is omitted.

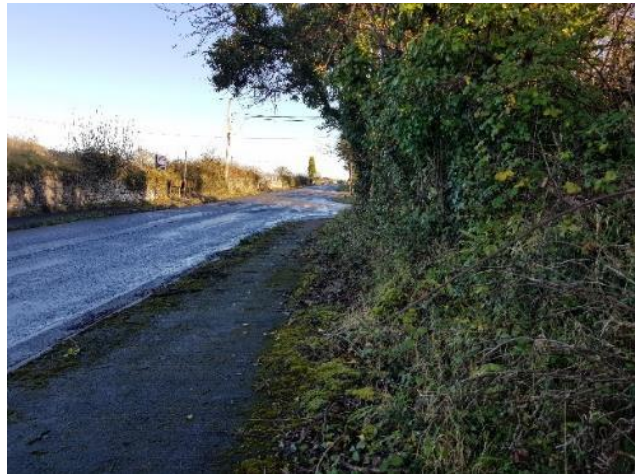
2.3.4 Rosshill Road / Rosshill Studfarm Road: Junction Visibility

Problem: Visibility to the right when exiting the development may be restricted due to roadside vegetation. Vehicles approaching the proposed junction from the east do so at high speed.

Hazard: Users may proceed from the new junction into the Rosshill Road into the path of oncoming vehicles. Impact may result.

Recommendation: Ensure the available junction visibility is suitable for the speed of traffic on the road.

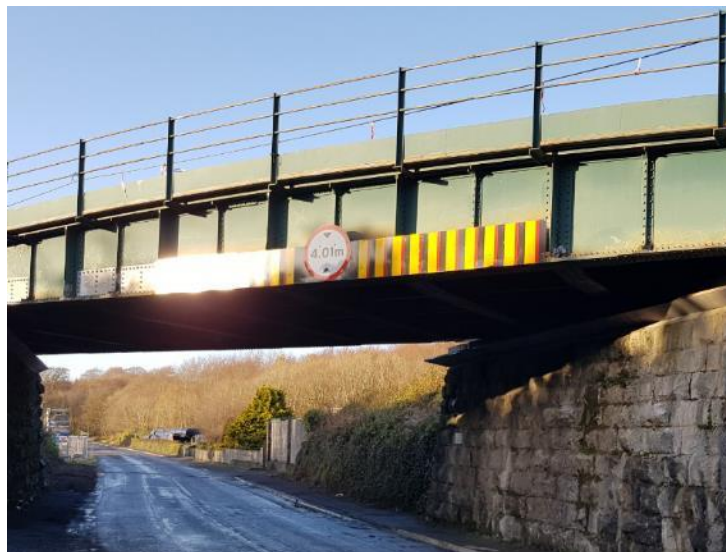
2.3.5 Railway Bridge: Height

Problem: The railway bridge over the Rosshill Road is signed as 4.0m clearance. Although unlikely to be a problem for the occupants of the development some construction traffic may be higher than this limit.

Hazard: Construction vehicles may strike the bridge and damage the structural integrity of the bridge.

Recommendation: Ensure the Construction Management Plan identifies a suitable access route for high vehicles.

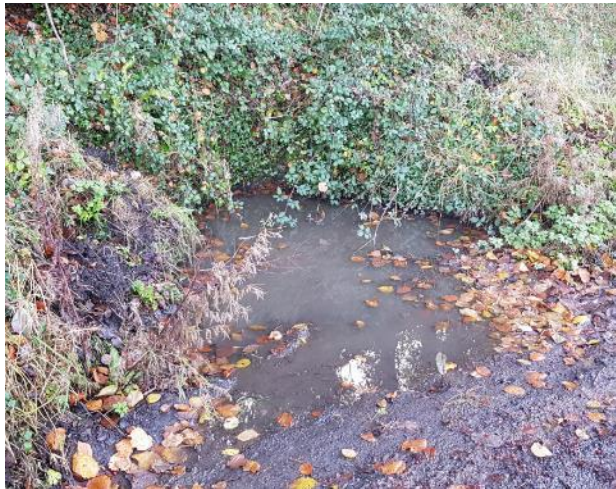
2.3.6 Rosshill Road: Drainage

Problem: The existing Rosshill Road drainage is not working adequately. The development will generate increased traffic movements on this road.

Hazard: During times of extreme rainfall standing water may encroach into the carriageway. Risk of vehicular loss of control will be heightened by the increased use of this road.

Recommendation: Ensure adequate surface water drainage is provided.

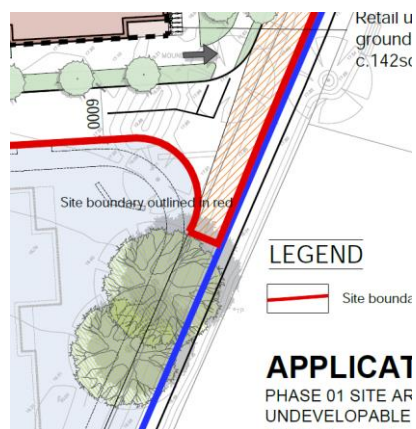
2.3.7 Development Junction with Rosshill Studfarm Road: Visibility

Problem: Large trees are proposed to the right of the new junction, within the visibility envelope.

Hazard: Users may pull out of the junction into the path of oncoming traffic.

Recommendation: Ensure all high landscaping is kept to the rear of the junction visibility splay.

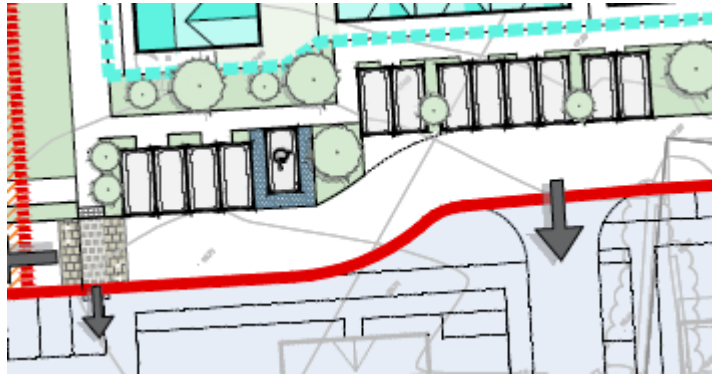
2.3.9 Chicane to Southwest of Phase 1

Problem: Perpendicular parking off a short sharp chicane to the southwest of Phase 1 has restricted visibility due to the further parking to the west.

Hazard: Motorists pulling out of the parking, particularly those reversing, may pull into the path of oncoming traffic and be struck.

Recommendation: Realign the road or remove some parking so that adequate visibility is achieved.

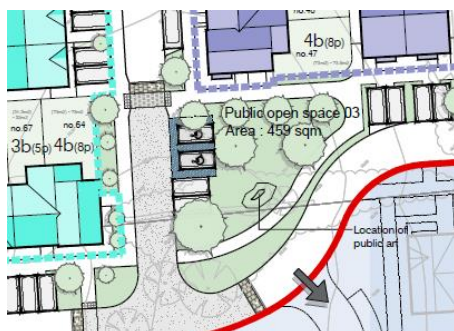
2.3.10 No path for disabled parking spaces

Problem: Safe access/egress from the disabled parking spaces shown below is not proposed.

Hazard: Users may travel in the carriageway and be struck.

Recommendation: Provide a footpath to the front of the parking spaces.
