Title: **STAGE 1 ROAD SAFETY AUDIT**

Proposed Residential development at Milltown Park, Sandford Road, Dublin 6.

Report reference: **0995R01**

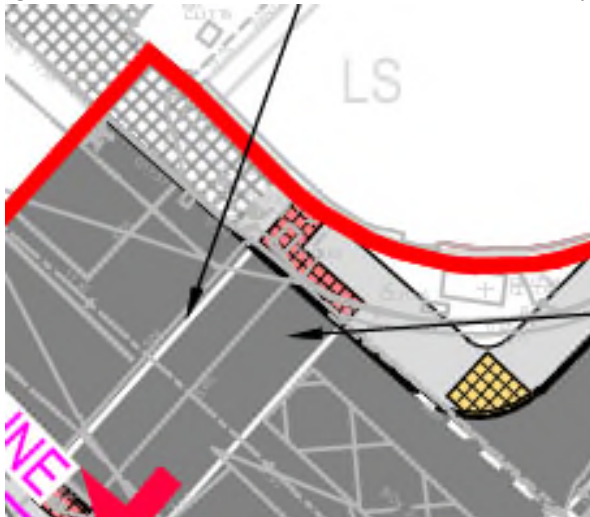
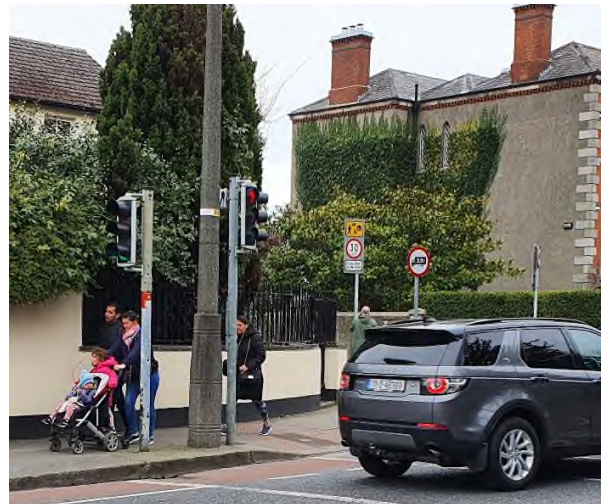
3.1 Problem

There is limited space at the north eastern side of the proposed toucan crossing on Sandford Road for bicycles and pedestrians given the relatively narrow footpath and the obstructions from the traffic signal poles and the large lighting column. This could lead to collisions between cyclists and pedestrians.

It is recommended the lighting column be relocated and that a single set of signal heads be used for pedestrians and vehicular traffic.

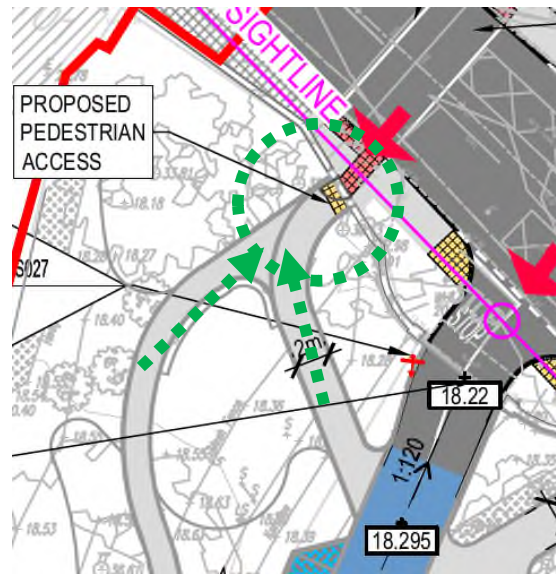
3.2 Problem

The width of the section of shared use area for pedestrian and cyclists on approach to the north western access onto Sandford Road may not be sufficient to cater for both user groups and could lead to collisions.

It is recommended that a wider shared area be provided to avoid collisions between cyclists and pedestrians.

Paragraph No. in Safety Audit Report	Problem accepted (yes/no)	Recommended measure accepted (yes/no)	Alternative measures (describe)	Alternative measures accepted by Auditors (Yes/No)
3.1	Yes	Yes		
3.2	No	No	The shared area width in question is acceptable as cyclists will primarily access from Sandford Road via the 4.8m wide shared access. We also note that there is constraints on the shared area width in question due to trees / existing walls.	Yes
3.3	Yes	Yes		
3.4	Yes	Yes		
3.5	Yes	Yes

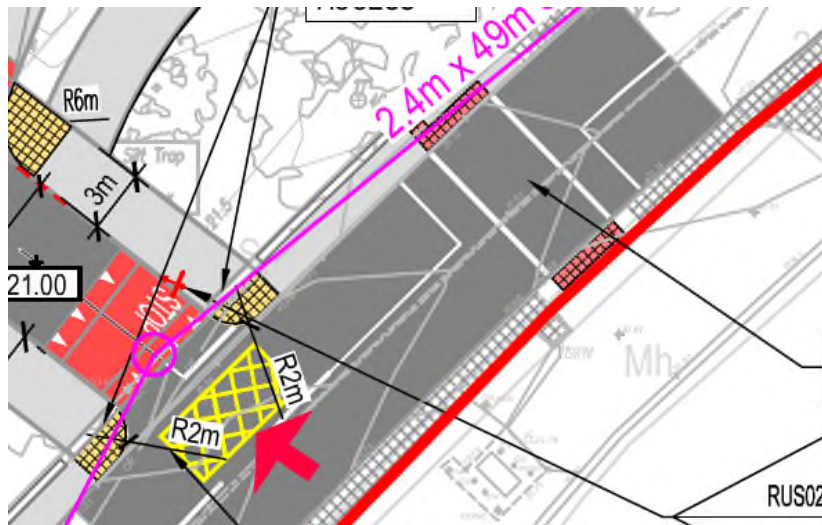
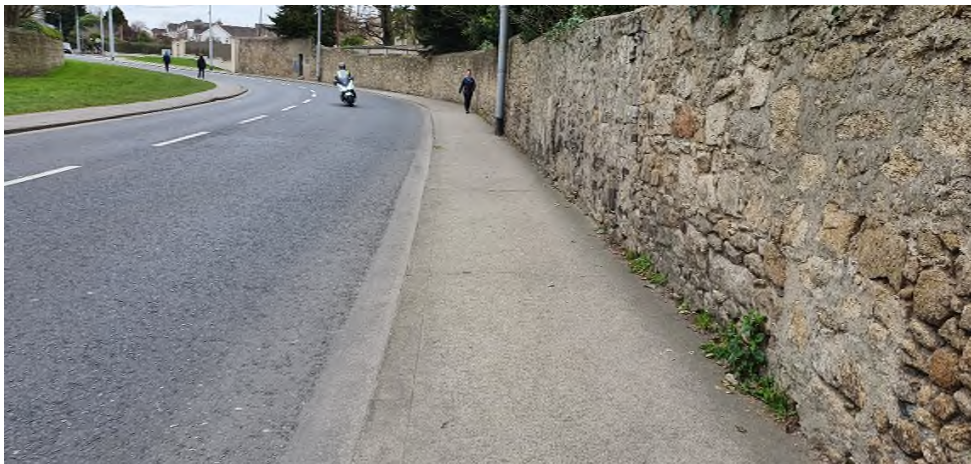
3.3 Problem

The footpath on both sides of Milltown Road at the proposed toucan crossing is very narrow. There is a risk of collisions between cyclists and pedestrians. There are also no cycling facilities on Milltown Road to connect with the proposed toucan crossing. The existing lane on Milltown Road is very wide and leads to higher vehicle speeds which could lead to higher severity injury collisions if vulnerable road users are struck.

It is recommended that the footpath be widened between the toucan crossing and the development access to become a shared use area for cyclists and pedestrians. And the toucan crossing be built out on Milltown road to act as a traffic calming feature.

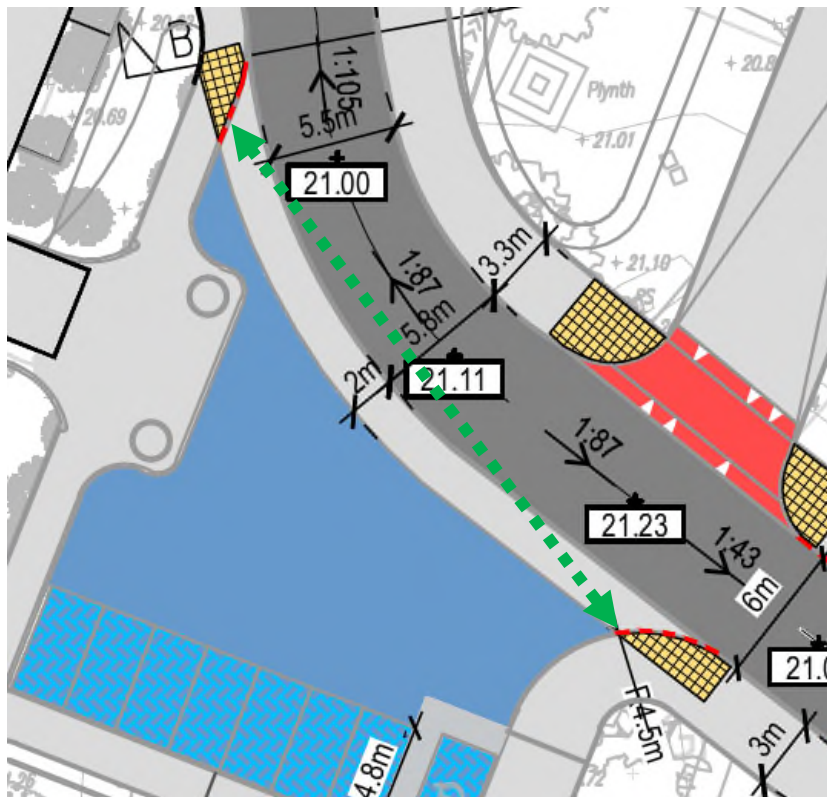
3.4 Problem

It is proposed to have dropped kerbs and tactile paving across the parking area in front of Tabor House. This is a wide area with a horizontal curve and blind or partially sighted pedestrians may inadvertently enter the carriageway where they would be at greater risk of being struck by a passing vehicle.

It is recommended that the footpath be made continuous with a 25mm lip for vehicular access that can be detected by blind or partially sighted individuals.

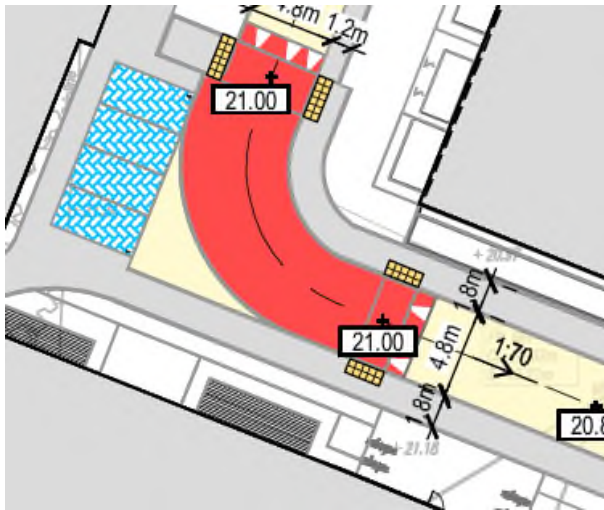
3.5 Problem

Between Block D and Block E there is a 90 degree bend in the carriageway which has a width of 4.8m. There is a risk of side swipe collisions if vehicles meet at the bend. In addition, the uncontrolled crossing appears to protrude beyond the edge of carriageway.

It is recommended that a swept path analysis be carried out and if necessary localised widening of the carriageway should take place.
