Route Access Survey 340497 - Vestas V162

Bracklyn Wind Farm

Galetech October 2020

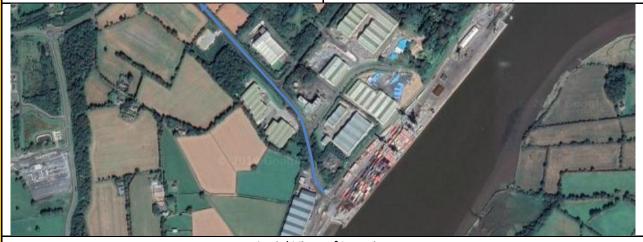
ITEM NUMBER	5.6.1	LOCATION	EXIT PORT OF WATERFORD ONTO THE N29
DIRECTION	Continue at this location		
GRID REFERENCE	S 65780 12965

Visual inspection indicates that the fence and road sign on the offside is to be removed.

Blade is required to contraflow the exit gate house to reduce the amount of modifications required.

Road signs on nearside of railway crossing required to be removed to allow rear projection of blade to oversail.

The barrier on the offside is to be removed.

The area in the port is to be cleared of containers.

Swept path analoysis is reccommended to confirm the above.

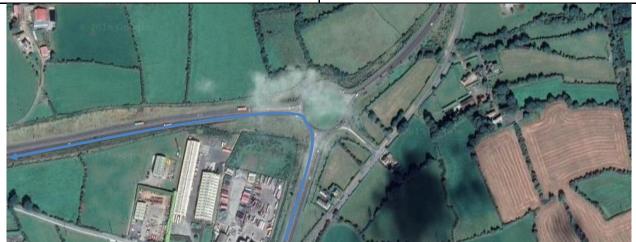
ITEM NUMBER	5.6.3	LOCATION	N29/N25 ROUNDABOUT	
DIRECTION	Take the 1 st exit at the roundabout			
GRID REFERENCE	S 64149 15861

Visual inspection indicates that the road sign and lamp posts on the nearside is to be removed.

Road signs on the offside to be removed.

Blade oversailing on coming carriageway.

Swept path analoysis is reccommended to confirm the above.

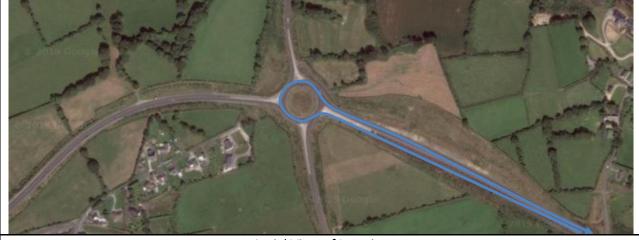
ITEM NUMBER
 5.6.4
 LOCATION
 N25/R680 ROUNDABOUT (OPTION 1)

Visual inspection indicates that road signs on central reservation and splitter island are required to be removed.

All Lamp posts on outside of roundabout required to be removed to allow rear proejction fo balde to oversail.

Swept path analaysis is reccommended to confirm the above.

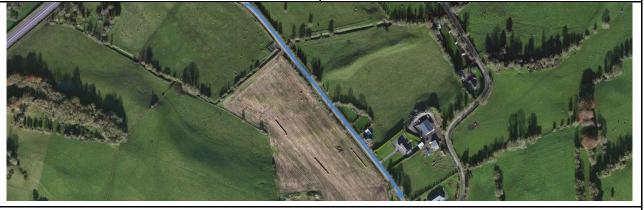
ITEM NUMBER
 5.9.3
 LOCATION
 VERTICAL CRESTS ON L1504

Vertical Analysis indicates that Loaded blade component will navigate this vertical crest with the neck of clamp raised.

Once the rear projection of blade is on the vertical crest it rises to above 5m, overhead cables are to be checked at this location to avoid the projection colliding with them.

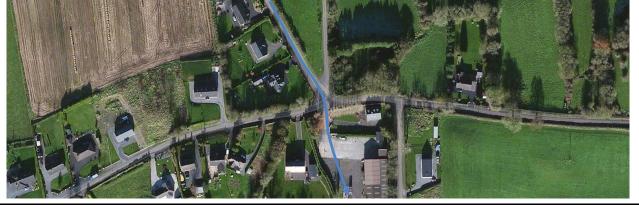
ITEM NUMBER	5.9.4	LOCATION	L1504/DUMPER DEPOT JUNCTION
DIRECTION	Continue straight at this ju	unction	
GRID REFERENCE	N 59242 60391

Wall and trees on the offside of the access to the Dumper Yard to be removed to allow access.

Ground within Dumper Yard to be assessed and, if required, upgraded to accept suitable axle loadings as per the Vestas specification.

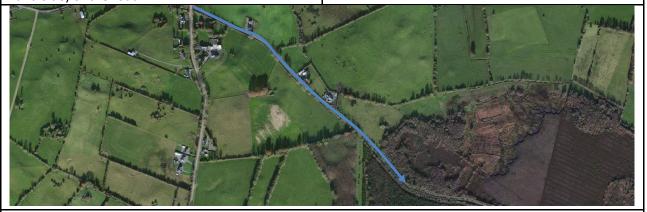
ITEM NUMBER	5.9.6	LOCATION	FULL LENGTH OF UNNAMED ROAD
DIRECTION	Continue straight at this lo	ocation	
GRID REFERENCE	N 59389 60202

The full length of the road from the Dumper Yard to site will require upgrading to the Vestas road specification.

Road requires upgrading to Vestas specification

These modifications will include road widening to the minimum stated road widths for straight sections and for bends, as well as pruning of vegetation to ensure the stipulated clear envelope is available for the turbine components.

Trees on the unnamed road will require pruning to create and envelope that meets the Vestas Specification.

Road widening to take place on the southern (right hand side) of the road

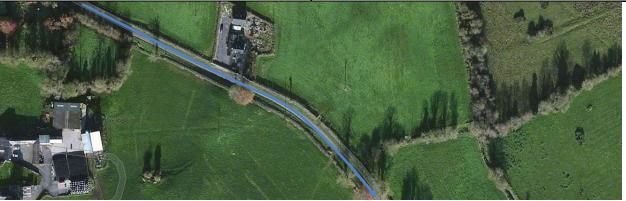
ITEM NUMBER 5.9.7 LOCATION RIGHT BEND ON UNNAMED ROAD

Road widening is required on the nearside of the road to allow the loaded blades to navigate this

bend.

Trees on the unnamed road will require pruning to create and envelope that meets the Vestas Specification.

Road widening to take place on the southern (right hand side) of the road

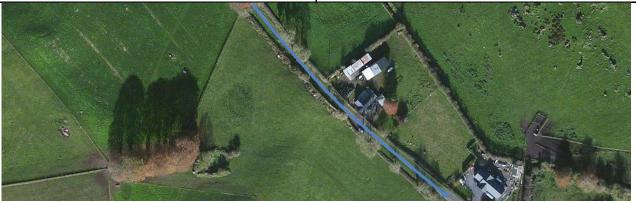
ITEM NUMBER

Vertical Analysis indicates that Loaded blade component will navigate this vertical crest with the neck of clamp raised.

Once the rear projection of blade is on the vertical crest it rises to 6.81m, overhead cables are to be checked at this location to avoid the projection colliding with them.

Trees overhanging the road will be required to be pruned to avoid damaging the blade.
