QUINTAIN DEVELOPMENTS IRELAND LIMITED

Portmarnock South Phase 1D

Stage 1 Road Safety Audit

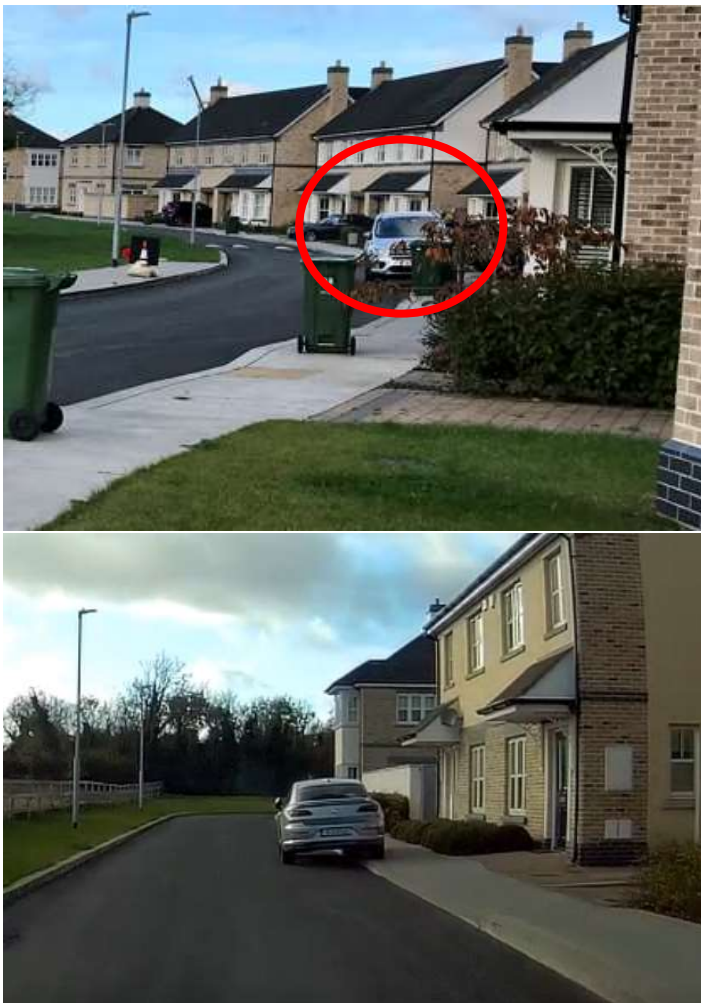
Whilst there appears to be enough parking spaces provided for the residents throughout the scheme, the visitors, service staff, delivery van drivers etc. will not have spaces available for them. Some residents might also be tempted to avoid perpendicular parking if they park for short time periods. Both scenarios might lead to vehicles being parked parallel on, or straddling, the footpath (observed during the site visit on the already constructed part of the estate), which might result in pedestrians walking on the carriageway leading to vehicle/pedestrian conflicts, or to unsafe passing manoeuvres of parked vehicles leading to potential vehicular conflicts on the carriageway.

Figure 2.2.1 Examples of cars parallel-parked straddling the footpath in the already constructed part of the estate.

A limited number of visitors' parking spots should be provided, evenly scattered around the estate.

Where there are no parking spots, footpaths should be separated from the carriageway by means of, for example, a row of vegetation, which will act as a parking deterrent.

| Paragraph No. in Report | To Be Completed by the Design Team | | | To Be Completed by the Audit Team |
|---|---|---|---|--|
| 2.2 | No | N/A | <p>The example shown in this RSA is in an earlier phase (1A), we believe this will not be an issue for this proposed phase (1D), since;</p> <ul style="list-style-type: none"> Phase 1 D is further from railway station, with no risk of non-resident parking, The last 2 Phases (1B and 1C) do not exhibit any problems on this point. Most importantly the design has evolved since Phase 1A was built in 2018 i.e. removal of undercroft parking, which resulted in some residents not using these spaces and sometimes parking on roads outside their houses. <p>Car parking design since then has not resulted in any evident issues or resident complaints.</p> | No, the audit team agree it may be less of an issue for the residents but given the size of the estate there is potential for several visitors daily, who will have nowhere to park and therefore potentially park on footpaths. |

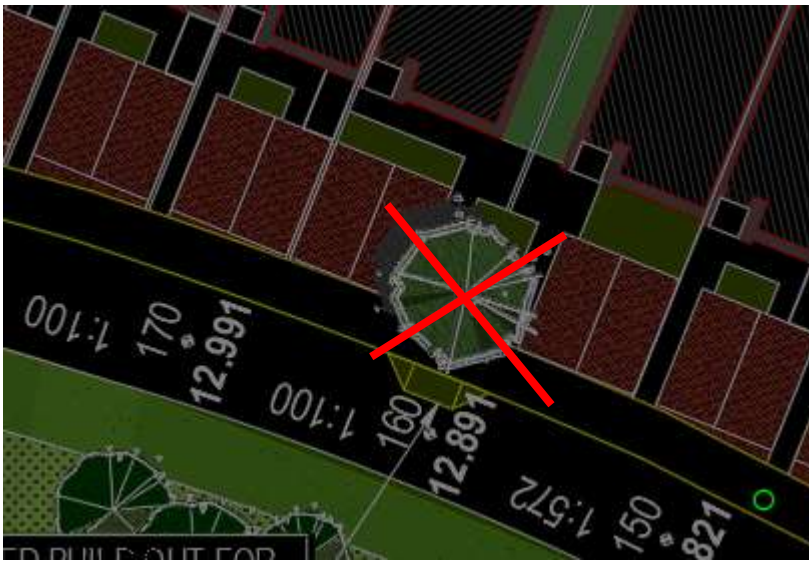
All parking spaces throughout the scheme are perpendicular, with footpaths in front. Drivers will be reversing either getting in or out of spaces and crossing the footpath with potential low visibility due to hedges, other parked vehicles (potentially large), waste bins, trees etc. This may result in drivers not seeing pedestrians in time, leading to vehicle/pedestrian conflicts on the footpath. This could be exacerbated by the likely usage of electric cars which are often front parked due to the location of the electric plug and do not emit sound and are therefore more difficult to notice in time.

Figure 2.3.1 An example of a tree proposed between the parking spots that could obscure visibility and should therefore be removed from the proposals

Ideally, footpaths should be run behind parking spots which would eliminate the problem. If this is not possible, a buffer strip should be introduced between the footpath and the parking spots, differentiated by surface type and colour, and/or with adequate road marking, to offer pedestrians an additional level of security and reaction time, and to draw drivers' attention to the likely presence of pedestrians.

Drivers should be actively encouraged to reverse-park only. This could be done by introducing an internal estate rule, and by installing "Reverse parking only" or similar signage/markings on estate entries, with reminders throughout the estate. It should be subject to a monitoring regime, similar to point 2.2 above, with gentle reminders issued to offending drivers.

No high vegetation, walls, piers or other features that could obscure visibility should be installed between the parking spots.

| Paragraph No. in Report | To Be Completed by the Design Team | | | To Be Completed by the Audit Team |
|---|---|---|---|--|
| 2.3 | Yes | Yes | Updated drawings 02014-02018 showing usage of F403 Totem Signs with 'Reverse Parking Only' information plates – sited at strategic locations around the development, are included with application. | Yes |

| | | | Note proposed trees will have 2m min. clearance to underside of crown | |

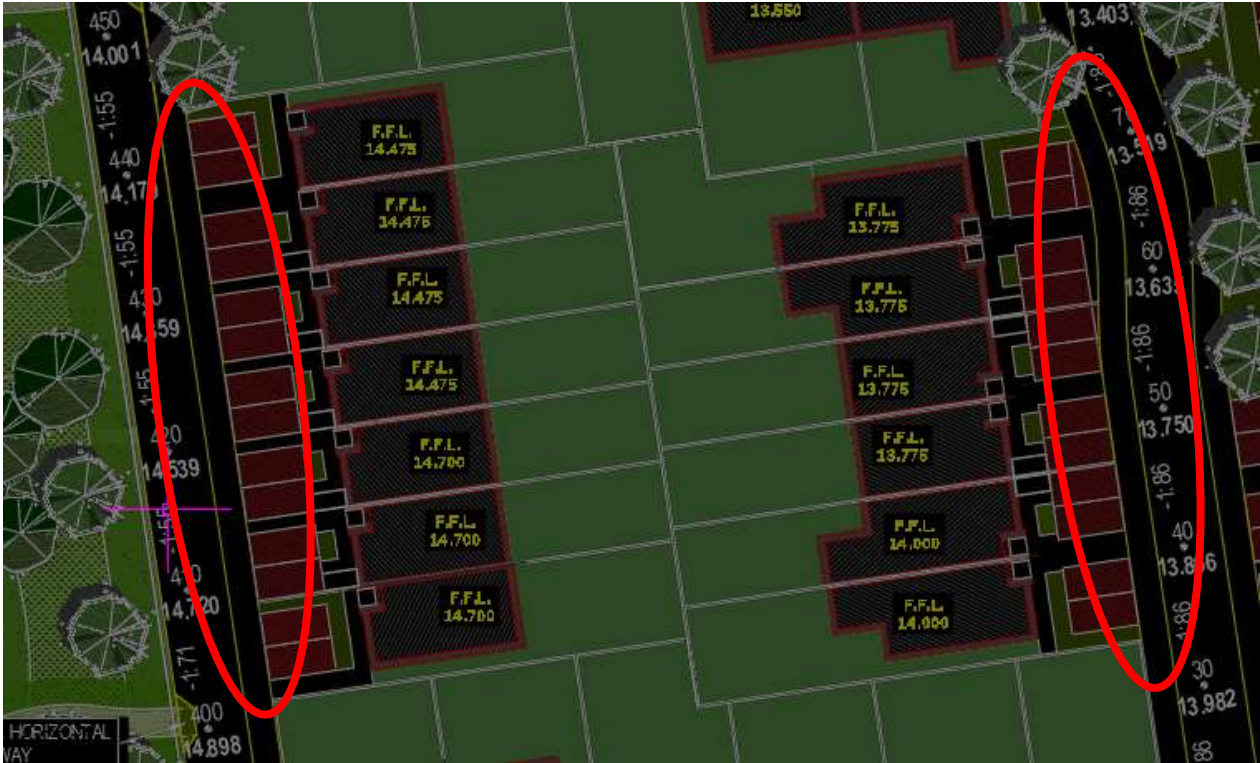
Continuous perpendicular parking spots are proposed adjacent to long stretches of roads. Detailed footpath level design has not been made available to the auditors, but presumably dropped kerbs will be proposed to enable vehicular access over the footpath. This will result in either successive undulations along the footpath, which may cause trips and falls especially for more vulnerable pedestrians, or a continuous dropped kerb over long stretches of road, which will reduce road users' perception of pedestrian priority and security on the footpath, will facilitate easier and faster driving in and out of parking spots, and could confuse the visually impaired pedestrians, all of which could lead to pedestrians being hit by vehicles.

Figure 2.4.1 Examples of long stretches of continuous perpendicular parking adjacent to footpaths

Ideally, footpaths should be run behind parking spots which would eliminate the problem. If this is not possible, careful detailed design of footpath levels should be carried out to ensure adequate balance between the road users' perception of pedestrian priority and security, and comfortable enough driveways.

Different surfacing type and colour should be applied to aid partially visually impaired pedestrians, and to highlight the potential hazards to all road users.

Adequate road marking should be introduced at the interface between the footpath and the carriageway.

| 2.4 | Yes | Partially | Utilising different colour approach. Road will be 'black' asphalt. Footpath will be 'light grey' concrete and Parking Bay will be 'dark grey' paviour – these colours achieve an LRV visual contrast of 80 and 35 respectively > than recommended LRV visual contrast of 30. | Yes |

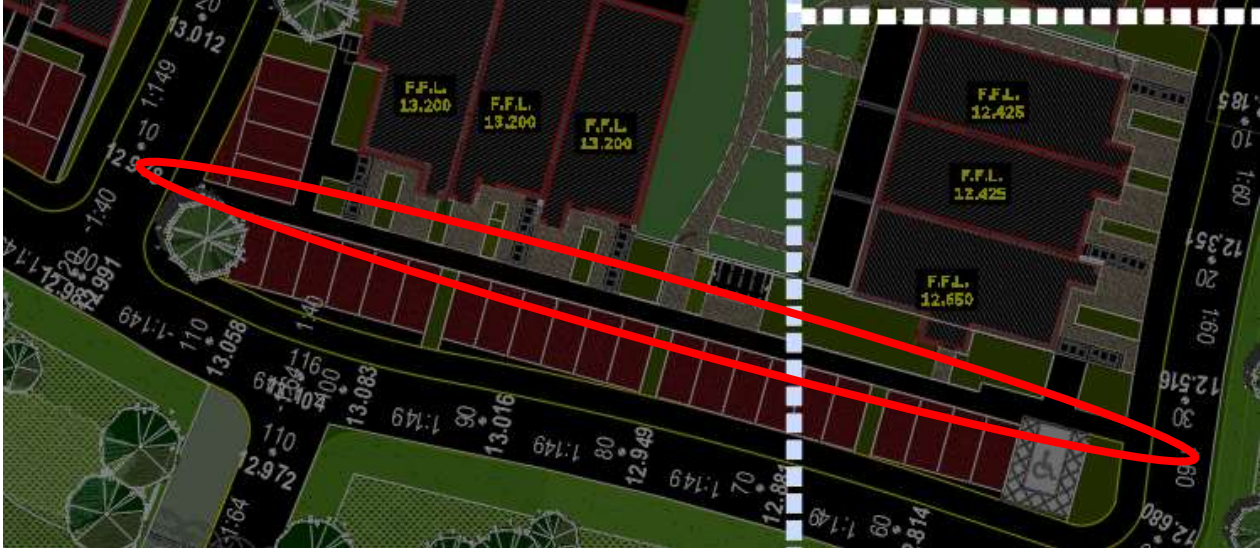
In one location on the scheme (see Figure 2.5.1) footpath is proposed both in front of and behind the perpendicular parking spaces. Vehicles parked in these spots might overhang the footpath. This could partially or fully block the footpath (narrower here than in other locations) and present an issue especially for more vulnerable road users, resulting in trips and falls.

Figure 2.5.1 Narrower footpath behind perpendicular parking spaces that might be blocked by overhanging vehicles

Wheel-stops should be provided.

| 2.5 | Yes | Yes | Wheel-stops or hard verge will be used. | Yes |

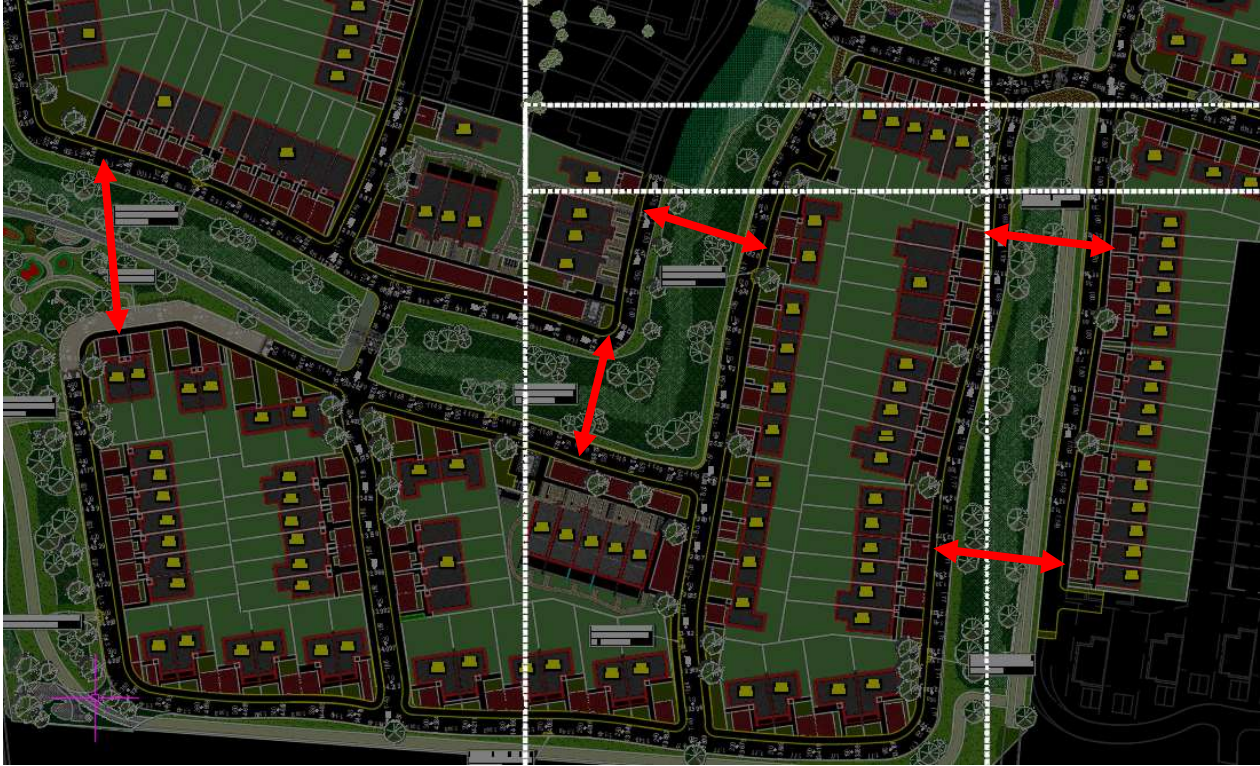
It seems that there are not enough pedestrian footway links interconnecting parts of the estate. Failure to provide good pedestrian permeability, by including pedestrian links where possible to shorten walking distances, could lead to pedestrians having to cross more roads and/or walk along carriageways, which increases their exposure to vehicular traffic and therefore could lead to pedestrian/vehicle collisions..

Figure 2.7.1 Examples of pedestrian footway links that could improve pedestrian permeability of the estate

Likely pedestrian movements and desire lines should be analysed, and more permeability footway links provided along the likely vulnerable road users desire lines as, much as possible..

| 2.7 | Partially | No | One of the Objectives (GI 9) of the Local Area Plan for these lands was to minimise disruption to the historic townland boundaries. This constrains the amount of permeability links that can be provided. We are of the opinion that the links provided match the most relevant pedestrian desire lines. | Yes |

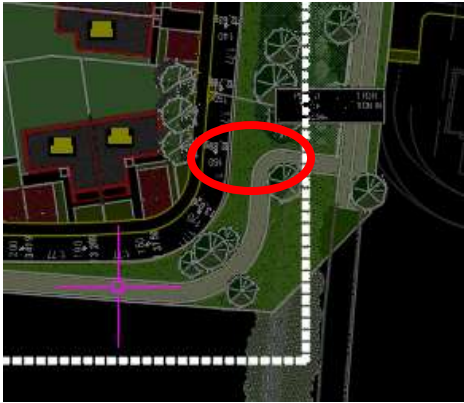
Furthermore, cyclists wishing to join the cycle/pedestrian facility at the eastern side of the estate have no convenient connection to it from the southern side of the estate.

Figure 2.8.1 Lack of convenient connection to the cycle/pedestrian facility at the south-eastern end of the estate

The southern and western perimeter walkway should be designated a cycle/pedestrian facility, It should be of sufficient width and detail, with adequate signage, and with adequate and convenient connection points.

| 2.8 | Yes | Yes | Updated drawing 02005 showing proposed connections to this shared surface path, are included with this application. | Yes |

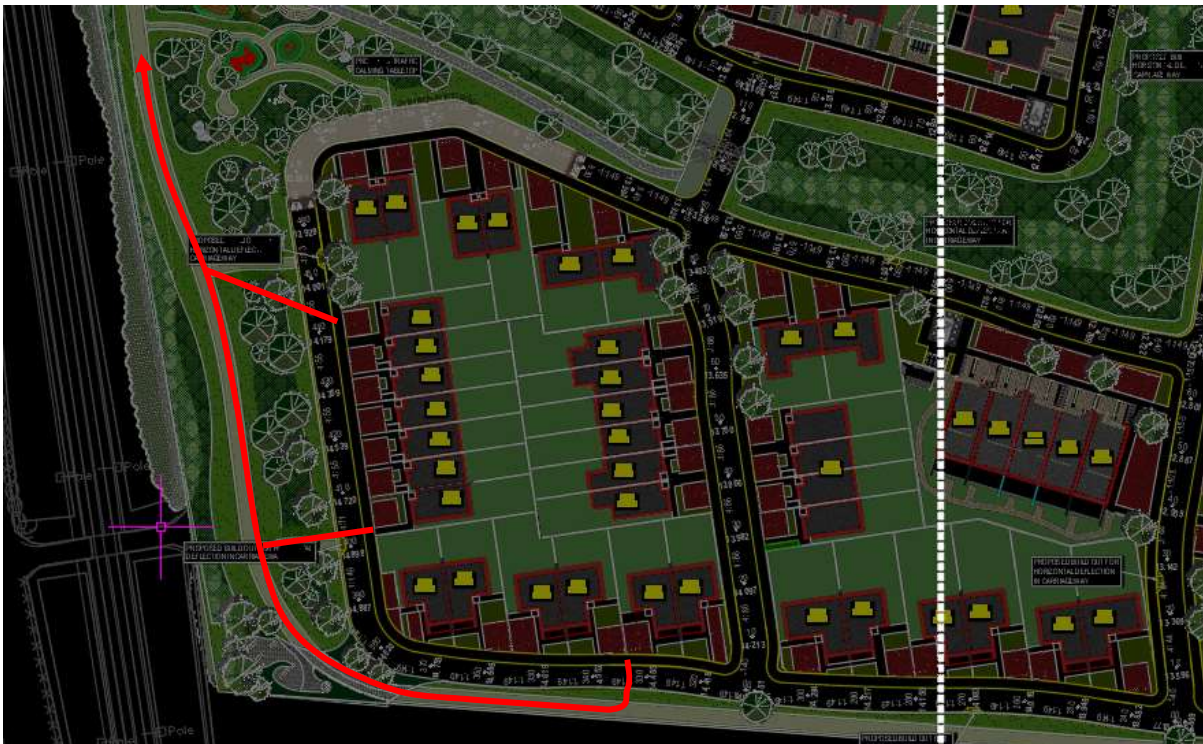
The walkway around the southern and western perimeter of the estate appears to be for pedestrian use only. It is considered quite likely that residents of the south-western quadrant of the estate wishing to cycle north will use this walkway rather than the estate roads. Lack of clarity with regards its function may confuse the users and lead to cyclist/pedestrian conflicts as pedestrians may not be expecting cyclists on the walkway.

Figure 2.8.2 Likely path taken by south-western quadrant residents wishing to cycle north

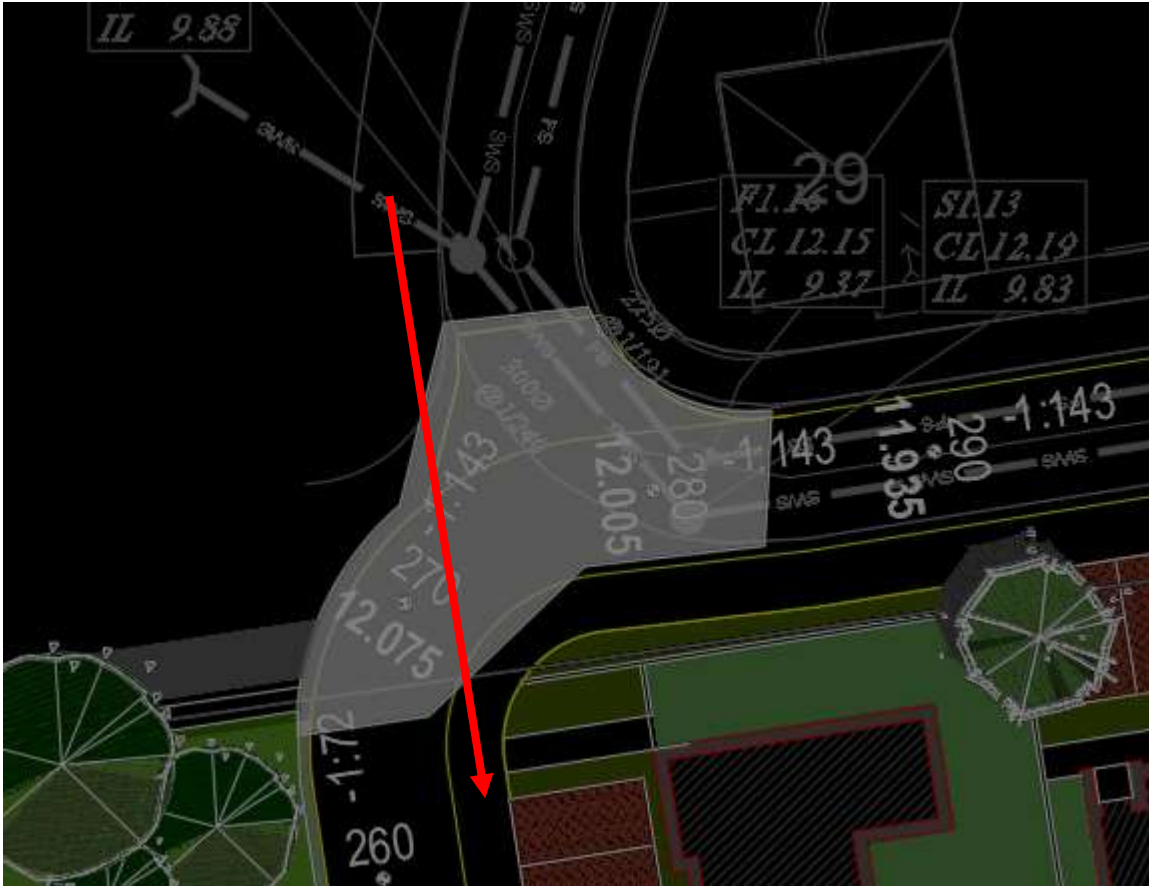
The pedestrian path near the north-western end of the scheme ends abruptly. Whilst this is part of the existing environment, it is affected by the proposals in that there will be more pedestrian journeys and desire lines in this location after the construction of the next phase of the development is finalised. This could lead to pedestrians crossing the road in random locations, and potentially walking through grassed area, which could result in trips and falls, and/or vehicle/pedestrian conflicts.

Figure 2.9.1 Discontinuous pedestrian facility and likely pedestrian desire line

Continuous pedestrian footpath, with adequate crossing facilities where required, should be provided along the likely desire lines.

| 2.9 | Yes | Yes | Existing footpath will be connected to proposed footpaths. | Yes |

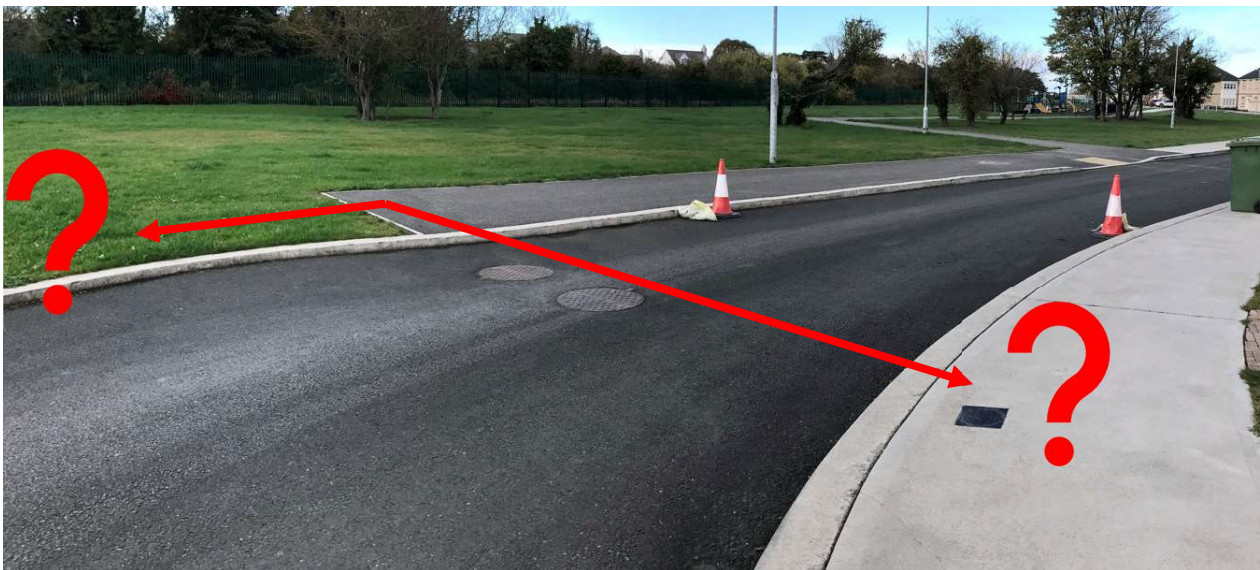
Figure 2.9.2 Currently constructed discontinuous pedestrian facility

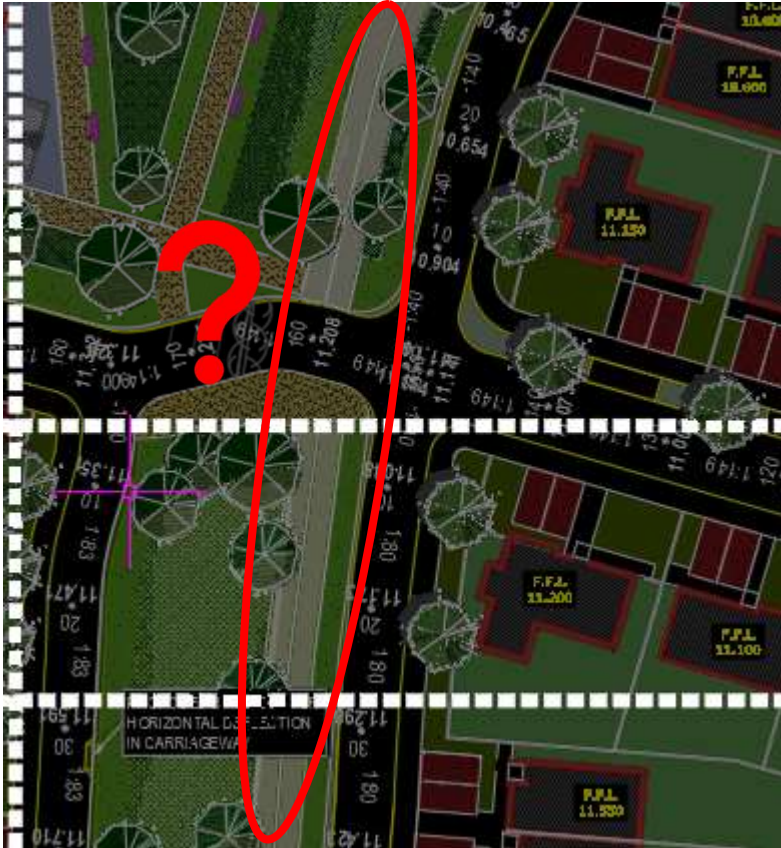
It is unclear what the purpose of the facility running along the eastern side of the scheme is. If this is meant to be a pedestrian/cycle facility, there are a number of potential safety issues that need to be addressed i.e. cross sectional detail, road crossings arrangement, signs and marking, pavement etc. Failure to provide adequate details for the pedestrian/cycle way could result in various cycle/pedestrian, and cycle/vehicle conflicts and/or cyclist loss of control incidents..

Figure 2.10.1 Facility at the eastern side of the scheme, with unclear purpose and design

Purpose of this facility should be clearly defined, and adequate design details incl. pavement, levels, signs and markings, crossing details etc should be developed to improve various aspects of road users' safety.

| 2.10 | Yes | Yes | Updated drawing 02004 showing proposed table top ramp at this location connecting shared surface path, are included with application. | Yes |

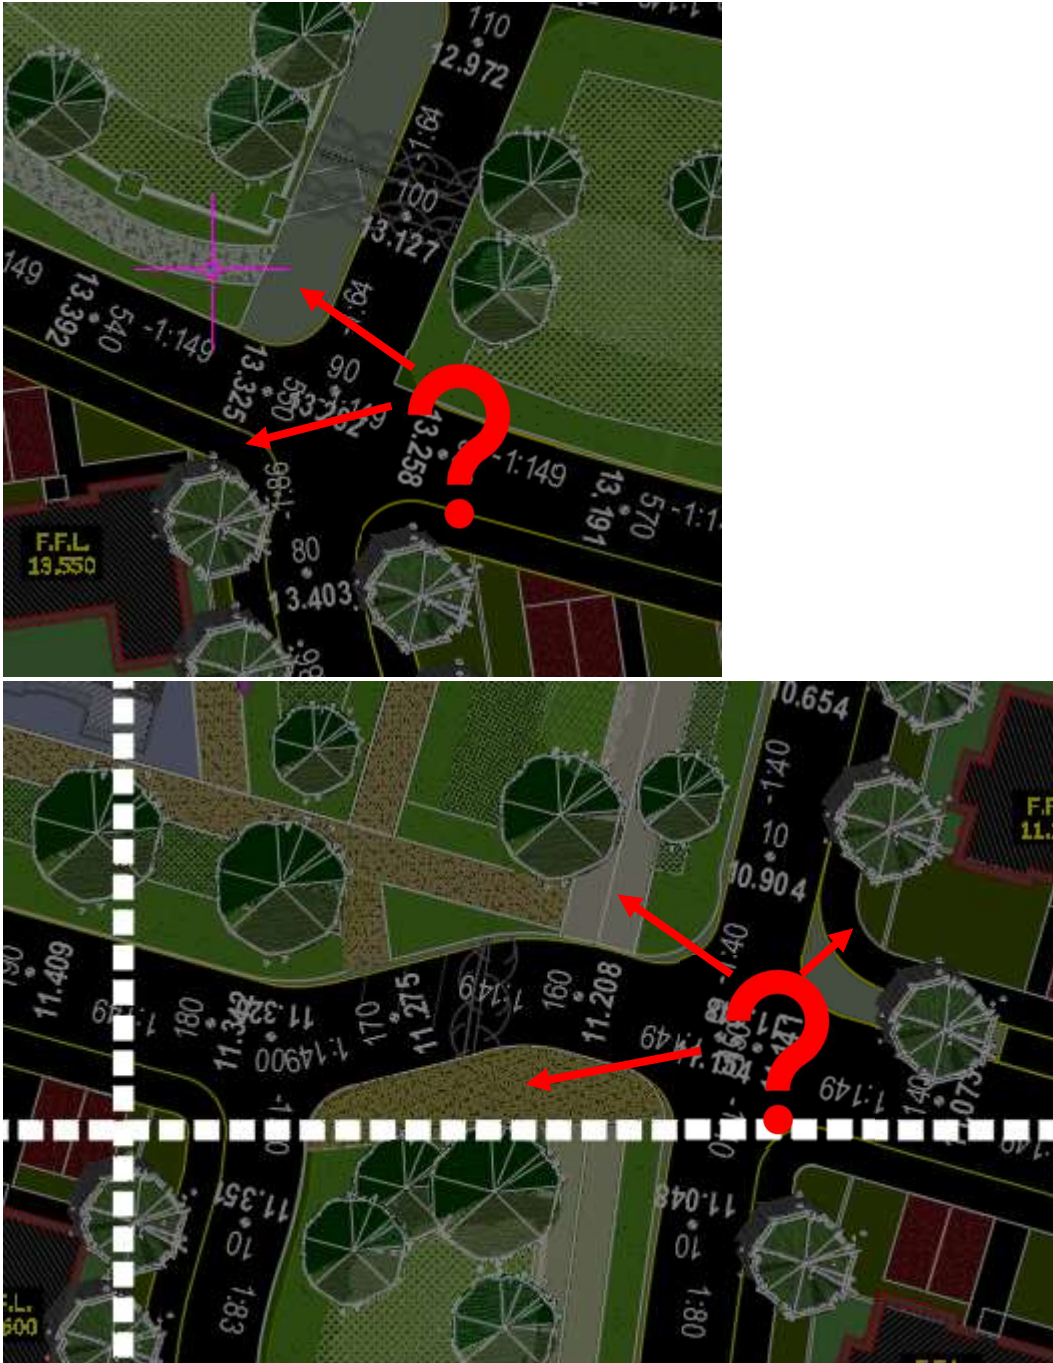
Details of paving surfaces have not been made available to the auditors, but it is understood from the drawing that several surface types are proposed for footways throughout the scheme. Whilst it is acknowledged that different surfaces may be used in recreational spaces like parks and playgrounds, the use of varying surfaces throughout the scheme without clear reasons for change could confuse visually impaired pedestrians, resulting in them coming into a conflict with vehicles. Consistency of design is one of the key features of a safe design for visually impaired pedestrians.

Figure 2.11.1 Examples of various footway surfaces used throughout the scheme

Footway surfaces should be consistent throughout the scheme as much as possible, and ideally matching those of adjacent phases of this development.

| 2.11 | Yes | Yes | Primarily three surface types proposed for 'paths' – Concrete for Footpaths, Asphalt for Shared Surface Paths and Gravel for Park Paths. | Yes |

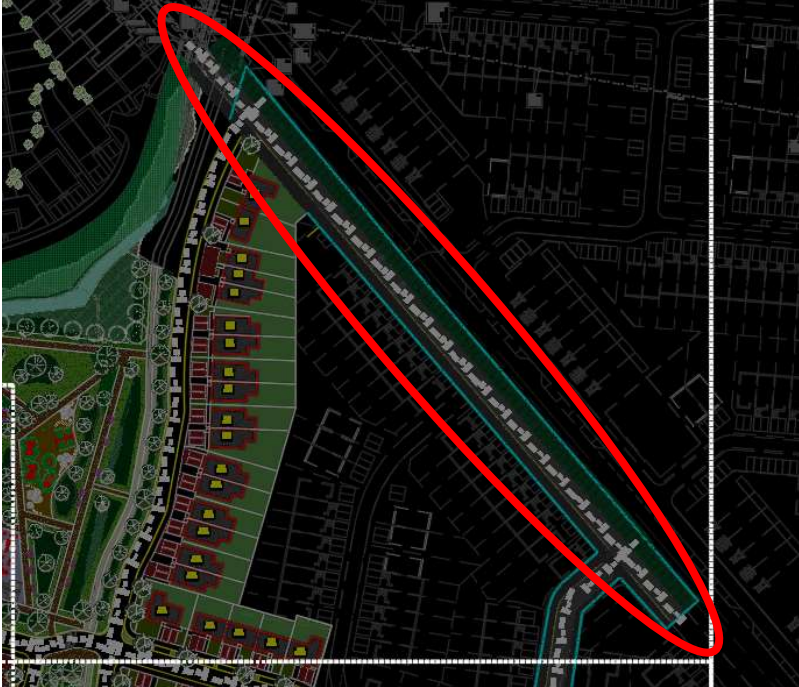
There is a relatively long straight proposed at the north-eastern side of the proposed scheme, which, at 6m, is also wider than other internal estate roads. Such layout may encourage speeds inappropriate for the housing estate, and as a result could lead to various collisions on this stretch of road. This could at some point be more exacerbated as the future development appears to include further extension of this road.

Figure 2.12.1 The relatively long and wide straight at the north-eastern end of the scheme

Traffic calming design integral with the road layout should be incorporated along this stretch.

| 2.12 | Yes | Yes | Updated drawings 02003 and 02004 showing proposed table top ramps at junction locations on these sections of the road, are included with this application. | Yes |

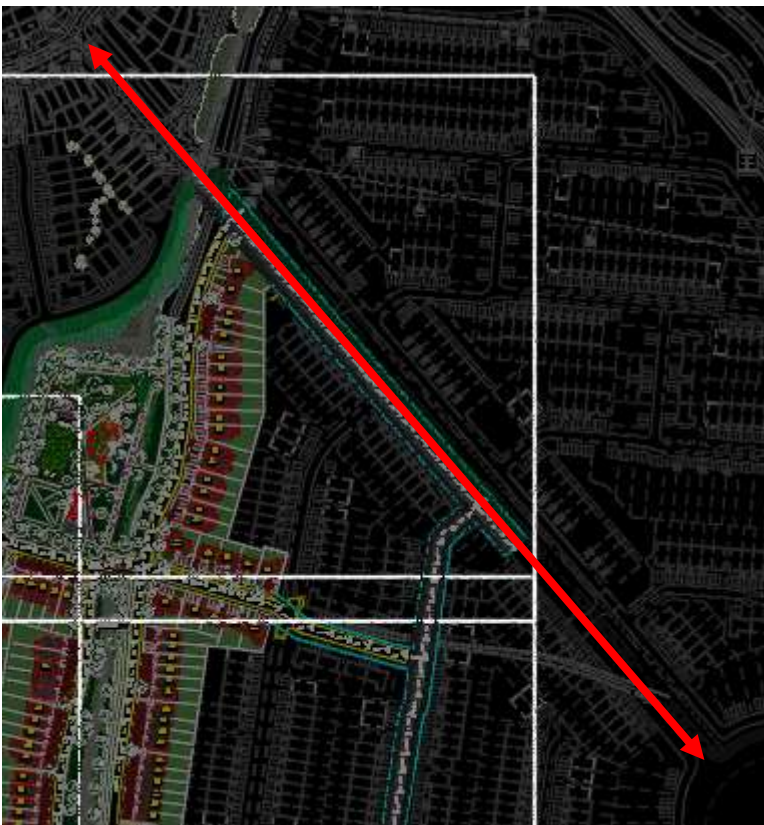
Figure 2.12.2 Potential future extension of this straight

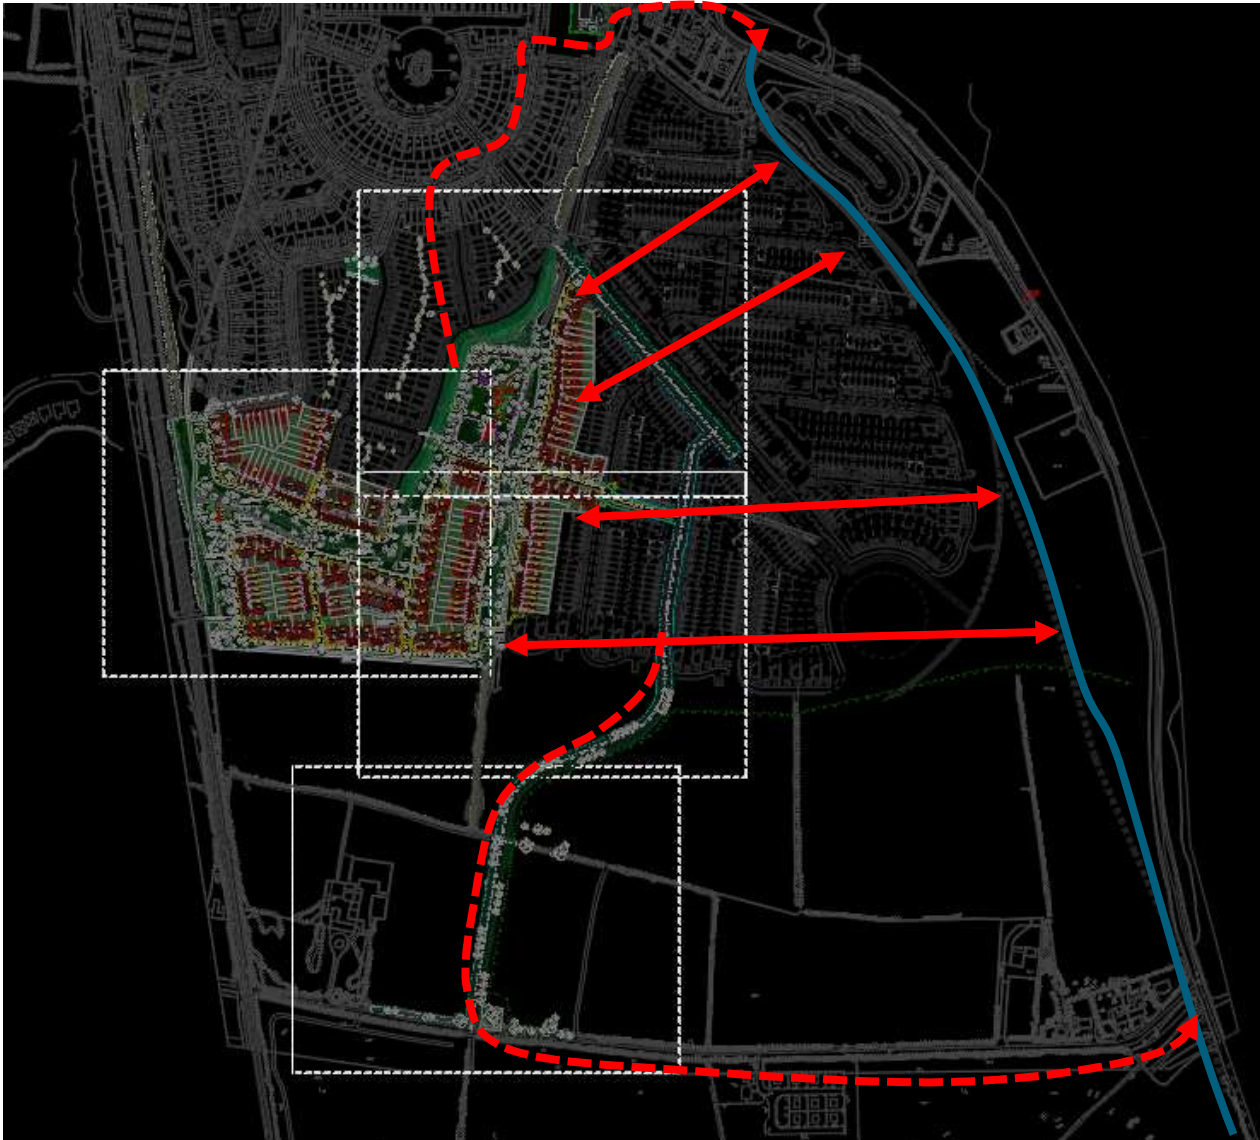
It is likely that the Portmarnock Greenway will attract a considerable number of estate residents to walk and cycle, but details of pedestrian and cycle connections of the estate with the greenway, that may be proposed as part of this and future development phases, are unclear. Failure to provide safe, direct, and comfortable connections may lead to vulnerable road users getting to the greenway using other existing public road links that may carry heavier traffic and have poor or no facilities for vulnerable road users, resulting in vulnerable road users' exposure to conflicts with vehicular traffic.

Figure 2.13.1 Portmarnock Greenway (blue) and the potential unsafe routes vulnerable road users might take (dashed red arrows) in the absence of direct connections (red arrows)

Safe, direct, and comfortable connections from the estate to the Portmarnock Greenway should be provided for vulnerable road users during all development stages.

| 2.13 | Yes | No | Given the scale of this development, it is being delivered in phases (3 phases currently delivered), therefore as each | Yes |

| | | | phase is put forward for planning approval, the relevant connections are being provided in accordance with the principles of the LAP, however it would be unreasonable to expect connections associated with future phases to be delivered until such time as those phases are fully designed and planning permission sought and attained. | |

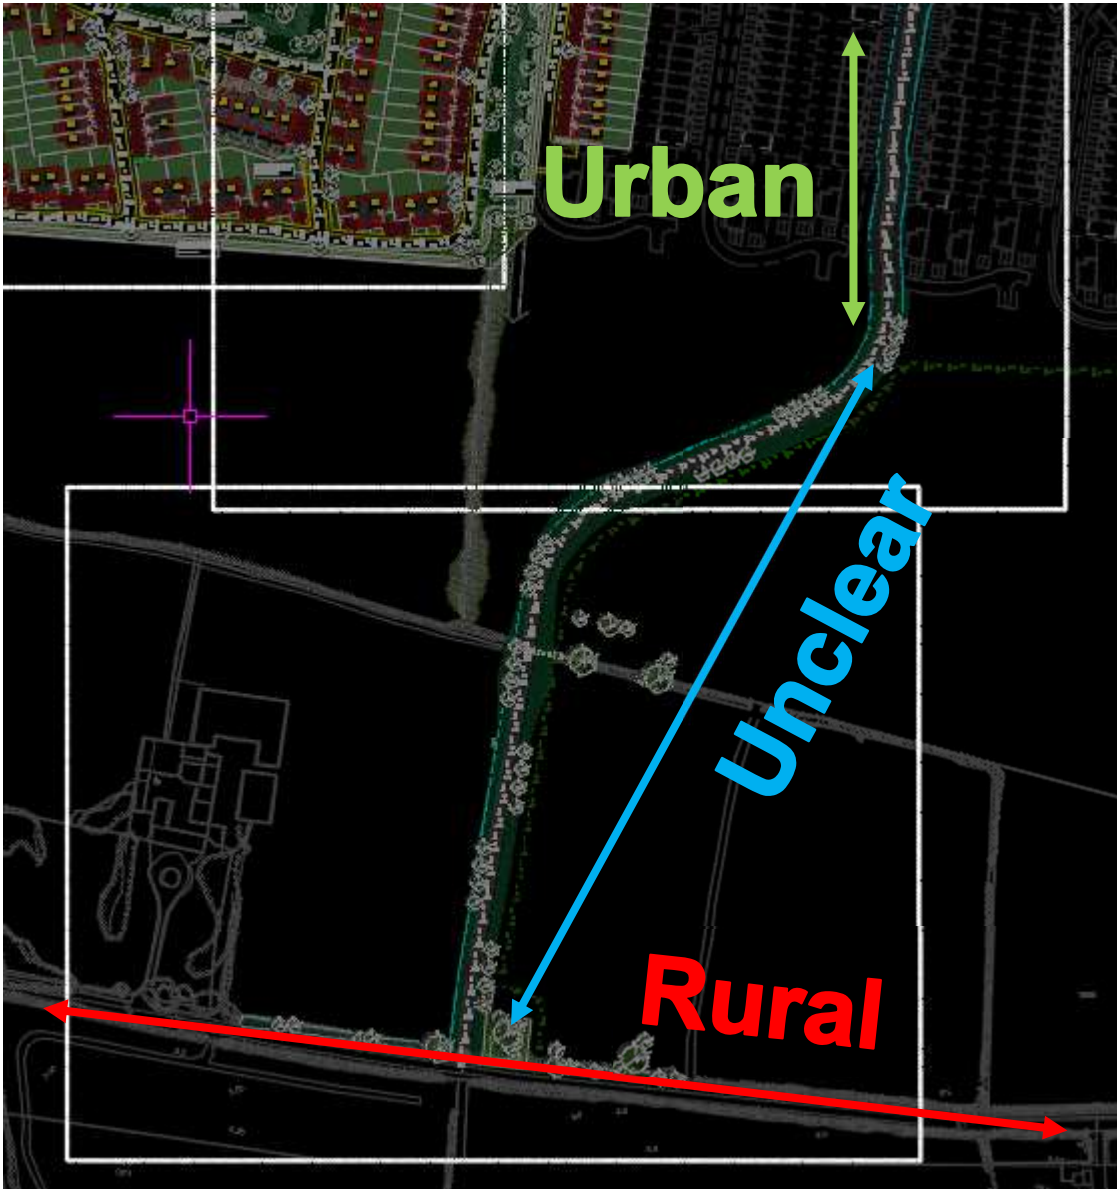
The details (like kerbs, road markings, public lighting) of the proposed access road connecting Moyne Road with the estate have not been made available to the auditors but it seems that the road environment over the southern section of this road is of unclear character. On the estate side it is urban with kerbs, footpaths, and artificial bends acting as traffic calming features, but on leaving the estate it suddenly becomes rather rural (no kerbs and footpaths, with vegetated verges), although with sharp curves. Drivers (especially going north from Moyne Road which is very rural in character despite the 60km/h speed limit) may misinterpret this road environment for a rural road, which could result in speeding, potentially leading to loss of control at sharp curves, and/or not slowing down enough on entering the estate, thus increasing the likelihood of conflicts with pedestrians. This could be exacerbated by darkness in the absence of public lighting.

Figure 2.14.1 Section of the access road where road environment seems unclear in character

Adequate signs and markings should be introduced for drivers entering and leaving the estate to make them aware of the changing road environment and the presence of sharp curves.

Public lighting should be installed along this stretch of road.

Suitable speed limit should be introduced.

| 2.14 | Yes | Yes | Lighting of this road is being provided. Updated drawing 02014 showing proposed entrance ramp and totem and speed (30kph) signage to raise drivers awareness they are entering an urban environment, are included with this application. | Yes |

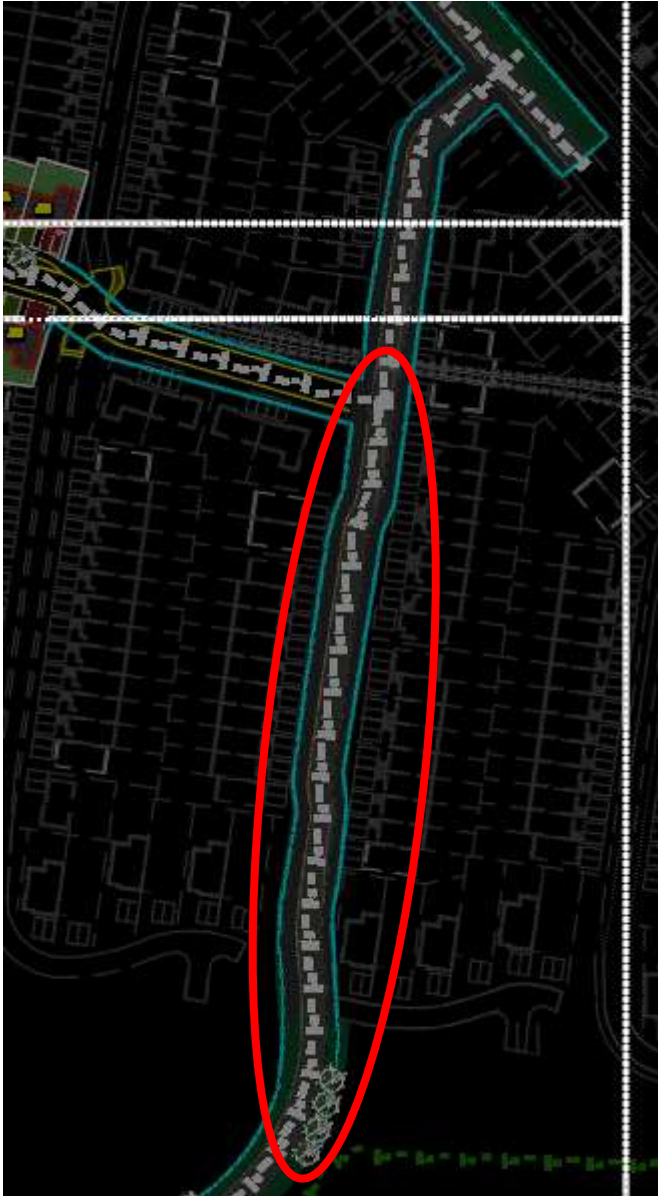
It is understood that the access to Moyne Road will be constructed as part of Phase 1D, but the adjoining houses and other infrastructure will only form part of future phases. This will result in the access road running through greenfield and/or construction site in the interim arrangement, which may cause drivers to be disoriented and confused especially during the time of darkness. This can lead to drivers not reading the road environment properly resulting in side swipe and loss of control collisions due to traffic calming features like bends and kinks in the alignment, and also loss of control collisions where the future extensions of the road are temporarily fenced off.

Figure 2.15.1 Bends and kinks in the alignment that may not be expected by drivers in the interim scenario, and may be hard to see in darkness

Public lighting should be provided along the access road.

In the interim scenario, reflective chevrons or other adequate signs should be provided on road edges at alignment kinks.

| 2.15 | Yes | Yes | Lighting of this road is being provided. Chevrons will be provided at key turning points. | Yes |

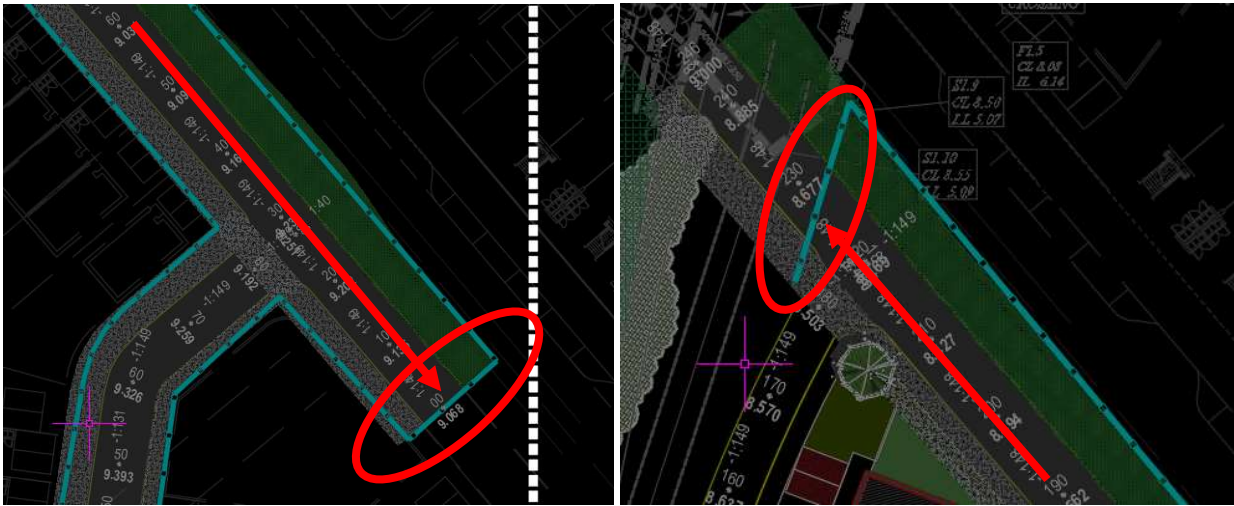
Figure 2.15.2 The fenced off extensions of the straight section of road that could mislead drivers in darkness

In the interim scenario, reflective chevrons or other similar signs should be installed on fences running across the straight section of road to highlight the presence of fencing during darkness.

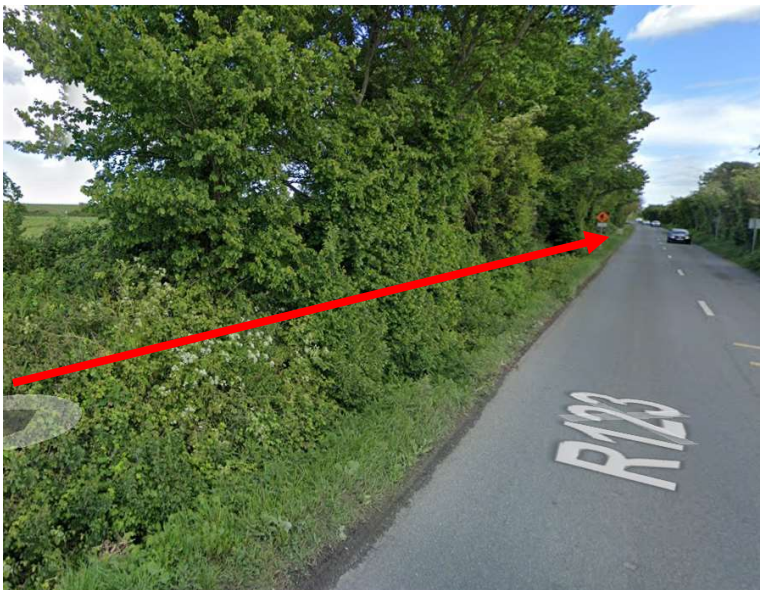
There is inadequate visibility in both directions where the proposed access road adjoins Moyne Road. Failure to provide adequate visibility to and from the junction could lead to angle, loss of control, and rear end collisions on the proposed junction.

Figure 2.16.1 Looking left along Moyne Road from the proposed access point (source: Open-source street view photography)

Adequate visibility to and from the junction should be provided in both directions where the proposed access road adjoins Moyne Road.

| 2.16 | Yes | Yes | Adequate sight distances are being achieved by removing and re-planting hedgerow to provide 90m x 2.4m visibility splays for a junction onto a 60kph road. | Yes |

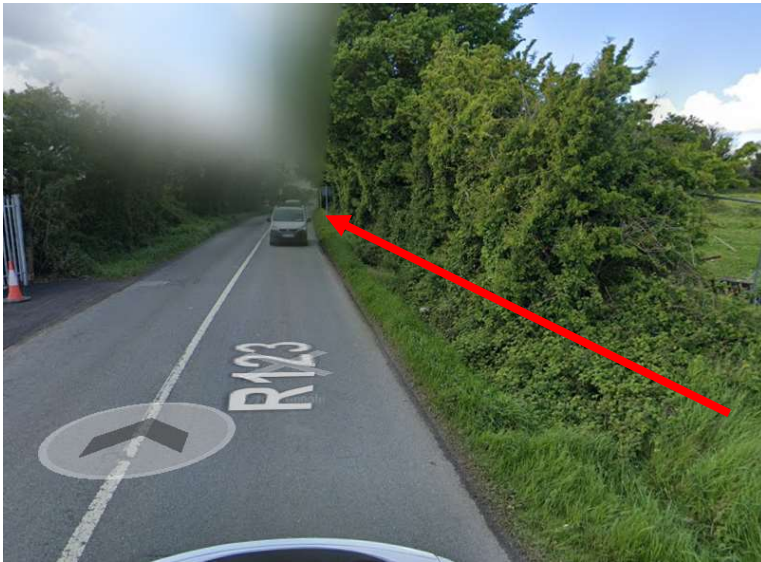
Figure 2.16.2 Looking right along Moyne Road from the proposed access point (source: Open-source street view photography)

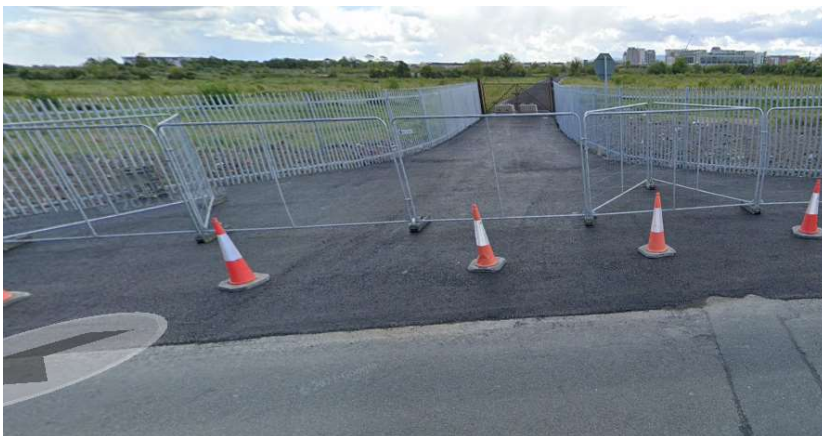
There is an existing temporary site access opposite to where the proposed estate access road adjoins Moyne Road. When constructed, it would form a crossroads on Moyne Road which, despite the 60km/h speed limit, is quite rural in character. Crossroads in rural road environment are known to cause serious road safety problems due to confusion regarding right-of-way, a see-through issue and resulting potential junction overshooting, as well as adding unnecessary complexity resulting in more potential conflict points.

Figure 2.17.1 The existing temporary site access opposite the proposed estate access (source: Open-source street view photography)

The temporary site access should be removed prior to opening of the estate access to general traffic. Chevron signs and/or shielding by vegetation or other features should be provided to ensure no see-through problem remains by leaving a section of the temporary access in place.

If the temporary site access was to be changed into a permanent entry, the junction layout should be revised and either a staggered junction, a signalised junction, or a roundabout be introduced.

| 2.17 | Yes | Yes | This is a temporary access road to construction compound on the southern side of Moyne Road. We will review and rectify as required prior to opening of estate access road to general traffic. | Yes |

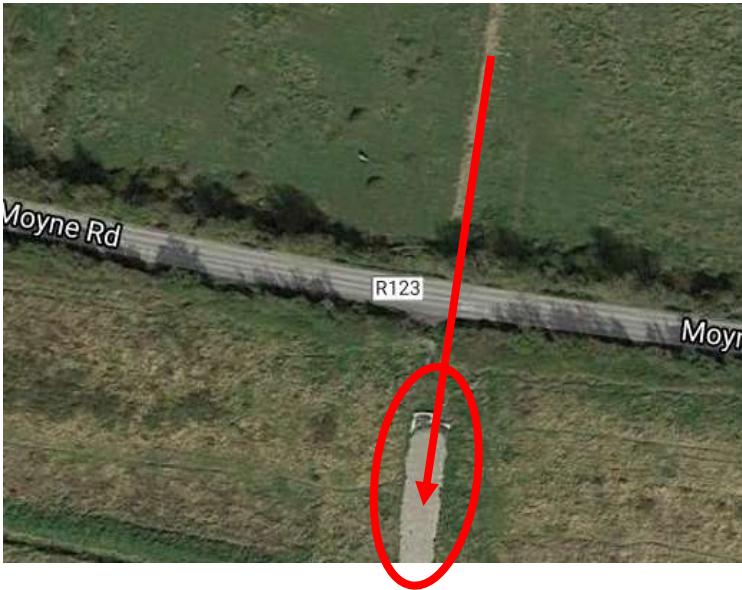
Figure 2.17.2 Aerial photo from before the access was constructed showing the existing road that could cause a see-through problem even if the access is blocked (source: Open-source aerial photography)
