### Refurbishment & Demolition Asbestos Survey

**Location:** *8 – 9 Moore Street & 10 – 12 Moore Lane  
[The Paris Bakery]  
Dublin 1*

**Client:** *Dublin Central GP Ltd*

**Survey Date:** *29<sup>th</sup> and 30<sup>th</sup> September, 2020*

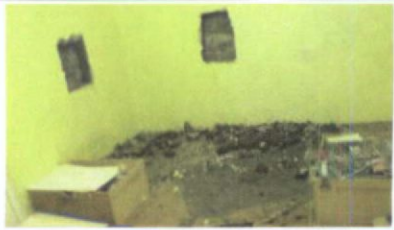
Ref No.	Building or Area of Site	Location or Functional Space	Sample No.	Material Description, surface treatment and condition	Extent	Asbestos identified (presumed, strongly presumed or identified)	Product type	Condition	Surface treatment	Asbestos type	Material assessment score	Recommendations	Photo
5	10 Henry Place	Ground floor Back room		Concrete under lino		NAD
