DCC PLAN NO. 2861/21
 RECEIVED 01/06/2021

Refurbishment & Demolition Asbestos Survey

Location: *9 Henry Place
Dublin*

Survey Date: *2nd October, 2020*

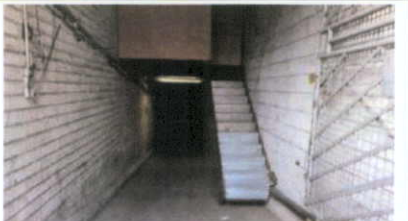
2	13 Moore Lane	Rear loading bay ramp				No visible asbestos containing materials identified.

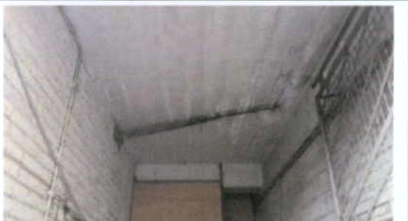
3	13 Moore Lane	Rear loading bay				No visible asbestos containing materials identified.
